Aquatic Resources Delineation Report

Bridge M-22-U

FINAL

January 2021

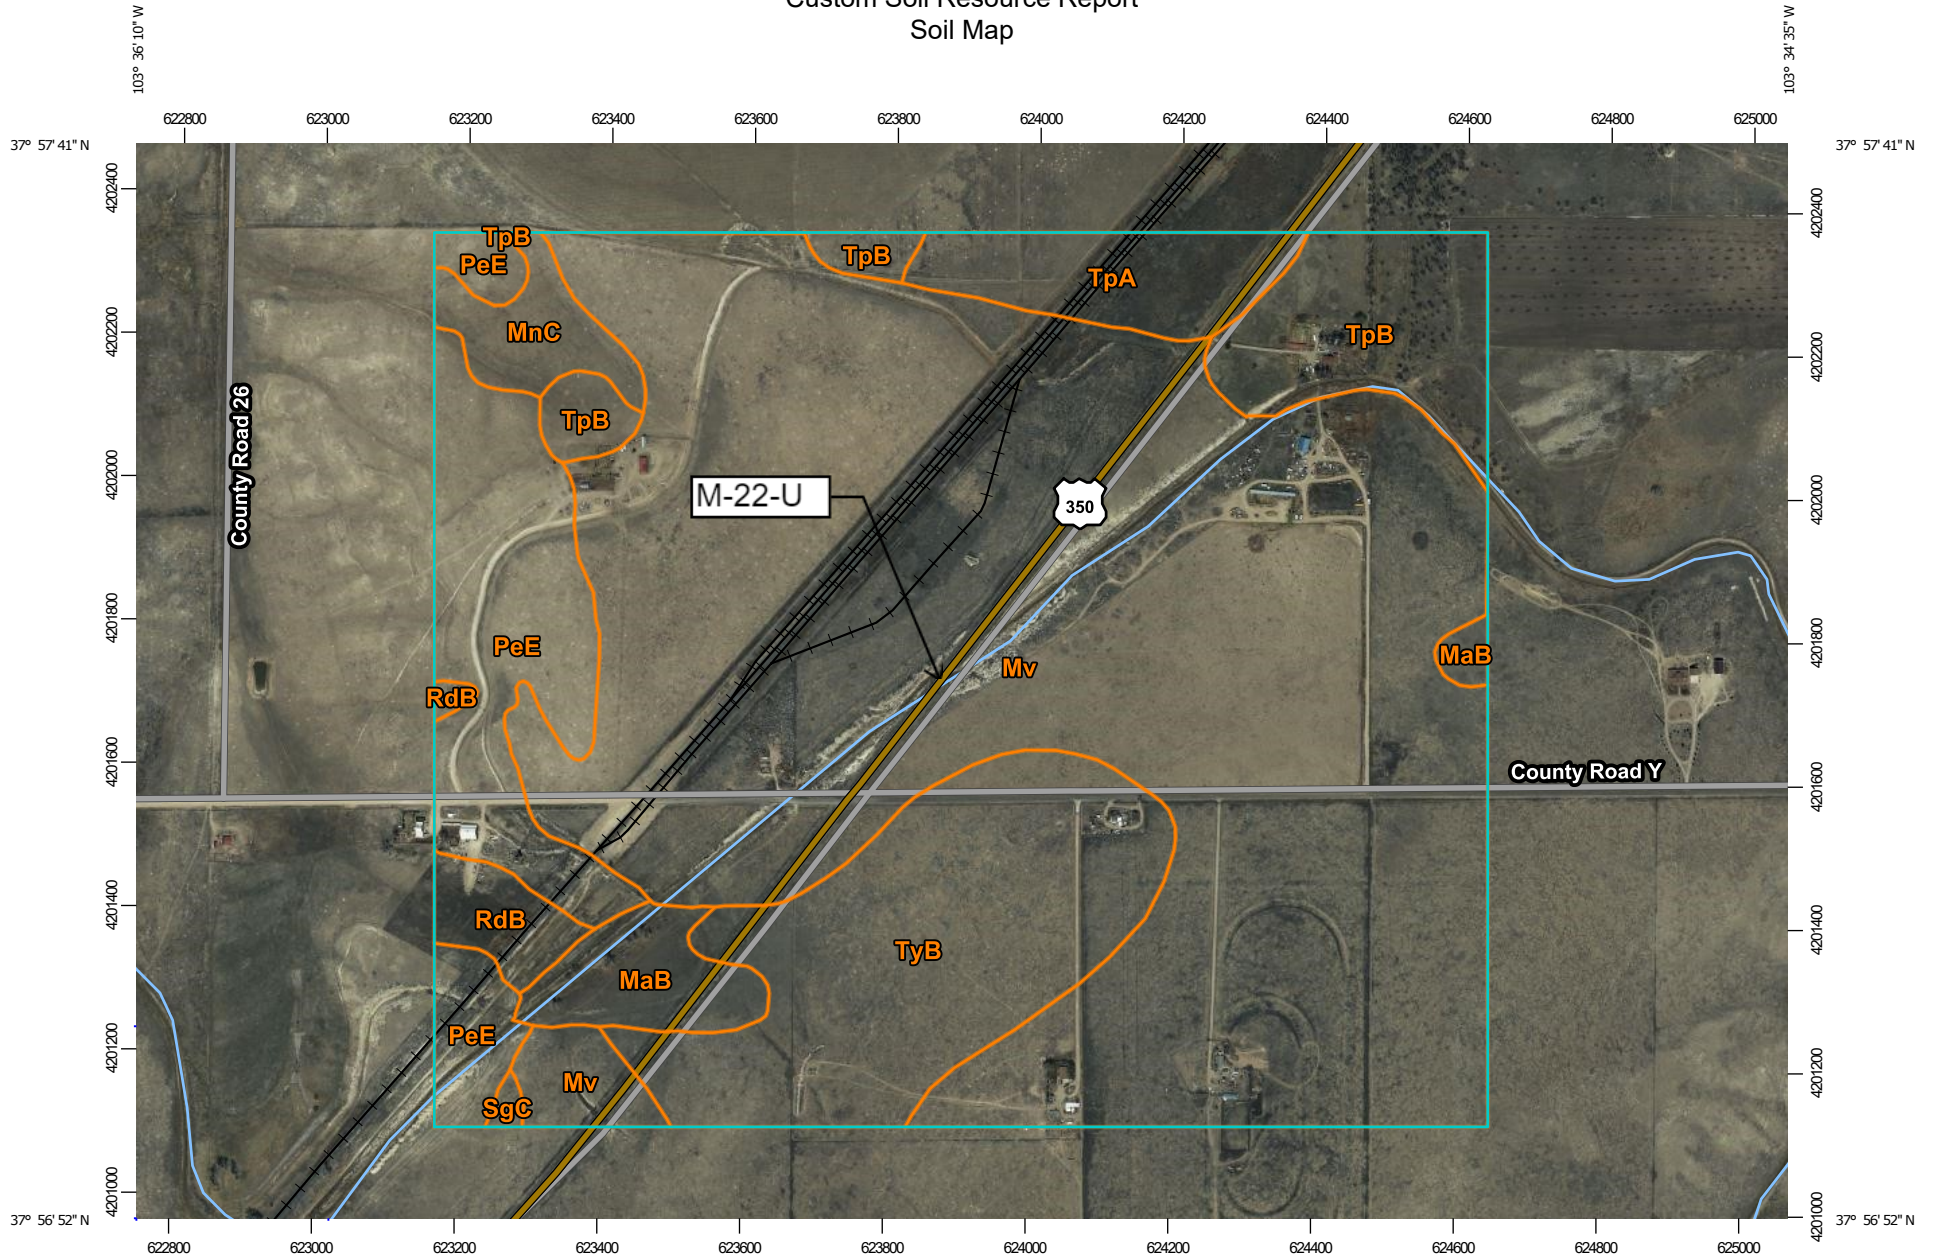
Custom Soil Resource Report Soil Map

The soil map section includes the soil map for the defined area of interest, a list of soil map units on the map and extent of each map unit, and cartographic symbols displayed on the map. Also presented are various metadata about data used to produce the map, and a description of each soil map unit.

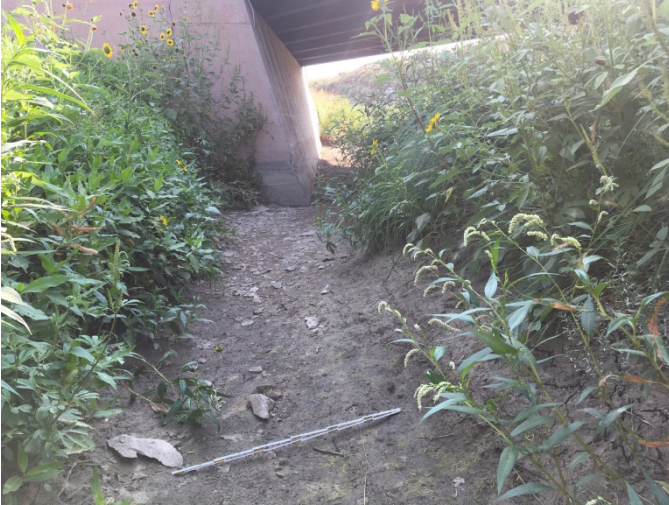
Photo 1.
Otero Canal, looking east and downstream towards the bridge abutments, at cross section A. OHWM can be seen on the abutment as staining, and starting below the overgrown bankside vegetation.

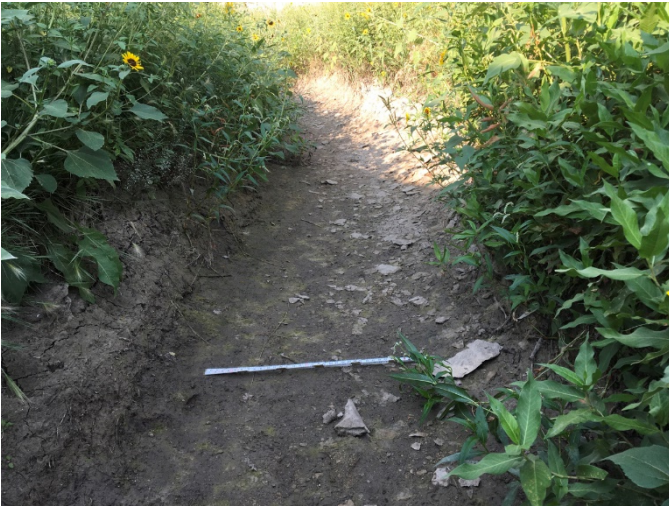
Photo 2.
Otero Canal, looking southwest and upstream away from the bridge, from cross section A. OHWM can be seen starting below the overgrown bankside vegetation.

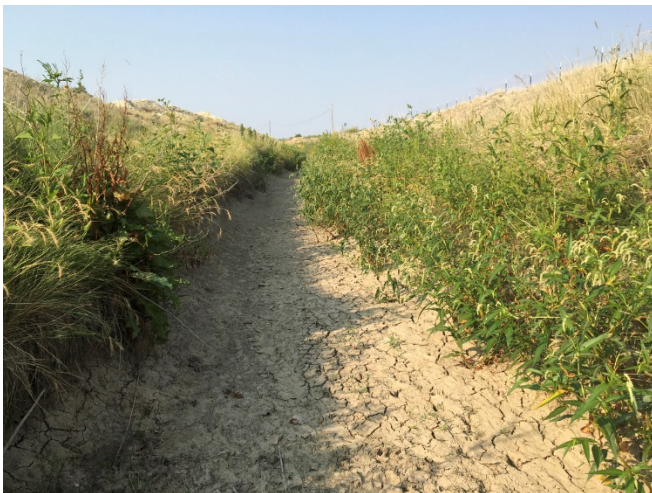
Photo 3.
Otero Canal, looking southwest towards the bridge (in the far distance). Bank sides less steep in places along this section of the canal.

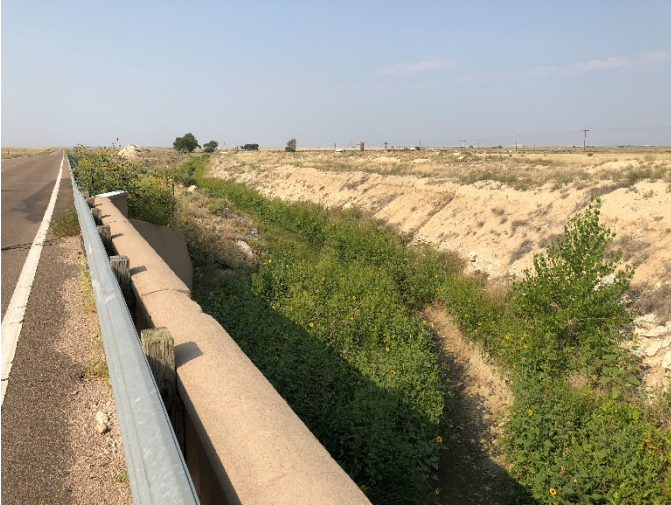
Photo 4.

Otero Canal, looking southwest from the bridge at entire upstream section of the canal. Note the high canal sediment castings lining the tops of the banks from years of maintenance of the canal.

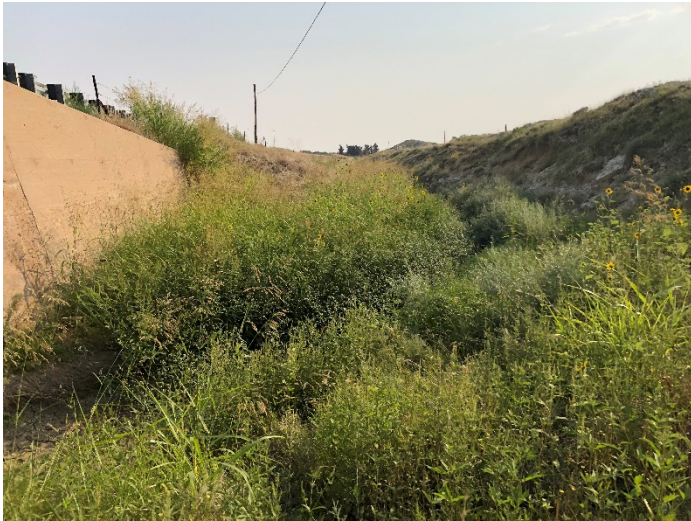
Photo 5.

Otero Canal, looking northeast and upstream of bridge. Upper top of the banks on east side (photo right) are steep and very tall.
