Aquatic Resources Delineation Report

Bridge M-22-Y

FINAL

January 2021

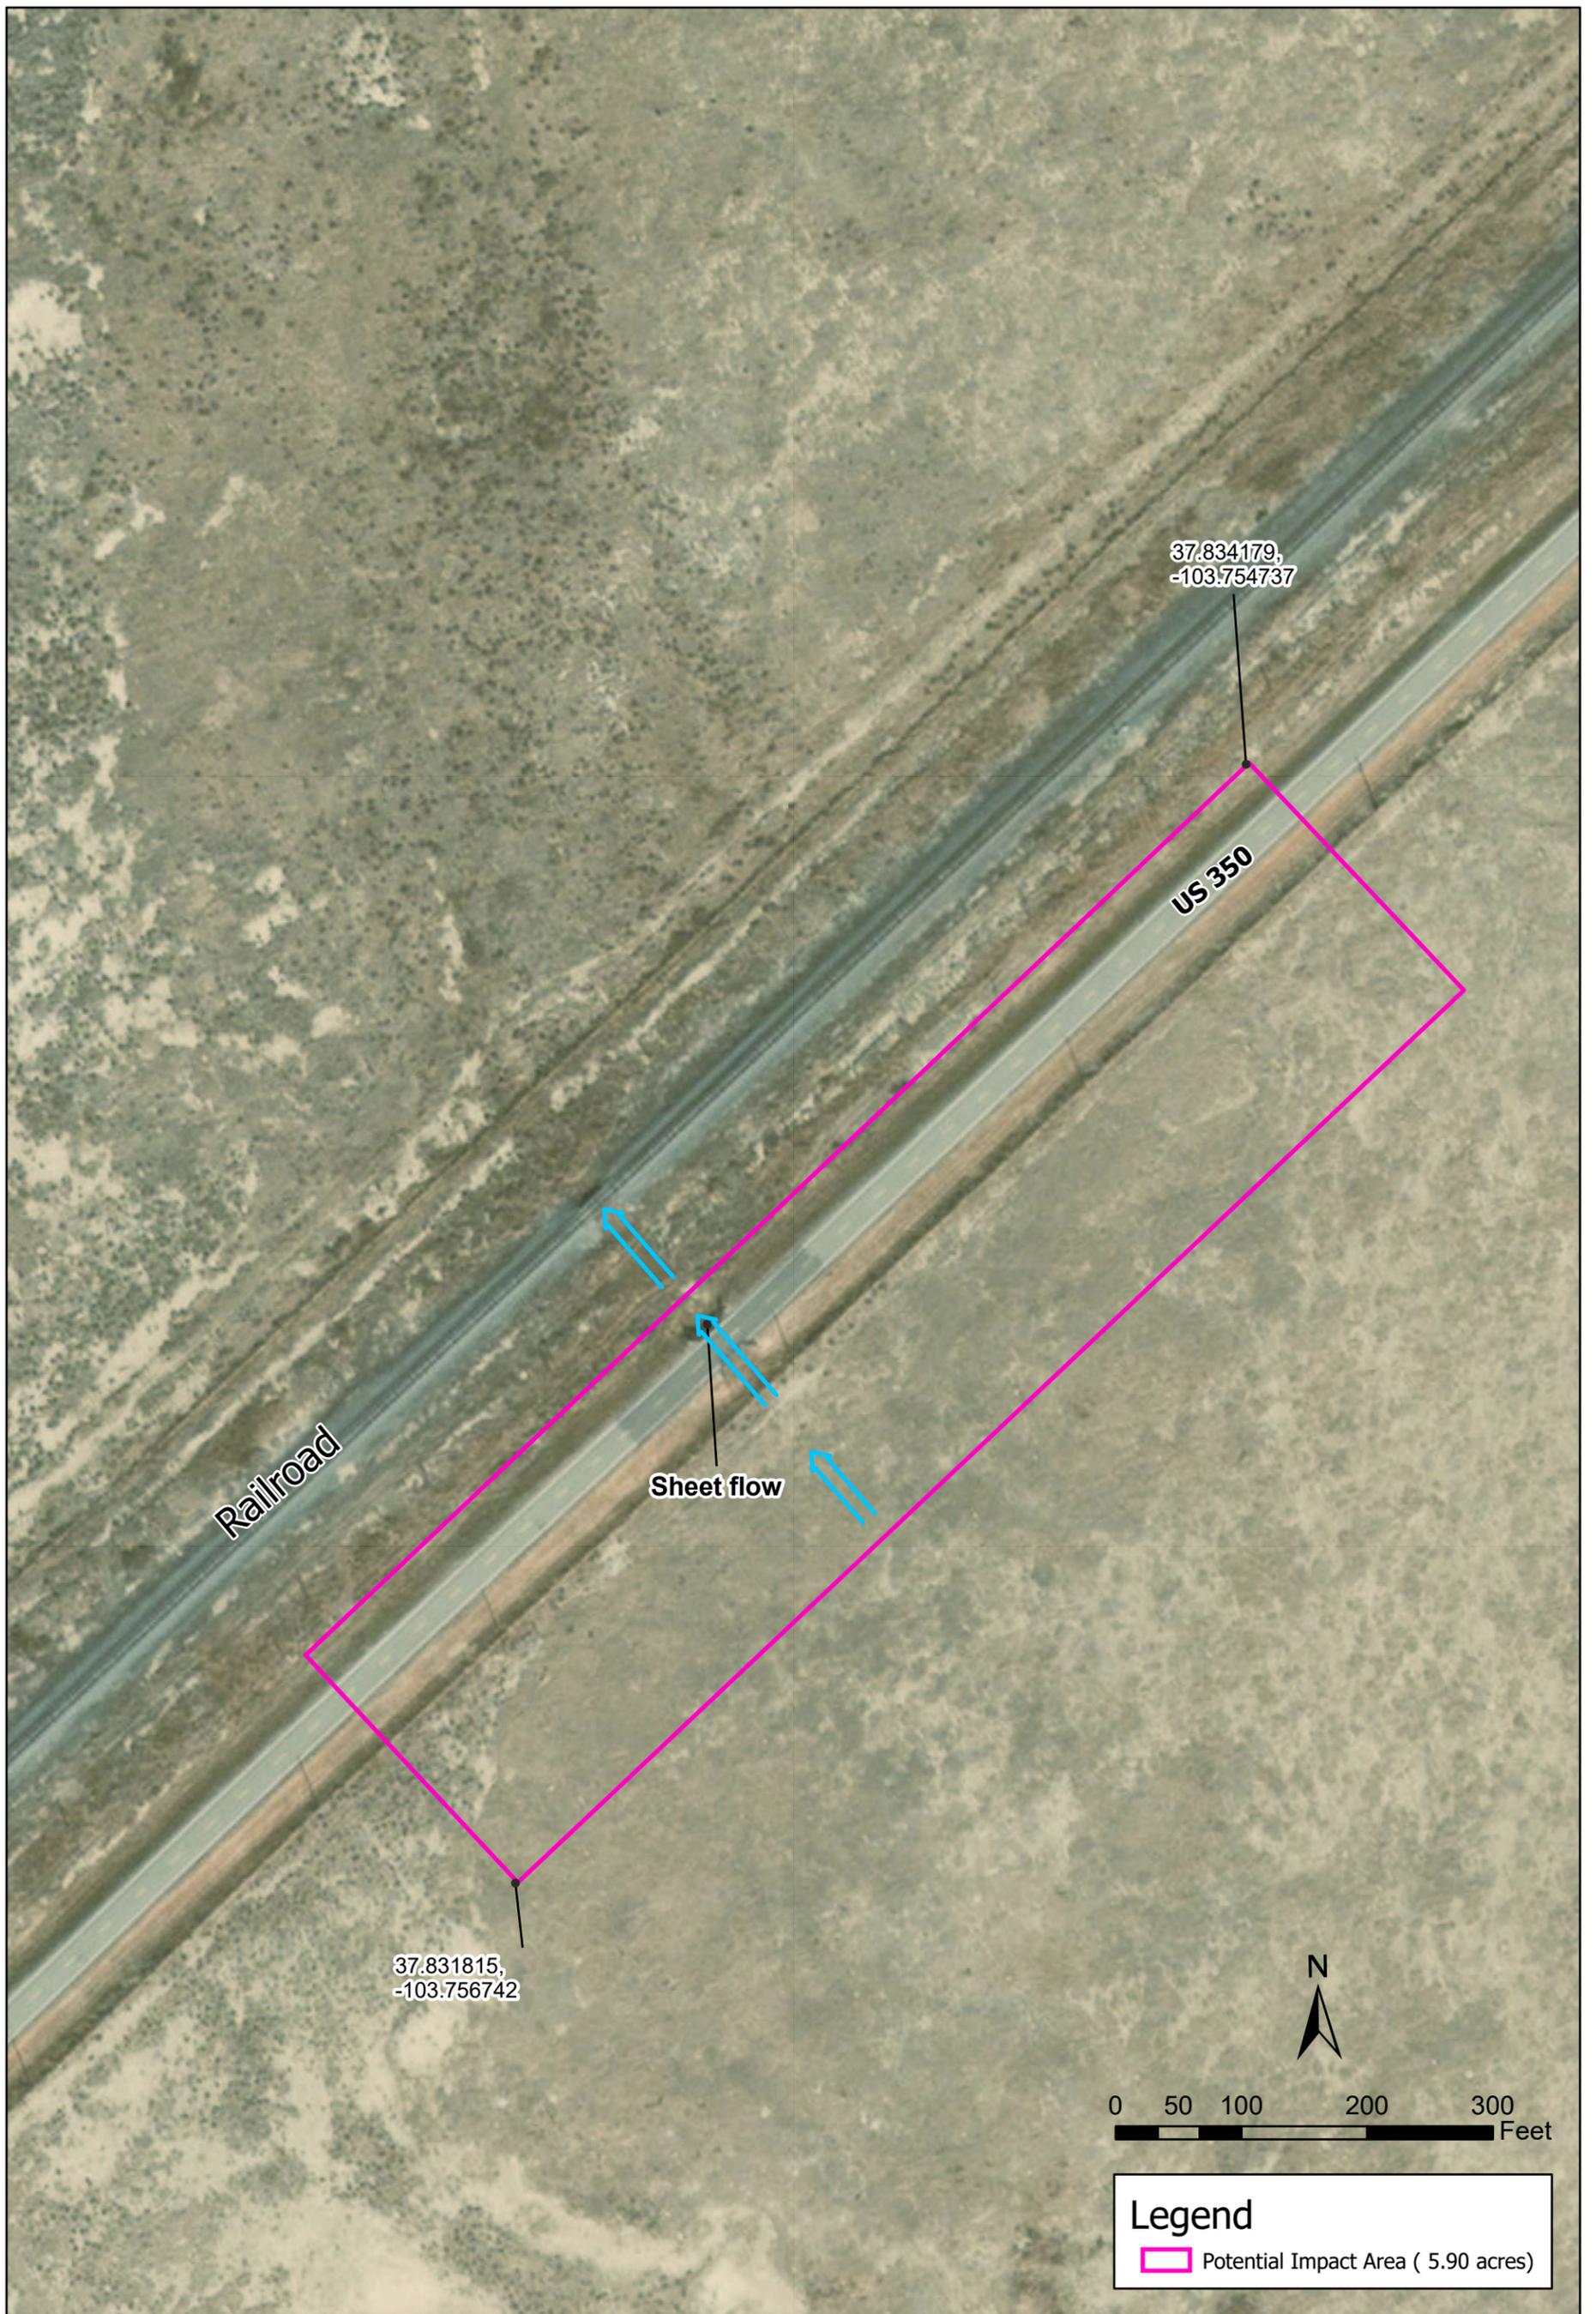
Figure 2: Aquatic Delineation Map

Data Source: Stanley Consultants, Inc.
Image Source: ArcGIS Online, World Imagery

National Wetlands Inventory (NWI) data indicated that no wetlands or waters of any sort exist within the PIA (Appendix A, Figure 2). The U.S. Geologic Survey (USGS) also does not indicate there is any sort of water feature at this location (Appendix A, Figure 1). The referenced feature at bridge M-22-Y appears only to be an unnamed path for sheet flow drainage within the landscape, only appears to collect rare storm event flows and transmits those flows vaguely northward to Timpas Creek, just to the northwest of the M-22-Y bridge by approximately 1 mile. Timpas Creek flows northeast to its confluence with the Arkansas River by the town of Swink, Colorado. From there, the Arkansas River flows east, then southeast to the Mississippi River and south to the Gulf of Mexico.

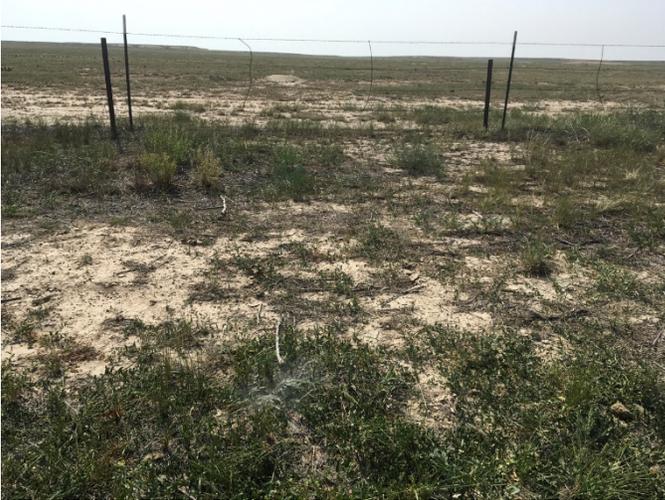
Photo 1.

Ephemeral feature, looking southeast and upgradient from bridge, at the condition of the swale-like feature. No floodplain of any type exists in this area, only a vague area indication of where sheet flow might be coming from.

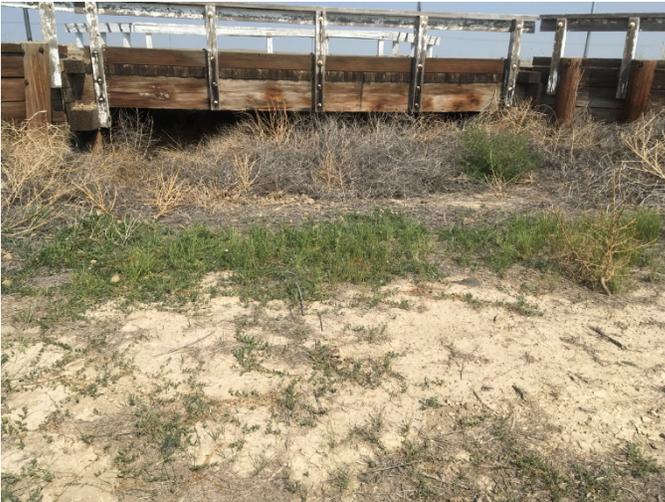
Photo 2.

Ephemeral feature, looking northwest and downgradient from near the CDOT ROW fence. The swale appears to just be a vegetated area with no defined channel of any sort. No distinct scour pool was observed under the bridge. Only the abutments appear to focus the normal sheet flow under the bridge. Tumbleweed and other dead vegetation choking area under bridge.

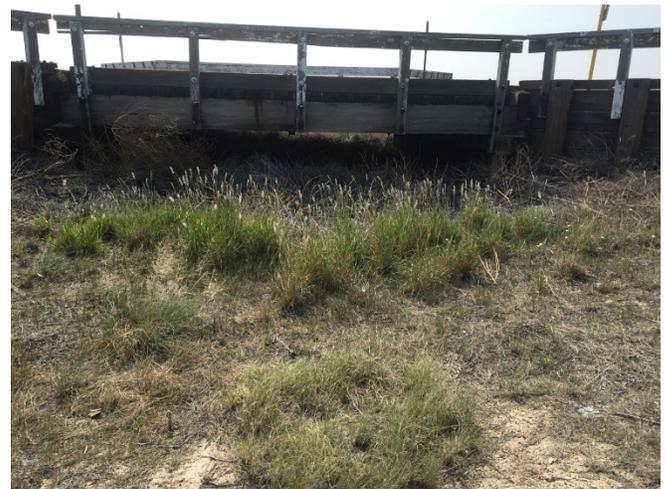
Photo 3.

Ephemeral feature, looking southeast at other side of bridge. No distinct floodplain, only a vague indication of any focused sheet flow moving under the bridge. Dense area of grasses can be seen, possibly suggesting a slight concentration of sheet flow.

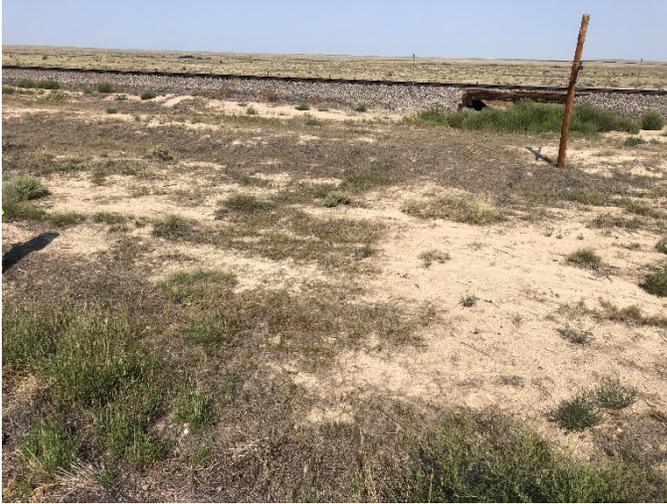
Photo 4.

Ephemeral feature, looking northwest and downgradient from the bridge. No distinct channels of any sort, not even a vague swale can be seen. Vegetation of grasses, shrub, and forbs cover parts of the exposed silty soils. Railroad bridge in the distance.
