Aquatic Resources Delineation Report

Bridge N-21-C

FINAL

January 2021

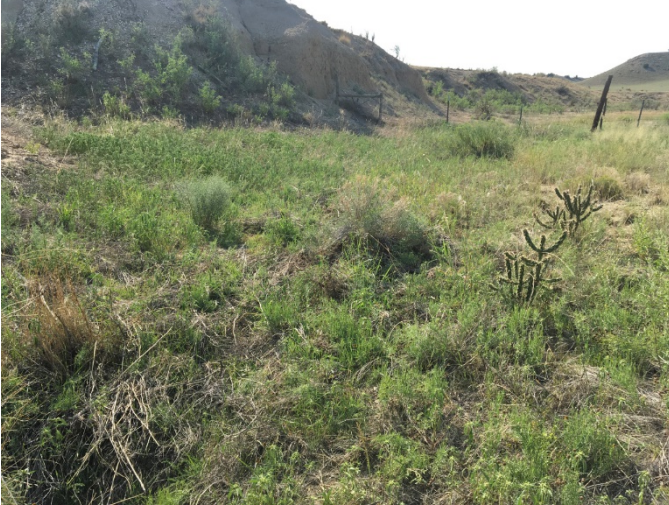
Photo 1.

Jack Treese Arroyo, looking south and upgradient from bridge, at the condition of the arroyo. No defined channel in this area, much of what should be the floodplain is covered in vegetation, some of which are perennial woody shrubs and cacti.

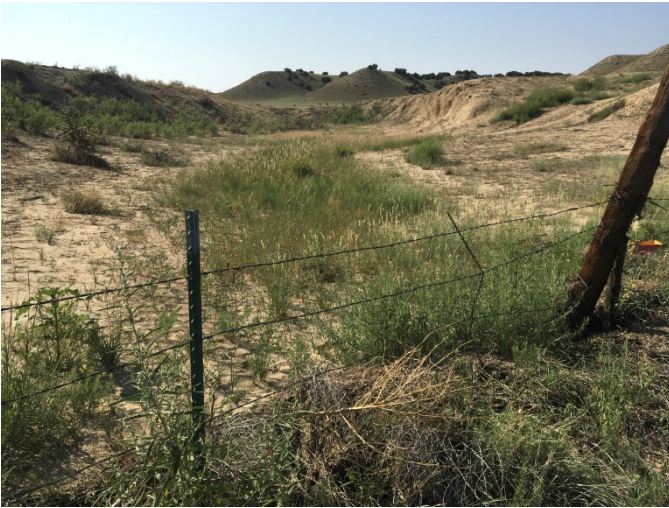
Photo 2.

Jack Treese Arroyo, looking south and upgradient from the CDOT ROW fence. The arroyo appears to be a vegetated, ephemeral swale, with no defined channel.

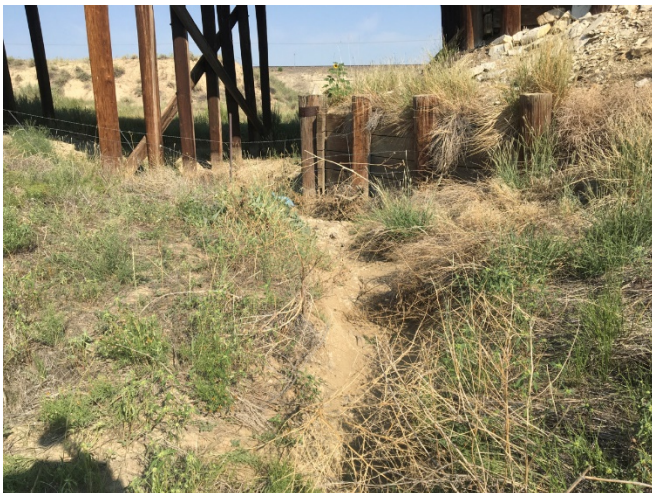
Photo 3.

Jack Treese Arroyo, looking northwest and under bridge structure. A small erosional channel has formed just before the bridge, likely due to the constricted nature of the abutments and slope. A small scour pool is located between the abutment wall and the first span supports.

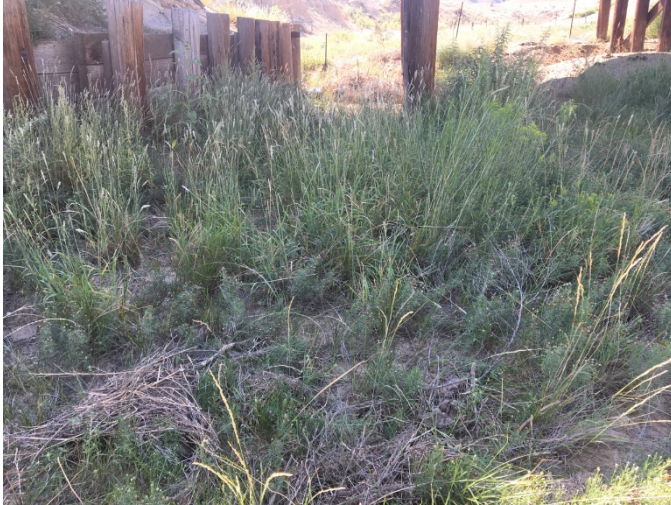
Photo 4.
Jack Treese Arroyo, looking southeast and upgradient by the bridge. No outlet appears on the other side of the small scour pool under the bridge. Dense upland vegetation, including shrubs, can be seen.

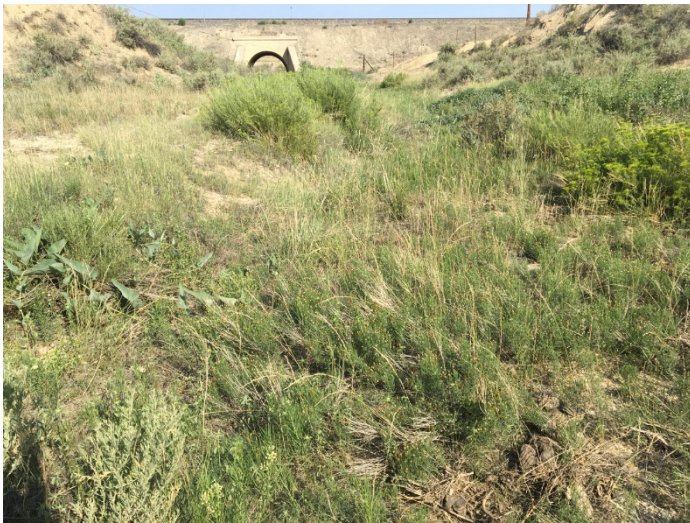
Photo 5.
Jack Treese Arroyo, looking northwest and downgradient of bridge. No distinct channels other than a vague swale (center of photo) suggesting rare flows. Dense arid, upland and shrub vegetation in all areas. Rail line bridge can be seen in the distance.
