# **Aquatic Resources Delineation Report**

Bridge N-21-F

FINAL

Colorado Department of Transportation  
 R2 Bridges Project - N-21-F

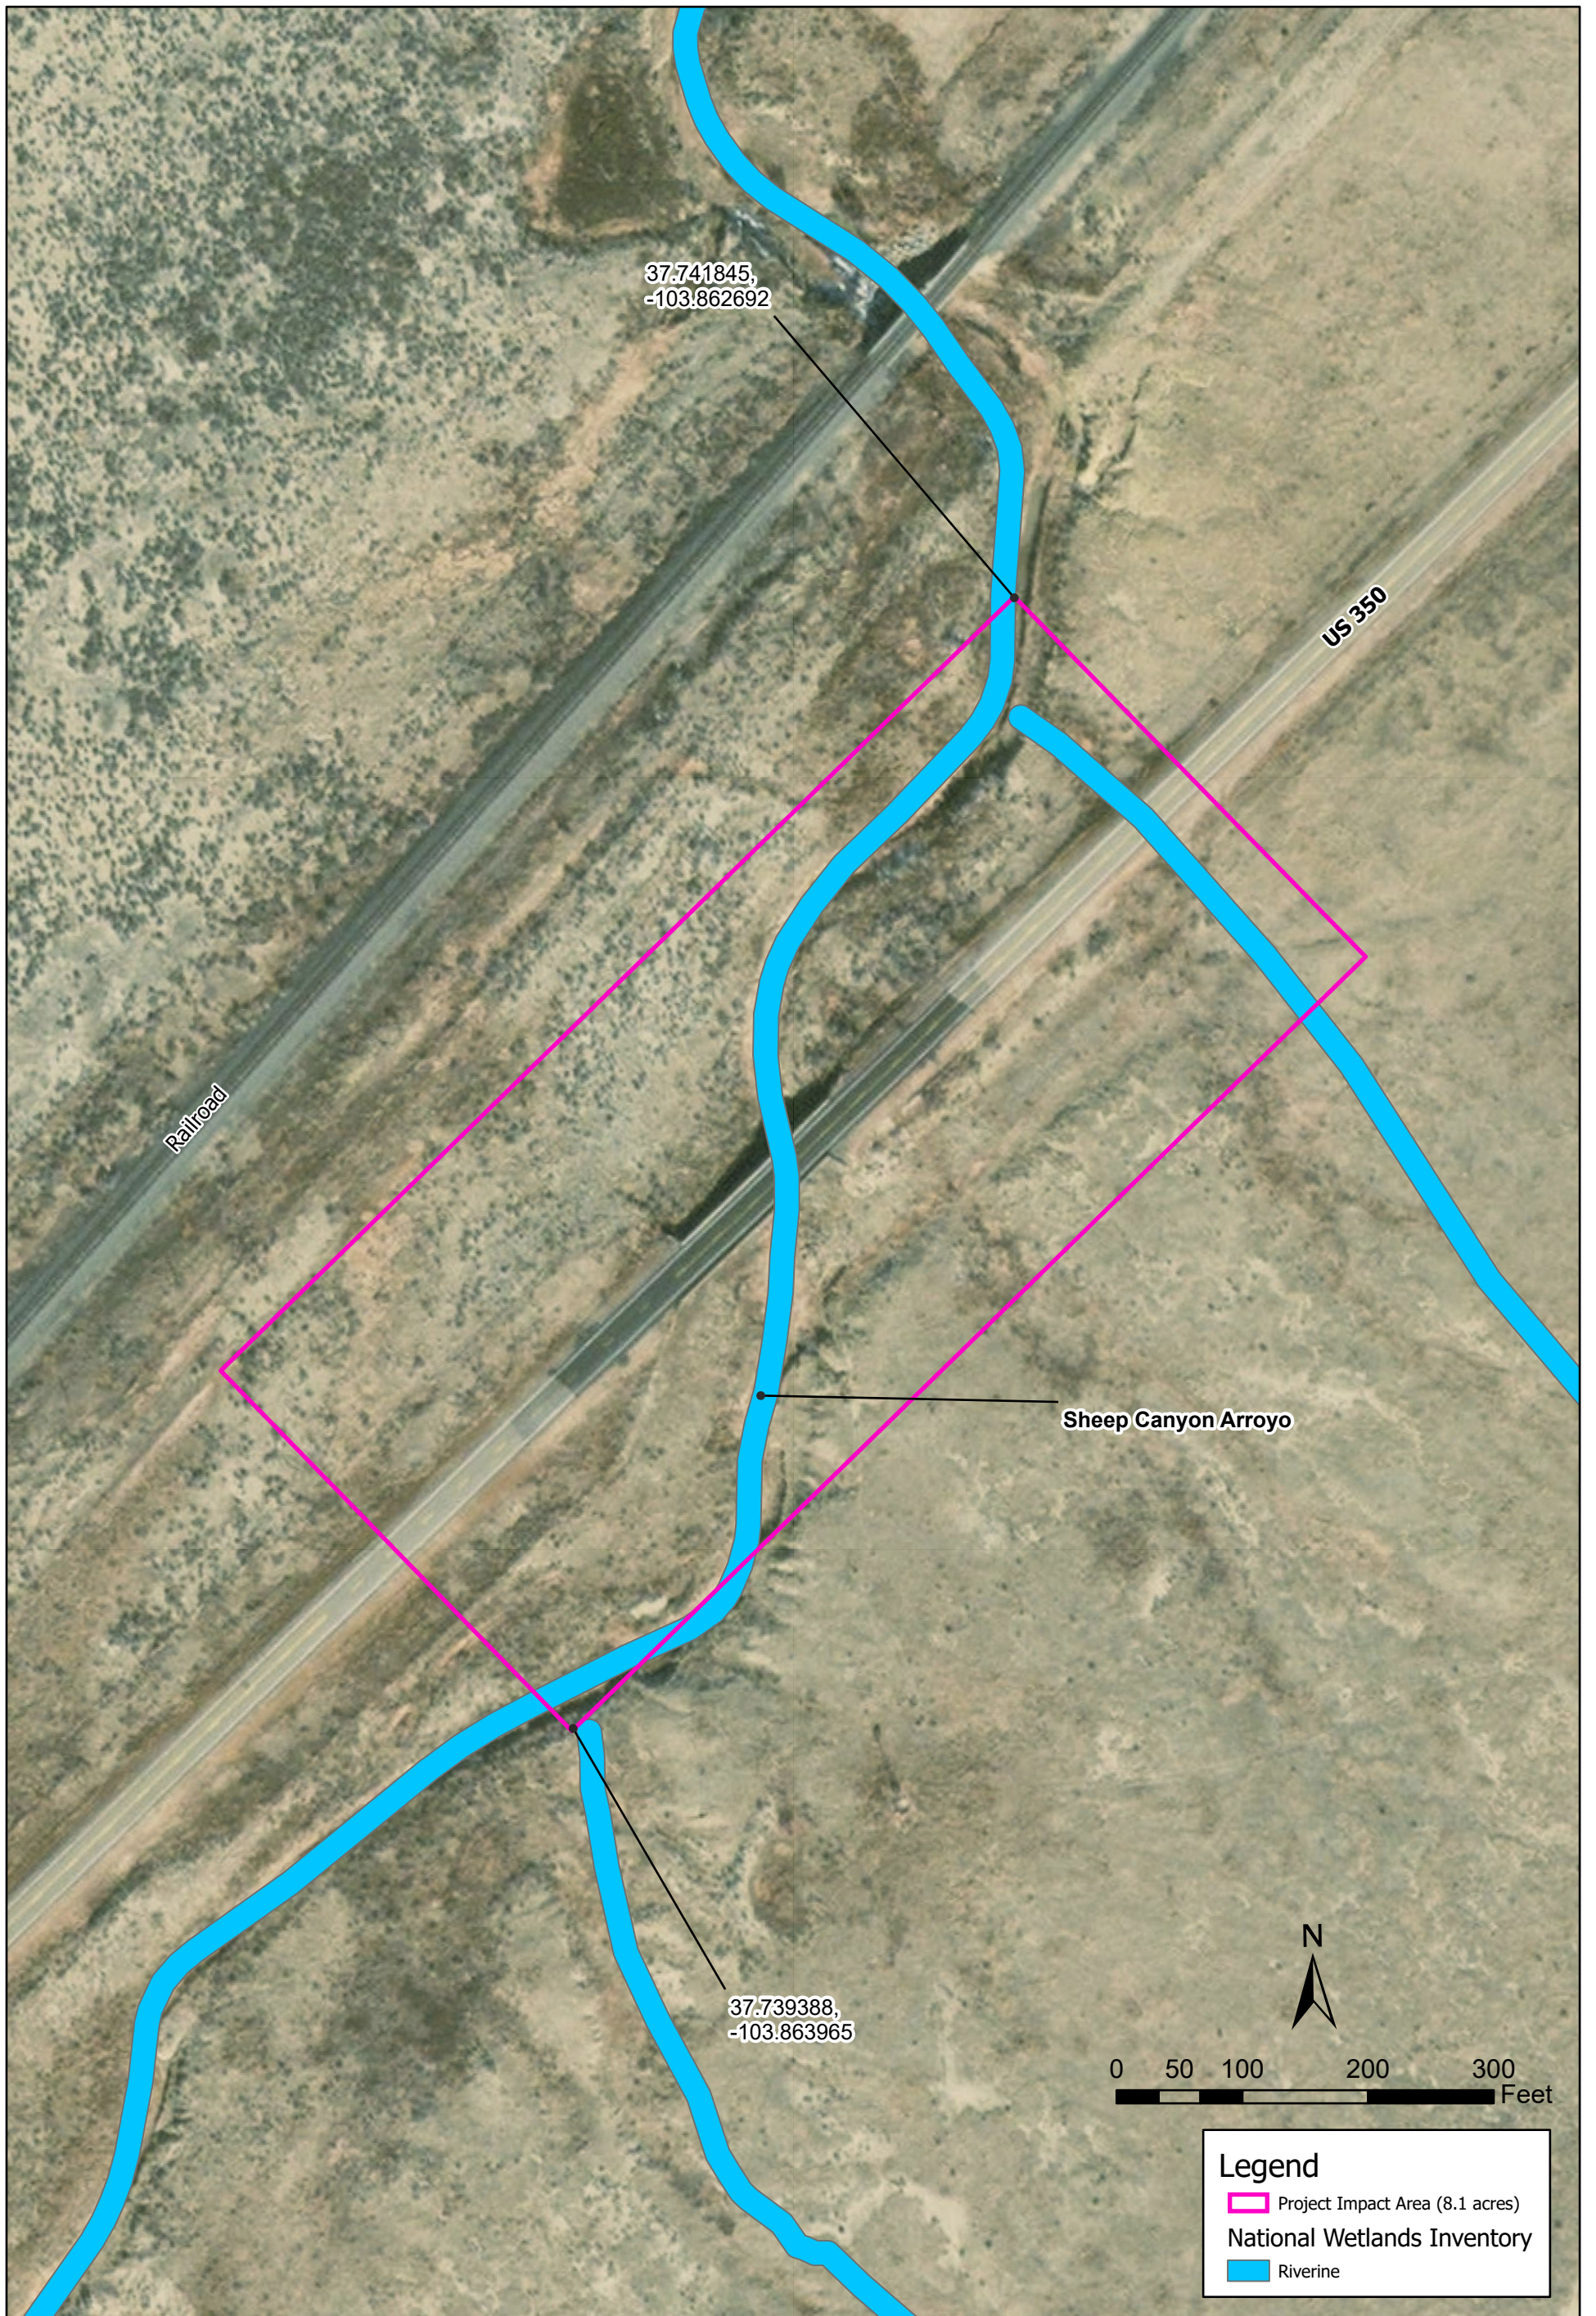
**Figure 2: Aquatic Delineation Map**

National Wetlands Inventory (NWI) data indicated that no wetlands exist within the PIA. Only one water was classified as riverine (Appendix A, Figure 2). The U.S. Geological Survey (USGS) classifies this feature as an intermittent stream (dashed line and dot feature: Appendix A, Figure 1), as opposed to being considered a perennial stream, the only other USGS classification for surface stream features. The referenced riverine feature is the Sheep Canyon Arroyo which is an ephemeral drainage feature within the landscape, but only appears to collect rare storm event flows and transmits those flows north to Timpas Creek, just to the north of the N-21-F bridge by approximately 0.45 miles. Timpas Creek flows northeast to its confluence with the Arkansas River by the town of Swink, Colorado. From there, the Arkansas River flows east, then southeast to the Mississippi River and south to the Gulf of Mexico.

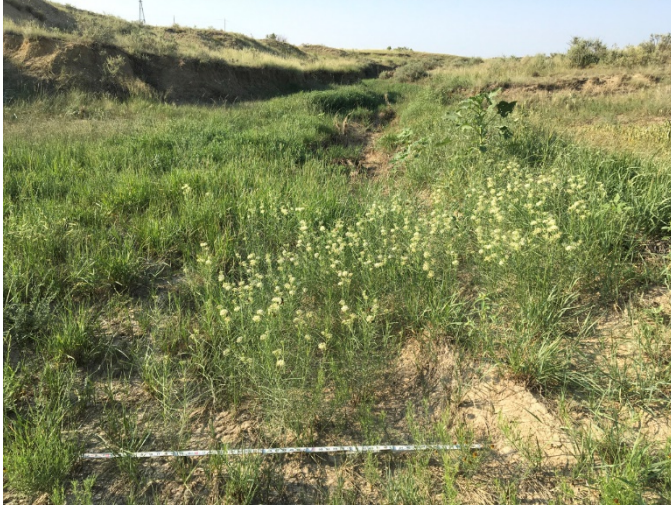
**Photo 1.**  
**Sheep Canyon Arroyo**, looking south and upgradient from bridge, at the condition of the arroyo. No continuous, well defined channel, only remnants of erosion gullies.

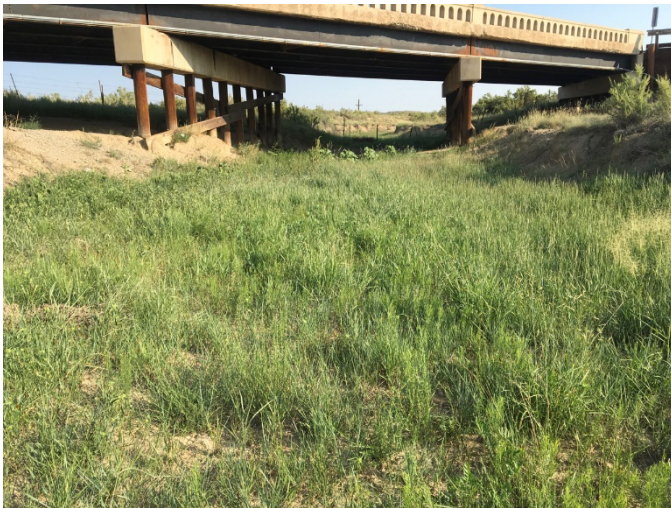
**Photo 2.**  
**Sheep Canyon Arroyo**, looking north and downgradient from near the CDOT ROW fence. The arroyo appears to just be a vegetated, ephemeral swale, with no defined channel.

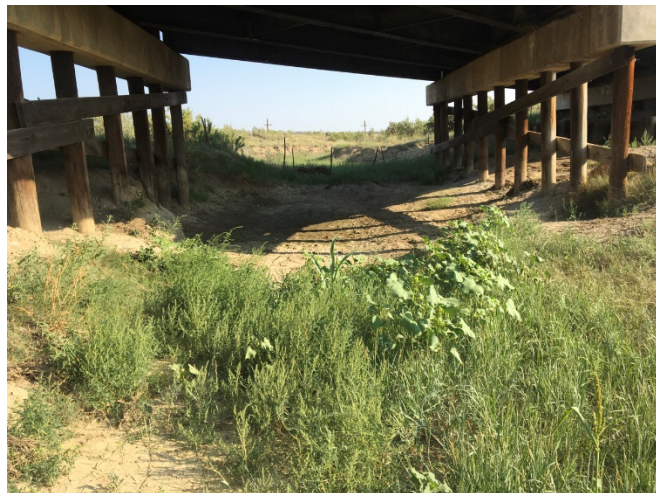
**Photo 3.**  
**Sheep Canyon Arroyo**, looking north and under bridge structure. A scour pool has developed under the bridge, but without any obvious channel flowing in or out. It appears just to collect local sheet flow and drainage from the bridge decks.

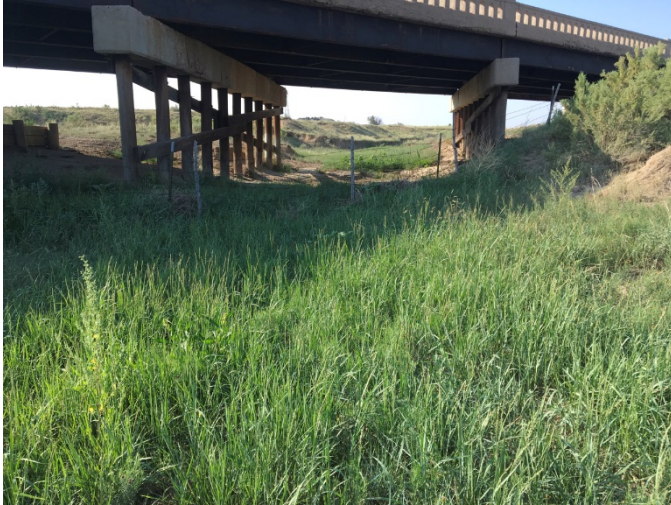
**Photo 4.**

**Sheep Canyon Arroyo**, looking south and upgradient towards the bridge. No outlet appears on the downgradient side of the scour pool under the bridge. Dense upland vegetation can be seen.

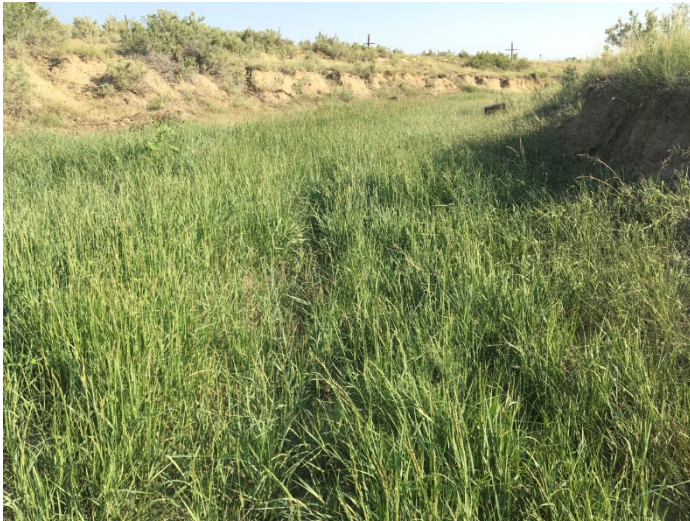
**Photo 5.**

**Sheep Canyon Arroyo**, looking north and downgradient of bridge. No distinct channels other than a vague gully (center of photo) suggesting rare flows. Dense upland vegetation in all areas. The vigorous growth of the vegetation suggests the area collects sheet flow from the surrounding area, supporting more growth than on the slopes above.
