# **Aquatic Resources Delineation Report**

Bridge P-19-G Minor

FINAL

**January 2021**

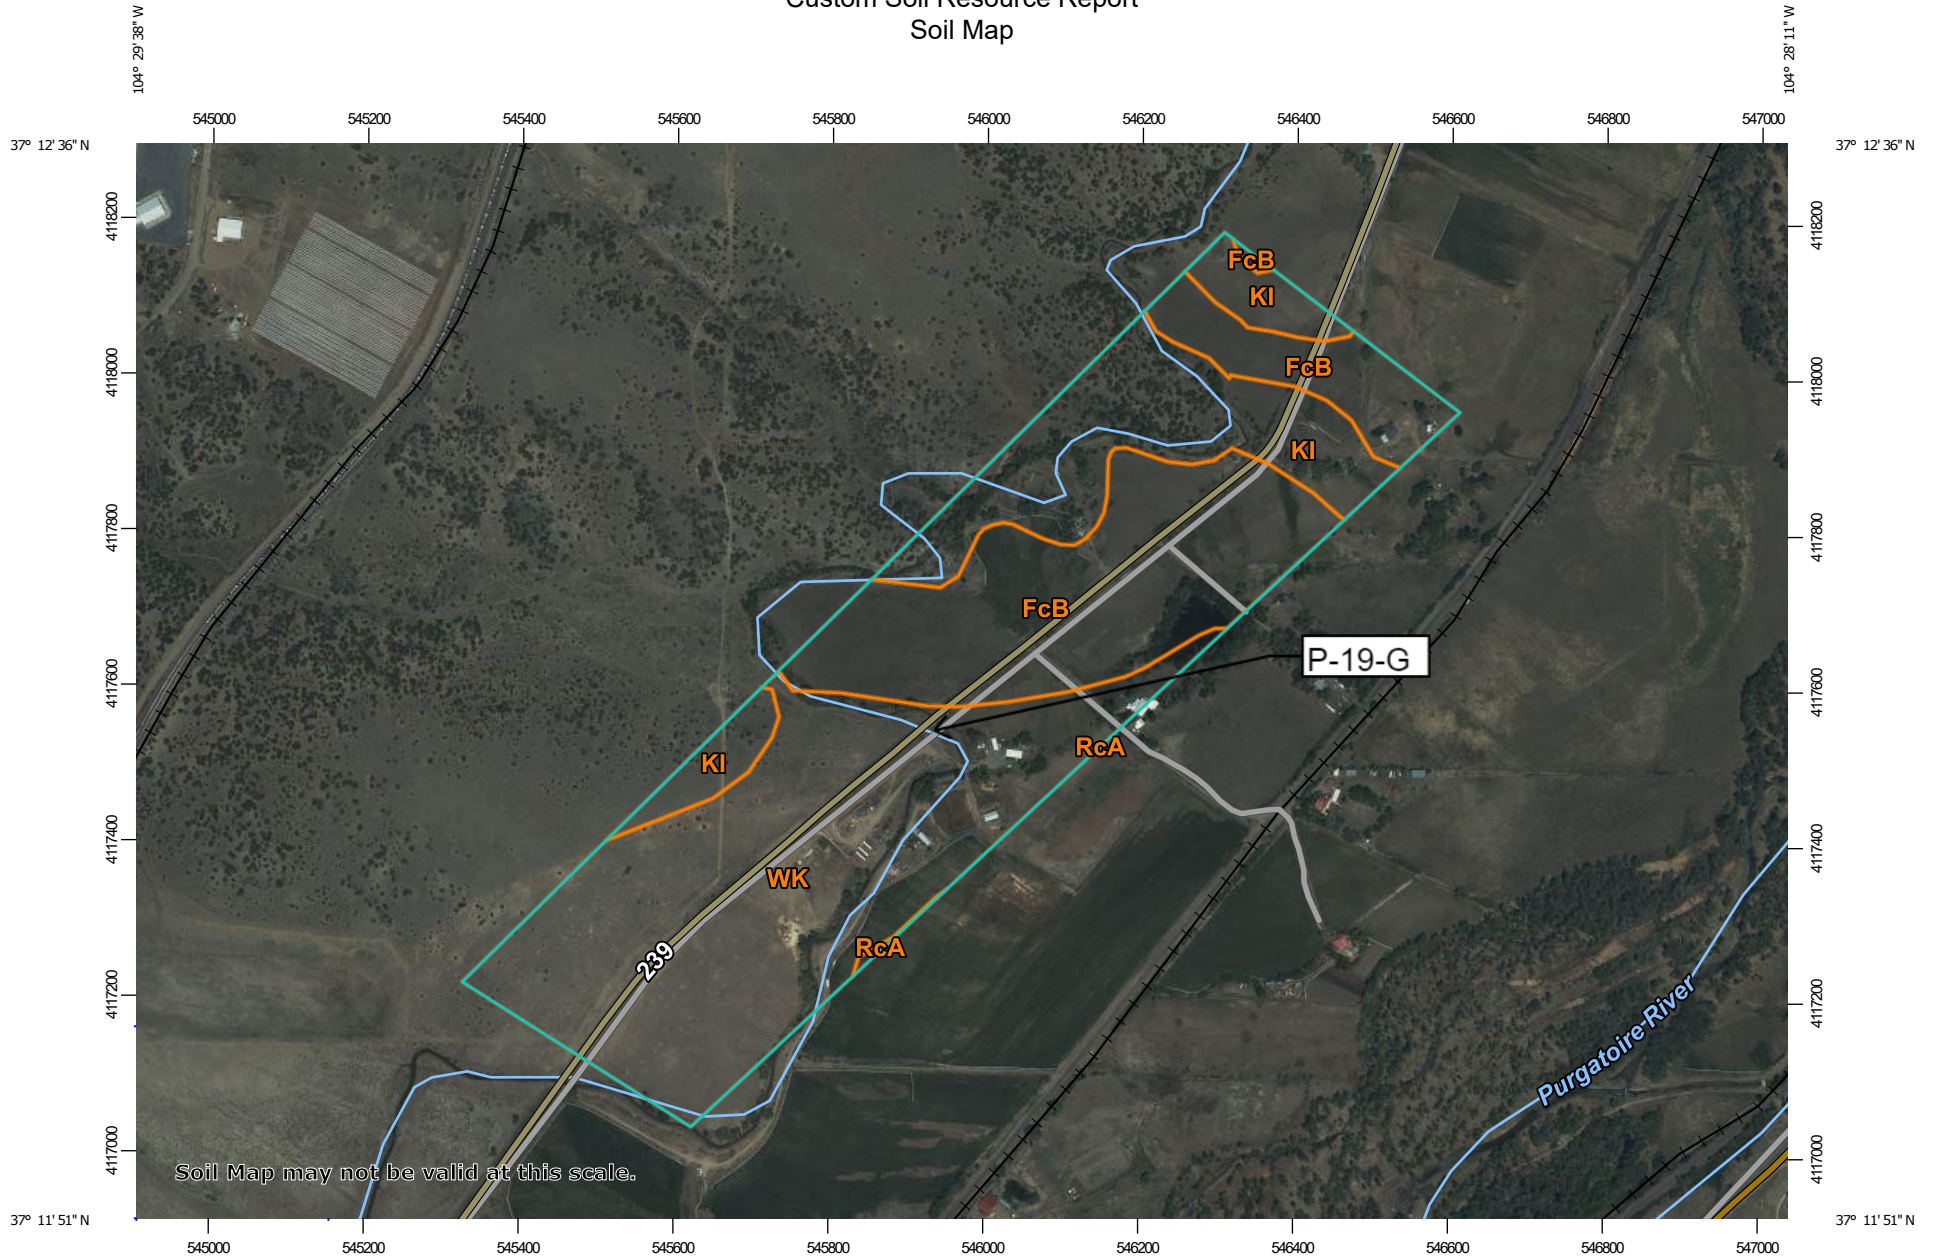
# Custom Soil Resource Report Soil Map

The soil map section includes the soil map for the defined area of interest, a list of soil map units on the map and extent of each map unit, and cartographic symbols displayed on the map. Also presented are various metadata about data used to produce the map, and a description of each soil map unit.

Enlargement of maps beyond the scale of mapping can cause misunderstanding of the detail of mapping and accuracy of soil line placement. The maps do not show the small areas of contrasting soils that could have been shown at a more detailed scale.

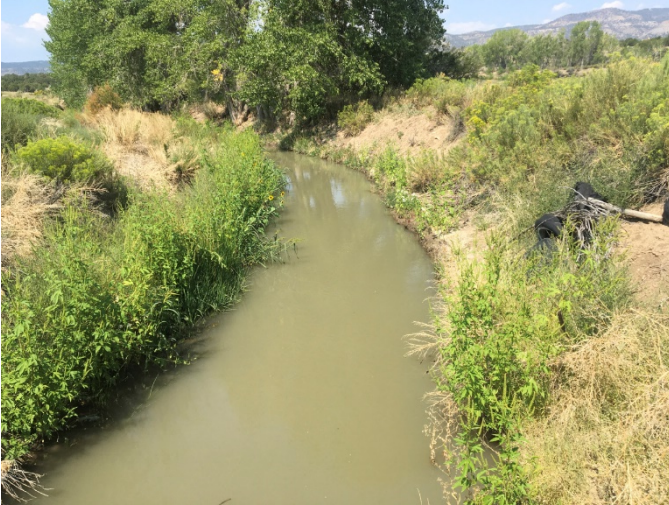
**Photo 1.**  
**Picketwire Ditch**, looking northwest and downstream away from the bridge, just upstream of cross section A (Appendix C). OHWM can be seen on the right bank (above the wetted area), and starting within the overgrown bankside vegetation on the left.

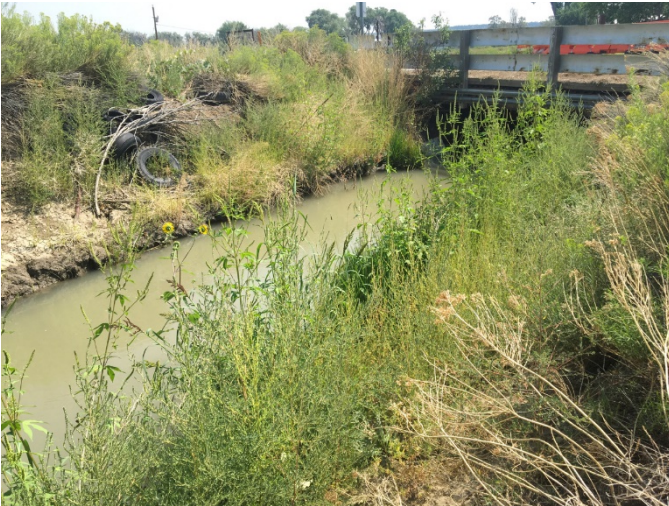
**Photo 2.**  
**Picketwire Ditch**, looking east and upstream towards the bridge, from cross section A. OHWM can be seen starting above the wetted and eroded area on the bank. Debris and trash can also be seen along the upper banks, likely from regular ditch maintenance.

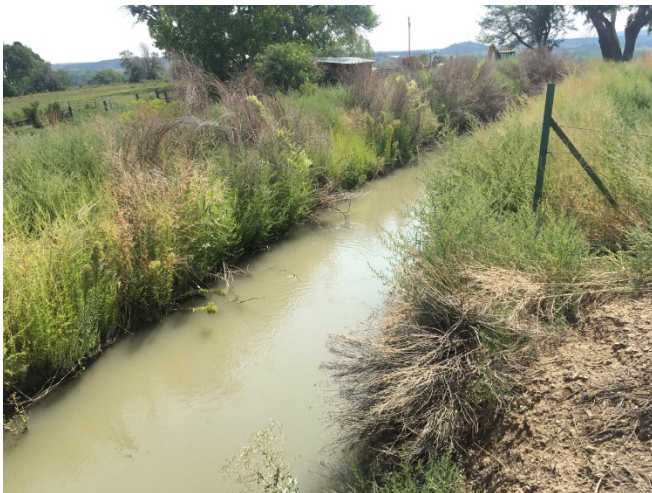
**Photo 3.**  
**Picketwire Ditch**, looking southeast away from the bridge on the upstream side of the bridge. The PIA (and also CDOT ROW) boundary at the fence line can be seen. Vegetation is denser along this part of the ditch.

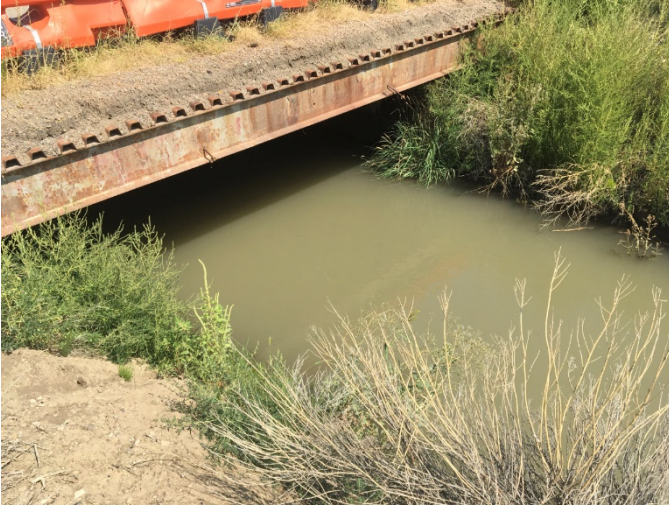
**Photo 4.**

**Picketwire Ditch**, looking north at the upstream side of the bridge. Note that the channel is a few feet narrower here and its normal operating water level is very close to the existing bridge beams and decking.
