# **Desktop for Sensitive Biological Resources**

Bridge G-12-C

Colorado Department of Transportation  
Denver, Colorado

**January 2021**  
Final

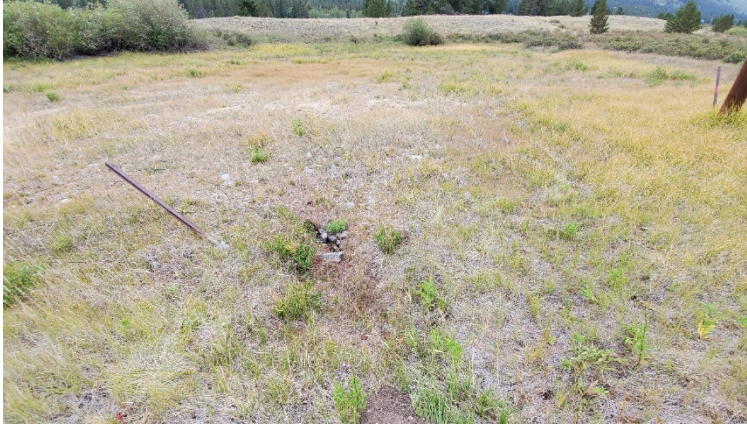
### **Photo 1.**

**Avoidance Area 1**, looking west from SH 9 ROW. Potential wetland basin feature but appears dry at time of investigation.

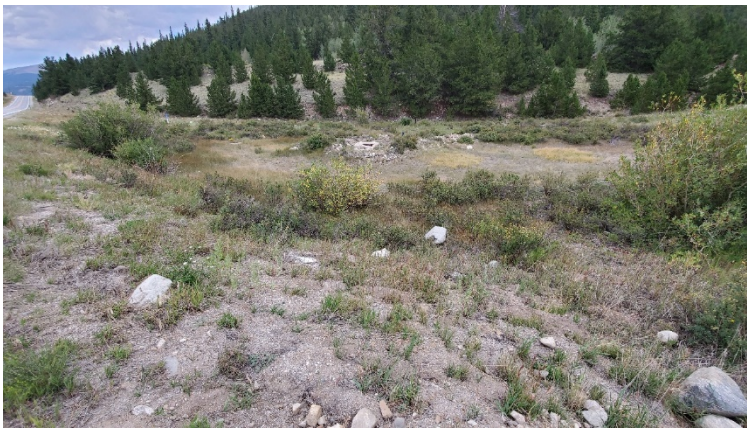
### **Photo 2.**

**Avoidance Area 2**, looking northeast from SH 9 ROW. Potential wetland basin feature. Basin appears mostly outside of ROW and dry at time of investigation, at least the part closest to the ROW.

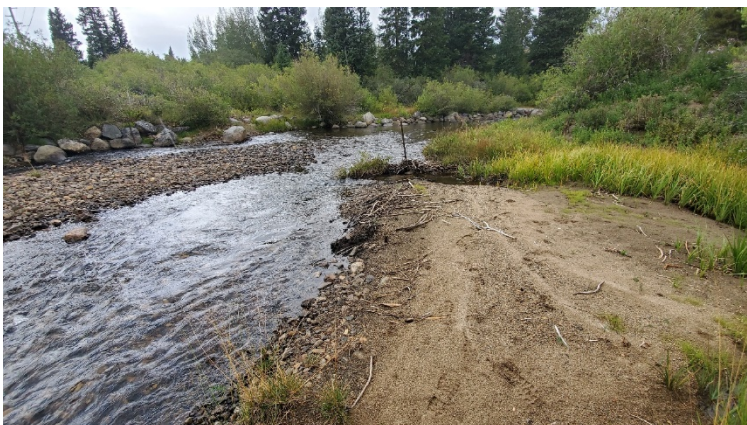
### **Photo 3.**

**Avoidance Area 3a**, looking west from SH 9 ROW. Upstream portion of the Middle Fork of the South Platte River and its associated wetlands and riparian areas.

**Note:** This is the potential habitat within the PRA for both the boreal toad and the river otter.

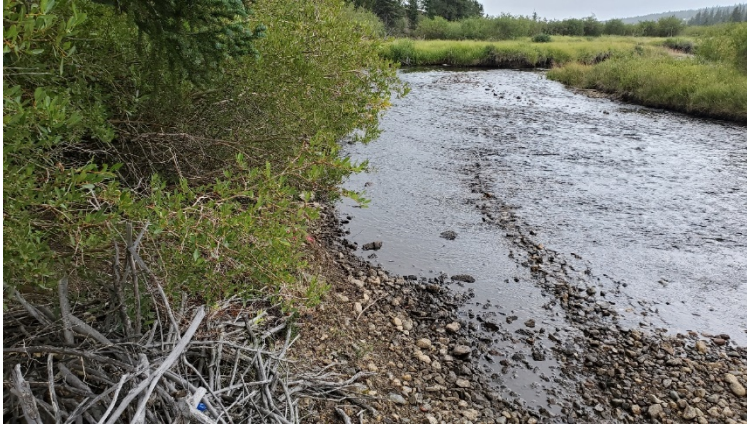
#### **Photo 4.**

**Avoidance Area 3b**, looking east from SH 9 ROW. Downstream portion of the Middle Fork of the South Platte River and its associated wetlands and riparian areas.

**Note:** This is the potential habitat within the PRA for both the boreal toad and the river otter.

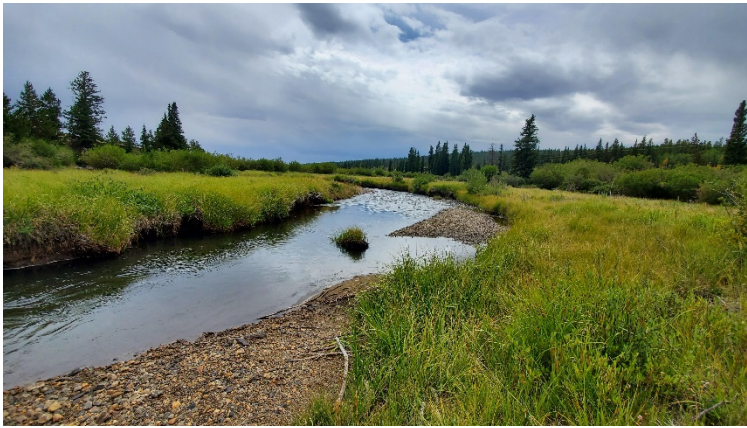
#### **Photo 5.**

**Avoidance Area 4**, looking south from SH9 ROW (right side of photo). Potential palustrine emergent wetlands along banks of the Middle Fork of the South Platte River that touch the eastern boundary of the SH 9 ROW.

**Note:** This is the potential habitat within the PRA for both the boreal toad and the river otter.

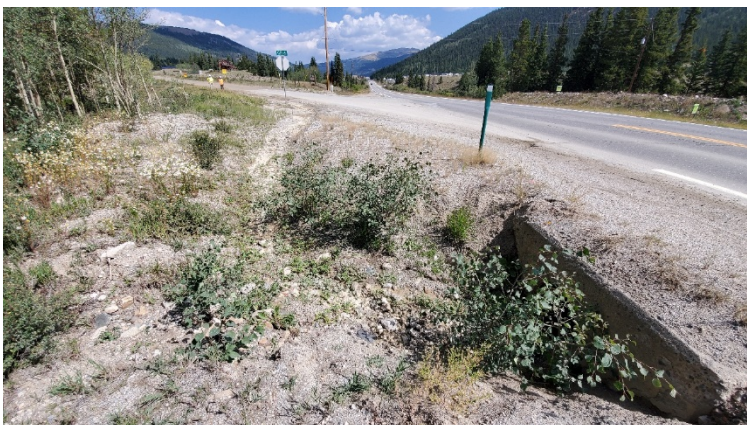
#### **Photo 6.**

**Avoidance Area 5a**, looking north from SH 9 ROW. Stormwater drainage ditch that flows under roadway and continues on east side of road. Section of large ditch, potentially jurisdictional status.

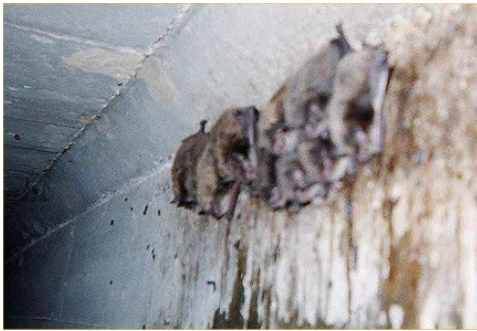
Photo 1: Bats hanging from cracks along Support beams

Cracks in the concrete are used by bats as a foothold in roosting (Photo 1). In addition, some bats may be hidden from sight in wider cracks in the concrete and behind deteriorating concrete sections in the ceiling or walls. Look for cracking along support beams and inner walls especially below a fillet (a concrete filling between ceiling and vertical beam). During inspection, sounds may be heard coming from behind such cracks and/or expansion joints.

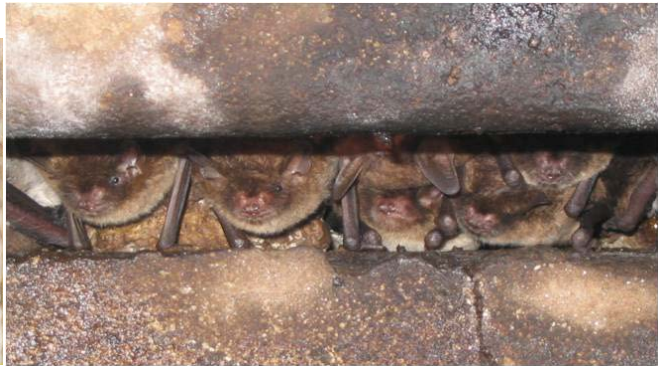
Photo 2: Visible bats within an expansion joint

Expansion joints can provide protected cover for bats (Photos 2 and 3), but do not always provide habitat, depending upon whether they are obstructed by road debris or other blockages to use. If possible during the assessment, individuals should look into expansion joints or in other cracks with a flashlight. If joints are used by bats, often there will be guano under the joints (Photos 4-6), but not always, since the joint may be located over water.

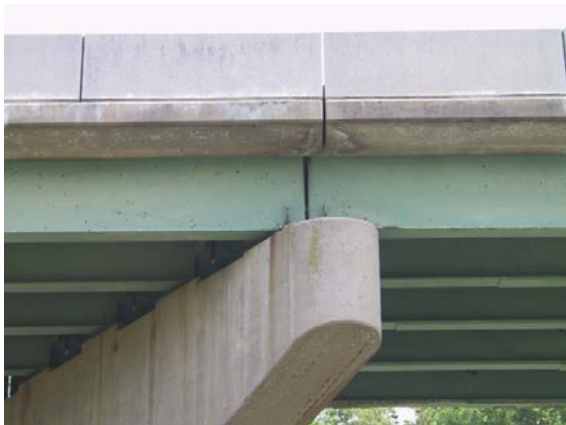
Photo 3: Example of open concrete joint used by bats

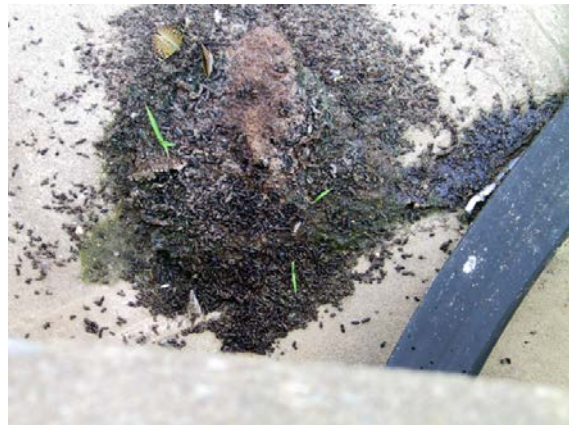
Photo 4: Guano deposits visible from bridge deck, on top of pier

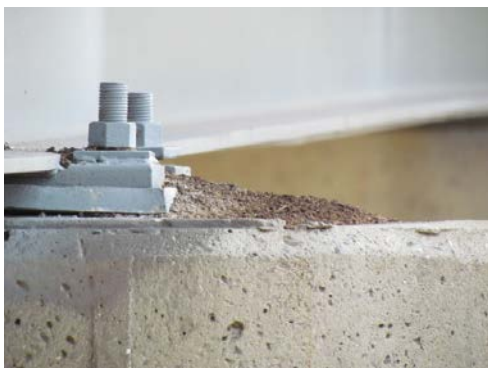
Photo 5: Guano deposit on pier, obscuring structural features.

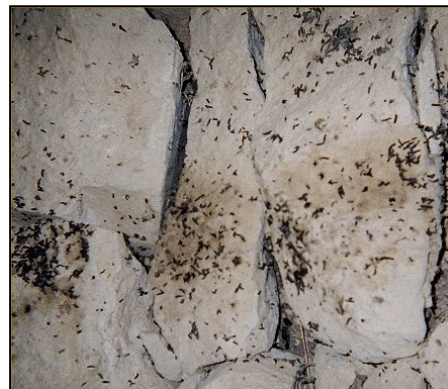
Photo 6: Bat Guano on Riprap

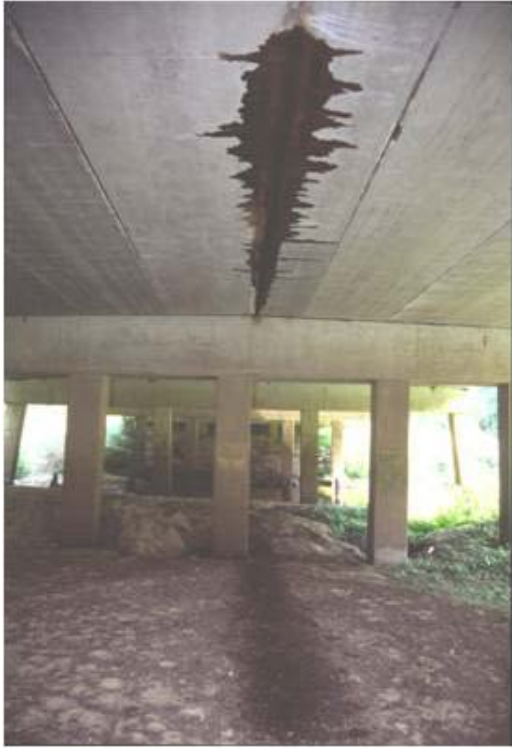
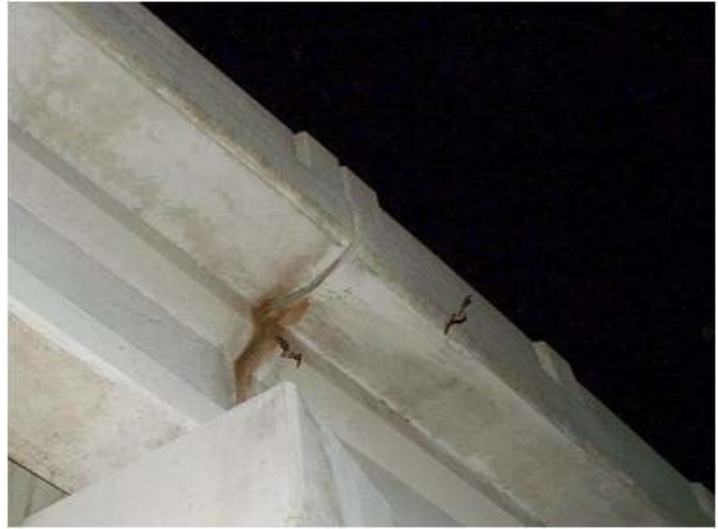
Photo 7: Staining along longitudinal joint. Note guano deposits on the ground. Photo 8: Staining on underside of expansion joint from bat use.

Stains may appear wet and are usually found in dark places. Look for four to six inch wide dark stains located on concrete support beams and walls immediately below the ceiling of the bridge, and beneath joints (Photos 8 - 11).

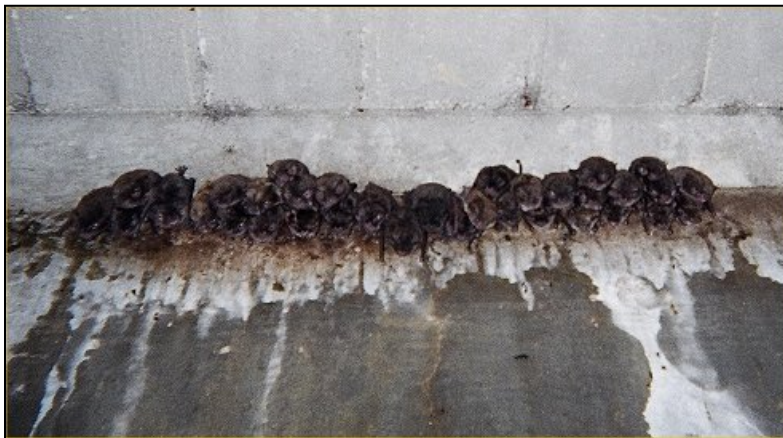
Photo 11: Bats Roosting & Associated Staining

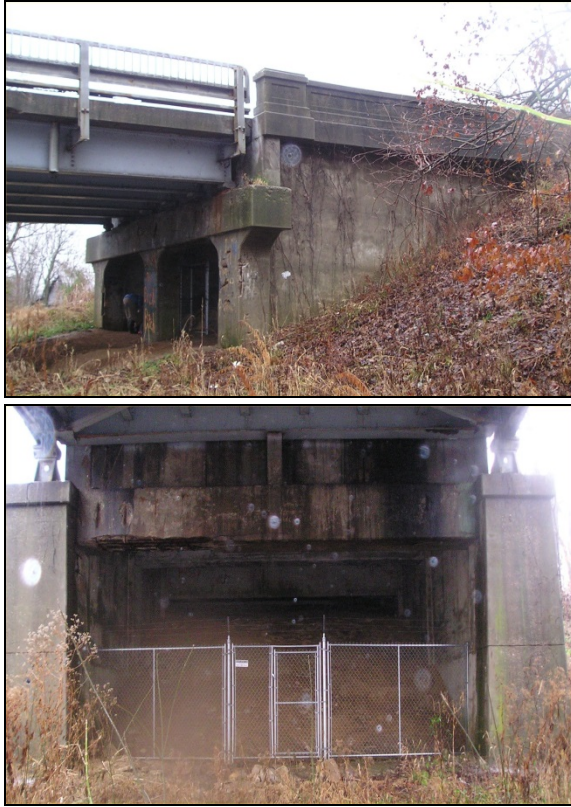
Photo 12 and 13: Bridge Design Mimicking “Cave-like” Atmosphere

While assessing bridges or structures, look for dark environments that mimic cave-like conditions such as under the deck in the case of a bridge (Photos 12 and 13) or an attic in the case of a structure. This may involve crawling under low areas so a hard hat is recommended. Such places (e.g., a concrete bunker secreted into a hillside with an open front) provide protection from wind, rain, sleet, hail and predators. Bats do not roost near the ground where predators (cats, raccoons, etc.) can reach them. Roosting is usually at least 4 feet from the ground.

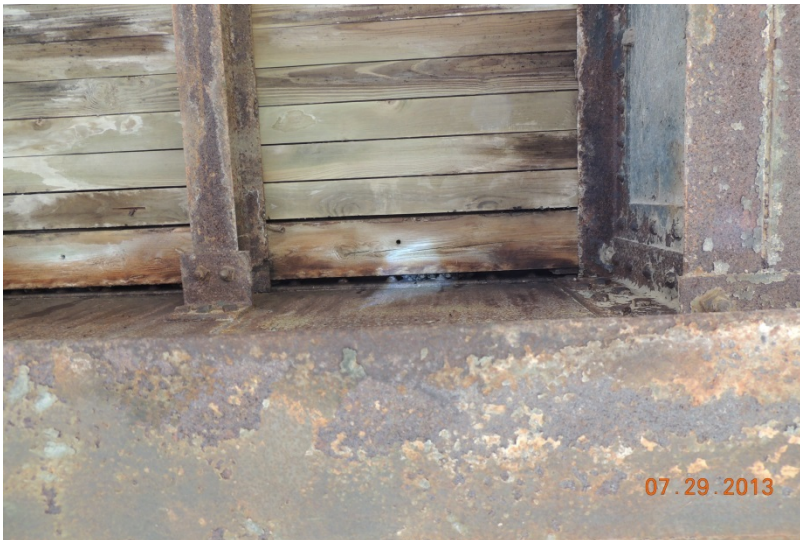
Photo 14: NLEBs Roosting Under a Timber Decked Bridge
