# **Desktop for Sensitive Biological Resources**

Bridge I-13-H

Colorado Department of Transportation  
Denver, Colorado

**January 2021**  
FINAL

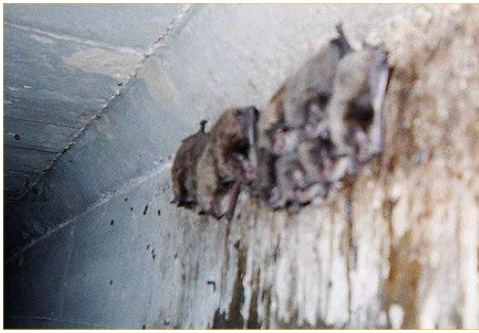
Photo 1: Bats hanging from cracks along Support beams

Cracks in the concrete are used by bats as a foothold in roosting (Photo 1). In addition, some bats may be hidden from sight in wider cracks in the concrete and behind deteriorating concrete sections in the ceiling or walls. Look for cracking along support beams and inner walls especially below a fillet (a concrete filling between ceiling and vertical beam). During inspection, sounds may be heard coming from behind such cracks and/or expansion joints.

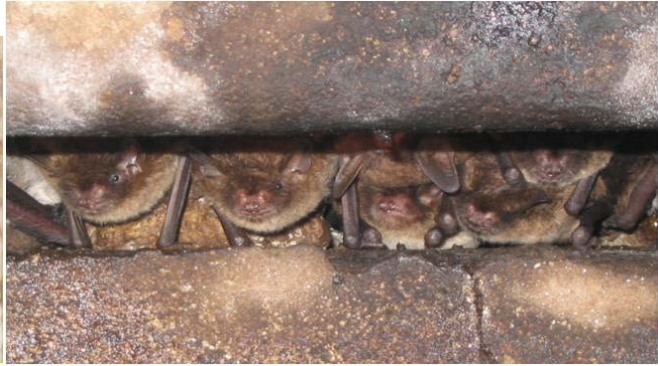
Photo 2: Visible bats within an expansion joint

Expansion joints can provide protected cover for bats (Photos 2 and 3), but do not always provide habitat, depending upon whether they are obstructed by road debris or other blockages to use. If possible during the assessment, individuals should look into expansion joints or in other cracks with a flashlight. If joints are used by bats, often there will be guano under the joints (Photos 4-6), but not always, since the joint may be located over water.

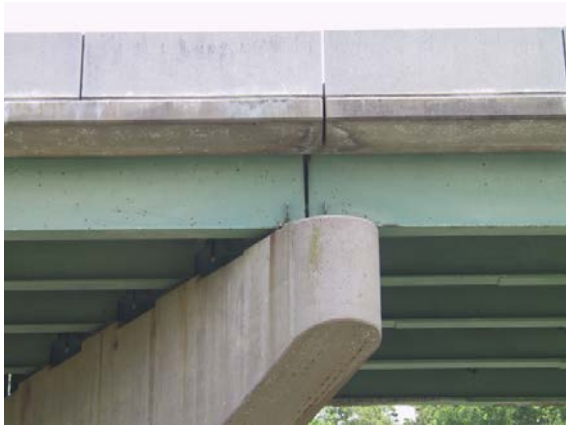
Photo 3: Example of open concrete joint used by bats

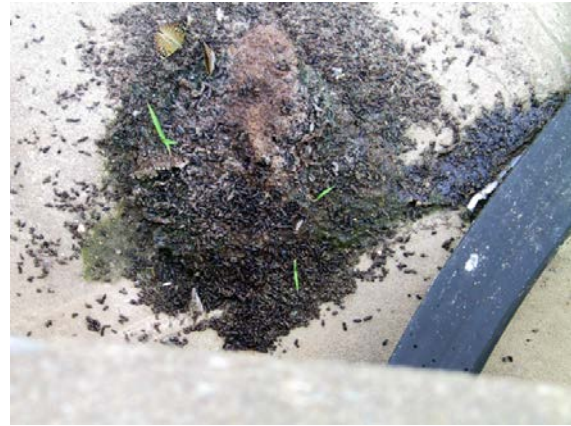
Photo 4: Guano deposits visible from bridge deck, on top of pier

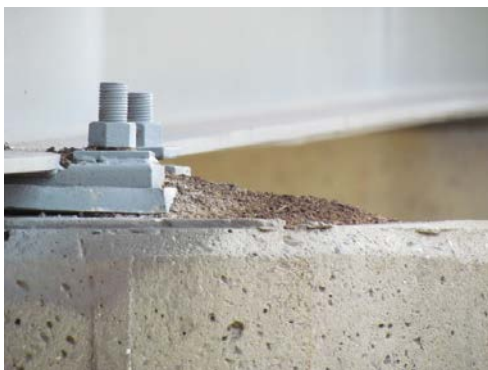
Photo 5: Guano deposit on pier, obscuring structural features.

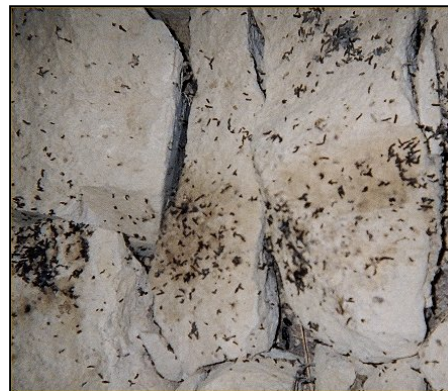
Photo 6: Bat Guano on Riprap

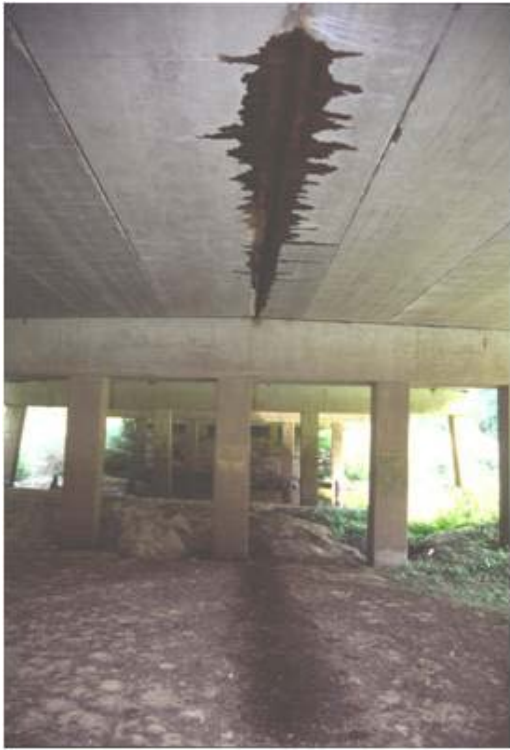
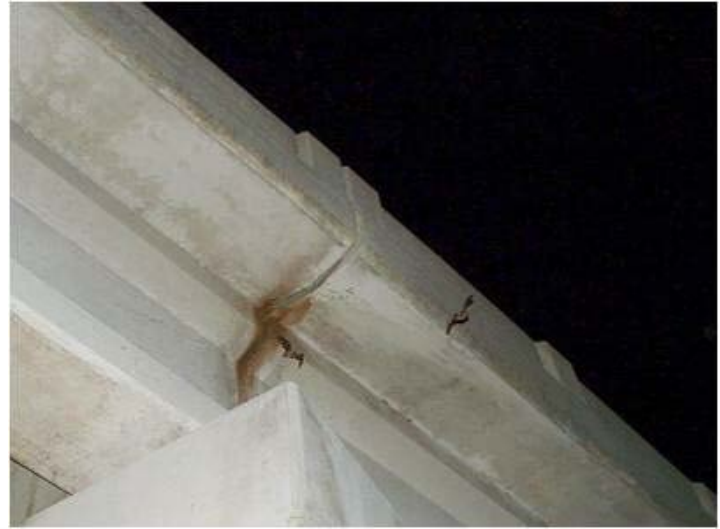
Photo 7: Staining along longitudinal joint. Note guano deposits on the ground. Photo 8: Staining on underside of expansion joint from bat use.

Stains may appear wet and are usually found in dark places. Look for four to six inch wide dark stains located on concrete support beams and walls immediately below the ceiling of the bridge, and beneath joints (Photos 8 - 11).

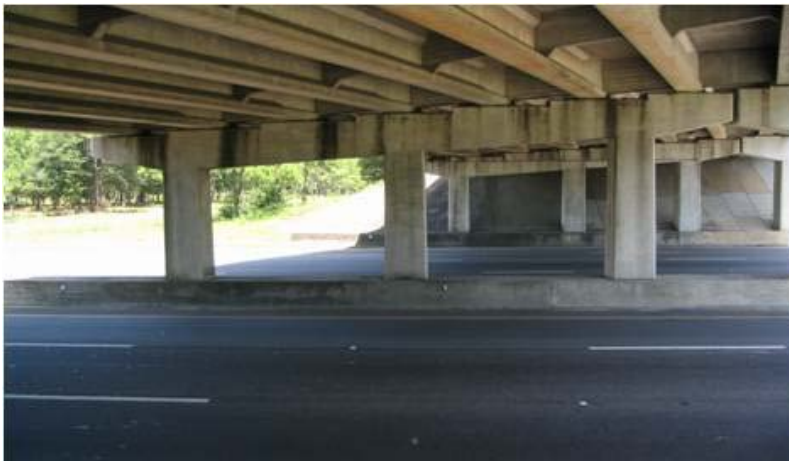
Photo 9: Staining on sides of pier caps

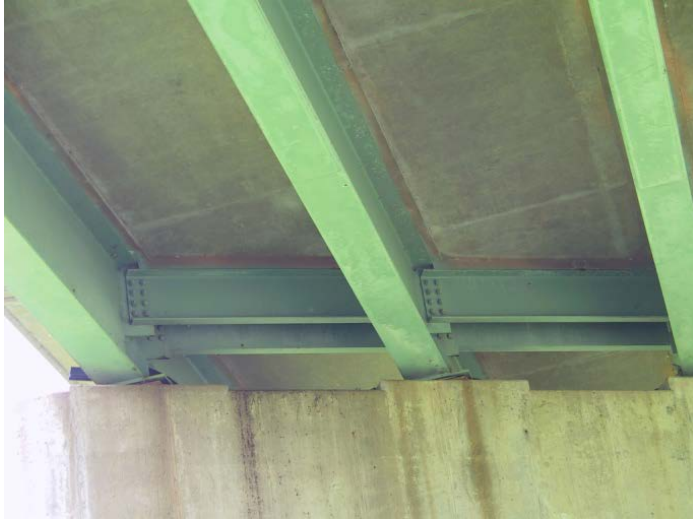
Photo 10: Guano staining on side of pier

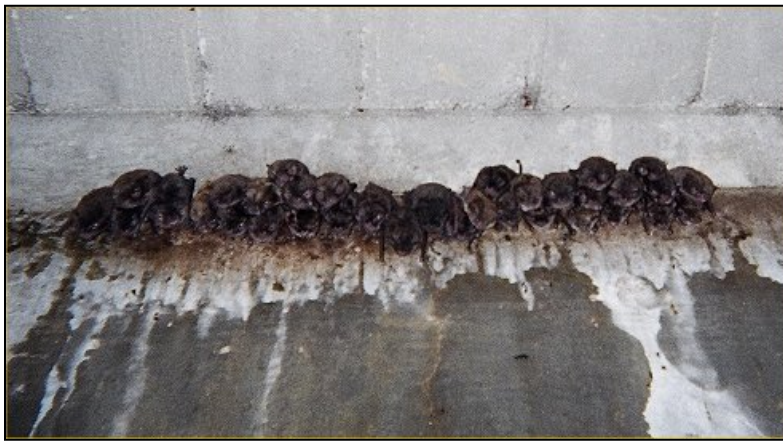
Photo 11: Bats Roosting & Associated Staining

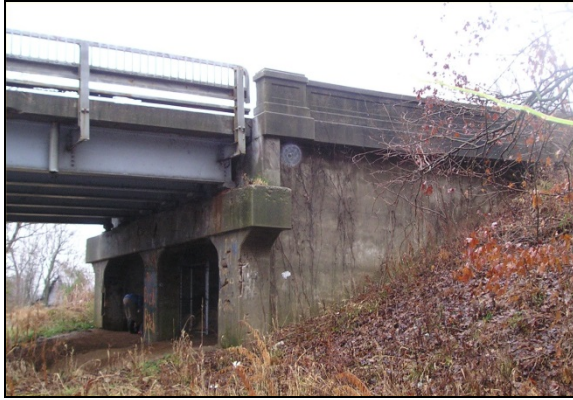
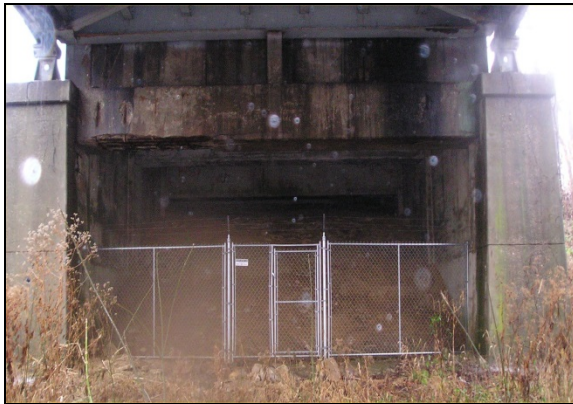
Photo 12 and 13: Bridge Design Mimicking “Cave-like” Atmosphere

While assessing bridges or structures, look for dark environments that mimic cave-like conditions such as under the deck in the case of a bridge (Photos 12 and 13) or an attic in the case of a structure. This may involve crawling under low areas so a hard hat is recommended. Such places (e.g., a concrete bunker secreted into a hillside with an open front) provide protection from wind, rain, sleet, hail and predators. Bats do not roost near the ground where predators (cats, raccoons, etc.) can reach them. Roosting is usually at least 4 feet from the ground.

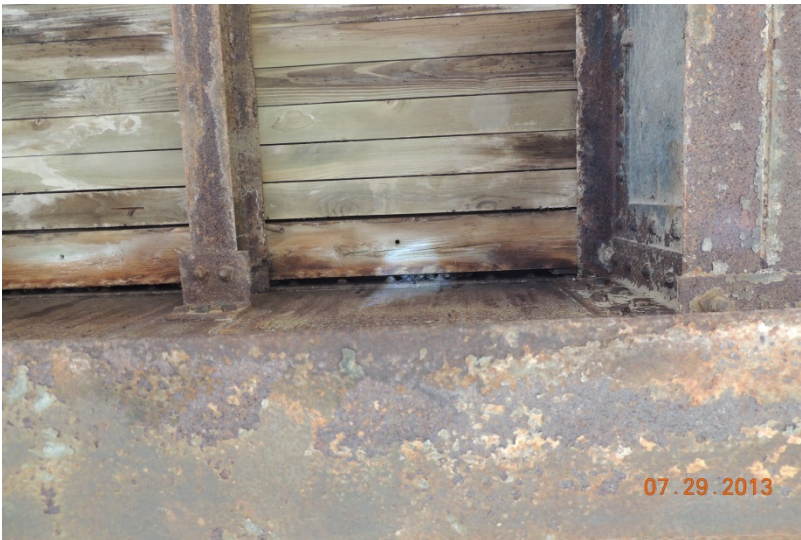
Photo 14: NLEBs Roosting Under a Timber Decked Bridge
