# **Desktop Analysis for Sensitive Biological Resources**

Bridge M-22-U

Colorado Department of Transportation  
Denver, Colorado

**January 2021**

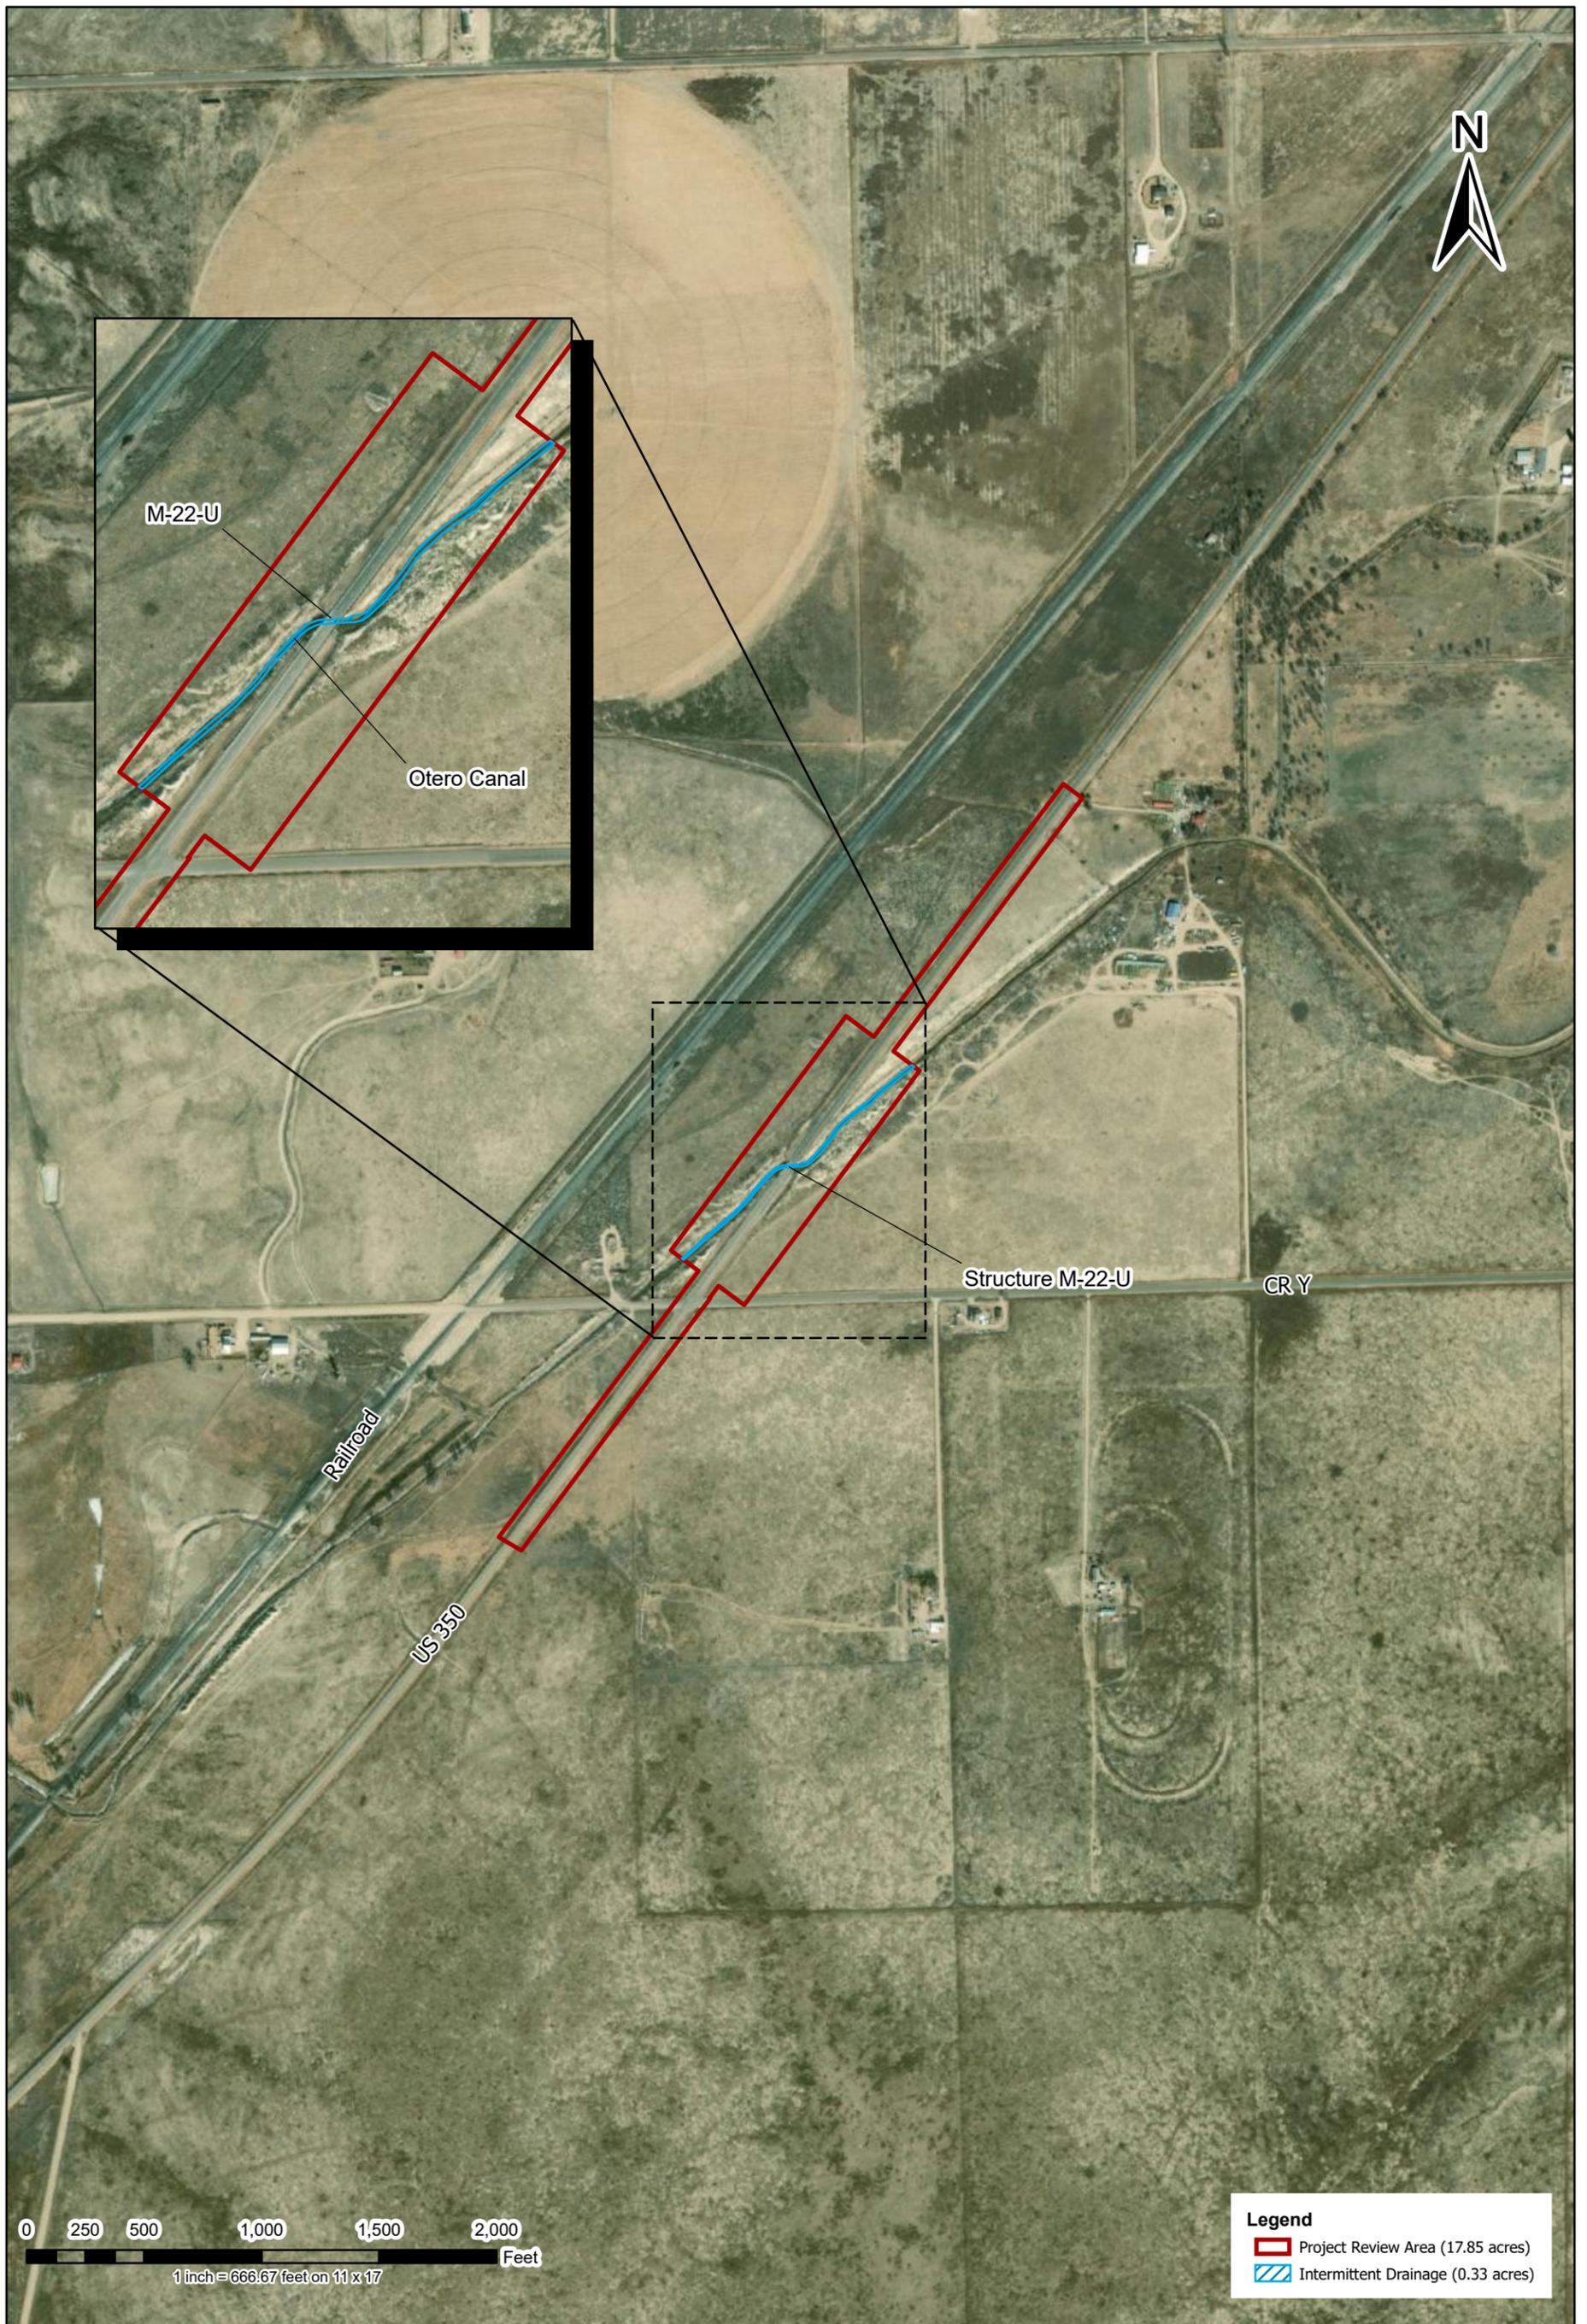
**Figure 5**  
 Aquatic Resources

During the survey, no wetlands were observed within the more restrictive PIA (and none within the larger PRA, see Figure 5 showing NWI mapping).

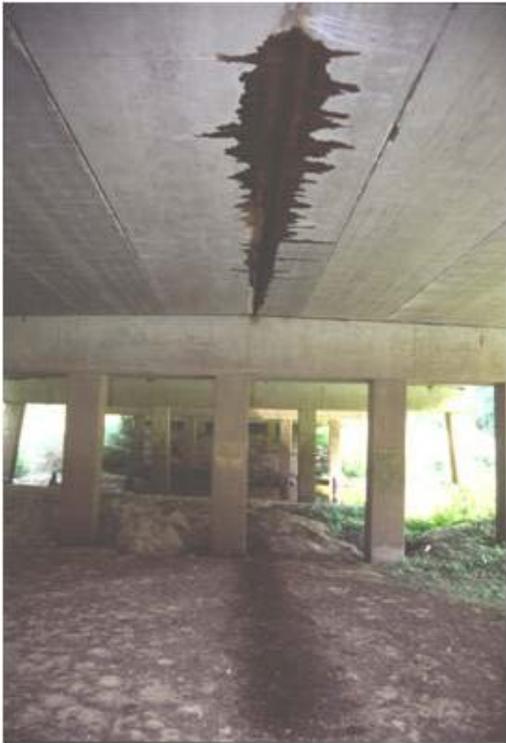
Photo 7: Staining along longitudinal joint. Note guano deposits on the ground. Photo 8: Staining on underside of expansion joint from bat use.

Stains may appear wet and are usually found in dark places. Look for four to six inch wide dark stains located on concrete support beams and walls immediately below the ceiling of the bridge, and beneath joints (Photos 8 - 11).
