Desktop Analysis for Sensitive Biological Resources Bridge M-21-I

Colorado Department of Transportation
Denver, Colorado

January 2021
Final

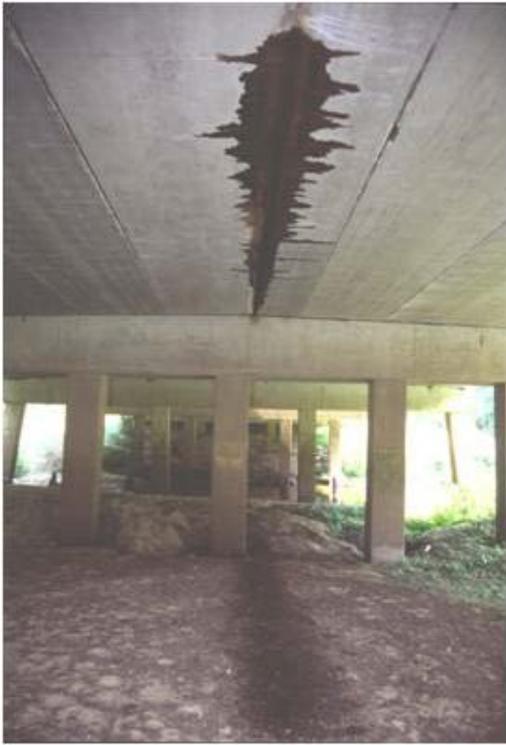
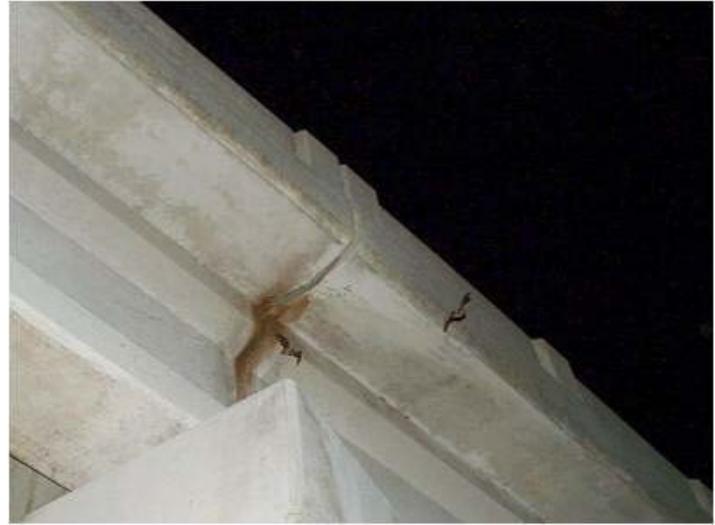
Photo 7: Staining along longitudinal joint. Note guano deposits on the ground. Photo 8: Staining on underside of expansion joint from bat use.

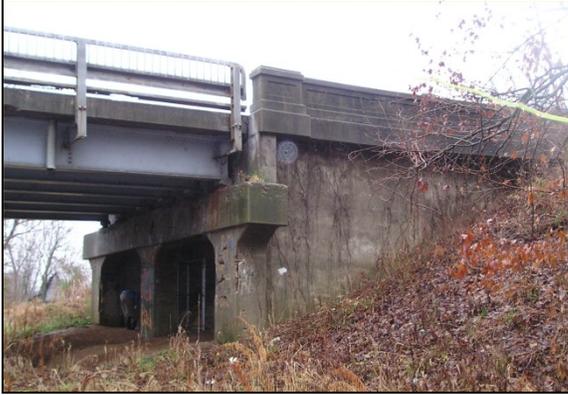
Photo 12 and 13: Bridge Design Mimicking “Cave-like” Atmosphere

While assessing bridges or structures, look for dark environments that mimic cave-like conditions such as under the deck in the case of a bridge (Photos 12 and 13) or an attic in the case of a structure. This may involve crawling under low areas so a hard hat is recommended. Such places (e.g., a concrete bunker secreted into a hillside with an open front) provide protection from wind, rain, sleet, hail and predators. Bats do not roost near the ground where predators (cats, raccoons, etc.) can reach them. Roosting is usually at least 4 feet from the ground.
