# **Desktop Analysis for Sensitive Biological Resources**

Bridge N-21-C

Colorado Department of Transportation  
Denver, Colorado

**January 2021**

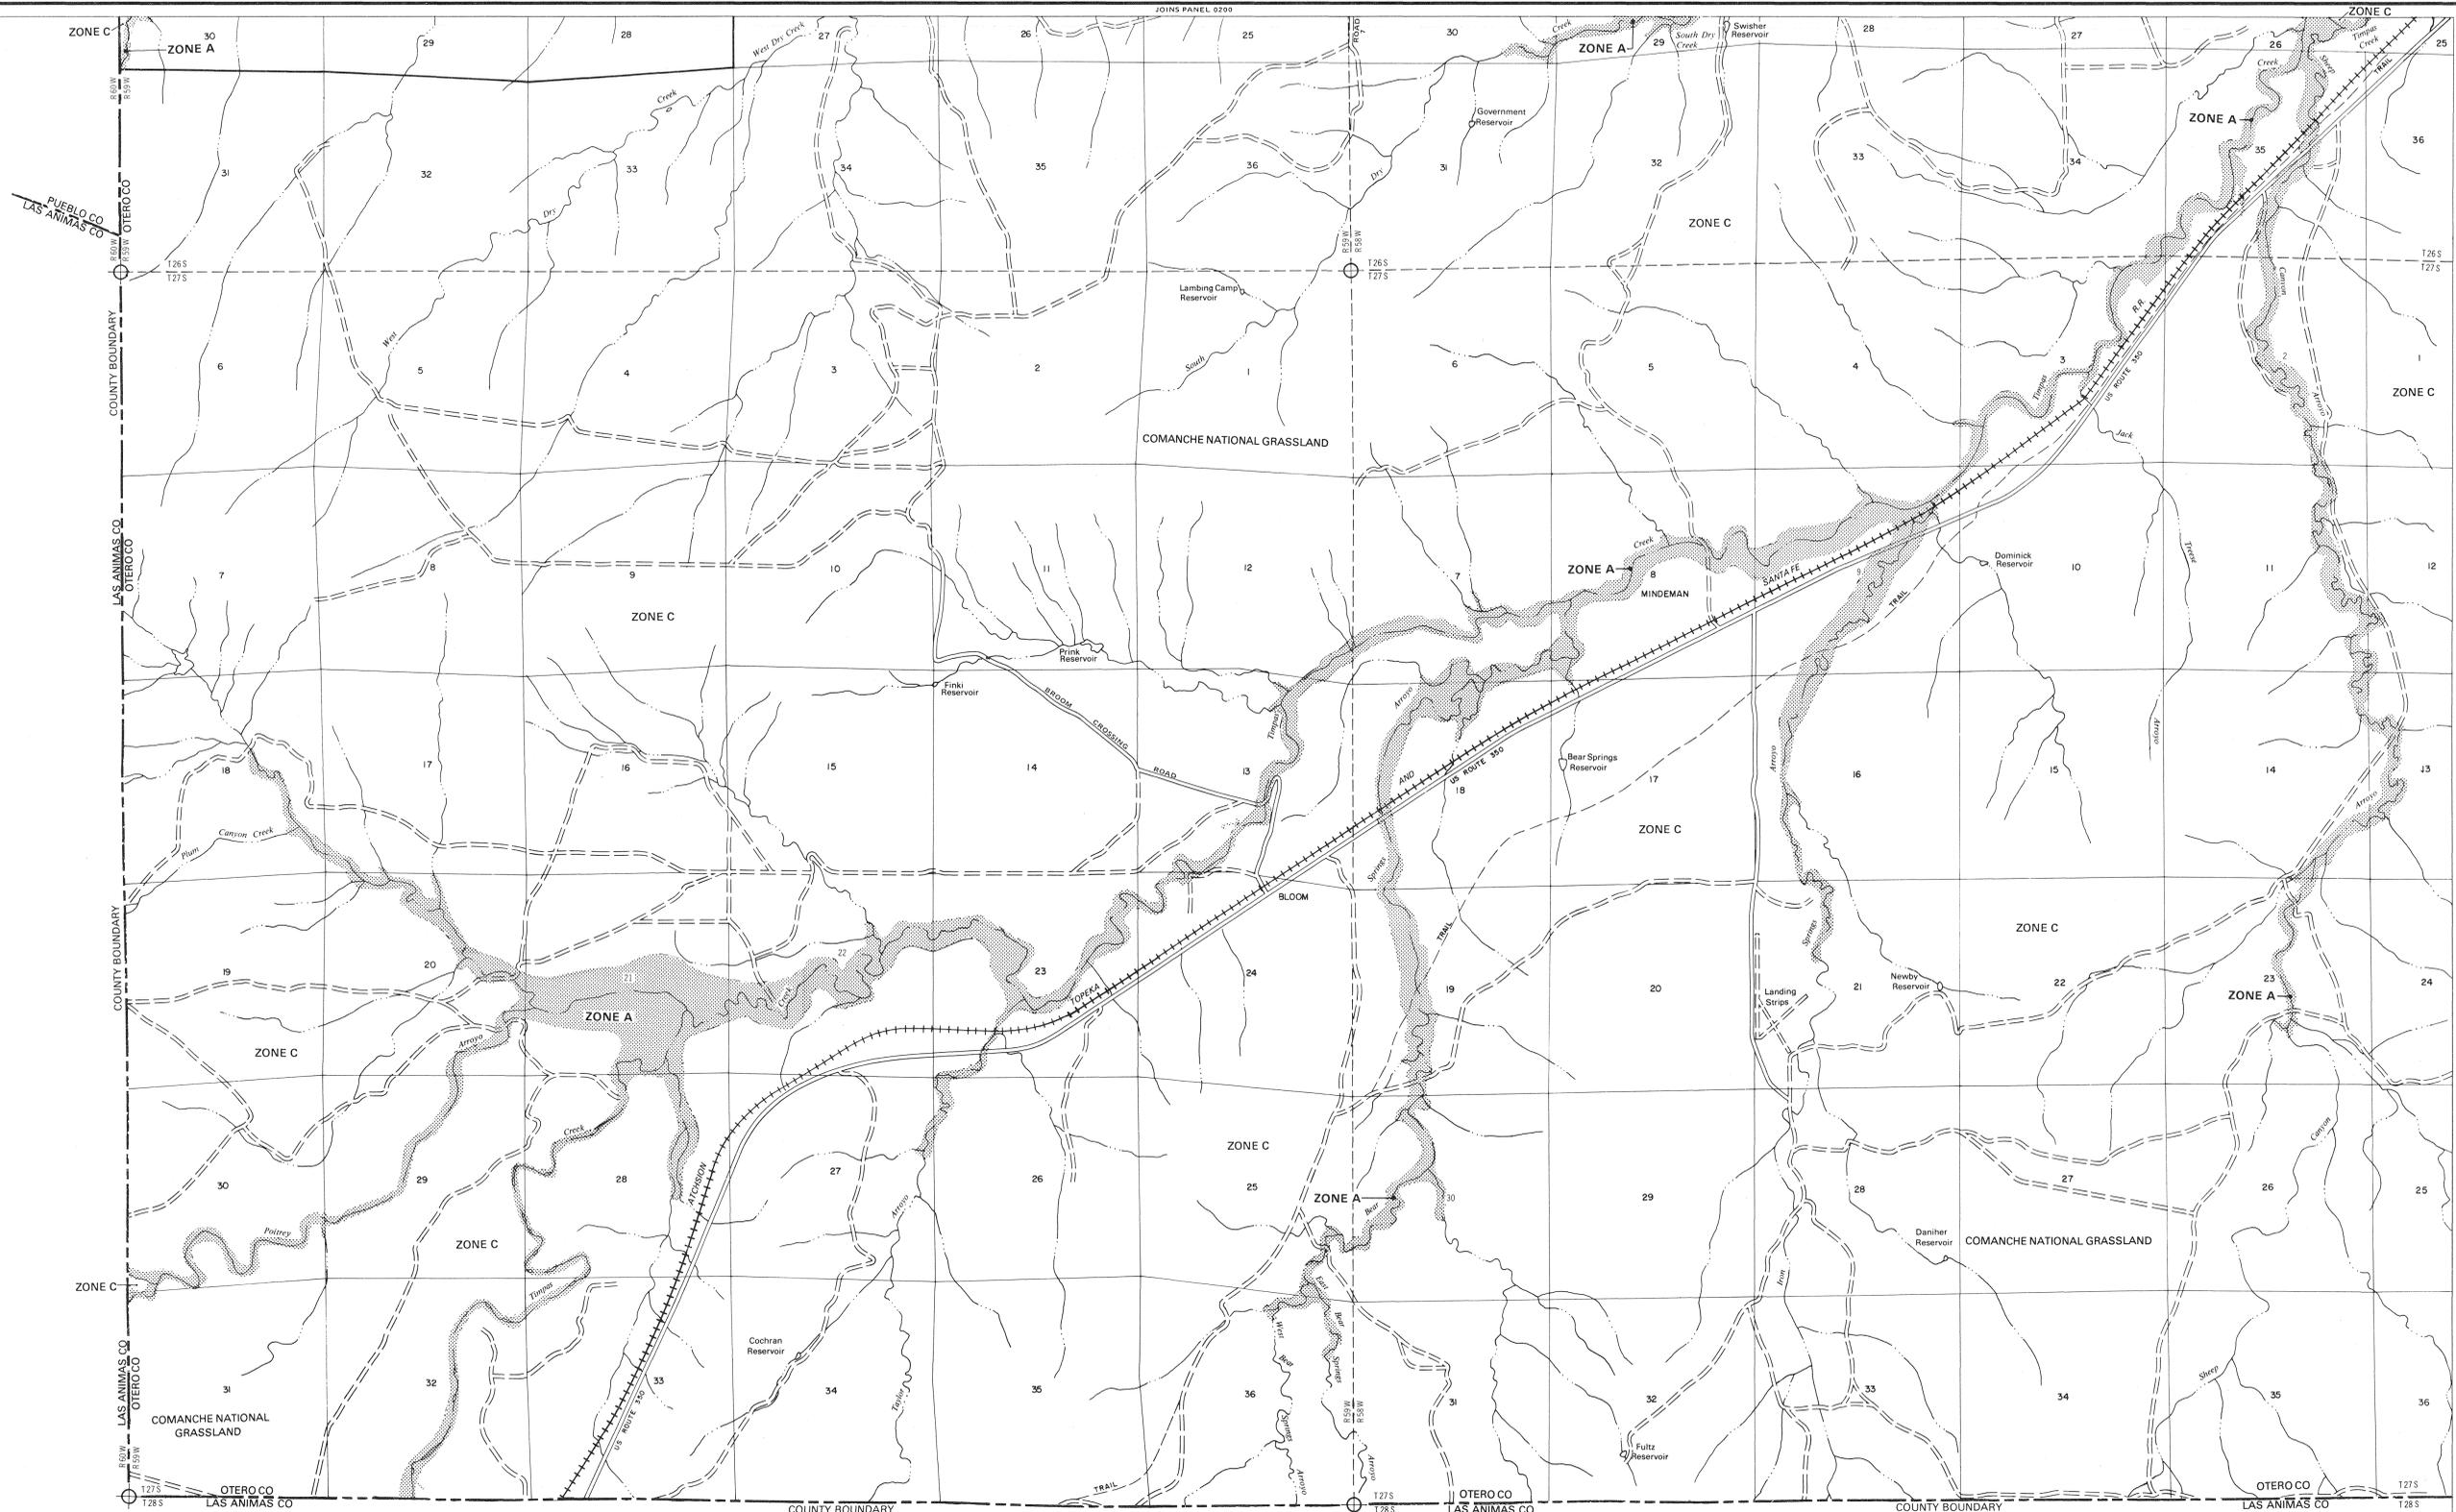
The FEMA Flood Insurance Rate Map (FIRM) has mapped the entirety of the PRA as occurring within an Area of Minimal Flood Hazard (Zone X; see Figure 4). The bridge and road rebuild will be designed to meet CDOT construction standards. Because the Project is not within the 100-year floodplain and the Project is not expected to alter any Special Flood Hazard Areas, the Project will not require floodplain permitting. The hydraulics of the watershed are currently being assessed and further details regarding flood design capacity will be provided in the Bridge Bundle Preliminary Hydraulics Report.

- There is potential for Migratory Bird Treaty Act (MBTA) species and bats to occur
- Floodplains
  - The Project is not located within any Federal Emergency Management Agency (FEMA) floodplain (Figure 4).

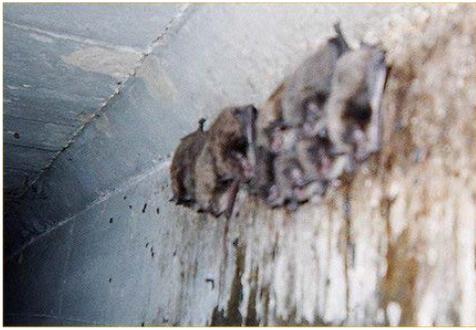
Photo 1: Bats hanging from cracks along Support beams

Cracks in the concrete are used by bats as a foothold in roosting (Photo 1). In addition, some bats may be hidden from sight in wider cracks in the concrete and behind deteriorating concrete sections in the ceiling or walls. Look for cracking along support beams and inner walls especially below a fillet (a concrete filling between ceiling and vertical beam). During inspection, sounds may be heard coming from behind such cracks and/or expansion joints.

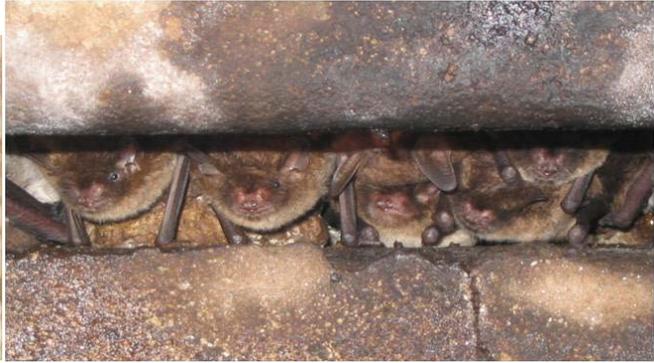
Photo 2: Visible bats within an expansion joint

Expansion joints can provide protected cover for bats (Photos 2 and 3), but do not always provide habitat, depending upon whether they are obstructed by road debris or other blockages to use. If possible during the assessment, individuals should look into expansion joints or in other cracks with a flashlight. If joints are used by bats, often there will be guano under the joints (Photos 4-6), but not always, since the joint may be located over water.

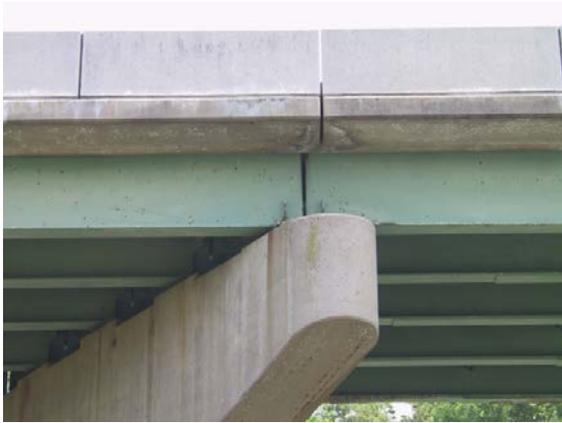
Photo 3: Example of open concrete joint used by bats

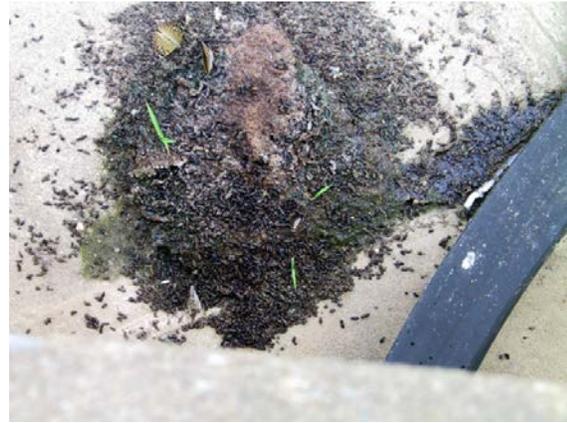
Photo 4: Guano deposits visible from bridge deck, on top of pier

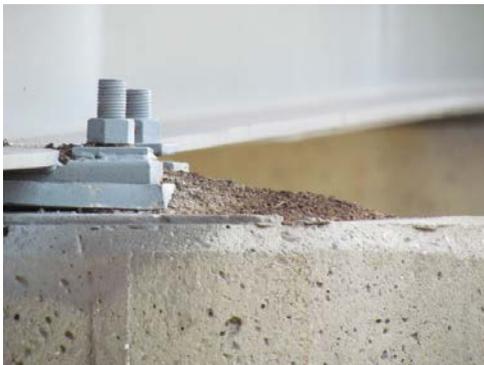
Photo 5: Guano deposit on pier, obscuring structural features.

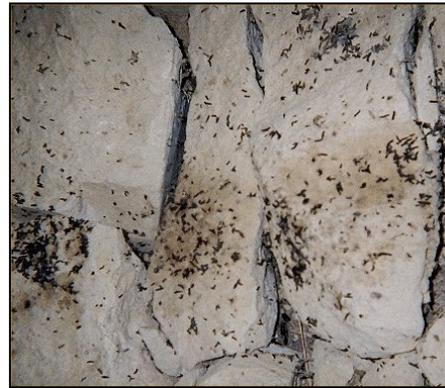
Photo 6: Bat Guano on Riprap

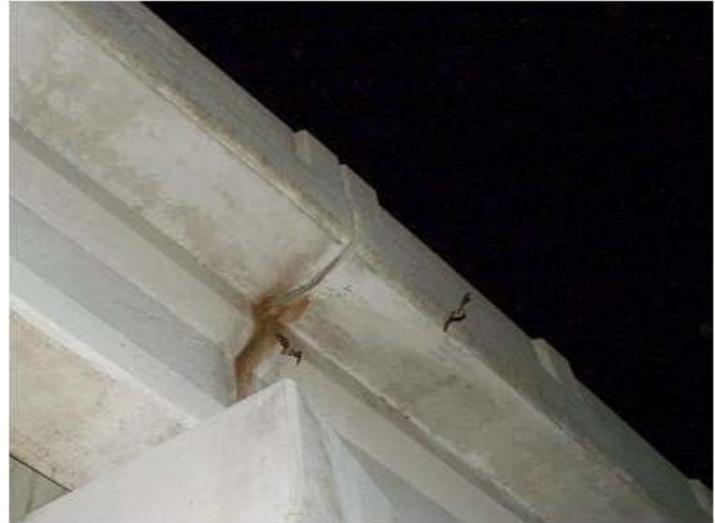
Photo 7: Staining along longitudinal joint. Note guano deposits on the ground. Photo 8: Staining on underside of expansion joint from bat use.

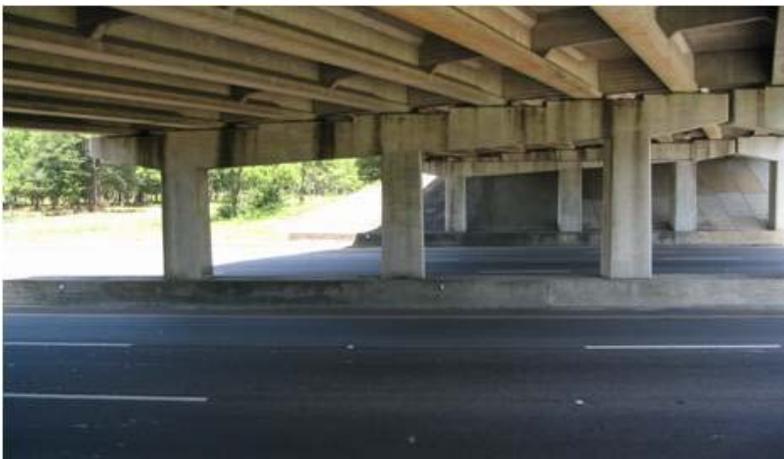
Photo 9: Staining on sides of pier caps

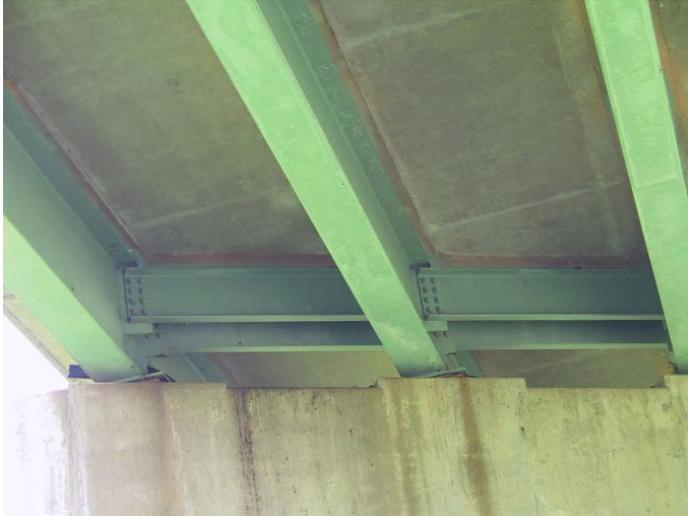
Photo 10: Guano staining on side of pier

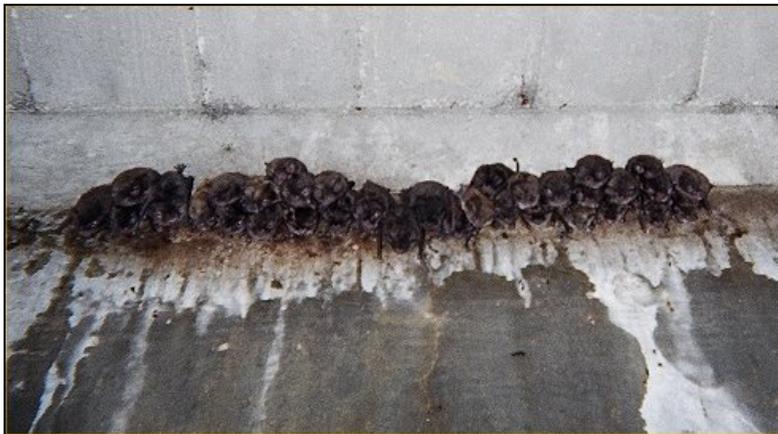
Photo 11: Bats Roosting & Associated Staining

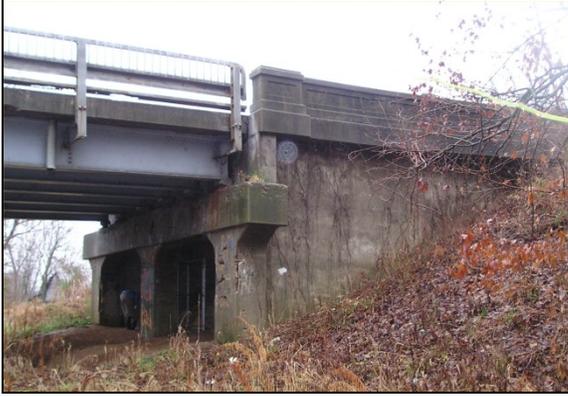
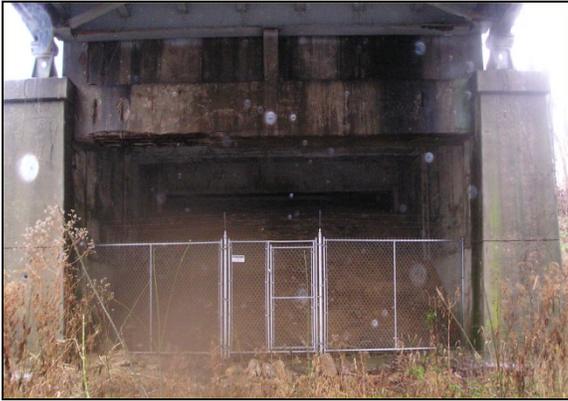
Photo 12 and 13: Bridge Design Mimicking “Cave-like” Atmosphere

While assessing bridges or structures, look for dark environments that mimic cave-like conditions such as under the deck in the case of a bridge (Photos 12 and 13) or an attic in the case of a structure. This may involve crawling under low areas so a hard hat is recommended. Such places (e.g., a concrete bunker secreted into a hillside with an open front) provide protection from wind, rain, sleet, hail and predators. Bats do not roost near the ground where predators (cats, raccoons, etc.) can reach them. Roosting is usually at least 4 feet from the ground.

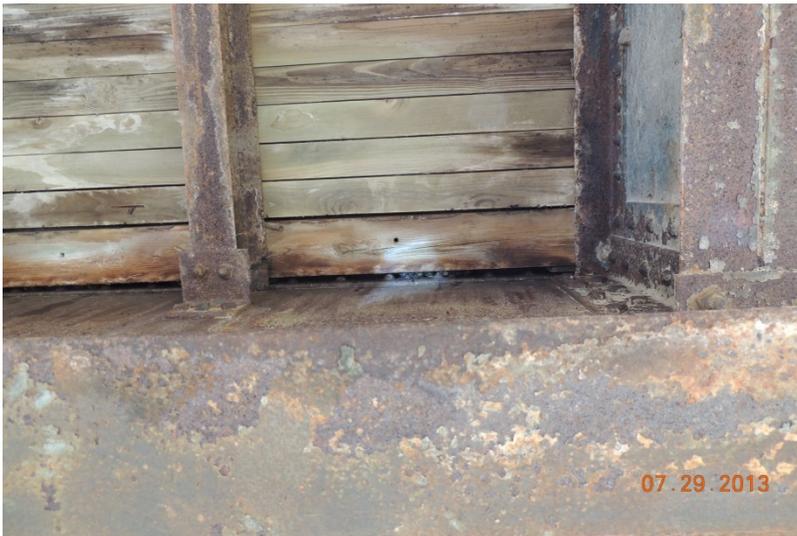
Photo 14: NLEBs Roosting Under a Timber Decked Bridge
