Desktop Analysis for Sensitive Biological Resources

Bridge M-22-Y

Colorado Department of Transportation
Denver, Colorado

Final

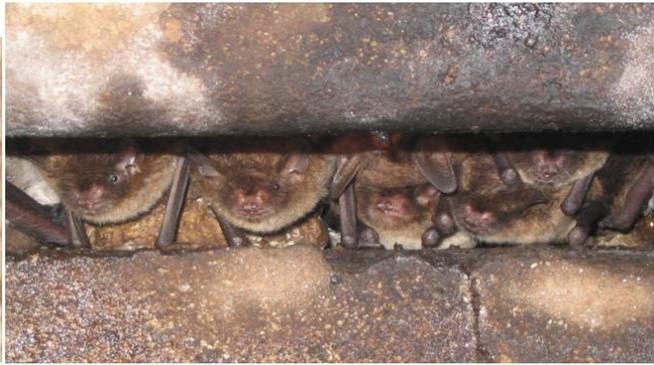
Photo 2: Visible bats within an expansion joint

Expansion joints can provide protected cover for bats (Photos 2 and 3), but do not always provide habitat, depending upon whether they are obstructed by road debris or other blockages to use. If possible during the assessment, individuals should look into expansion joints or in other cracks with a flashlight. If joints are used by bats, often there will be guano under the joints (Photos 4-6), but not always, since the joint may be located over water.

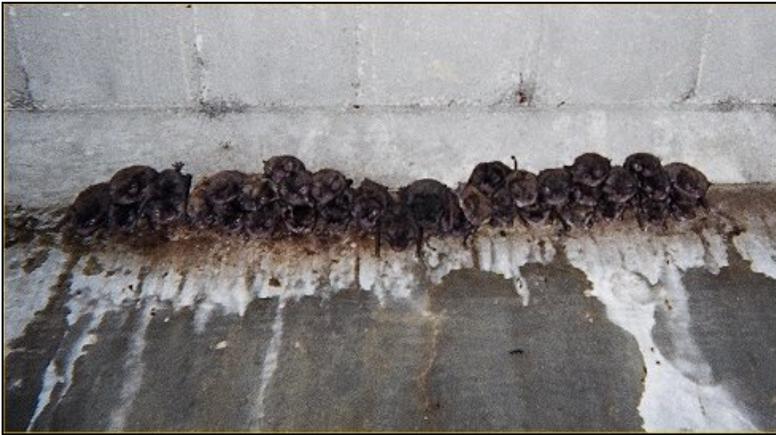
Photo 11: Bats Roosting & Associated Staining

Stains may appear wet and are usually found in dark places. Look for four to six inch wide dark stains located on concrete support beams and walls immediately below the ceiling of the bridge, and beneath joints (Photos 8 - 11).
