Desktop Analysis for Sensitive Biological Resources

Bridge N-21-F

Colorado Department of Transportation
Denver, Colorado

January 2021

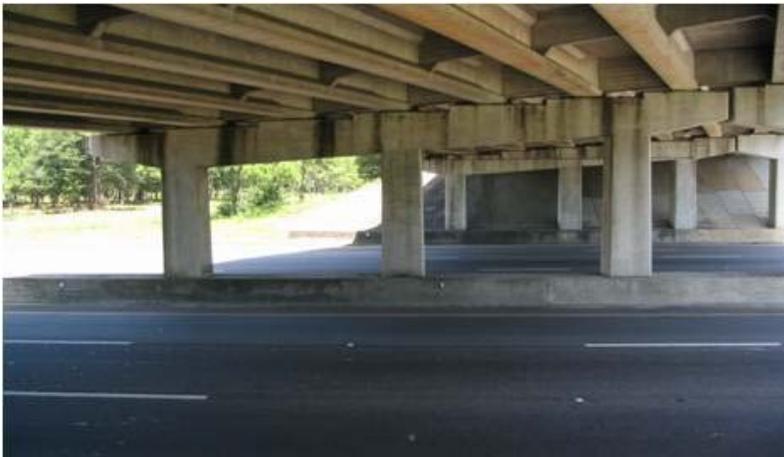
Photo 9: Staining on sides of pier caps
