**COLORADO DEPARTMENT OF TRANSPORTATION
HEADQUARTERS
2829 West Howard Place
Denver, CO 80204**

Summary Observations

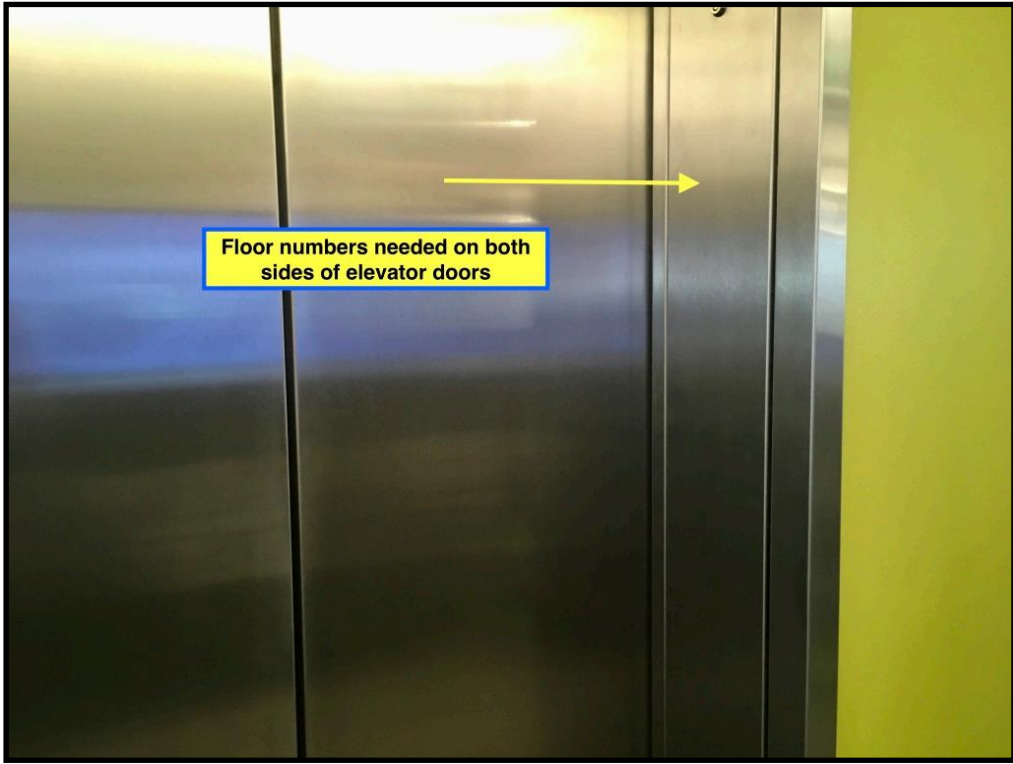
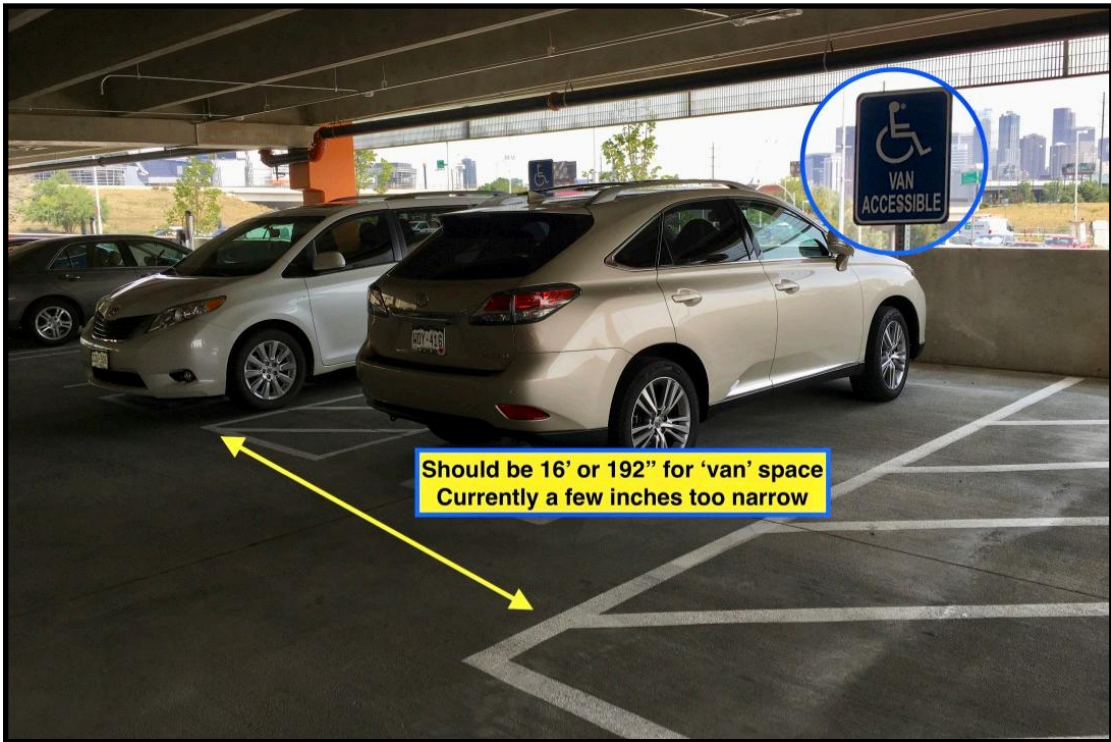
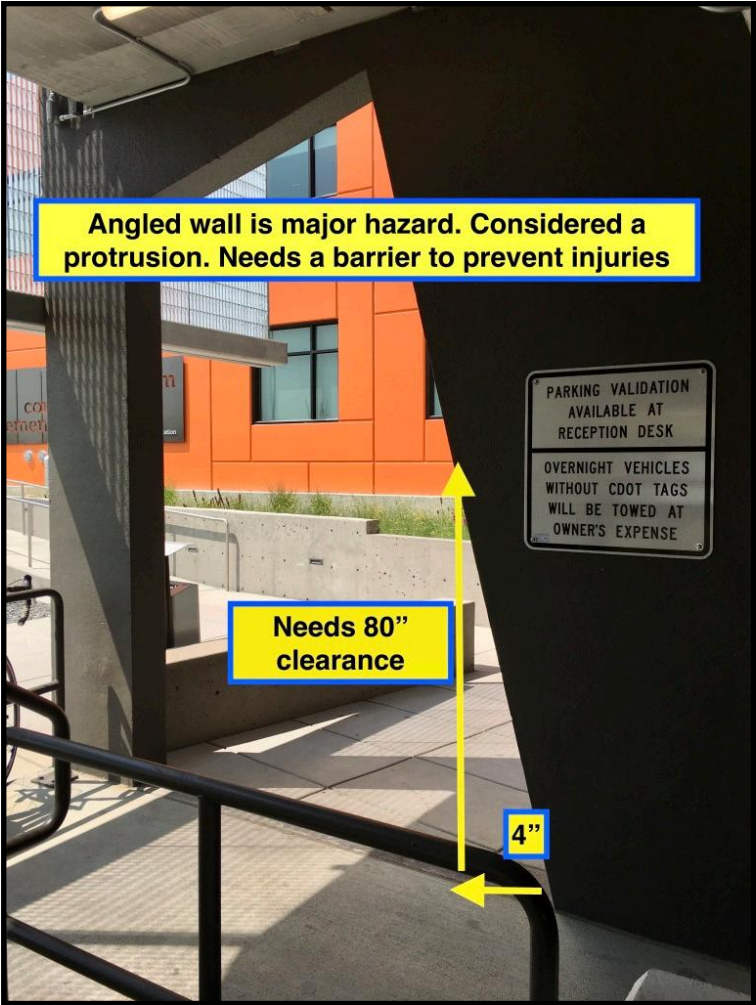
Angled wall is major hazard. Considered a protrusion. Needs a barrier to prevent injuries

Needs 80" clearance

4"

Minor Remedial Recommendations	
Description	Priority
Add additional floor number on 1st floor elevator door	Immediate
Place a cane detectable item under any hallway protrusions that exceed 4" (e.g. EAD's, fire extinguishers)	Immediate
Place a cane detectable item under the arch in the path-of-travel from the parking garage to the main entrance. See picture below	Immediate
Restripe 'van' space & access aisle in garage to extend to 192"	Future
