**Pueblo - Pinon Rest Area NB - I-25 MM 114.99**  
**Elevation  $\approx$  4900'**

**CDOT Region #2**

## **Summary Observations**

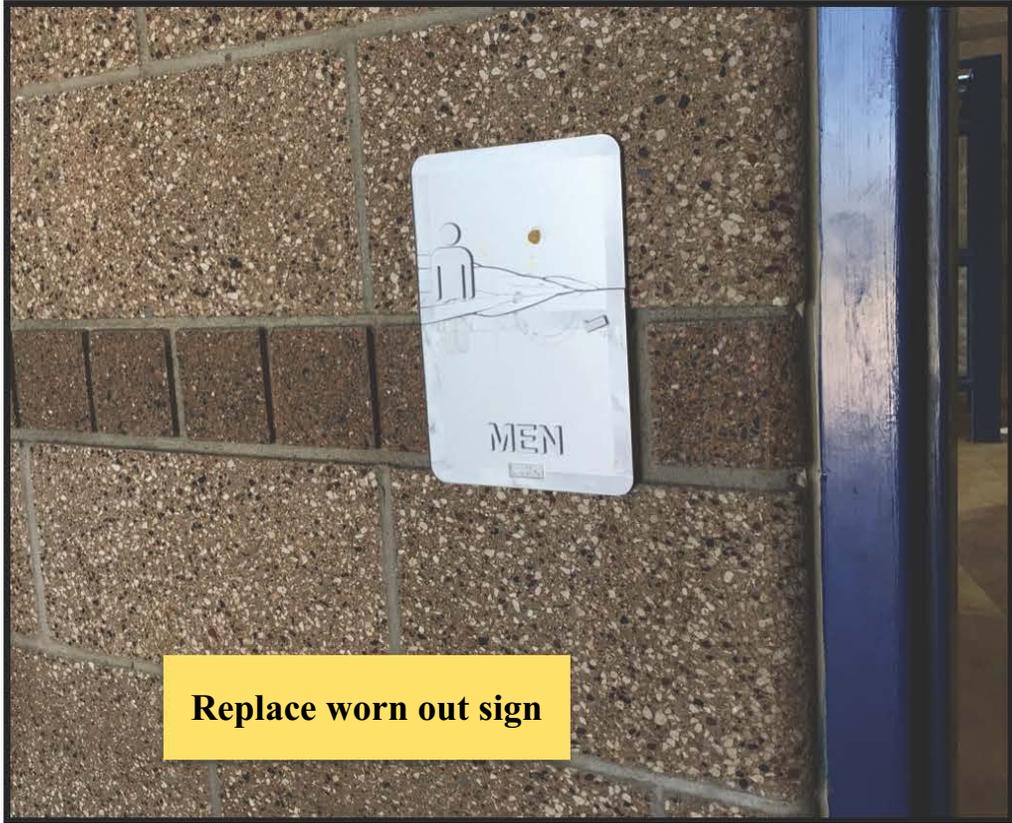
**Replace worn out sign**

Recommendations	
Description	Priority
Add a restroom sign at 'family' restroom on wall, latch side of door.	Immediate
Reduce door pressures at 3 restrooms to ≤ 5 lbs.	Immediate
Replace worn-out sign at men's restroom	Immediate
Add 'van' to vertical post at one of accessible parking spaces	Immediate

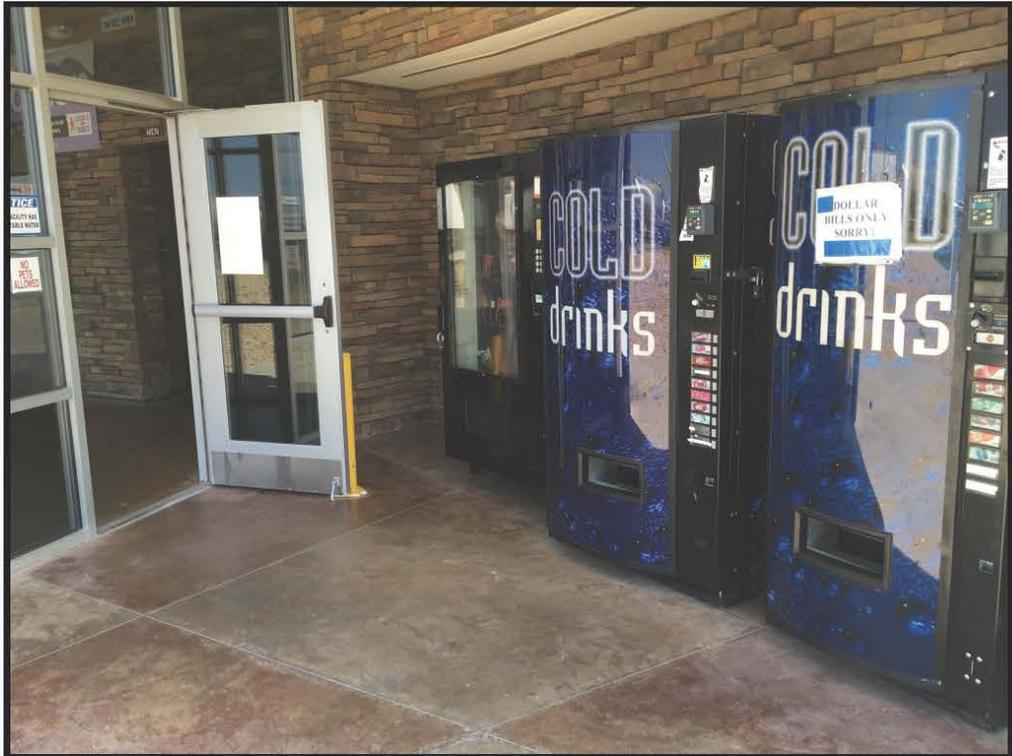
The minor corrections needed include a restroom sign on the wall on the latch side of door for the 'family' restroom and replacing the worn out sign at the men's restroom. The women's rest room has six stalls, with one full size accessible toilet stall. With six or more stalls there should also be an ambulatory stall. This may be accomplished by just adding grab bars on each side of a regular stall, ideally next to the ADA accessible stall.
