El Moro/Trinidad I-25 - MM 17.72
Elevation \approx 6100'

CDOT Region #2

Summary Observations

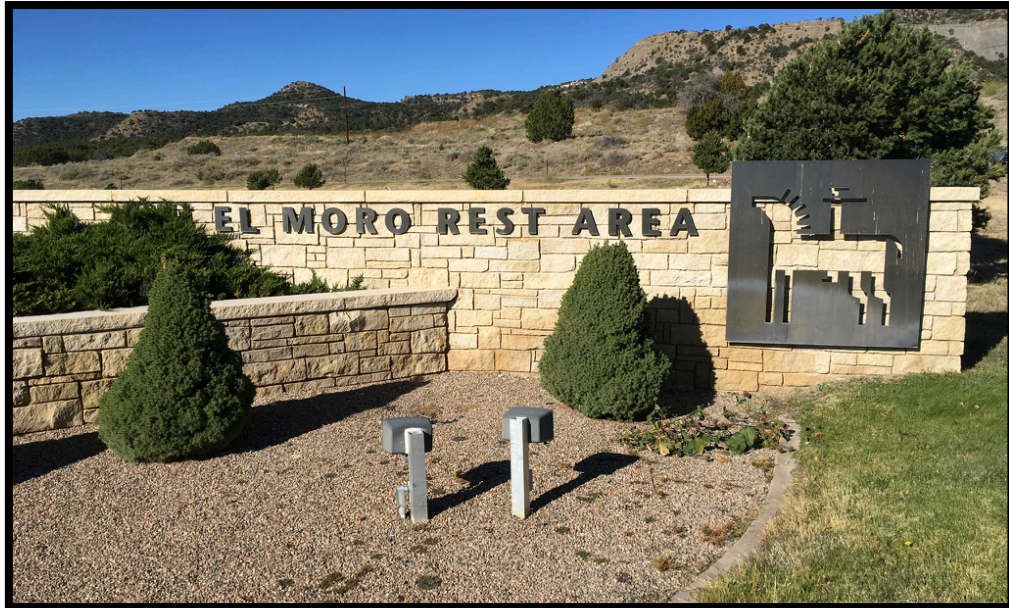
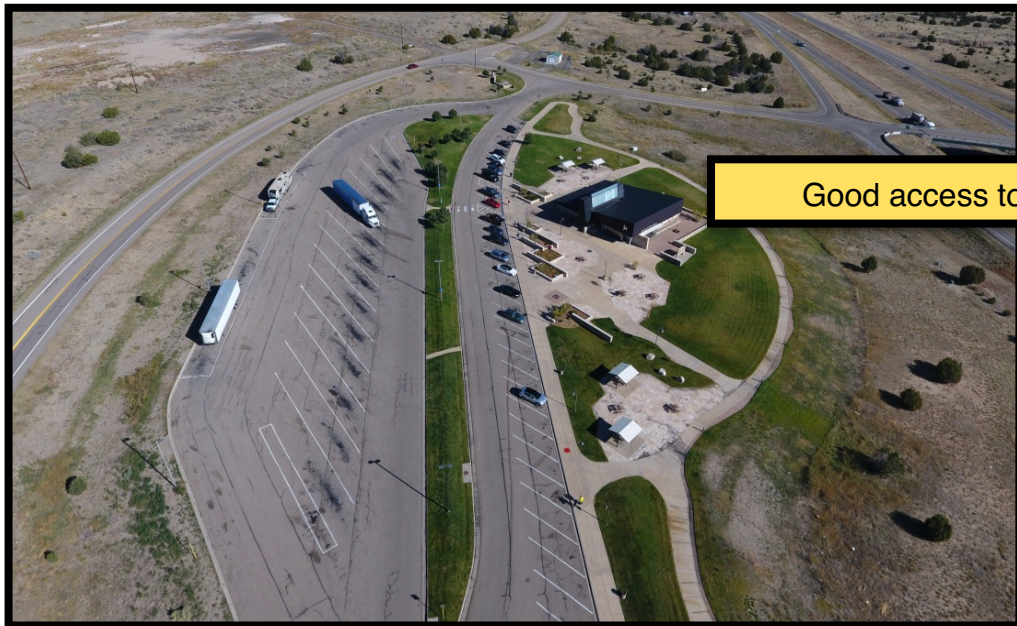
Good access to I-25
