Vail Pass Rest Area - I-70 MM 190
Elevation \approx 10,600'

CDOT Region #3

Summary Observations

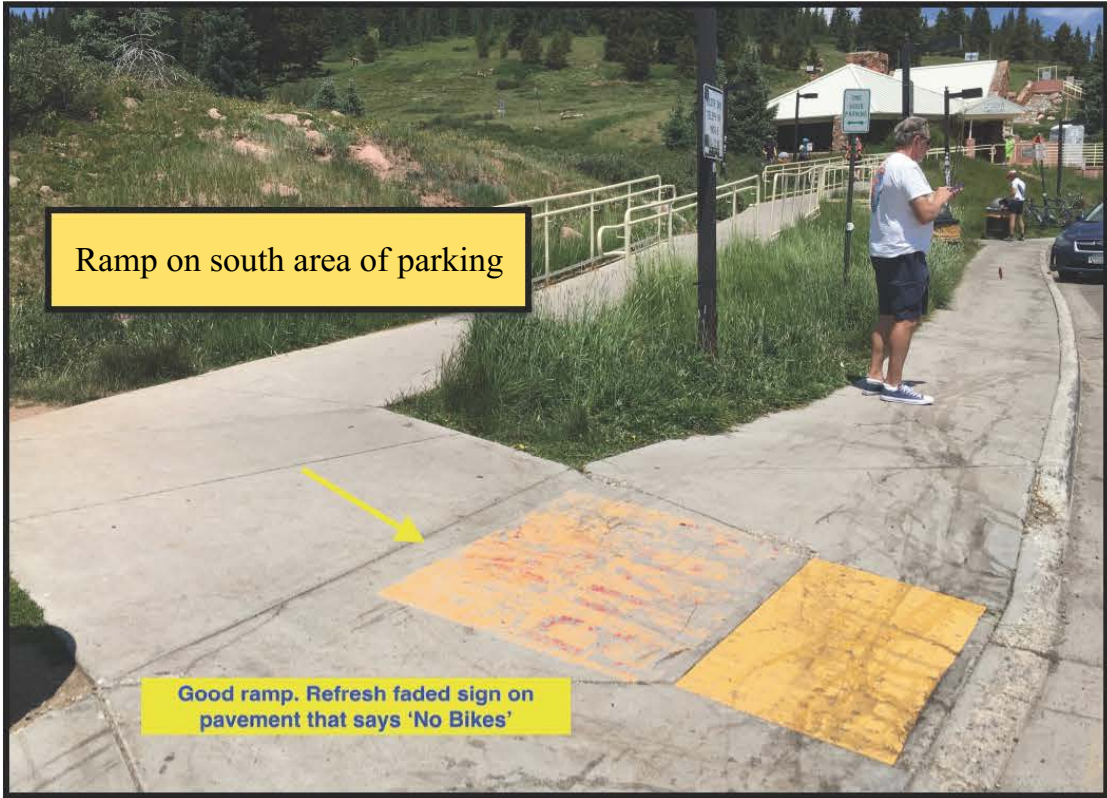
Ramp on south area of parking

Good ramp. Refresh faded sign on pavement that says 'No Bikes'

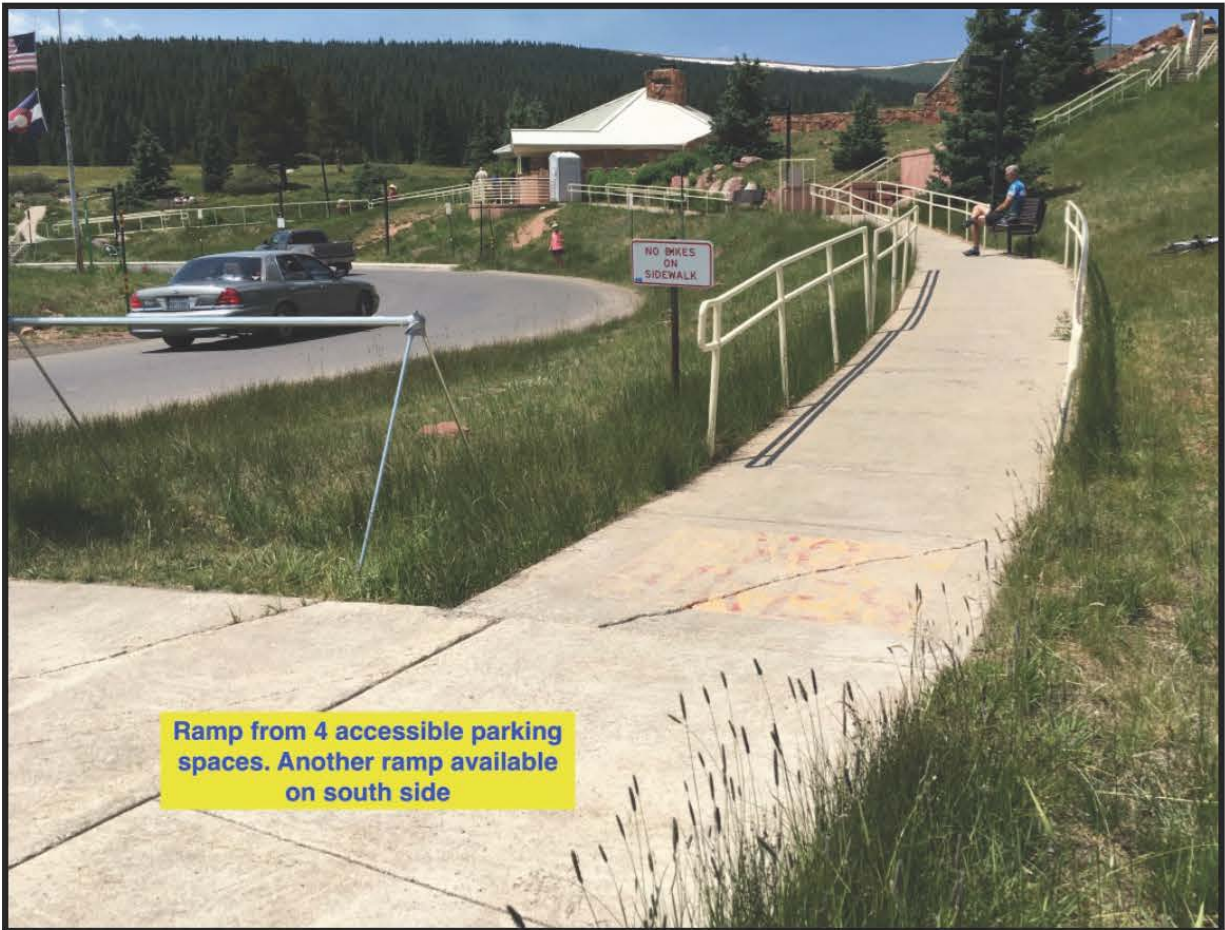
Ramp from 4 accessible parking spaces. Another ramp available on south side

The route from the four current accessible parking spaces to the building is a long ramp with a level landing midway. It is challenging but should be manageable for most people with a mobility impairment. There is a less steep ramp at the south side of the parking area although there are not any designated accessible parking spaces nearby.

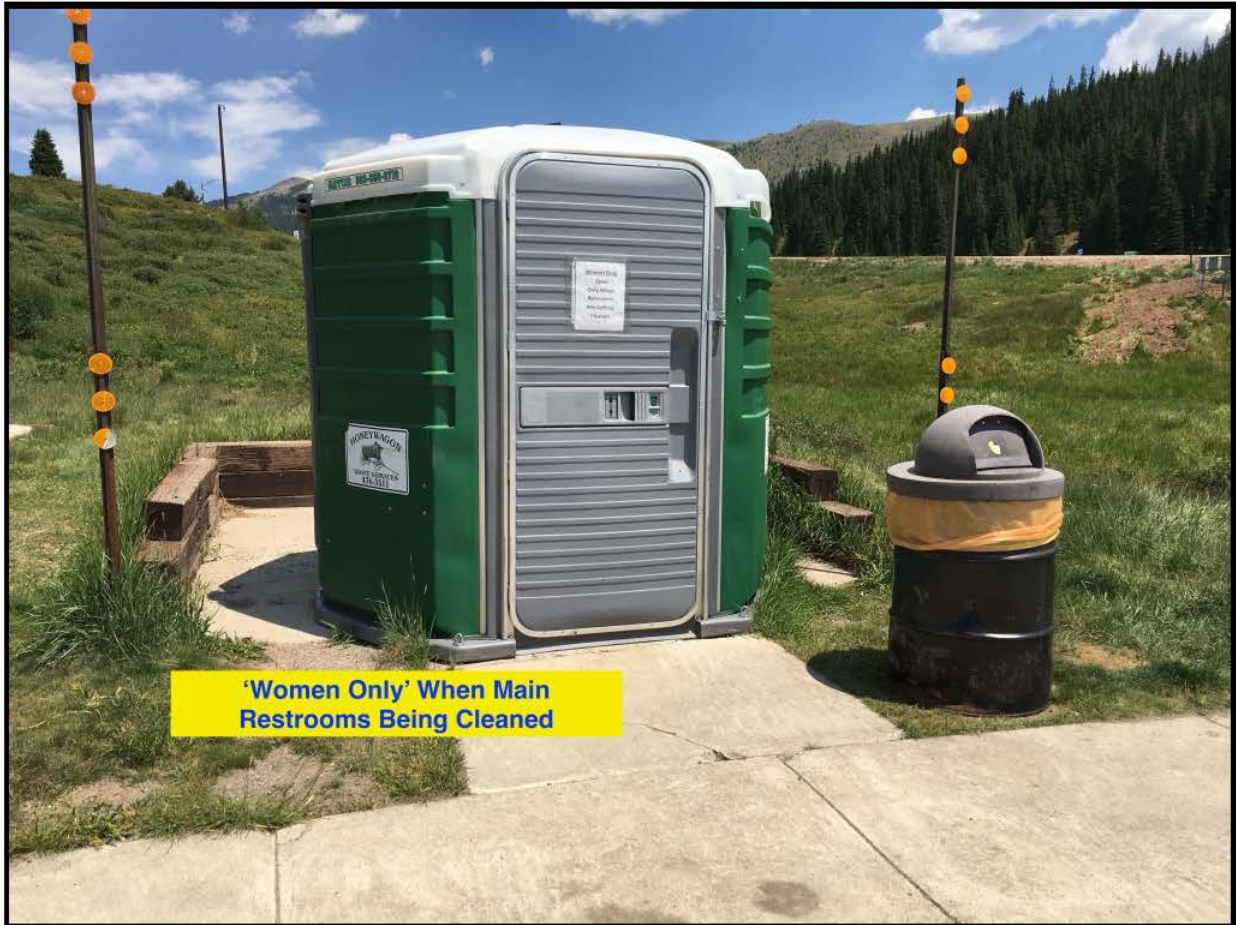
'Women Only' When Main Restrooms Being Cleaned

The men's and women's restrooms are ADA compliant with the exception they do not have a full-size accessible toilet stall. There is an 36" wide ambulatory toilet stall in each restroom. There is a portable toilet (aka porta-john) at the edge of the accessible parking spaces. However, this is only available periodically when the permanent restrooms are not available due to cleaning or other maintenance. See picture below.

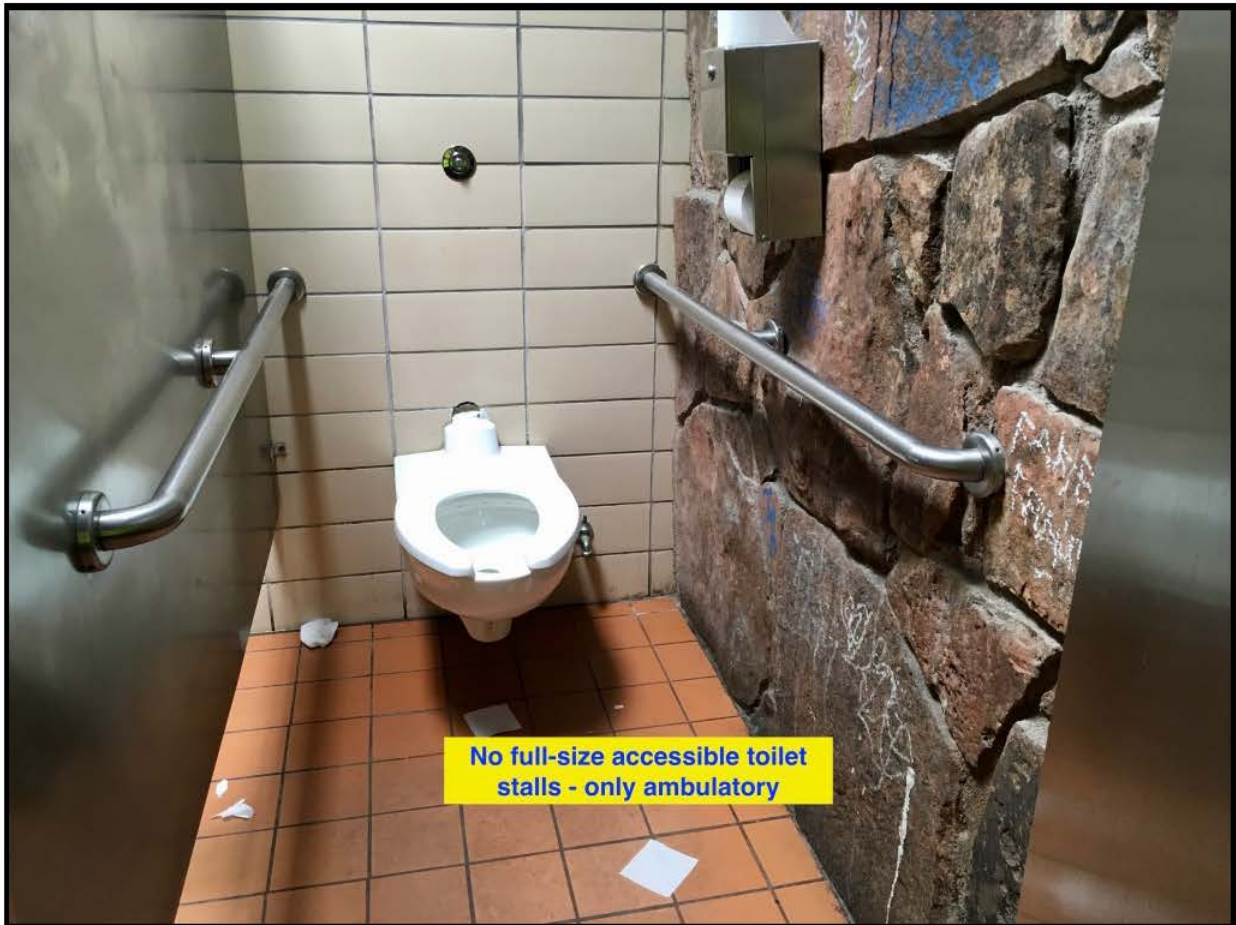
No full-size accessible toilet stalls - only ambulatory

Recommendations	
Description	Priority
Designate a 'van' space & add 'van' to vertical post.	Immediate
Refresh faded paint at accessible parking spaces.	Soon
Pave small section of sidewalk that leads to accessible parking and ramp on north side	Soon
Construct a full-size accessible toilet stall in each restroom	Soon

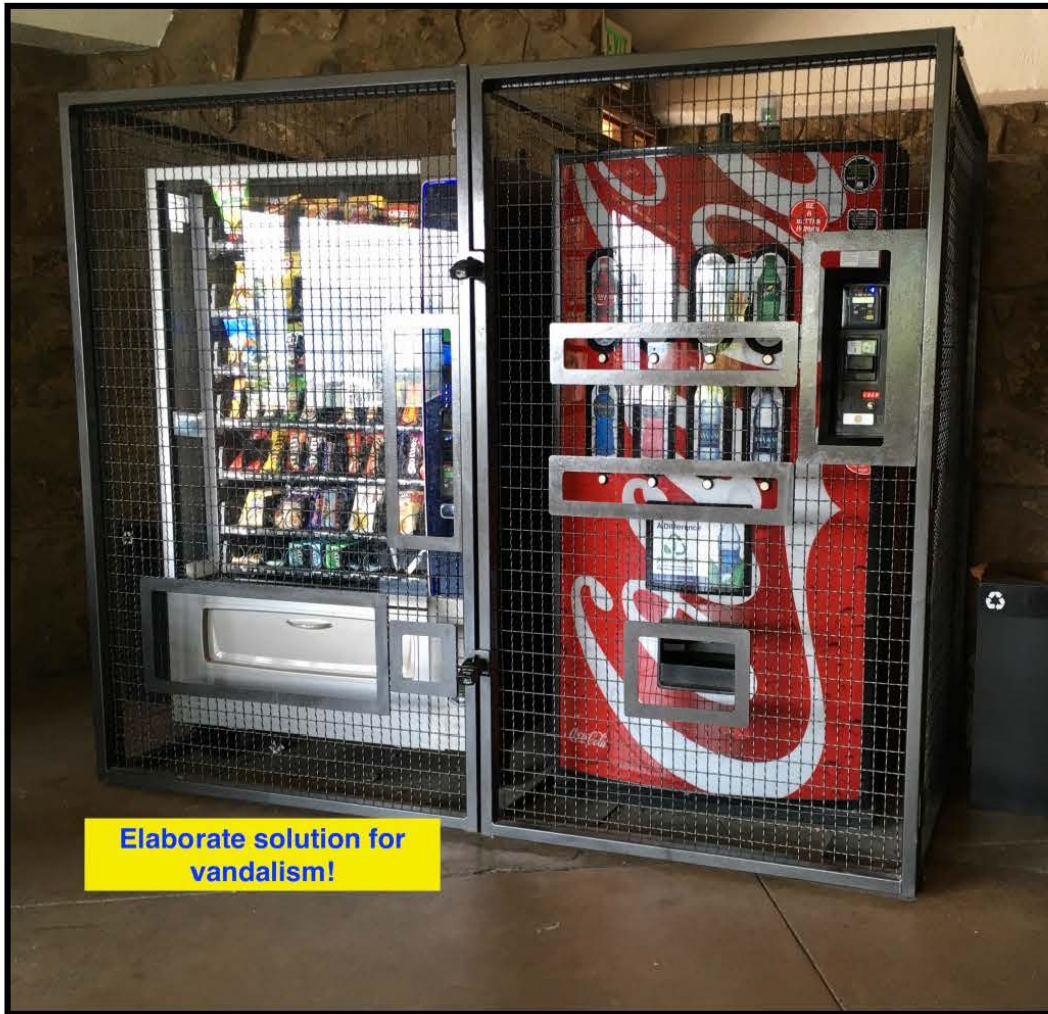
Elaborate solution for vandalism!

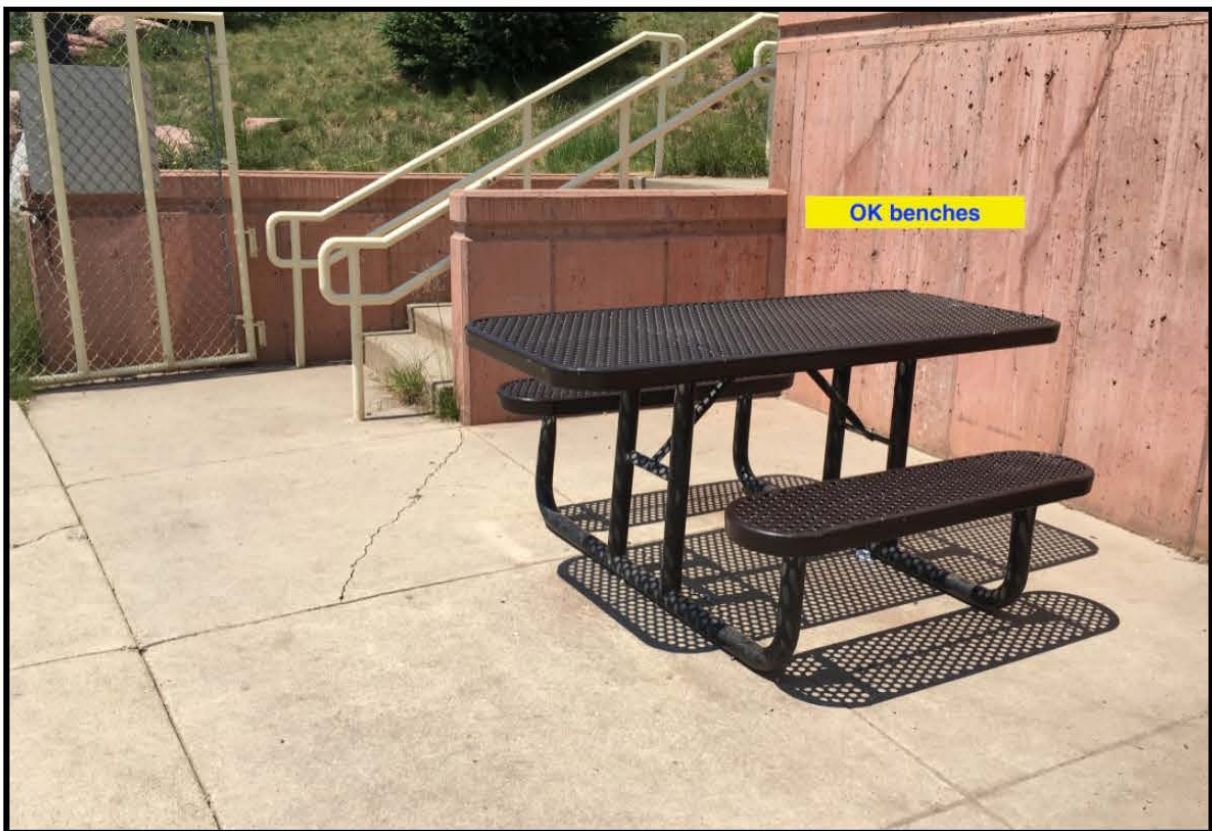
OK benches
