# Existing Conditions Report

Project No. NH 0504-037

***US 50 Corridor  
Pueblo To Kansas***

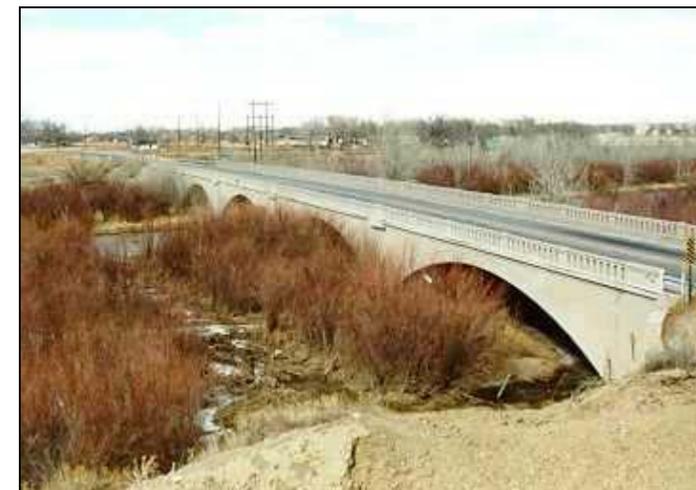
**Figure 6-1 Historic Bridge over Huerfano River**

The average age of all of the bridges is 44 years, with 54 percent of the bridges built before 1960. The bridge over the Huerfano River just east of Boone was constructed in 1921, is the oldest of the structures along the corridor. It is listed on the National Register of Historic Places, and is one of two concrete arch bridges along the US 50 corridor. There is one other bridge that is eligible for the list. Twenty-two additional structures are categorized as possibly eligible for the Register.

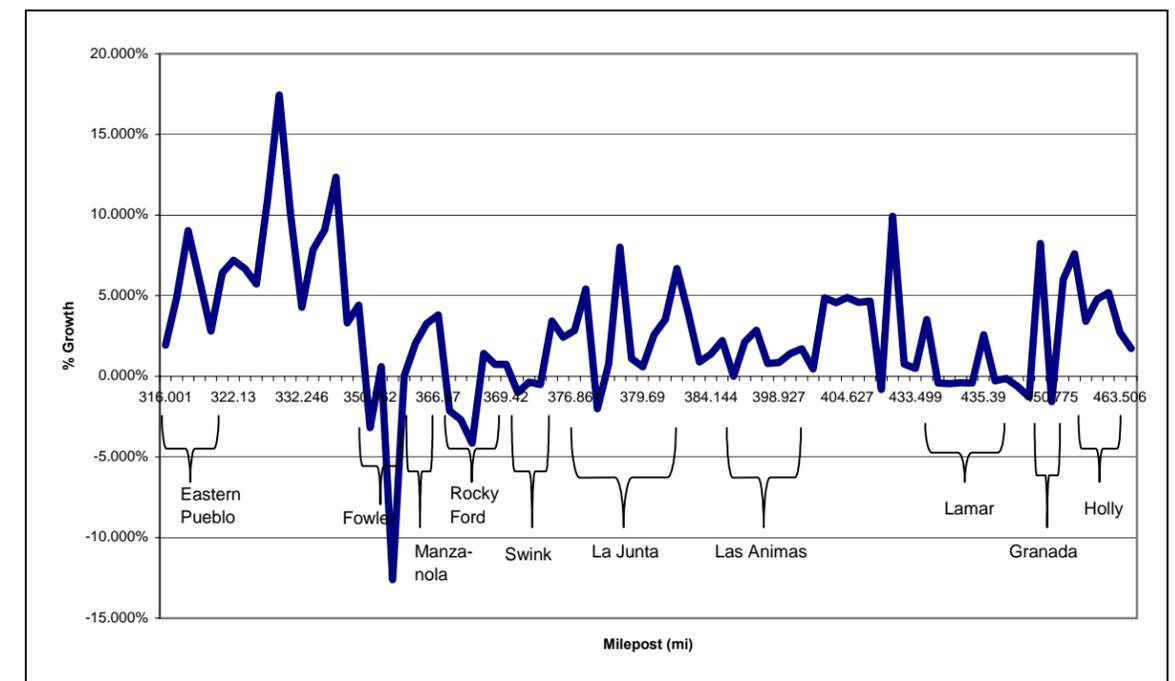
Figure 8-1 Traffic Growth Along Corridor

Historical traffic trends were evaluated over a five-year period beginning in 1995. Overall, the corridor experienced an average 2.8% growth rate in traffic volume while the 10-year census shows an average 0.95% population growth in cities along the corridor. Figure 8-1 shows the traffic growth trends are greatest from Pueblo to Fowler.

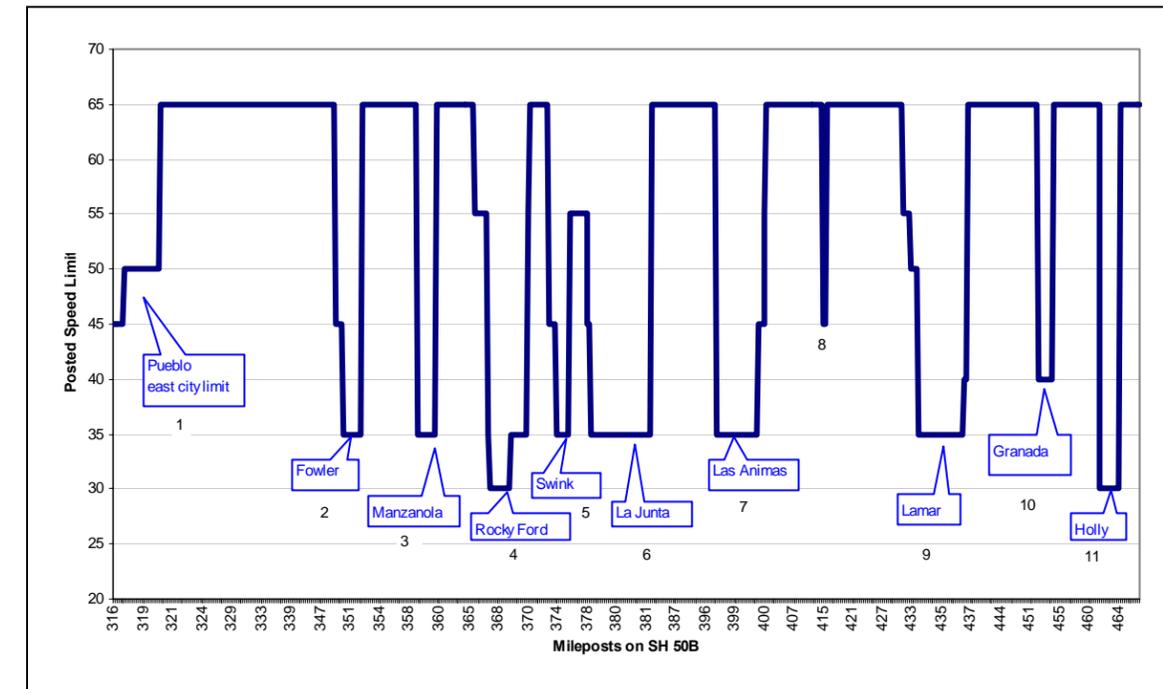
**Figure 8-2 Speed Limit Change Through Corridor**

A planning level travel-time analysis was completed for the 152-mile corridor to determine the overall travel efficiency. The travel-time analysis evaluated the impact of speed reduction zones and signal timing on corridor efficiency. Figure 8-2 graphically shows the 11 speed reduction zones and their locations along the corridor.

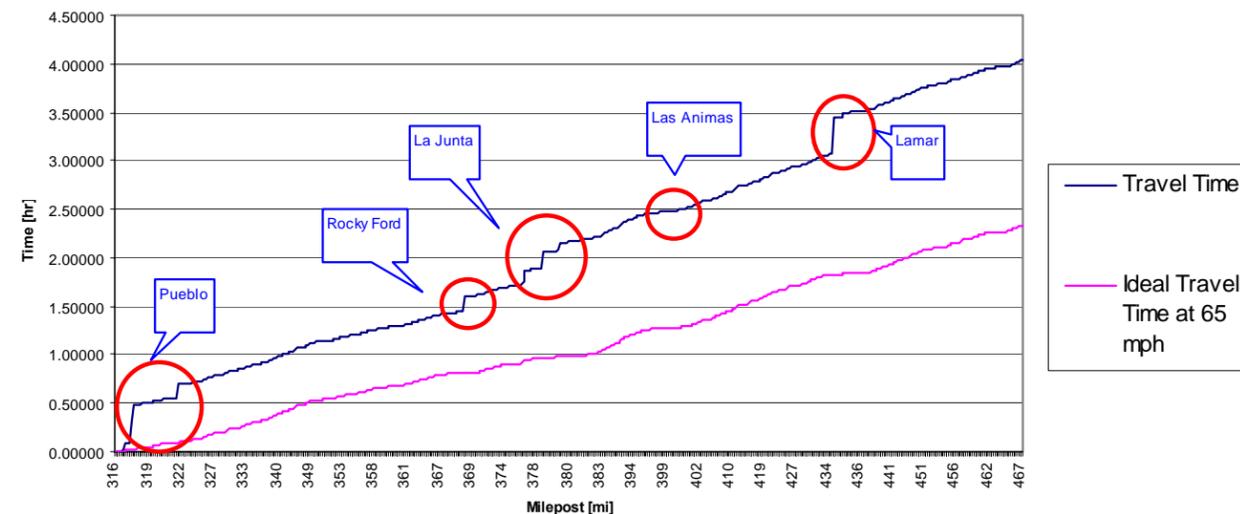
Figure 8-3 Cumulative Travel Time Through Corridor

A graph showing existing travel time has been shown in Figure 8-3. The travel time graph includes the time delay caused by the 10 speed reduction zones and the 13 traffic signals. Corridor delay is greatest in the towns where the travel time line appears as a vertical line. Focusing on corridor mobility, the existing travel time was compared to a 65 mph highway without speed reduction zones or traffic signals. This ideal highway would have a total travel time of approximately 2 hours 15 minutes. Because of signal delay, the additional time to traverse the corridor is approximately 1 hour 30 minutes. With speed reduction zones adding an additional 15 minutes of delay, the total travel time through the corridor is approximately 4 hours with an average corridor travel speed of 37.55 mph. The thirteen signals create the greatest delay in the system. Delay from the three railroad crossings, which further increase travel time, was not included in the analysis.

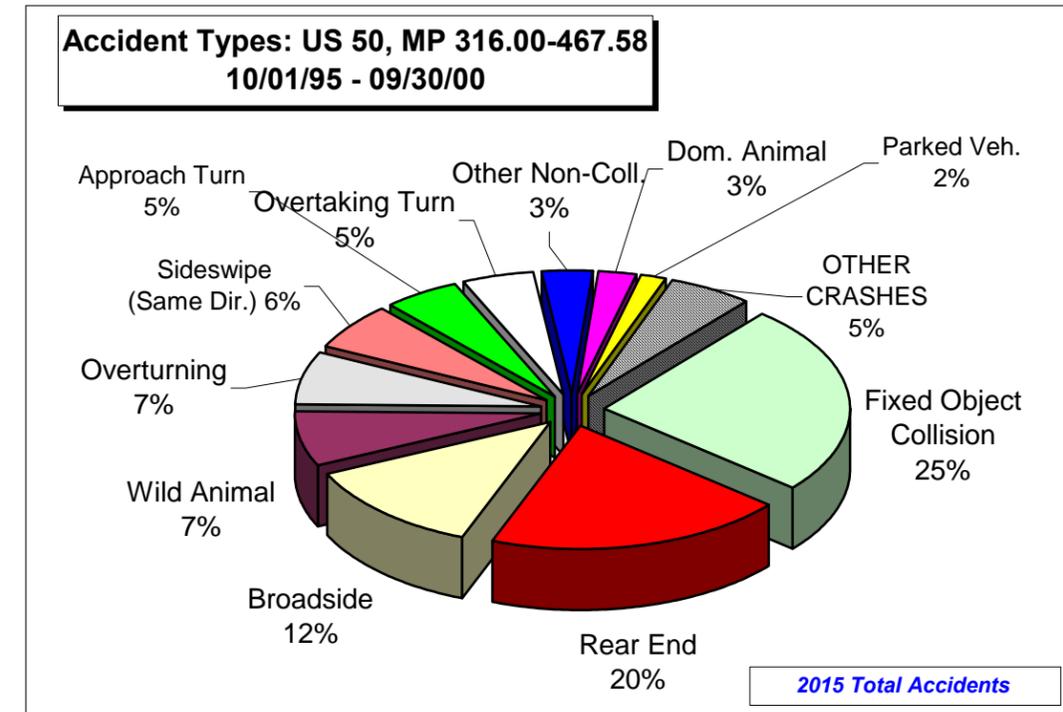
**Figure 8-5 Type and Distribution of Accidents on US 50**

The types of accidents occurring along the corridor have been graphically shown in Figure 8-6. The predominant and secondary accident types are the fixed object type (25%) and rear-end (20%). Approximately 95% of the fixed objects collisions are of the single vehicle, running-off-the-road type, with the majority (58%) running off to the right.

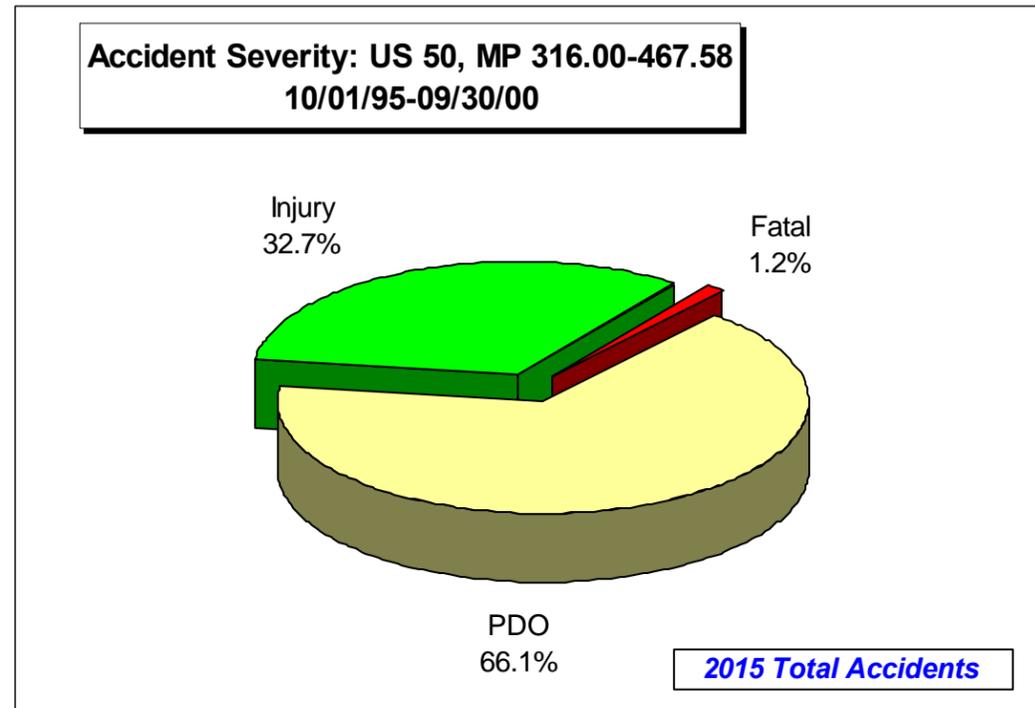
**Figure 8-6 Breakdown of Accident Severity**

Analysis of crash severity along US 50 determined that overall the corridor exhibits a history that is less severe than comparable locations. However, as shown in Figure 8-6, nearly one-third of all the accidents reported resulted in injury.

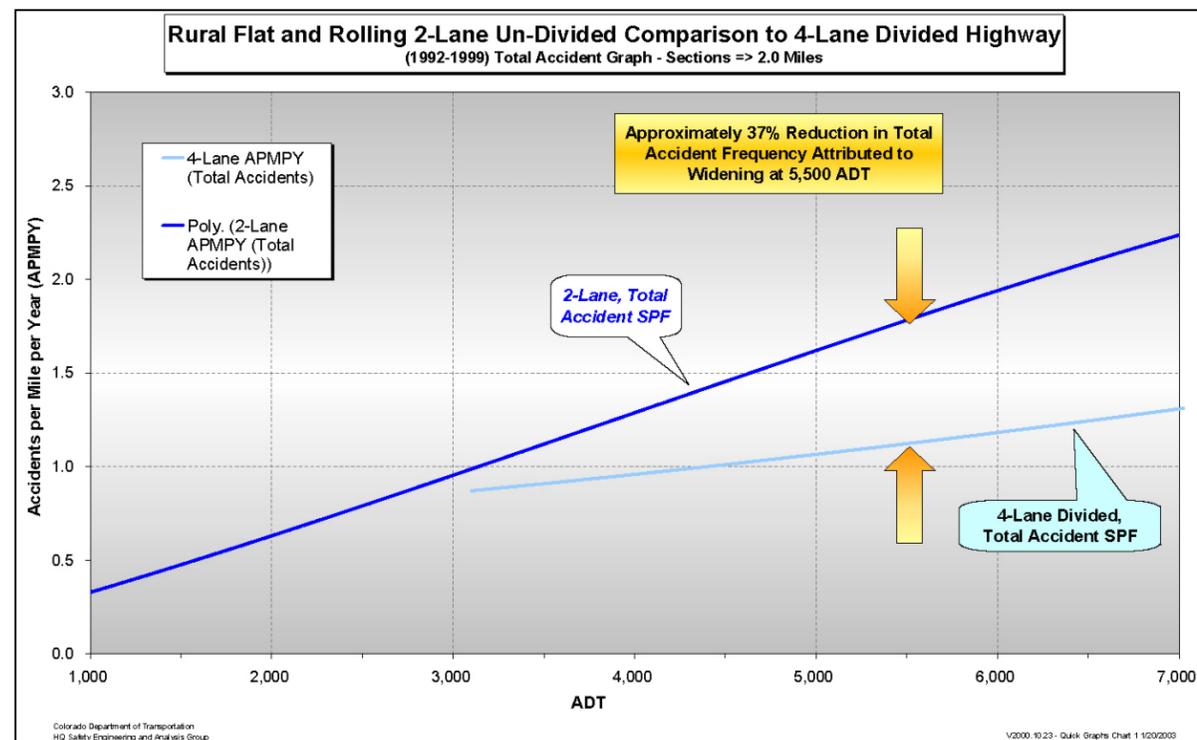
Figure 8-7 Safety Benefits of Widening US 50 to Four Lanes

Similarly, safety benefits (up to 40% accident reduction) can be achieved when a rural four-lane non-divided segment of road is improved to include a divided median<sup>2</sup> of adequate size.
