**WETLAND DELINEATION TECHNICAL REPORT**  
**FOR THE**  
**I-25 (US 36 to 104<sup>th</sup> Avenue)**  
**Environmental Assessment**

Colorado Department of Transportation  
Region 1  
2829 W. Howard Place  
Denver, CO 80204

March 2020

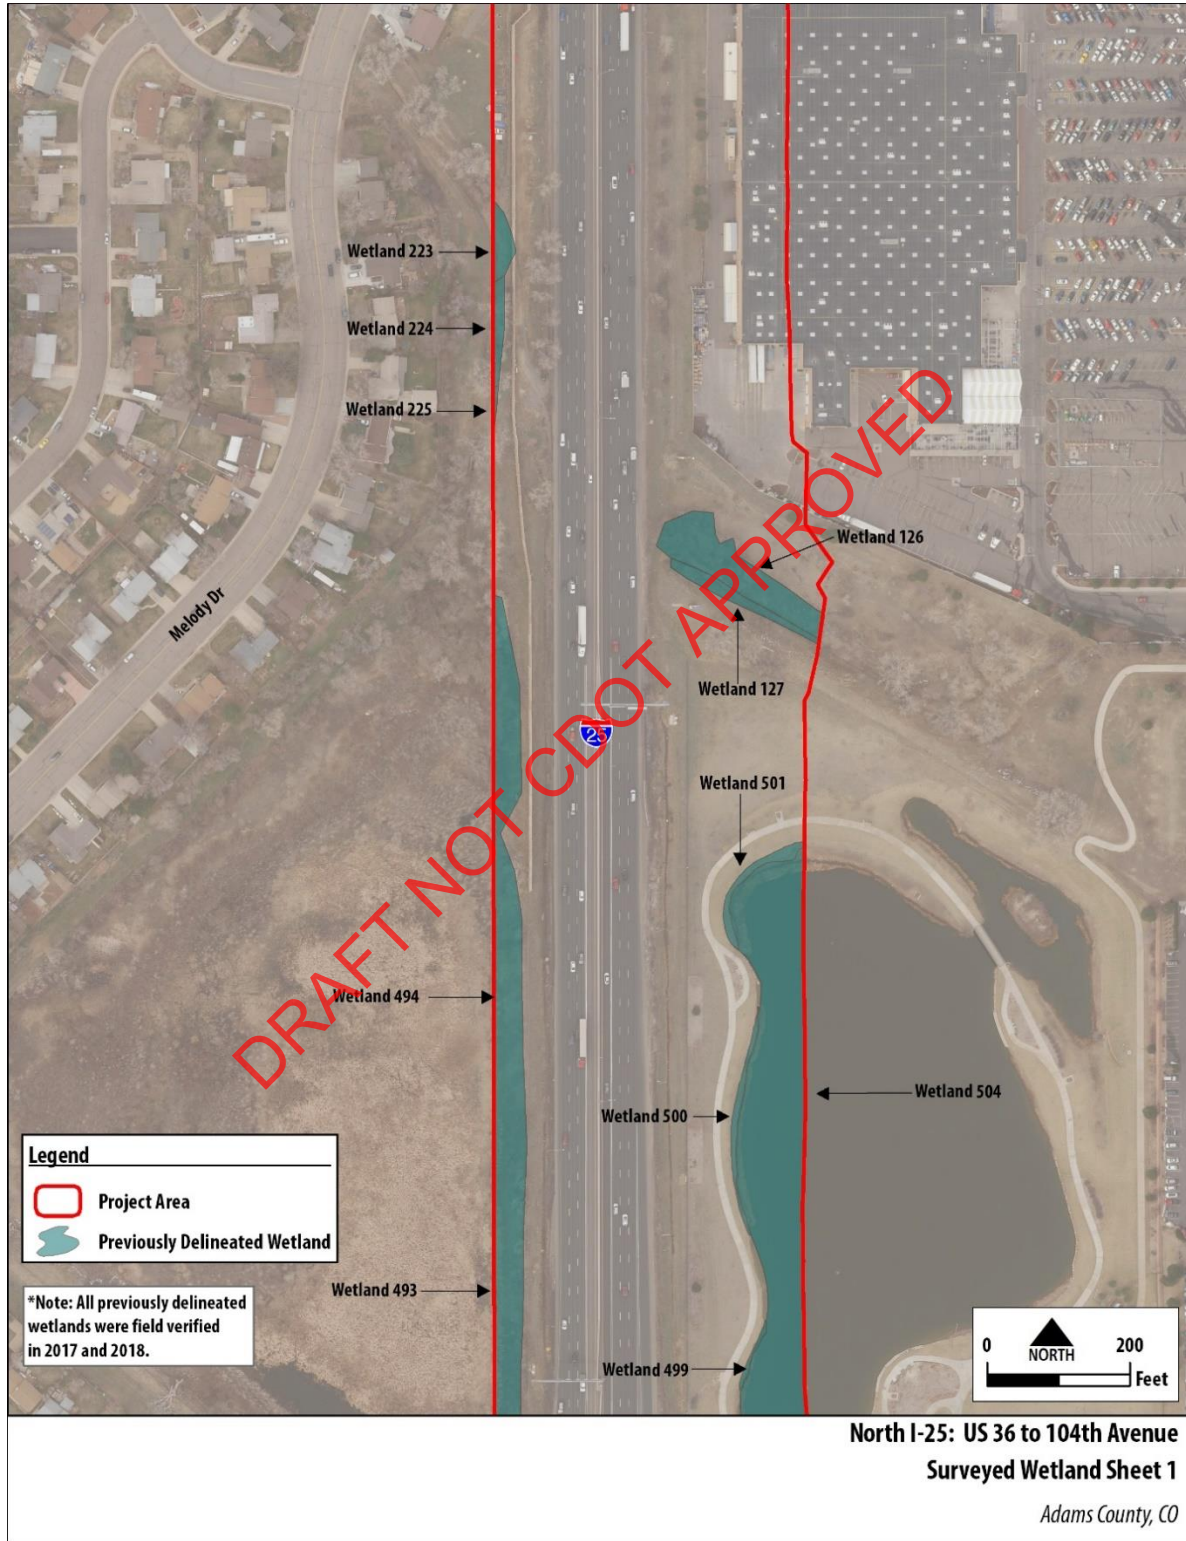
Figure 4. Wetland Map Sheet 1

**Figure 3** provides an index map of all previously and newly delineated wetlands. **Figure 4** through **Figure 9** show both previously delineated wetlands and newly delineated wetlands.

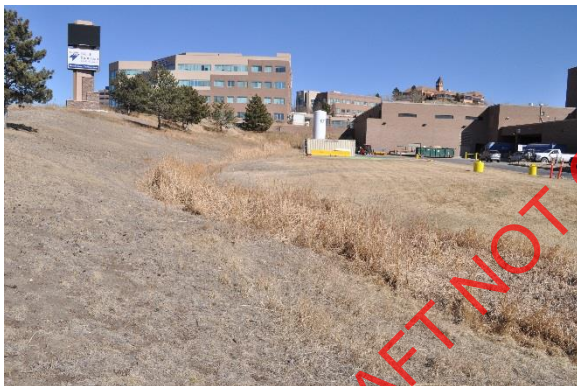
#### Photo 3. Wetland 21180-001

FHU staff identified and delineated Wetland 21180-001 in the middle of the project area as shown on **Figure 3**. Wetland conditions include a drainage swale draining into a water quality pond. FHU staff analyzed one sample point and compiled a wetland determination form for Wetland 21180-001. This wetland determination form is described as SP-1 (**Appendix B**). SP-1 showed wetland characteristics.

The total size of Wetland 21180-001 is 0.06 acre. Detailed wetland characteristics are described below.

Herbs dominate the vegetation in Wetland 21180-001 at SP-1. The shrub stratum contained sandbar willow (*Salix interior*) (FACW) (5 percent). The herb stratum contained narrowleaf cattail (*Typha angustifolia*) (OBL) (60 percent), broadleaf cattail (*Typha latifolia*) (OBL) (30 percent), and reed canarygrass (*Phalaris arundinacea*) (FACW) (5 percent). SP-1 passed the Dominance Test and the Prevalence Index; therefore, the area contains a predominance of hydrophytic vegetation.

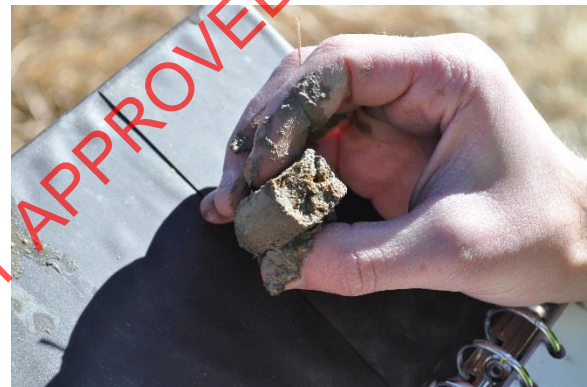
#### Photo 4. Soil Redox Characteristics in Wetland 21180-001

investigate the soil profile. From 0 to 10 inches, the soil profile included a saturated clay layer with two colors in the matrix: 10YR 5/2 (95 percent) and 2.5YR 5/8 (5 percent) as redox features. Deeper than 10 inches, a restrictive layer of rock was present preventing any further soil analysis. According to USACE guidelines, these soil conditions qualify this soil as hydric due to the presence of redox depressions and a depleted matrix (**Appendix B**).

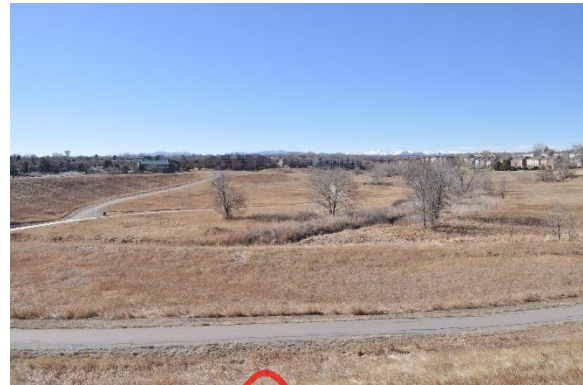
## Photo 5. Wetland 21180-002

Trees, shrubs, and herbs dominate the vegetation in Wetland 21180-002 at SP-2. The tree stratum contained crack willow (*Salix fragilis*) (Not Listed) (4 percent) and Siberian elm (*Ulmus pumila*) (UPL) (3 percent). The shrub stratum contained sandbar willow (FACW) (10 percent). The herb stratum contained broadleaf cattail (OBL) (70 percent), poison hemlock (*Conium maculatum*) (FACW) (9 percent), wild licorice (*Glycyrrhiza lepidota*) (FACU) (1 percent), and common teasel (*Dipsacus fullonum*) (FACU). SP-2 passed the Dominance Test and the Prevalence Index; therefore, the area contains a predominance of hydrophytic vegetation.

During the field survey, FHU staff dug soil pits at SP-2 to investigate the soil profile. At SP-2, from 0 to 2 inches the soil profile was an organic layer of cattail material. From 2 to 14 inches, the soil profile included a saturated clay (loamy sand layer with one color in the matrix: 10 YR 3/2 (100 percent). No restrictive layer was present. According to USACE guidelines, these soil conditions qualify this soil as hydric due to the presence of a depleted matrix (Appendix B).

Primary hydrologic indicators for SP-2 include a high water table, surface water (approximately 14 inches deep), and saturation (2 to 14 inches within the soil profile), sediment deposits, and dry-season water table. Secondary indicators include drainage patterns and geomorphic position. Therefore, wetland hydrology is present at Wetland 21180-002.

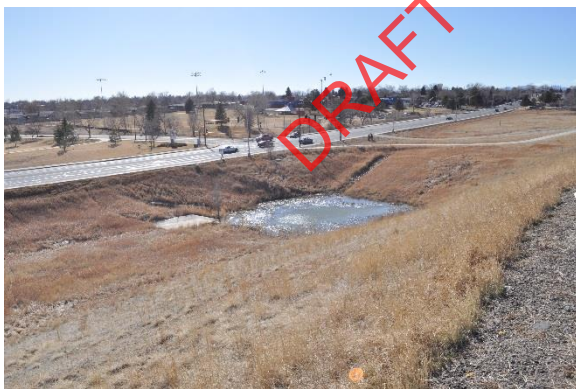
Photo 6. Wetland 21180-003 Complex

The only plants found in the Wetland 21180-003 complex were common spike rush (*Eleocharis palustris*) (OBL) (98 percent) and common teasel (FACU) (2 percent). Both of these plant species were in the herb stratum. SP-3 passed the Dominance Test and the Prevalence Index; therefore, the area contains a predominance of hydrophytic vegetation.

At SP 3 from 0 to 2 inches, the soil profile included a moist clay layer with one color in the matrix: 10 YR 3/2. From 2 to 14 inches, the soil profile included a moist clay layer with one color in the matrix: 10 YR 5/4. Deeper than 14 inches, a restrictive layer of soil compaction was present preventing any further soil analysis. The soil profile contained a depleted matrix. This sample indicated a problematic hydric soil with a darker layer on top, suggesting that a possible liner soil layer, likely Bententite, was placed on the site previously.

Primary hydrologic indicators for SP-3 included water marks. Secondary indicators included drainage patterns and geomorphic position. Therefore, wetland hydrology is present at Wetland 21180-003.

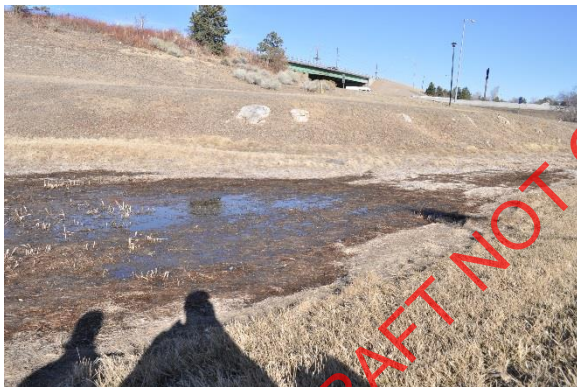
### Photo 7. Wetland 21180-005

The total size of Wetland 21180-005 is 0.08 acre. Detailed wetland characteristics are described below.

Only plants in the herb stratum were present in Wetland 21180-005 at SP-5. This wetland area had been mowed, making plant identification down to the species difficult. The herb stratum contained common spikerush (OBL) (90 percent) and an unidentified cattail species (OBL) (*Typha* ssp.) (10 percent). SP-5 passed the Dominance Test and the Prevalence Index; therefore, the area contains a predominance of hydrophytic vegetation.

During the field survey, FHU staff dug a soil pit at SP-5 to investigate the soil profile. At SP-5, from 0 to 18 inches, the soil profile was a clay layer with two colors in the matrix: 10YR 3/2 (95 percent) and 7.5YR 5/8 (5 percent) as redox features. According to USACE guidelines, these soil conditions qualify this soil as hydric due to the presence of redox depressions and a depleted matrix (**Appendix B**).

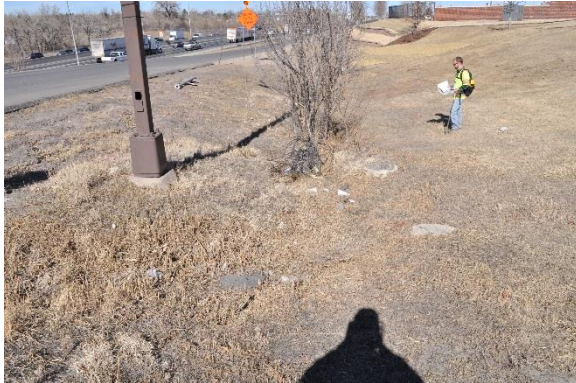
**Photo 8. Previously Delineated Wetland that is No Longer a Wetland**

Only one previously delineated wetland was determined to no longer meet the criteria of a wetland. This previously delineated wetland is located in the northeast quadrant of I-25 and Thornton Parkway. It is a small drainage ditch on the side of the I-25 on-ramp. However, it was observed that most of the wetland had been displaced by a retaining wall on the eastern and southern boundary of the wetland. In addition, a grate drained the wetland located on the northern boundary of the wetland. Additionally, mowing activity occurred before FHU’s observation. This wetland was 0.057 acre in size; however, due to the absence of the wetland, it was not included in the total acreage of wetlands within the project area.

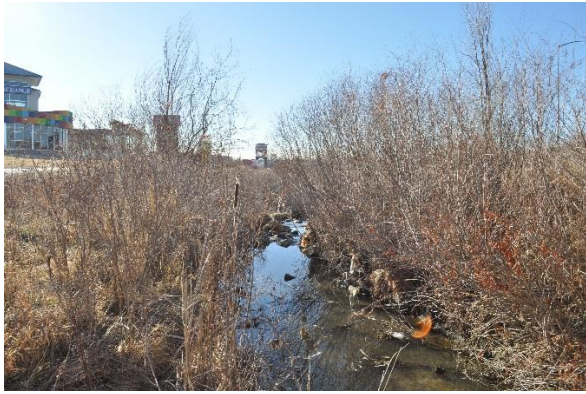
Photo 1: February 14, 2017 - Previously delineated section of Niver Creek, in the southeast portion of the project area.

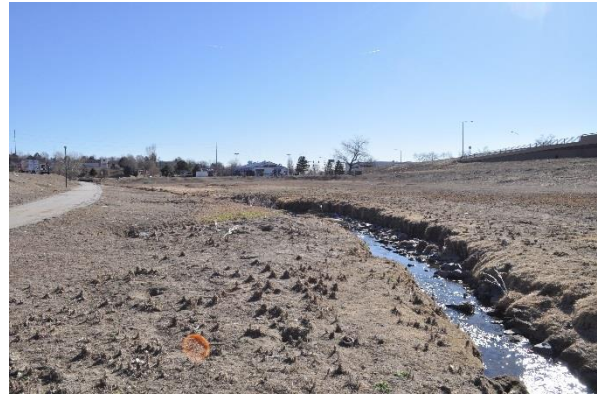
Photo 2: February 14, 2017 - Southernmost extent of Niver Creek within the project area.

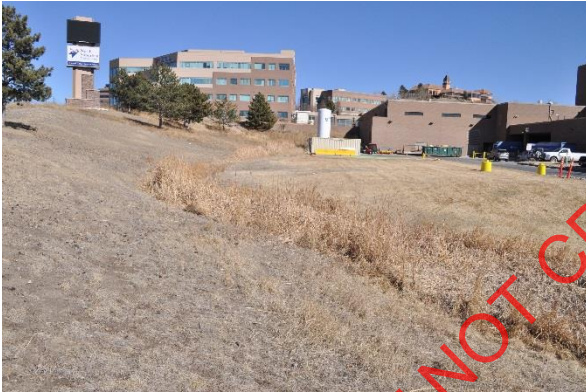
Photo 3: February 14, 2017 - Wetland 21180-001.

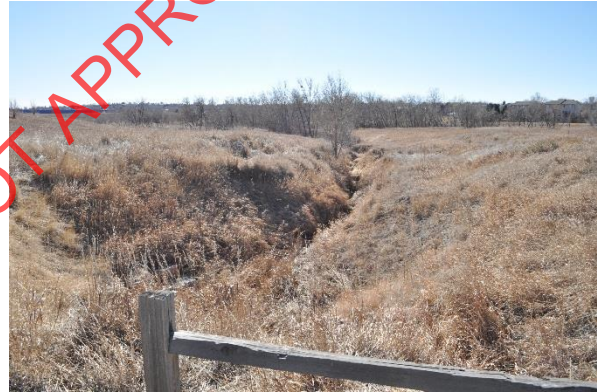
Photo 4: February 14, 2017 - Previously delineated wetlands 229, 230, and 231, which are the same size and quality.

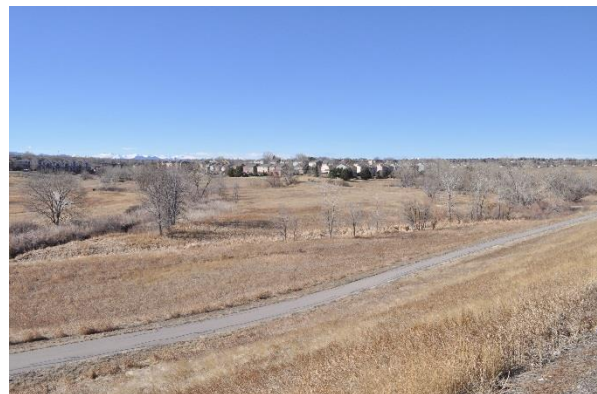
Photo 6: February 14, 2017 - Niver Creek and Wetland 21180-002.

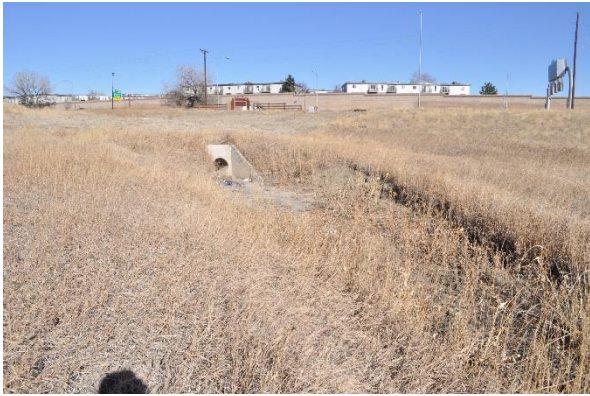
Photo 7: February 14, 2017 - Wetland 21180-003.

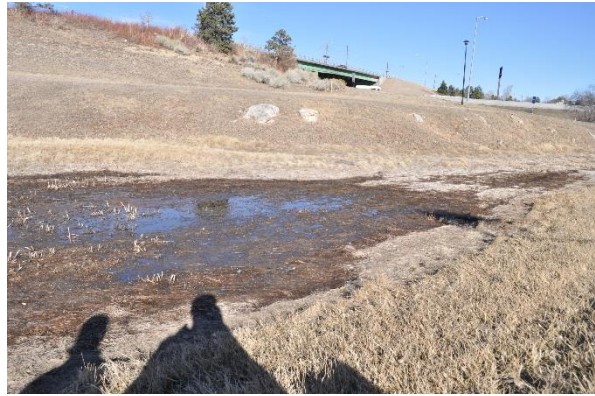
Photo 8: February 14, 2017 - Wetland 21180-005.
