**PLAN OF ACTION  
SCOUR CRITICAL BRIDGE REPORT**

**Structure B-16-H at US 287 over Spring Creek  
Mile Marker 344.87  
City of Fort Collins, Colorado**

**Colorado Department of Transportation  
Region 4 Hydraulics Unit**

**September 30, 2009**

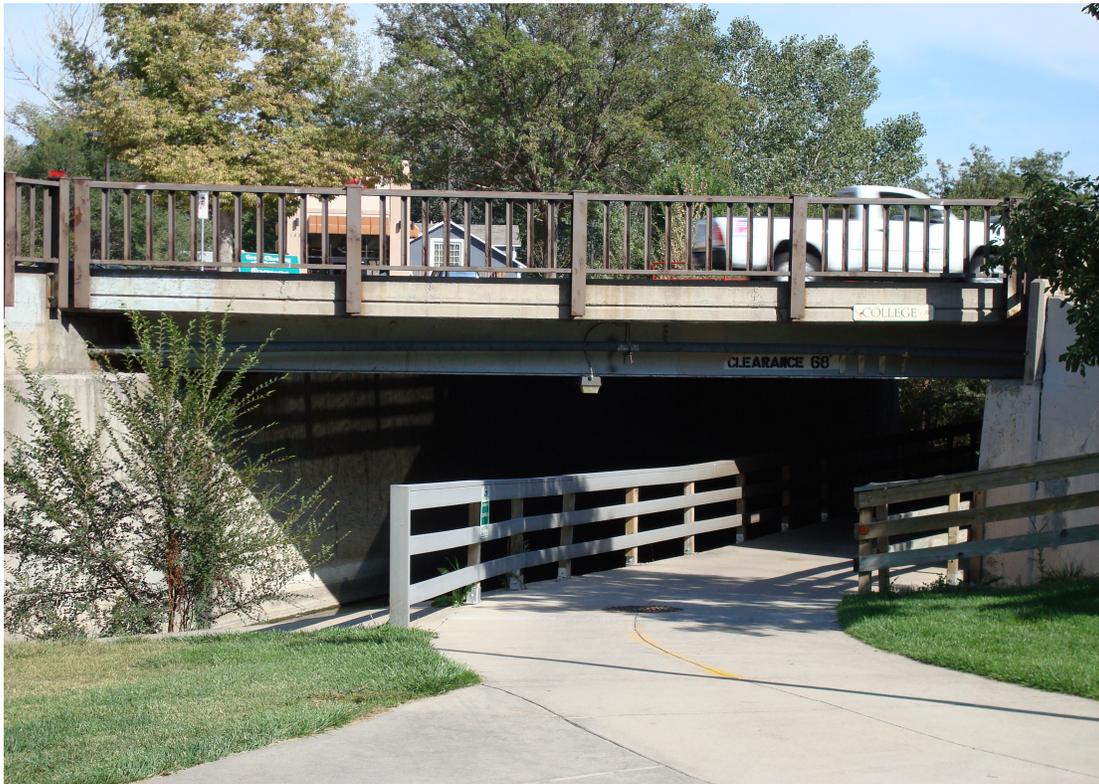
**Figure 1 – Structure B-16-H Upstream (West) side**

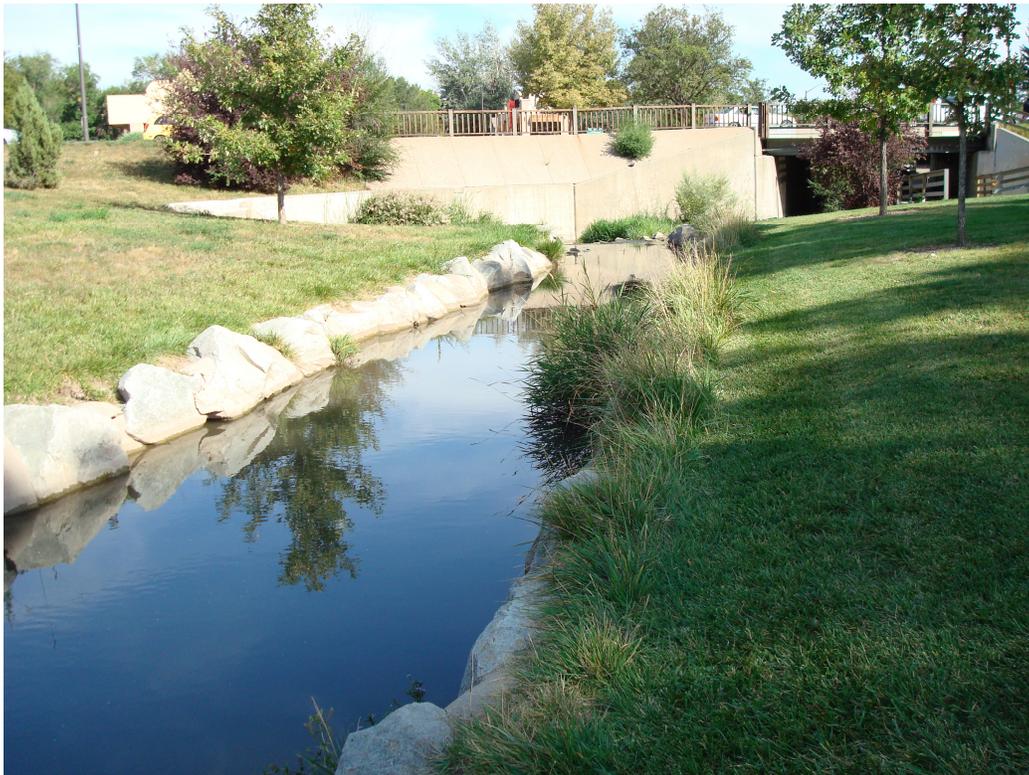
The alignment of the Spring Creek channel on the upstream side of structure B-16-H forces the flows directly into the north-west wing before entering the bridge opening (Figures 7 and 8). The effects of this misalignment are evident in the scour results above, which show significantly greater scour depths on the left abutment as opposed to the right.

**Figure 7 – Alignment of Spring Creek channel and B-16-H Bridge.**

The channel re-alignment should aim to more closely match the main channel upstream with the bridge opening, and to eliminate the sharp transition from north to south of the channel at the upstream face of B-16-H. Close coordination would be required with the City of Fort Collins (the upstream property owner) to achieve such a re-alignment, which would also require a revision of flood hazard mapping to reflect the changes.

This option should serve to greatly relieve the abutment scour on this structure. It may also serve to somewhat lessen the estimated contraction scour, though this will largely remain due to the undersized structure.

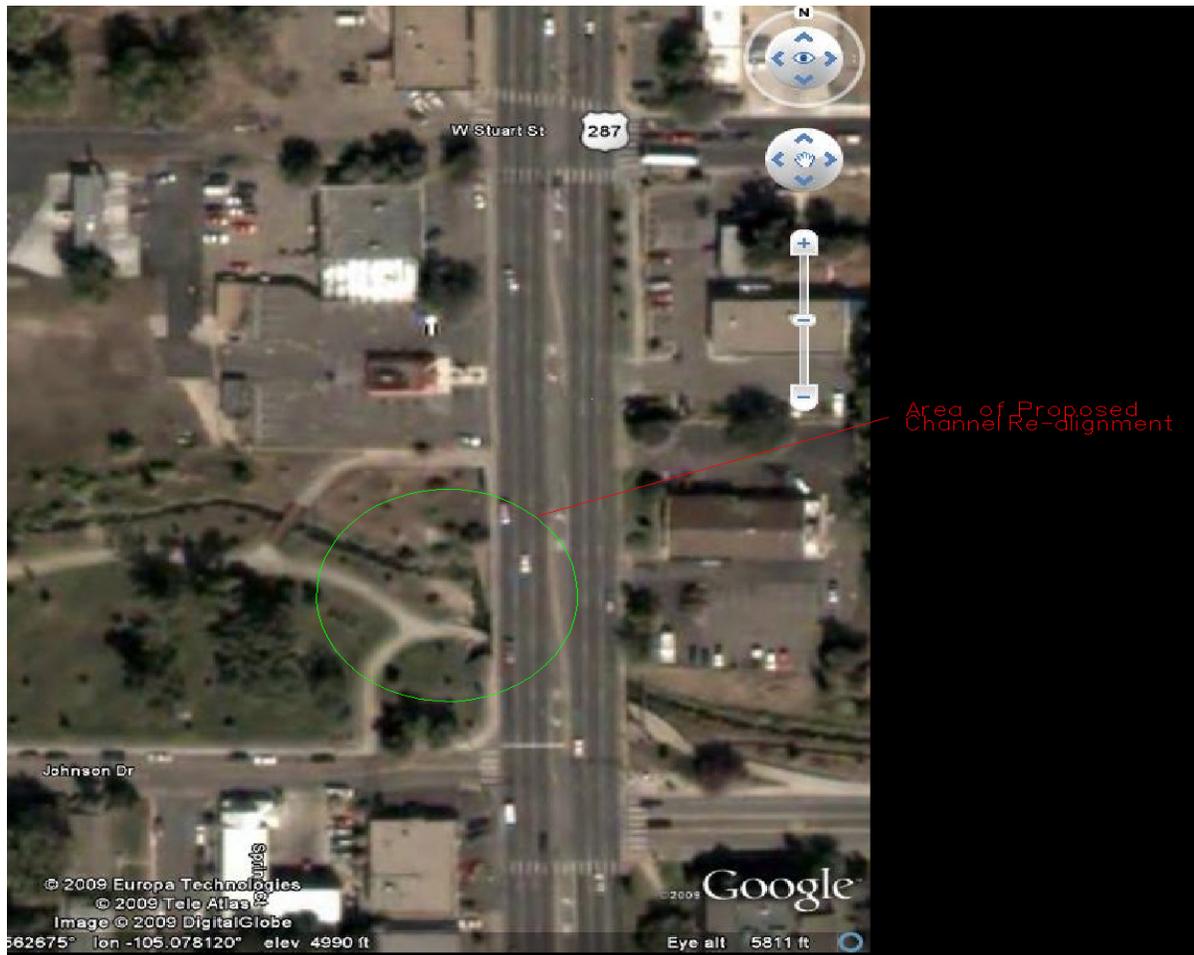
**Figure 8 – Area of Spring Creek Channel Re-Alignment.**
