**PRE-DEMOLITION/RENOVATION
ASBESTOS AND LEAD-BASED PAINT
INSPECTION REPORT FOR
COLORADO DEPARTMENT OF
TRANSPORTATION BRIDGE STRUCTURES
K-18-AX and K-18-AY
INTERSTATE 25 OVER SANTE FE AVENUE,
MILE MARKER 97.691**

STRUCTURE ID'S: K-18-AX and K-18-AY

WALSH Project Number: WA-000944-0229

May 22, 2013

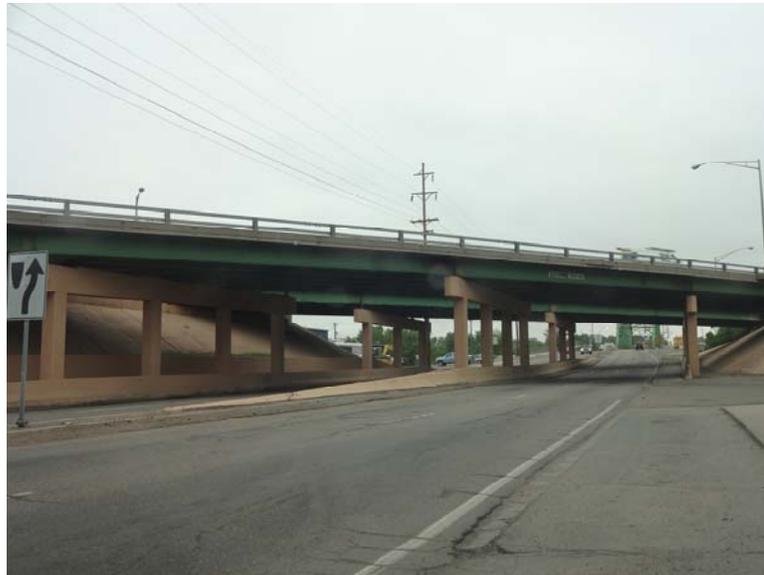
Bridge Structure ID's: K-18-AX and K-18-AY consist of Concrete on Rolled I-Beam Continuous located on Interstate 25, at Mile Post 97.691. Structure ID K-18-AX is 240-feet long and 30-feet wide. Structure ID K-18-AY is 240-feet long and 40-feet wide. Both bridges were constructed in 1958. Both bridges are considered one functional space for inspection purposes.

View of Bridge Structure ID: K-18-AX/AY.

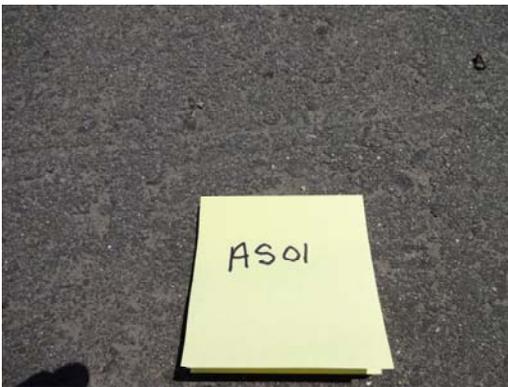
AS01

Homogeneous Area	Material Description	Asbestos Content	Location	Quantity
K-18-AX-AS01	Asphalt	ND	Road Base	16,800 SF
K-18-AX-PT01	Paint, Green	ND	I-Beams	19,200 SF
K-18-AX-RT01	Road Tar	ND	Over Expansion Joints	210 SF

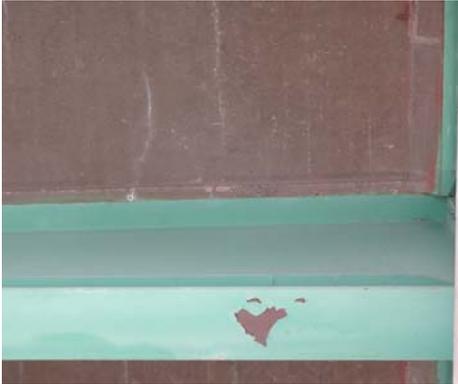
LBP01

Sample ID	Location	Substrate	Color	Condition	Result % by Weight
K-18-AX-LBP01	I-Beams	Metal	Green	Poor	0.14%
K-18-AX-LBP02	Shoulder Stripes	Asphalt	White	Poor	BRL
K-18-AX-LBP03	Median Stripes	Asphalt	Yellow	Poor	1.2%

- Metal Substrate - Green Paint on I-Beams (0.14% pb).

- Materials that are recycled such as metal components are not subject to waste characterization provisions under EPA and CDPHE, but proper disclosure of lead-containing materials should be provided to the recycling facility for hazard communication purposes.

- The types and locations of lead-based paint and regulatory requirements should be disclosed to the demolition contractor and/or salvage contractor to avoid accidental disturbance, and for contractor compliance with applicable regulations (to ensure proper worker protection).

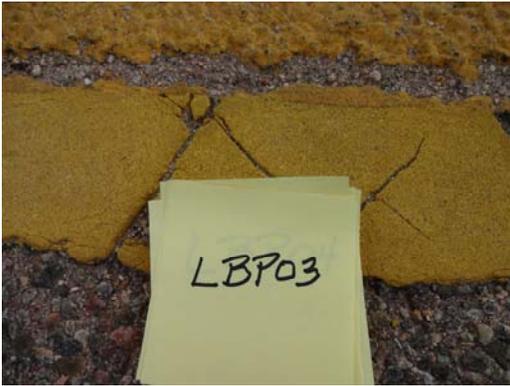
LBP03

- Asphalt Substrate - Yellow Median Stripes.

Additionally, lead-containing materials require a hazardous waste determination pursuant to 40 CFR 262.11, and 40 CFR 261.24. It is a standard industry approach that demolition waste characterization should be performed on structures containing lead-based paint. This procedure is the Toxicity Characteristic Leaching Process (TCLP), where sample composite representative of all building components to be demolished (i.e. all lead-based paint coated and non-lead-based paint coated materials from the structure) is submitted to the laboratory for analysis. The Toxicity Characteristic (TC) limit for lead is 5ppm in the leachate. Materials that exceed this limit must be disposed of as hazardous waste. Materials that do not exceed this limit may be disposed of as solid waste.

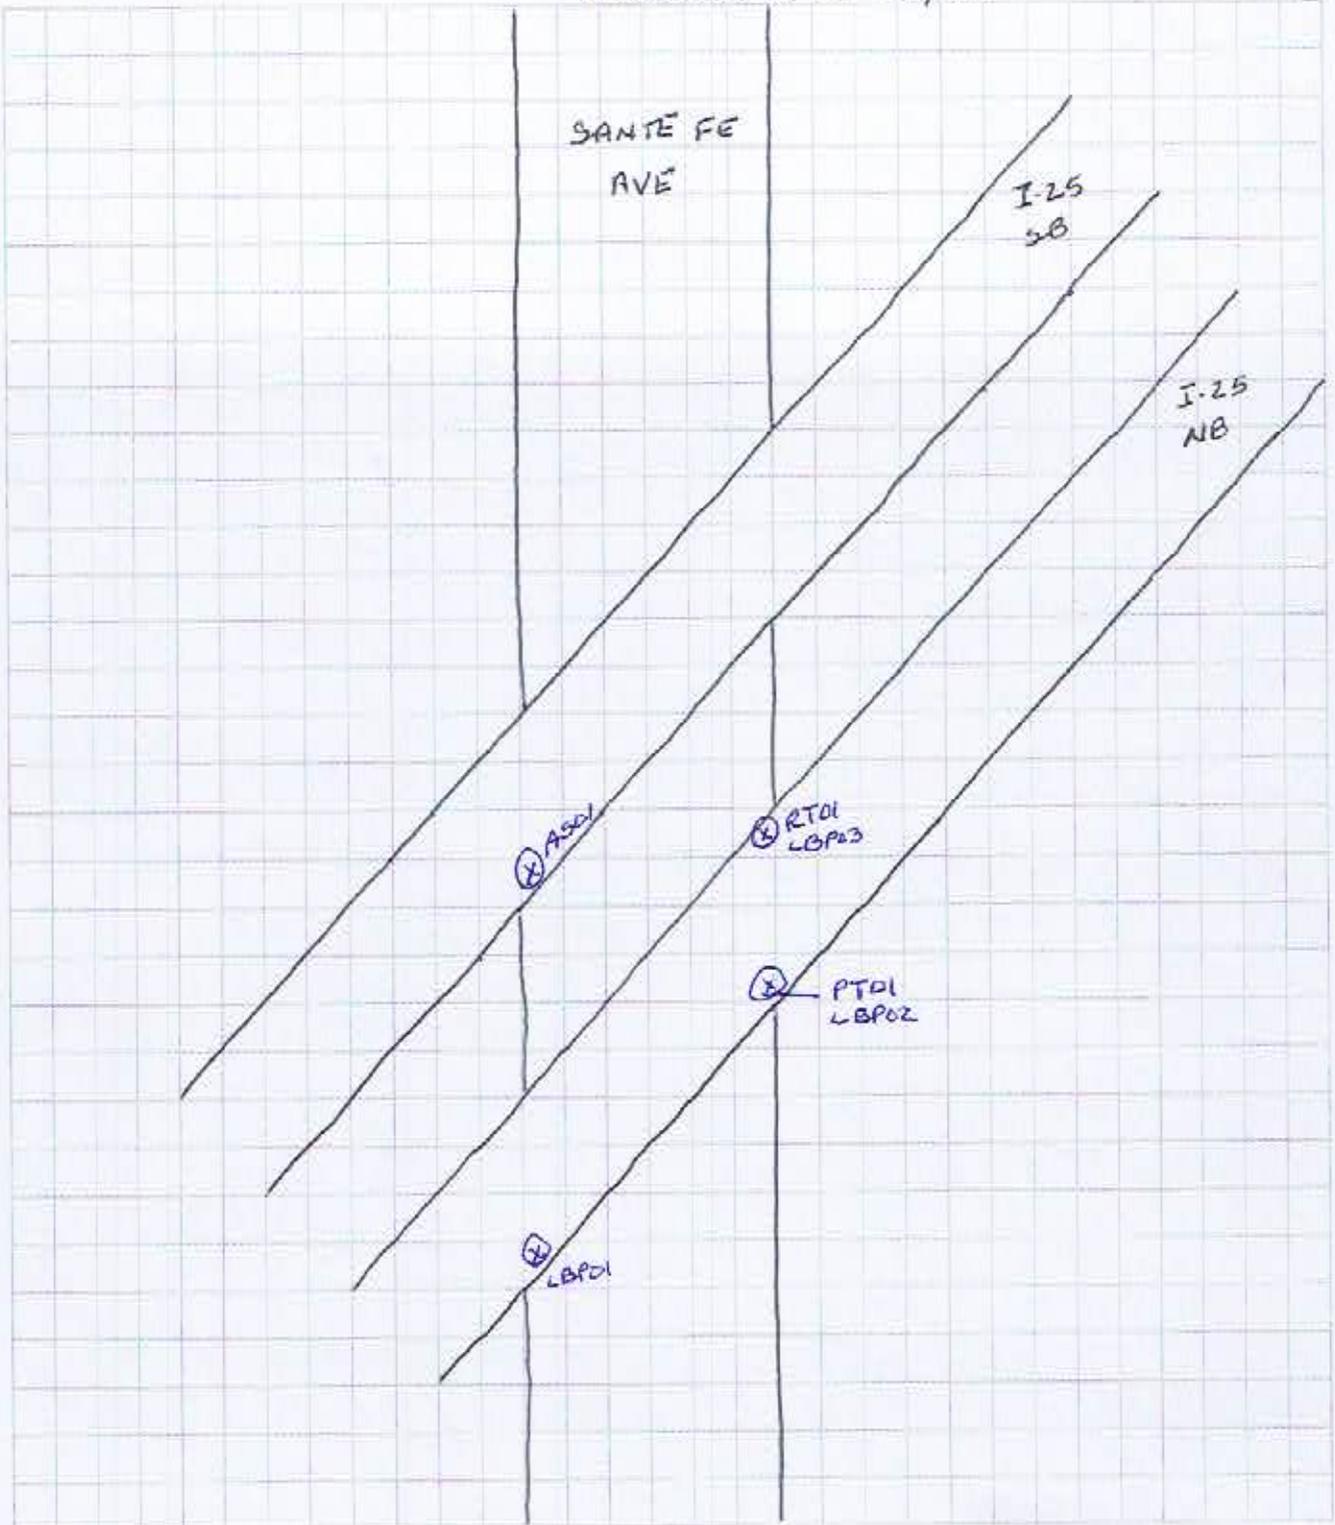
DAILY FIELD DRAWING

Structure ID: K-18-AX/AY
