*Assessment of Jurisdictional Status - Irrigation Ditches, Ponds & Associated Wetlands on Webb Ranch*

**To:** Don Connors, AMEC  
**From:** Tim Funk, PWS, Kerrienne Zdimal, PWS and Sean Moore, SME Environmental, Inc.  
**Date:** 12/06/2013, Revised July 2014  
**Project:** US 550-US 160 Reconnect (SME Project No. 130019)  
**Re:** Assessment of Jurisdictional Status – Irrigation Ditches, Ponds, and Associated Wetlands on Webb Ranch

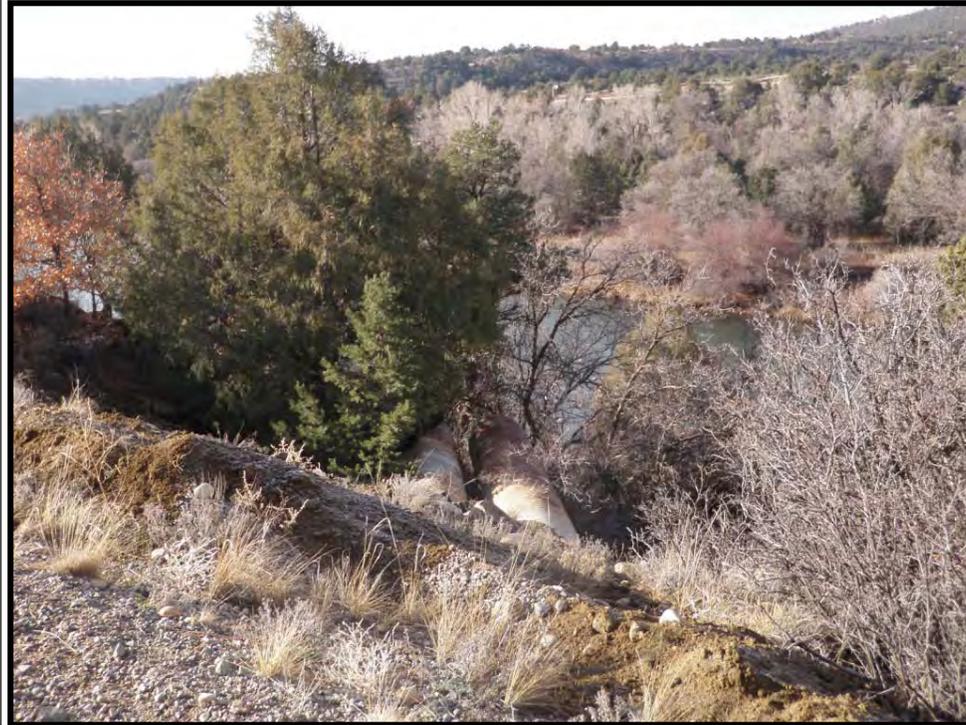
PP1 depicts the corrugated metal pipes that convey the flow of an unnamed intermittent tributary under Trestle Lane with the discharge located approximately 100 feet from the Animas River. This tributary is downstream of the water features surveyed on the pasture portion of the Webb Ranch.

was surveyed by SME on December 2, 2013. At this location the tributary is conveyed under Trestle Lane by two corrugated metal pipes (CMPs). Despite seven days with no observable precipitation, and no active irrigation at the time of the survey, water was observed flowing through the pipes and discharging to a stream channel that flows into the Animas River approximately 100 linear feet below the culverts. The presence of the flowing water at the time of survey indicates that this tributary is likely a natural RPW, and the USACE would likely consider this feature to be jurisdictional per the *Rapanos Guidance*. SME collected data on this feature using the USACE OHWM data sheet for ephemeral and intermittent streams in the Arid West (attached). In addition to the flowing stream channel, SME observed palustrine scrub-shrub (PSS) wetlands directly abutting the stream in the area upstream of the CMPs. The presence of these wetlands indicates surface or near-surface hydrology in this area for a significant portion of the growing season.

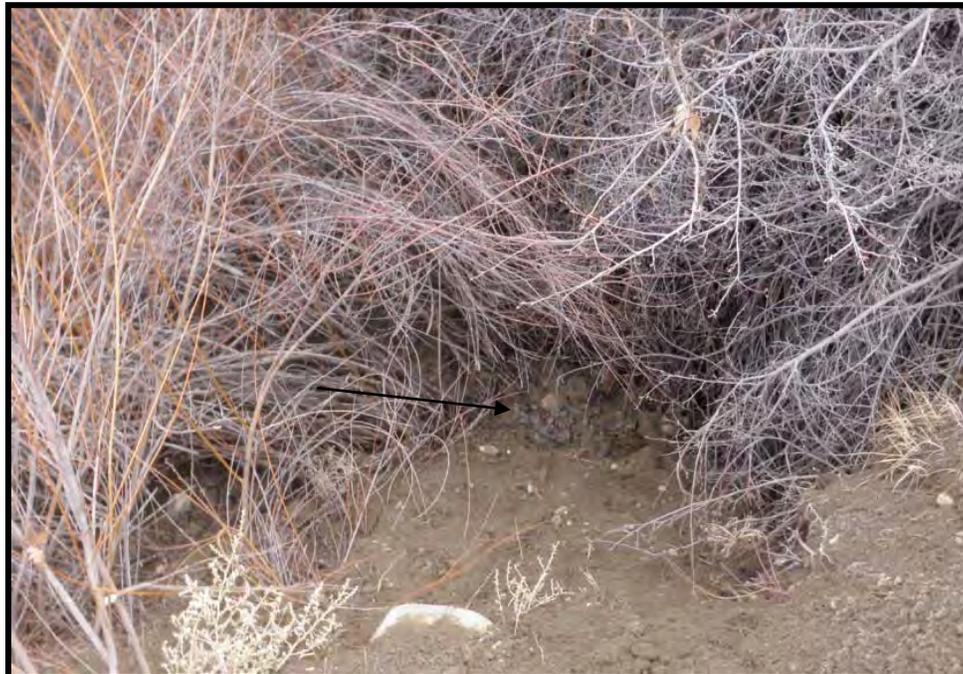
PP2 depicts the unnamed tributary upstream of Trestle Lane. Flowing water was observed in this segment of the stream and dense willow (*Salix*) shrubs indicating a PSS wetland were observed along the fringes of the stream.

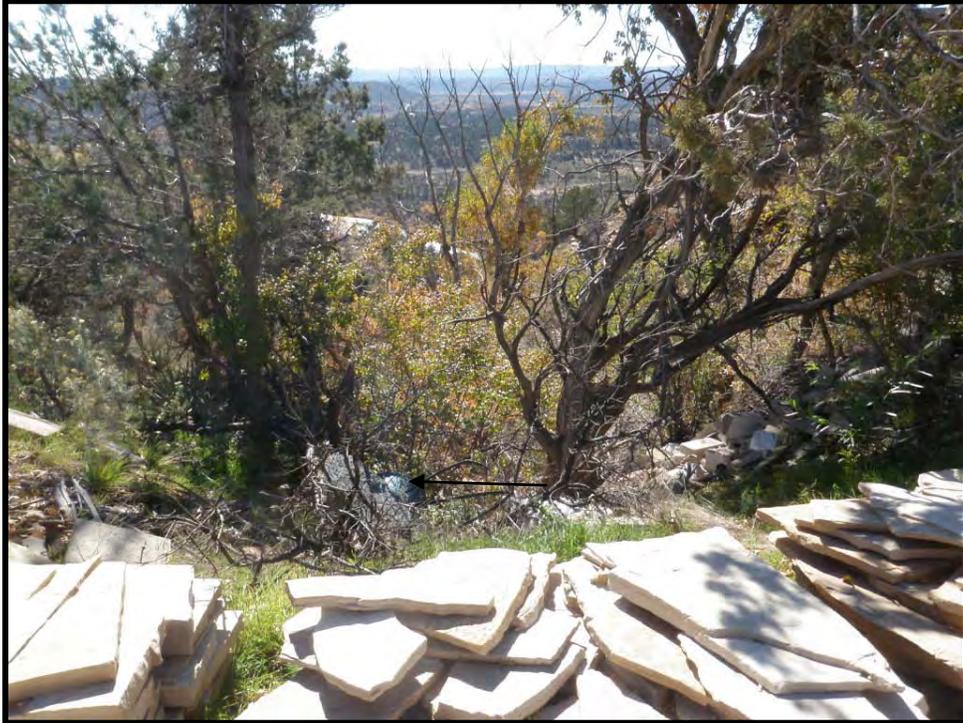
PP3 is facing south from the dam of the pond on the Piccoli property, and depicts the culvert that connects this pond to the unnamed tributary depicted above.

This tributary was also observed downstream of a man-made pond on the Piccoli property (Figure 1); however, surface flow was not observed in this segment of the channel. It is anticipated that the natural flow of this system is being held back by the pond, which is an impoundment of this tributary. Per the USACE's *Jurisdictional Determination Form Instructional Guidebook* (2007), impoundments generally do not affect the jurisdictional status of a waterway. Therefore both the pond as well as the dry segment of the tributary below pond would be considered WOUS. Based on site topography, we believe other features on the Webb Ranch that are located in-line with the USGS-mapped intermittent waterway (i.e., features 39-4, 39-6a, 39-6b, 39-7, and 39-8) are also impoundments and/or wetlands abutting these impoundments, and therefore meet the criteria for jurisdictional WOUS.

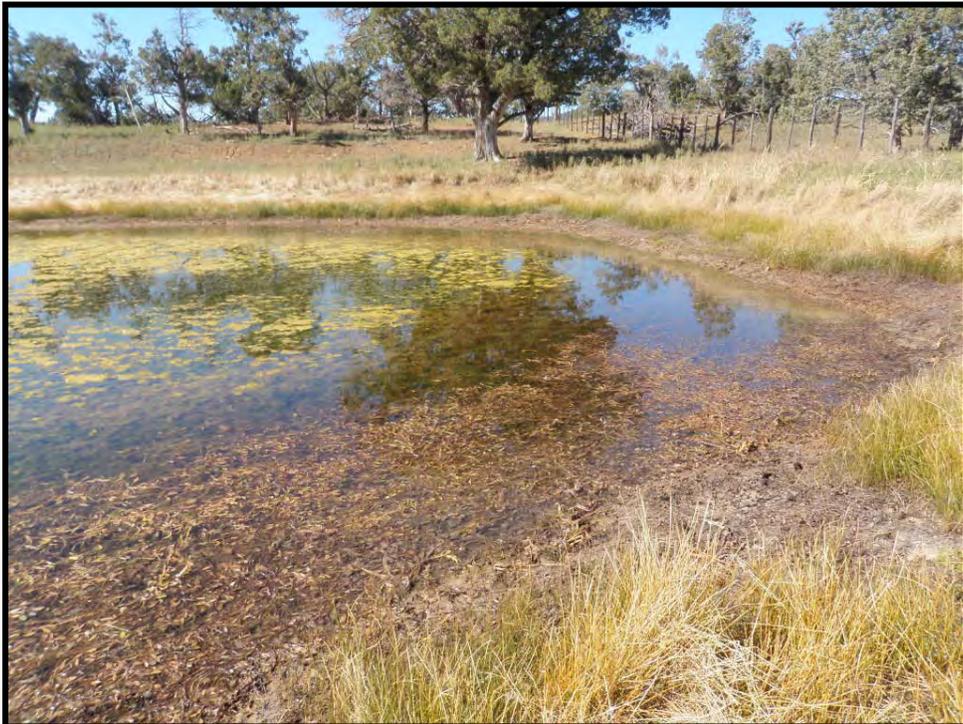
PP4 depicts features 39-6a and 39-6b, which are a pond and fringing wetlands believed to be the result of an impoundment on the natural unnamed tributary mapped on the USGS quad sheet in this area.

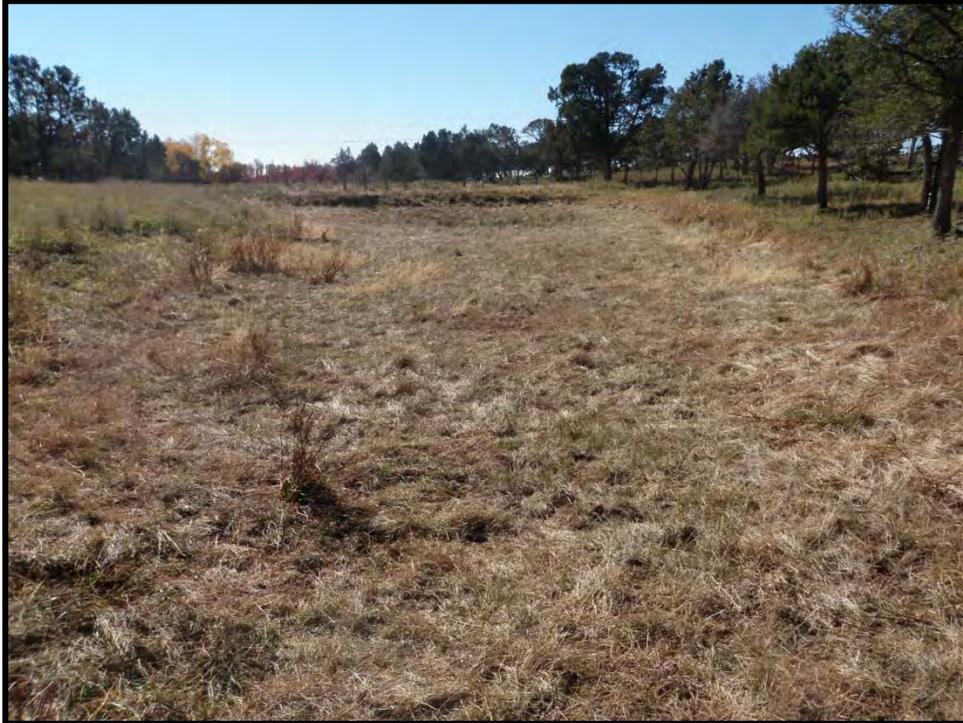
PP5 is facing south and depicts feature 39-4, an emergent wetland located along the mapped intermittent tributary. The lower end of this wetland appears to be impounded. Although no standing water was observed at the time of the survey, this area met the three parameters for wetland identification.

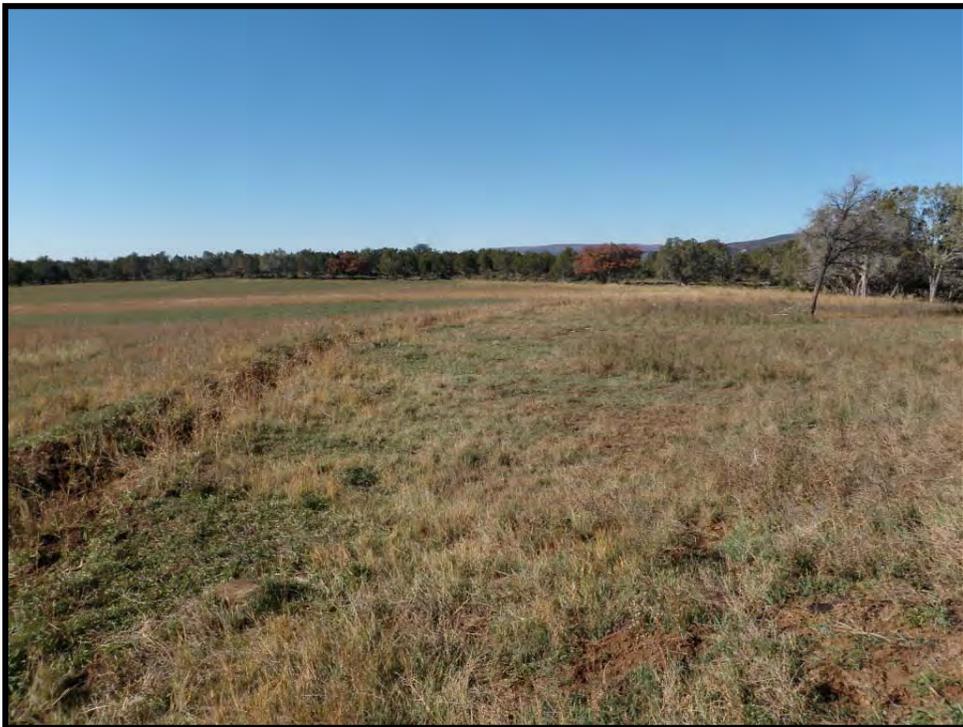
PP6 depicts irrigation ditch 39-1. This ditch and a series of similar ditches convey irrigation water derived from the Florida River to two stock ponds located within the pasture, and discharge into wetland 39-4 depicted above.

In addition to the water features that are located in-line with the USGS-mapped intermittent stream, the pasture portion of the Webb Ranch includes a series of irrigation ditches and two man-made stock ponds (39-2 and 39-3) that discharge into the features located along the natural drainage described above. The *Rapanos Guidance* states that USACE generally does not assert jurisdiction over ditches (including roadside) provided they are "excavated wholly in and draining only uplands and that do not carry a relatively permanent flow of water." We do not believe the irrigation ditches meet the criteria of "draining only uplands" since the source of the water in these ditches appears to be diverted from the Florida River. Further, if irrigation water flows through these ditches continuously for three months in a "typical" (i.e., non-drought) year, then they would meet the definition of an RPW, and would be considered jurisdictional. The stock ponds, which directly abut these features, would also be considered jurisdictional. Conversely, the roadside ditch identified as feature 39-9 appears to only convey stormwater runoff from the adjacent roadway and pasture (not irrigation water derived from the Florida River); therefore, this feature only drains uplands, is not an RPW, and is not a jurisdictional WOUS (subject to USACE verification).

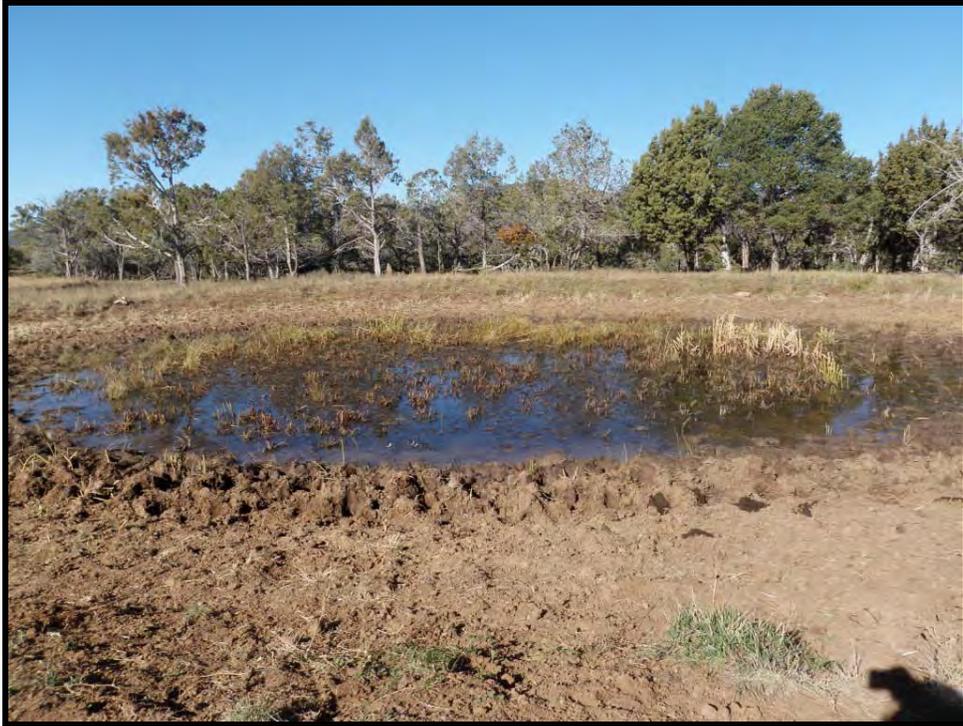
PP7 depicts 39-2, one of two vegetated stock ponds, whose source is irrigation water provided by the irrigation ditches depicted above.

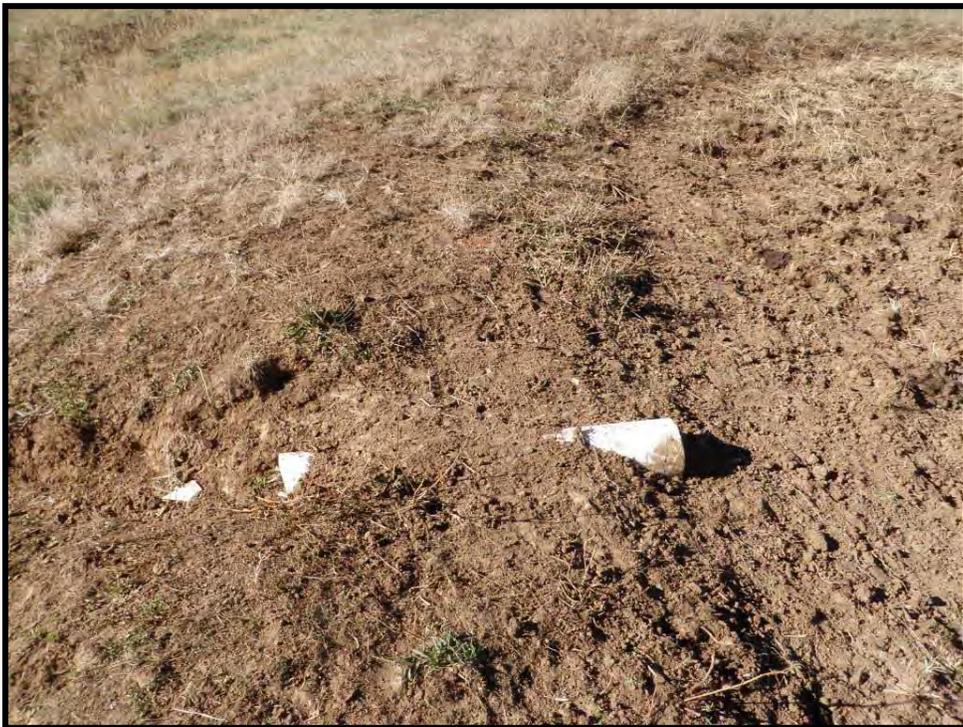
PP8 depicts a PVC pipe that conveys overflow water from the stock pond depicted above back into the irrigation ditch.
