**MODIFIED ENVIRONMENTAL SITE ASSESSMENT
FOR THE
VALLEY HIGHWAY EIS
DENVER, COLORADO**

Federal Highway Administration
Colorado Department of Transportation

Felsburg Holt & Ullevig

FEBRUARY 28, 2005

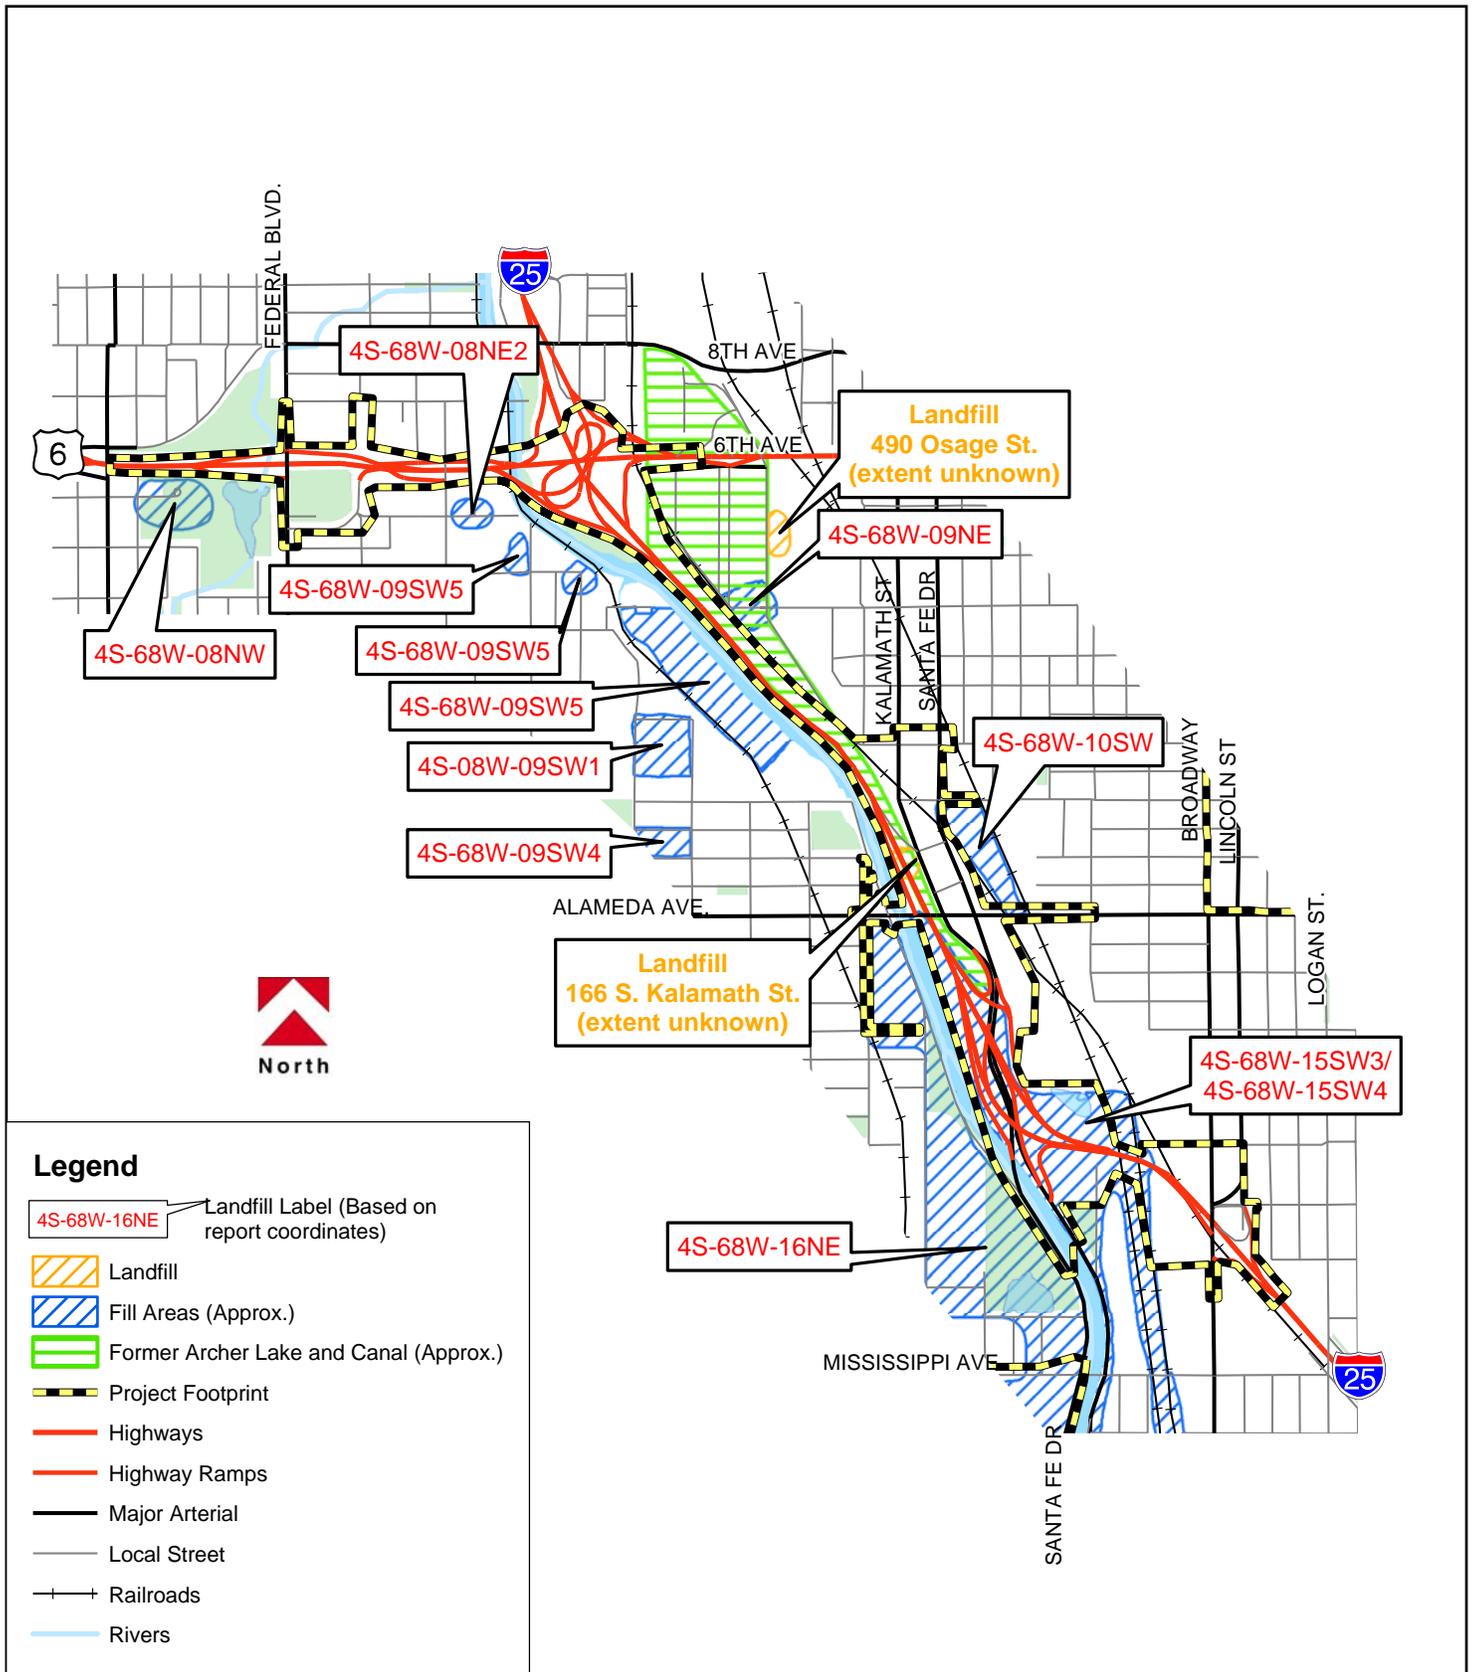
Map I.D.	Location	Use/Contents	Environmental Concerns
4S-68W-15SW3/ 4S-68W-15SW4	Area of the Santa Fe Drive and I-25 Interchange	Artificial fill; composed of earth, rock fragments, and refuse	Unknown groundwater contamination or potential methane
4S-68W-10SW	Area between Bayaud and Alameda, east of Consolidated Main Line railroad	Artificial fill; composed of earth, rock fragments, and refuse	Unknown groundwater contamination or potential methane
4S-68W-09NE	Area between Quivas and Osage Streets along 4th Avenue	Unknown use and contents	Unknown groundwater contamination or potential methane
4S-68W-16NE	Area between Alameda and Virginia Avenues, east of Lipan Street.	Municipal landfill; unknown contents	Unknown groundwater contamination. High levels of methane gas present.
4S-68W-08NE2	Area around 500 Alcott Street	Unknown use and contents	Unknown groundwater contamination or potential methane
4S-68W-08NW	Area around 500 Julian Street, along 6th Avenue exit ramp	Unknown use and contents	Unknown groundwater contamination or potential methane

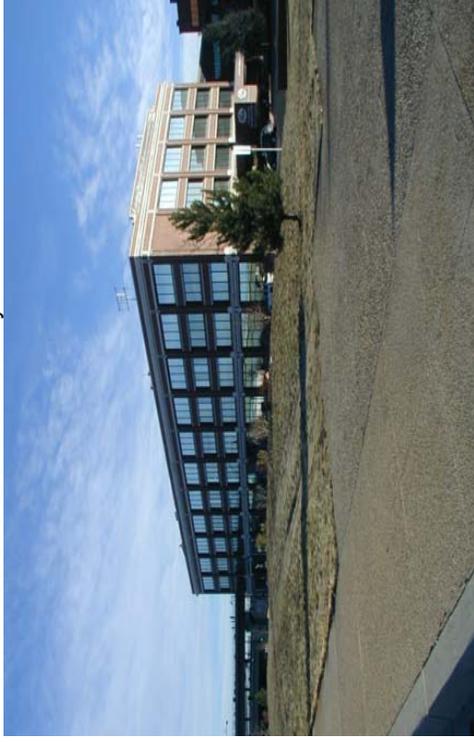
1. View from the west of the Gates Rubber Company properties at 900/950/900 S. Broadway.

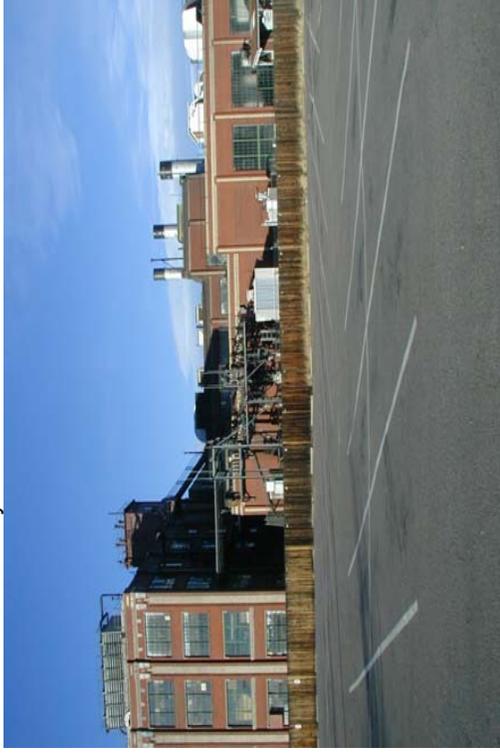
The Cherokee Denver LLC site extends south from I-25, excluding the RTD park-n-Ride facility, to Arizona Avenue and from Broadway west to Santa Fe Drive. The Cherokee Denver site consists of a series of manufacturing facilities, warehouses, and parking lots. At the time of the site inspection, the Cherokee Denver site was undergoing decommissioning and was vacant. The Cherokee Denver site, which includes Swis Tire and Automotive Service at 887 S. Broadway, is currently part of or is submitting an application for the CDPHE VCUP (see **Section 5.1**). No evidence of hazardous substances or petroleum products, such as stored 55-gallon drums of material, ASTs, or USTs were observed on the portions of the site adjacent to public right-of-way.

2. View from the east of the Cherokee Denver property at 999 S. Broadway.

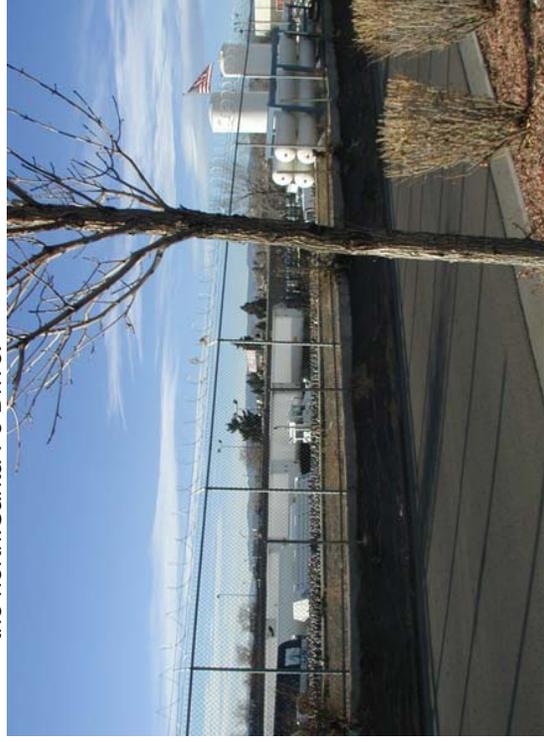
US Welding is located north of I-25 at 600 S. Santa Fe Drive. The US Welding site and the Stor-All Storage site appear to have been part of a larger former Union Carbide Facility. The US Welding site was fenced, and several administrative and industrial buildings were visible on the site. Several ASTs and pallets of containers also were present on the site. One 2,000-gallon AST for diesel is registered with OPS for the US Welding site. FHU personnel were unable to determine the contents of the ASTs or the containers. Hazardous materials management at the site is unknown. Based on the unknown conditions at this site, this is a site with **potential environmental conditions**.

3. View from the north of the U.S. Welding property at 600 from the north. Santa Fe Drive.

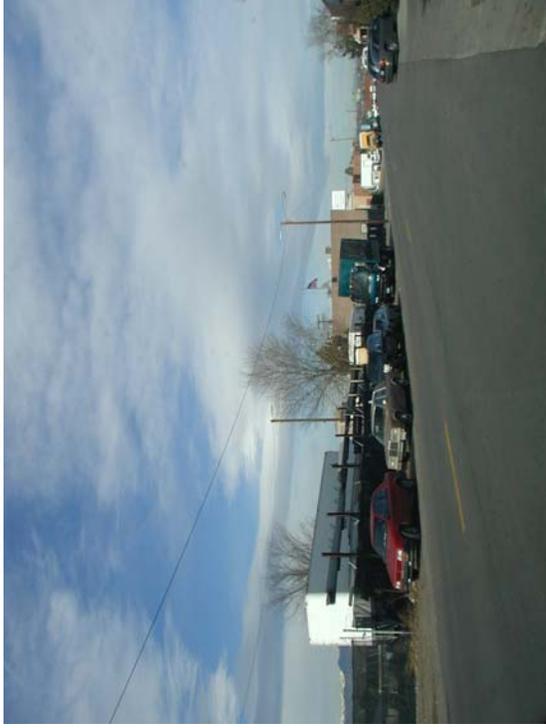
The sites in this area consist primarily of brick, cinder-block, and/or masonry industrial warehouses. El Rey Distributing and Calaham Construction at 50 Rio Grande and 95 Rio Grande Boulevard, respectively, have fenced yards with a variety of vehicles, heavy equipment, and materials stored. FHU personnel were unable to access the site for further observation. Petroleum and hazardous materials management at these sites is unknown. Based on the unknown conditions at these sites, they are sites with **potential environmental conditions**. The El Rey Distributing facility is not identified in the database search.

6. View from the southeast of Calaham Construction at 95 S. Rio Grande Boulevard.

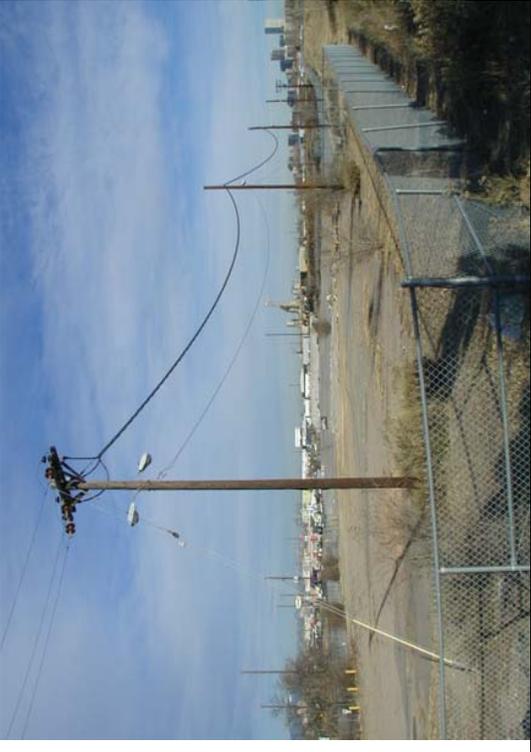
A vacant site is located at 350 S. Santa Fe Drive, which was the former site of the RTD Bus and Denver Tramway Maintenance Facilities. The concrete foundations of the former structures are visible on the site. Piping is visible on various portions of the property. The site is also a closed LUST site and is further discussed in **Section 5.3**.

15. View from the south of the former RTD Alameda facility property at 350 S. Santa Fe Drive.
