# I-70B West

# Wetland Finding

Prepared For:  
Colorado Department of Transportation

February 8, 2008

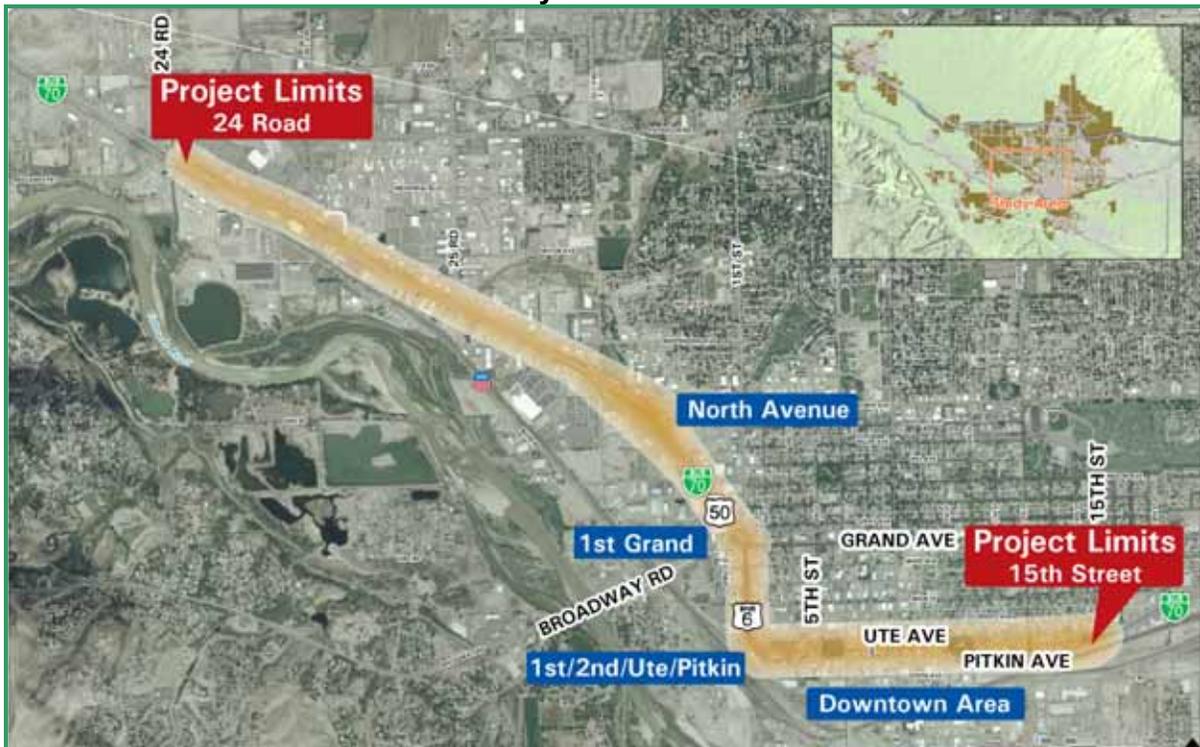
**Figure 2:  
Study Corridor**

would be controlled to improve through traffic operations and safety. The North Avenue interchange would be improved to provide additional through capacity, better traffic operations, access to businesses west of I-70B, and improved safety. The 1<sup>st</sup> & Grand intersection would be reconfigured and improved to include additional through capacity and turn lanes. The 1<sup>st</sup>/2<sup>nd</sup>/Ute/Pitkin area would be improved to upgrade operations to accommodate the third lane in each direction and improve safety. The 4<sup>th</sup>/5<sup>th</sup>/Ute/Pitkin area would be converted to one-way 4<sup>th</sup> and 5<sup>th</sup> streets with additional turn lanes added to reduce vehicle conflicts and improve traffic operations. **Figure 2** shows the study corridor.

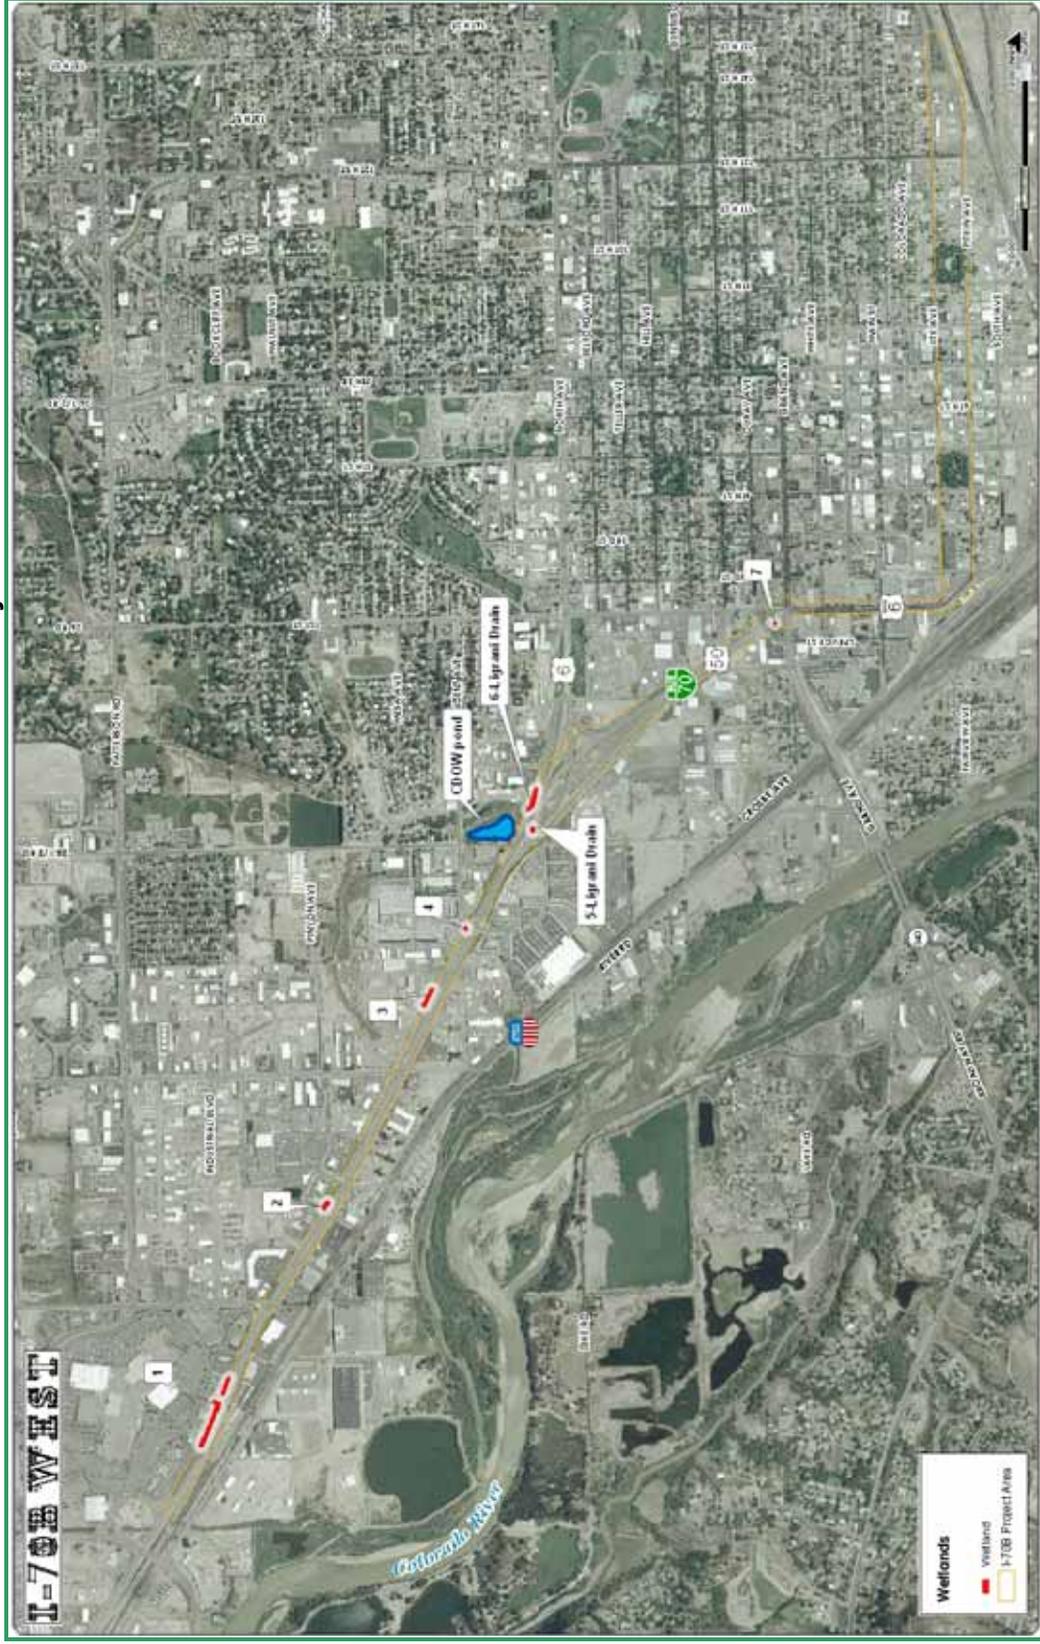
**Figure 3:**  
**Wetlands within the I-70B West Study Area**

Seven small roadside ditch or cross culvert pipe wetlands totaling 0.096 acre are present within the study area (see **Figure 3**). This total wetland acreage represents an extremely small portion of the entire study area. Wetlands 1, 2, and 3 are comprised of emergent vegetation (cattail, spikerush, barnyard grass) along the banks of roadside ditches which receive runoff from adjacent parking lots and I-70B. Wetlands 4 and 7 are emergent cattail wetlands located at stormwater culvert outlets. Wetlands 5 and 6 are bands of emergent vegetation (reed canarygrass, common reed) adjacent to Ligrani Drain.

Wetlands 1, 2, 3, 4, and 7 drain to cross culverts under I-70B. Wetlands 5 and 6 are associated with the Ligrani Drain, a historical drainage that was established in 1950 as a measure to lower groundwater levels in the area. Both Wetland 5 and Wetland 6 drain into the Colorado River. In events of intense precipitation, Wetland 6 also empties into the CDOW pond located north of I-70B. **Table 1** provides a summary of wetlands present in the study area.

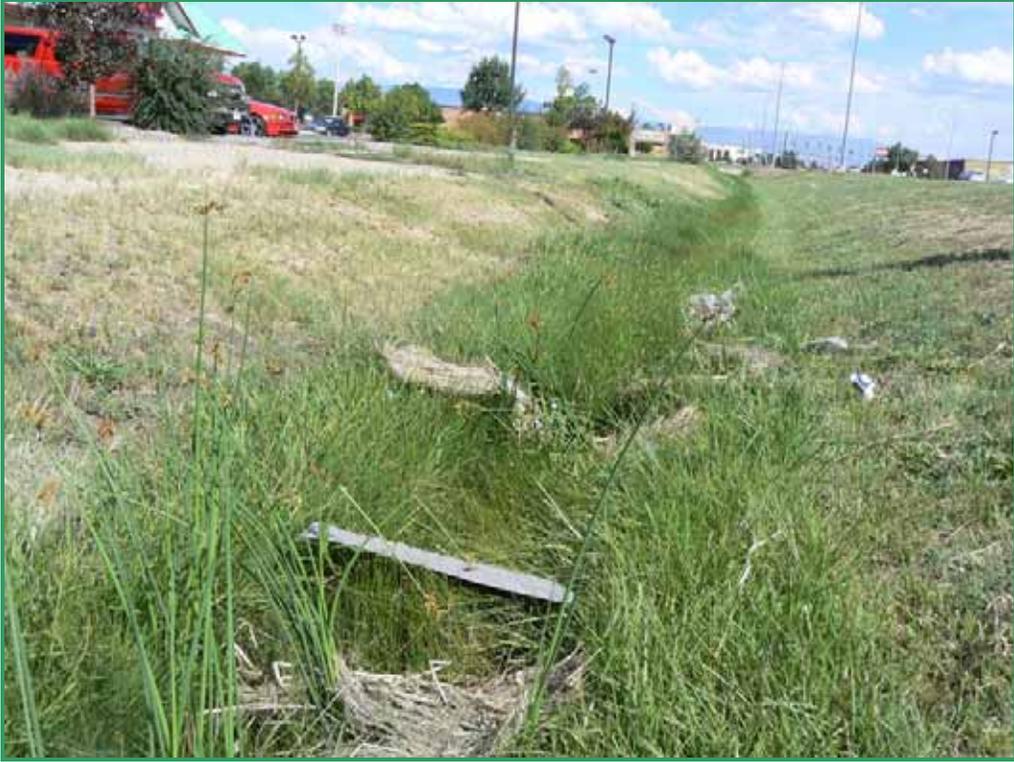
Wetland 1 is a 0.052 acre emergent wetland dominated by cattail with minor cover by lady's thumb, bulrush, barnyard grass, sedges, and buttercup. The wetland is comprised of three separate areas; all are in the ditch between business parking lots and the northern side of I-70B.

Hydrology is primarily provided to this area by parking lot drainages from several adjacent commercial restaurant locations. Additionally, the side slopes are landscaped and have bluegrass sod that is watered by overhead sprinklers, which adds to the hydrology of the ditch.

Hydrology for Wetland 1 is provided primarily by runoff from parking lots and groundwater. Much of the area surrounding the wetland is commercial landscaping and bluegrass that is irrigated throughout the growing season. Frequent recharge from these activities creates standing water in the wetland.

Soils are brown (10YR 5/3) clay with common gray (10YR 6/1) mottles. The soils show borderline colors, indicating that the soils are developing. Wetland 1 is classified by its map unit name as Sagers silty clay loam.

**Wetland 1: View to the Southeast**

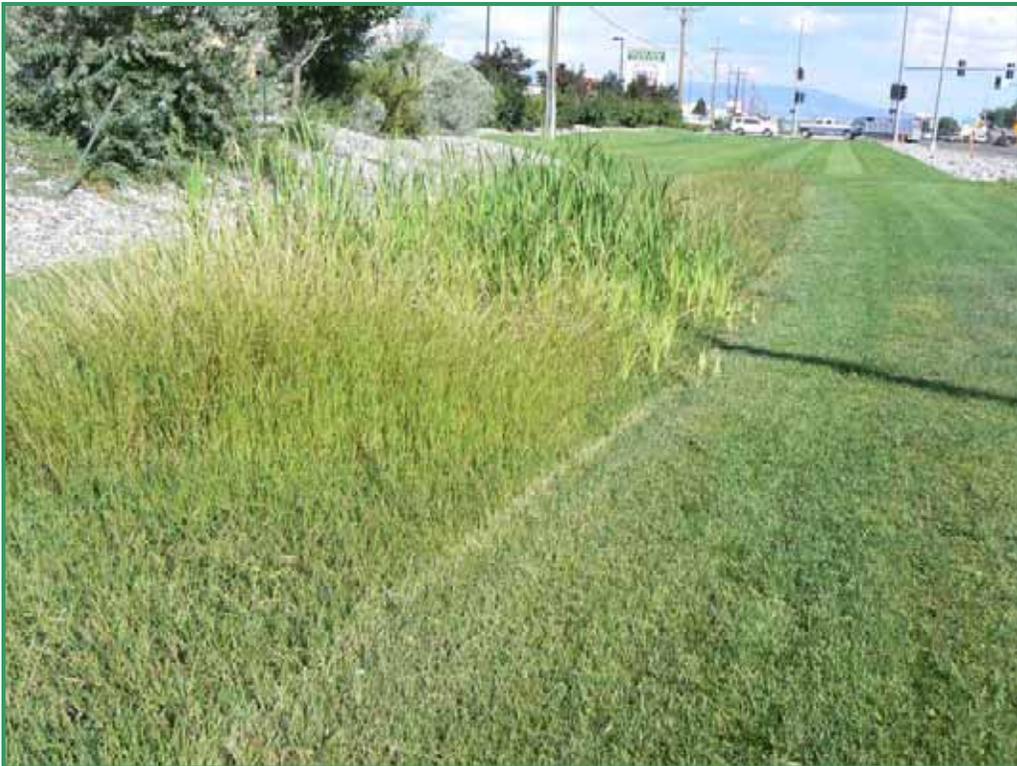
Wetland 2 is a 0.013 acre emergent wetland dominated by creeping spikerush and narrowleaf cattail. The wetland is located in the ditch between business parking lots and the northern side of I-70B. This wetland is very similar to Wetland 1 in both position in the landscape and the hydrology.

Hydrology for Wetland 2 is provided primarily by runoff from parking lots and groundwater. Much of the area surrounding the wetland is commercial landscaping and turfgrass that is irrigated throughout the growing season. Frequent recharge from these activities creates standing water in the wetland. Wetland 2 drains into Wetland 1.

Soils are dark grayish brown (10YR 4/2) with dark gray (10YR 4/1) mottles commonly associated with developing soils. Wetland 2 is classified by its map unit name as Sagers silty clay loam.

**Wetland 2: View to the Southeast**

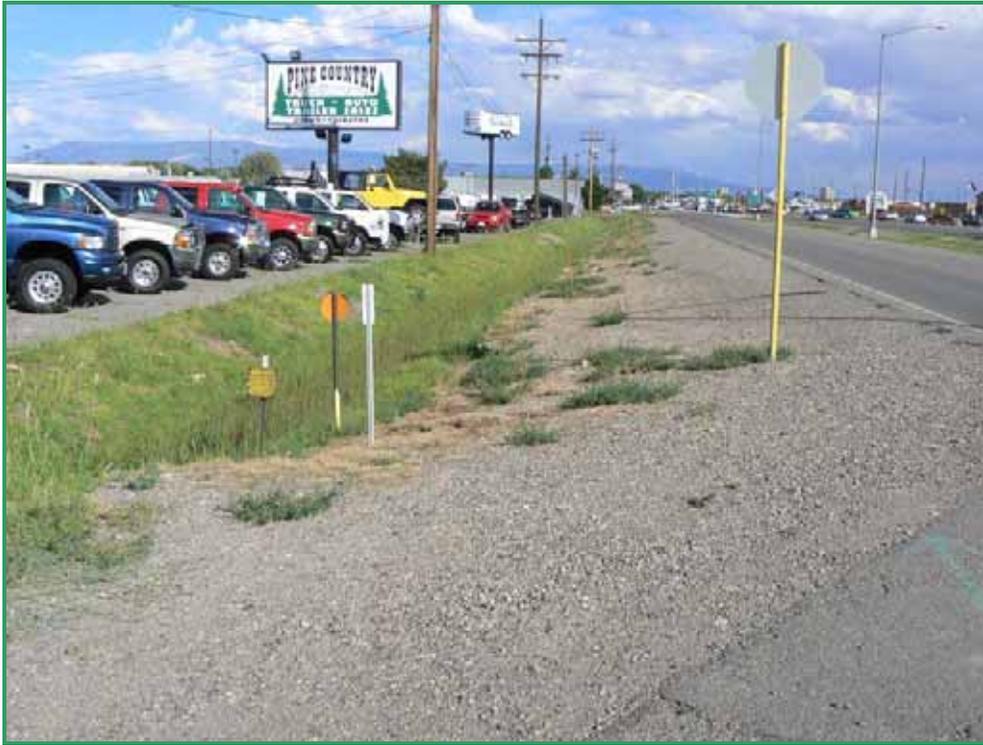
Wetland 3 is a 0.010 acre emergent wetland dominated by barnyard grass. This wetland is also a roadside ditch but is not surrounded by

bluegrass sod like Wetlands 1 and 2. It receives runoff from a large paved parking lot and the westbound lanes of I-70B.

Hydrology for Wetland 3 is provided primarily by runoff from parking lots and culverts at its east and west ends from I-70B. Hydrology was very faint at the time of survey and appears to occur only during short, seasonal intervals.

At the time of the wetland survey the soils were damp at the surface. A sandy clay loam soil displayed a gleyed or low chroma condition. At a depth of 12 inches, the soil is a dark grayish brown (10YR 4/2) with common mottles exhibiting yellowish red (5YR 4/6) color. Wetland 3 is classified by its map unit name as Green River clay loam.

**Wetland 3: View to the Southeast**

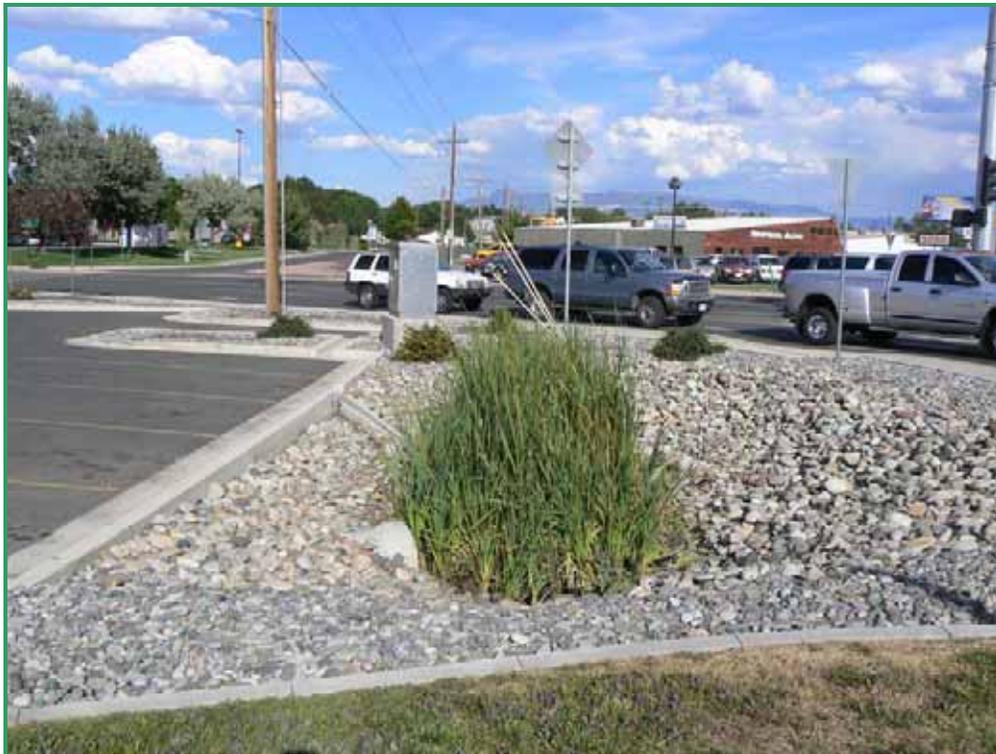
Wetland 4 is a 0.003 acre emergent wetland dominated by narrowleaf cattail. Wetland 4 is a small stormwater catchment in a cobblestone covered median area. It does not appear to have an actual outlet pipe and acts as a detention basin.

Hydrology for Wetland 4 is provided primarily by runoff from parking lots and culverts at its east and west ends and from I-70B. Much of the area surrounding the wetland is commercial landscaping and turfgrass that is irrigated throughout the growing season. Frequent recharge from these activities creates standing water in the wetland and there is no apparent outlet associated with Wetland 4.

No soil sample was collected for this site due to a restrictive surface layer. Soils are assumed to be hydric based on the dominance of obligate vegetation with a distinct, sharp boundary. Wetland 4 is classified by its map unit name as Green River clay loam.

**Wetland 4: View to the East**

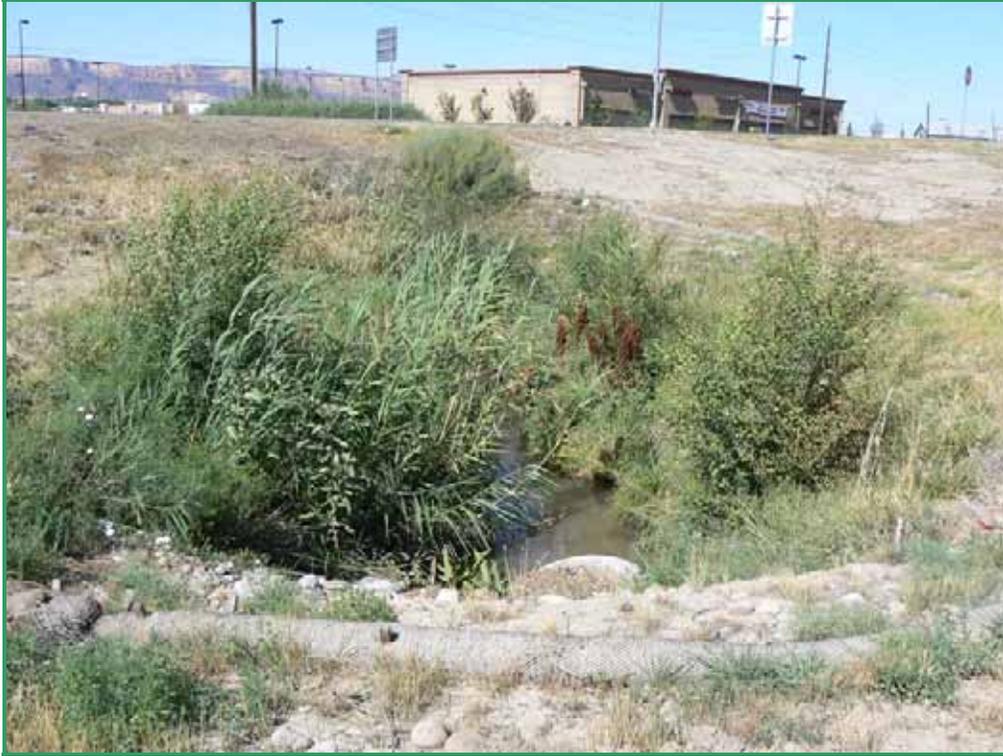
Wetland 5 is a 0.007 acre emergent wetland dominated by reed canarygrass, with curly dock, showy milkweed, and Chinese elm also present. Wetland 5 is located along the banks of the Ligrani Drain as it flows between pipes under I-70B westbound and eastbound. Due to its location in the landscape, being surrounded with steep, dry banks, the zone of influence from this drain is very limited. There are a couple of small terraces at or slightly above the water level, otherwise it is much too dry to support wetland vegetation or create hydric soil

Hydrology for Wetland 5 is provided primarily from drainage. The wetland had water flow in the ditch at the time of survey. Wetland 5 drains to a cross culvert under I-70B and eventually empties into the Colorado River.

Soils are very dark grayish brown (10YR 3/2), a sandy clay loam with low chroma. Soils in this wetland are borderline and appear to be in transition. Wetland 5 is classified by its map unit name as Sagers-urban land complex.

**Wetland 5: View to the West**

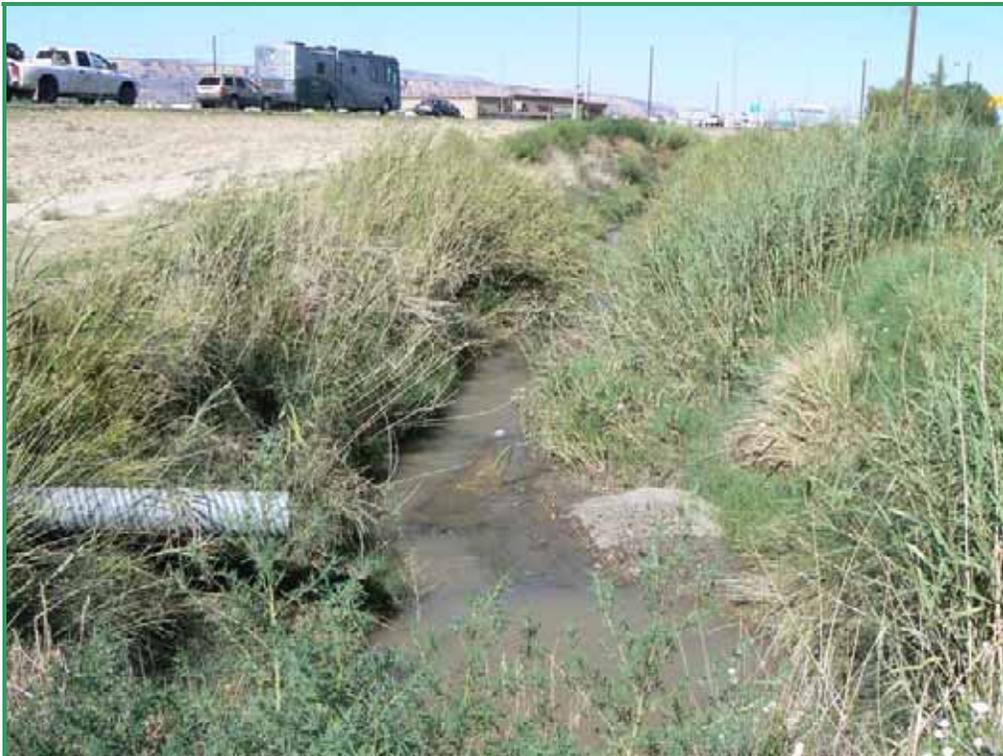
Wetland 6 is a 0.010 acre emergent wetland dominated by common reed, with inland saltgrass also present. Wetland 6 is also located along the banks of the Ligrani Drain. It is located along the north side of the Highway 6 frontage road and westbound I-70B, at the toe of slope.

Hydrology for Wetland 6 is provided by overflow from Wetland 5. Wetland 6 drains to the Colorado River, and in instances of intense precipitation, to the CDOW pond north of I-70B. Water was flowing in the ditch at the time of survey.

Soils were a dark brown (10YR 3/3) sandy loam from 0-6 inches displaying a low chroma, but absence of mottles. At 6-12 inches a value of 25 N with a sulfuric odor was observed: no mottles present in the sandy loam soil. Wetland 6 is classified by its map unit name as Sagers-urban land complex.

**Wetland 6: View to the West**

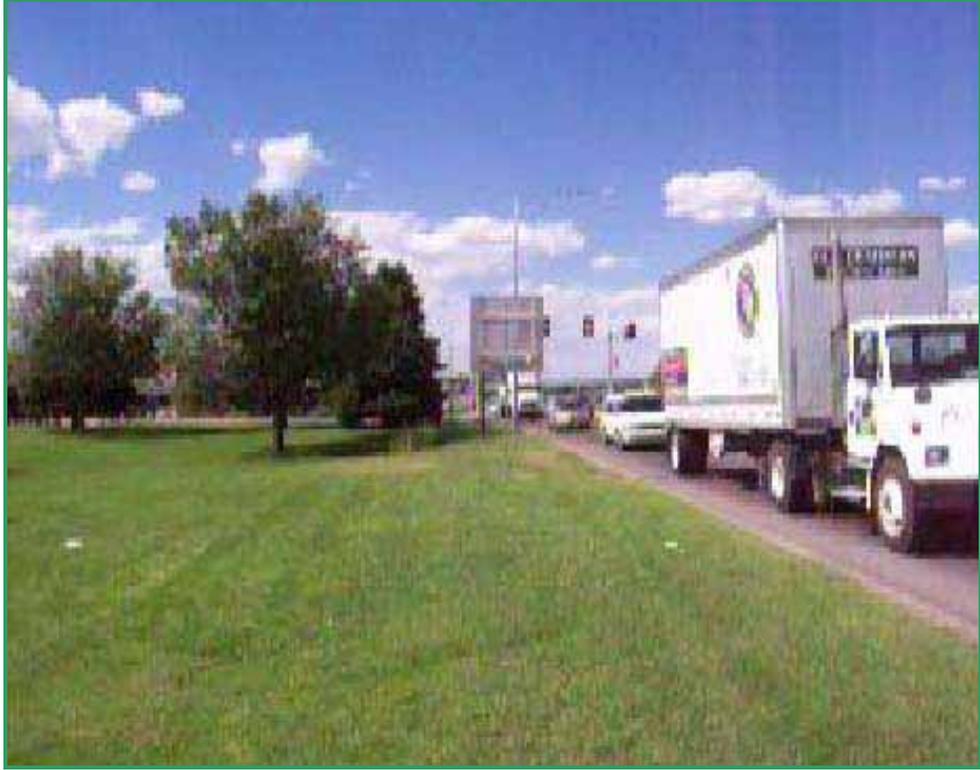
Wetland 7 is a 0.001 acre emergent wetland dominated by cattail species with a very distinct boundary. The wetland is located at a stormwater culvert outlet in a landscaped island west of the 1<sup>st</sup> and Grand/I-70B intersection in the NW quadrant.

Hydrology for Wetland 7 is provided by roadway runoff and saturation was observed at the time of survey.

No soil samples were collected at Wetland 7 due to restrictive ground layer. Soils are assumed hydric based on the dominance of wetland obligate vegetation and a very distinct wetland boundary. Wetland 7 is classified by its map unit name as Sagers-urban land complex.

**Wetland 7: View to the Northwest.  
Wetland is to the left of the sign.**
