CHAPTER 1

Purpose and Need

1 The Colorado Department of Transportation (CDOT),
2 in cooperation with the Federal Highway
3 Administration (FHWA) and other stakeholders, has
4 prepared this Environmental Assessment (EA) to
5 identify and assess potential transportation
6 improvements at the interchange of US 6 (also
7 referred to as 6th Avenue) and Wadsworth Boulevard
8 (referred to as Wadsworth throughout this EA) and to
9 Wadsworth north of the interchange. Additional
10 supporting documentation for the study is included
11 in Appendix C. The *Traffic Study Report* (CH2M HILL,
12 2009a), also contained in Appendix C, provides more
13 detail on the needs for the proposed action.

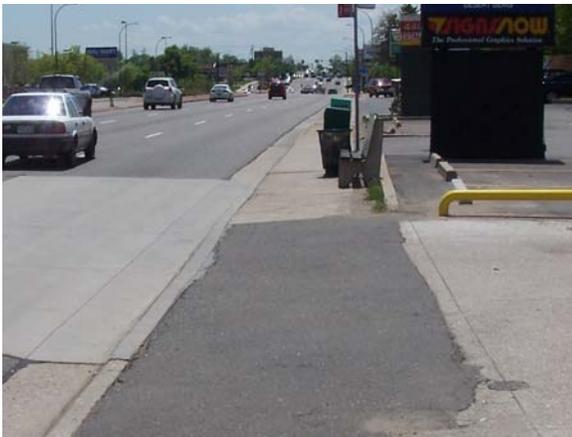
EXHIBIT 1-3: MISSING SIDEWALKS AND OBSTRUCTIONS NEAR 5TH AVENUE

9 Within the study area along Wadsworth, approximately
 10 50 percent of the sidewalk on the east side and
 11 85 percent of the sidewalk on the west side are
 12 nonexistent or in substandard condition. Substandard
 13 conditions include sidewalks that are too narrow, not
 14 buffered adequately from travel lanes, and contain
 15 obstacles such as curbs, signs, or utility poles in the
 16 traveled way. Some of the sidewalk conditions are
 17 illustrated in Exhibits 1-3 and 1-4.

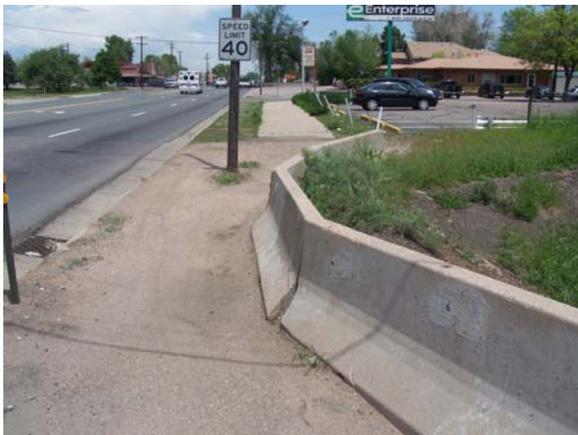
EXHIBIT 1-4: MISSING SIDEWALK SEGMENT SOUTH OF 12TH AVENUE
