### Toad Wall

## **Toad Wall**

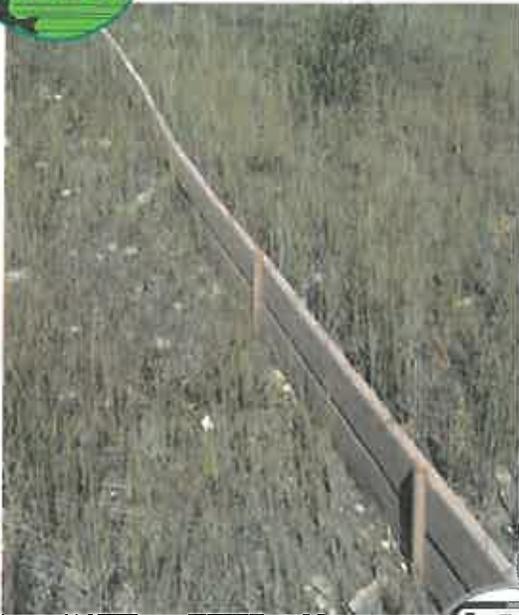
*Photo Source: Colorado Department of Transportation*

In 2002, biologists noticed an excessive amount of roadkill of the boreal toad (*Bufo boreas boreas*) along US Highway 40 at Muddy Pass, near the boundary of Grand and Jackson counties. This small species of toad was listed as Endangered by the State of Colorado.

A nearby underpass was available for safe crossing, but the toads were not using it. CDOT developed a simple and low-cost solution to this problem. In 2003, CDOT created a plastic wall (because metal structures could be toxic to this species) in a wide “V” shape that channels movement of the animals in the adjacent habitat to the underpass.

During the year after installation of this fence, biologists observed a marked reduction in roadkill of this species in the vicinity of the walled habitat area.

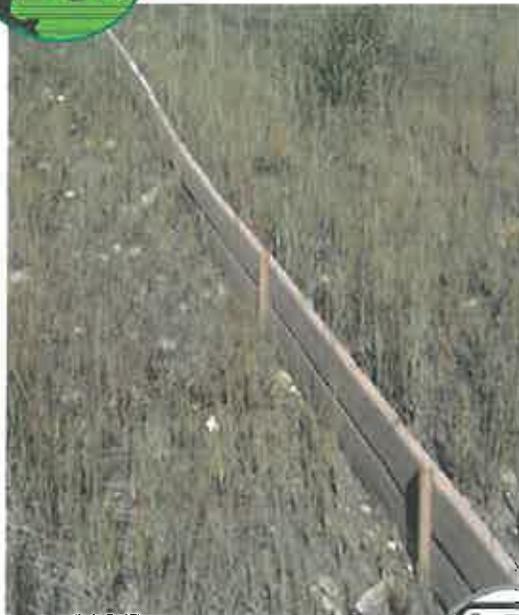
### Toad Wall

*Photo Source: Colorado Department of Transportation*

In 2002, biologists noticed an excessive amount of roadkill of the boreal toad (*Bufo boreas boreas*) along US Highway 40 at Muddy Pass, near the boundary of Grand and Jackson counties. This small species of toad was listed as Endangered by the State of Colorado.

A nearby underpass was available for safe crossing, but the toads were not using it. CDOT developed a simple and low-cost solution to this problem. In 2003, CDOT created a plastic wall (because metal structures could be toxic to this species) in a wide “V” shape that channels movement of the animals in the adjacent habitat to the underpass.

During the year after installation of this fence, biologists observed a marked reduction in roadkill of this species in the vicinity of the walled habitat area.

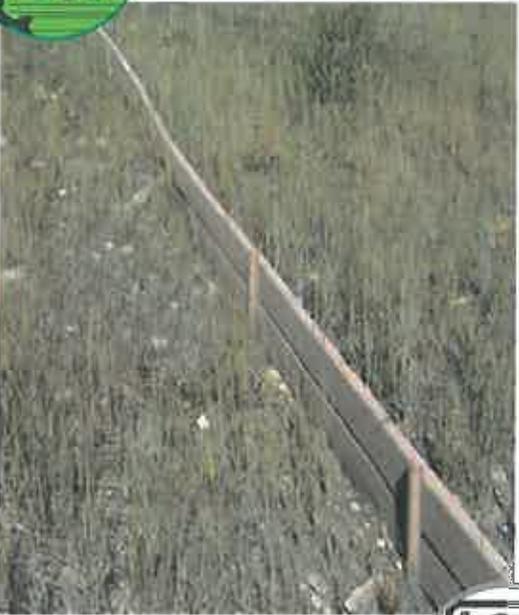
### Toad Wall

*Photo Source: Colorado Department of Transportation*

In 2002, biologists noticed an excessive amount of roadkill of the boreal toad (*Bufo boreas boreas*) along US Highway 40 at Muddy Pass, near the boundary of Grand and Jackson counties. This small species of toad was listed as Endangered by the State of Colorado.

A nearby underpass was available for safe crossing, but the toads were not using it. CDOT developed a simple and low-cost solution to this problem. In 2003, CDOT created a plastic wall (because metal structures could be toxic to this species) in a wide “V” shape that channels movement of the animals in the adjacent habitat to the underpass.

During the year after installation of this fence, biologists observed a marked reduction in roadkill of this species in the vicinity of the walled habitat area.

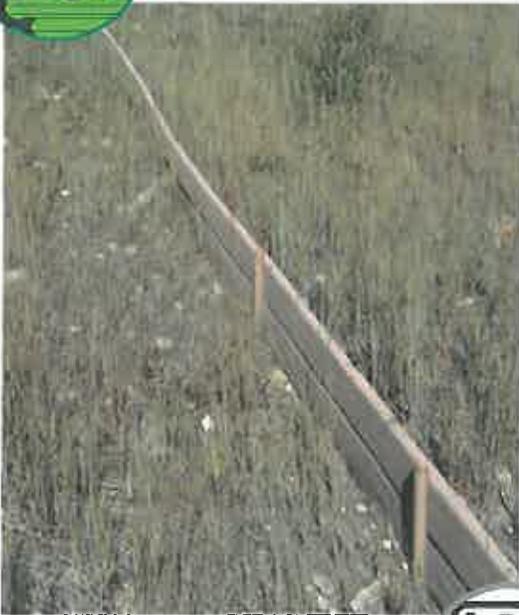
### Toad Wall

*Photo Source: Colorado Department of Transportation*

In 2002, biologists noticed an excessive amount of roadkill of the boreal toad (*Bufo boreas boreas*) along US Highway 40 at Muddy Pass, near the boundary of Grand and Jackson counties. This small species of toad was listed as Endangered by the State of Colorado.

A nearby underpass was available for safe crossing, but the toads were not using it. CDOT developed a simple and low-cost solution to this problem. In 2003, CDOT created a plastic wall (because metal structures could be toxic to this species) in a wide “V” shape that channels movement of the animals in the adjacent habitat to the underpass.

During the year after installation of this fence, biologists observed a marked reduction in roadkill of this species in the vicinity of the walled habitat area.
