IN-SERVICE EVALUATION OF HIGHWAY SAFETY DEVICES EXPERIMENTAL PROJECT NO. 7

Construction Report November 1990

sponsored This report, by the Federal Highway Administration, describes the construction sequence for installing three roadside safety hardware devices. They included 10-gauge guardrail on Project HES 0003(35), the Brakemaster End Terminal system on Project CX-0082-27, and the Crash-Cushion Attenuating Terminal (CAT) system on Project SR (CX) 0008(3).

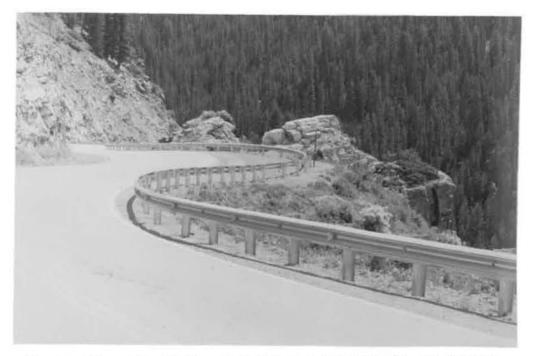
Photo A2. 10-gauge galvanized guardrail on Battle Mountain Pass.

The location of the 10 and 12-gauge guardrail is on State Highway 24 about 20 miles south of Vail (Location Map, Page 17). The railing begins on Battle Mountain Pass (Photos A1 & A2) and extends south to the north end of Camp Hale (Photo A3).

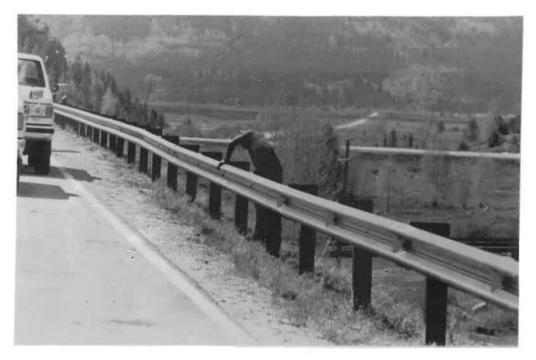
Photo A3. 10-gauge corrosion resistant guardrail with view of Camp Hale in the background.

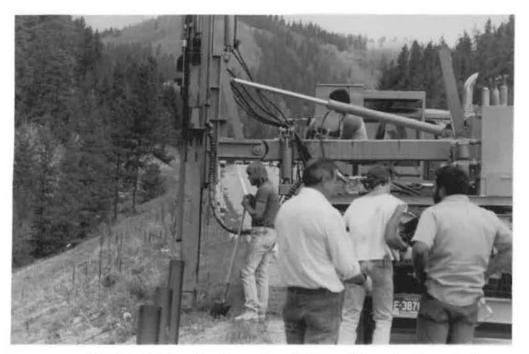
Photo A4. Back end of the "Punch Truck."

To begin the installation, the posts first had to be driven into the ground. The contractor did this with a post driver or "punch truck." This mechanical device is simply a truck with a bed-mounted hydraulic apparatus used for driving posts (Photo A4). From his seat and control panel, the punch truck operator drove the posts at their required spacing and depth.

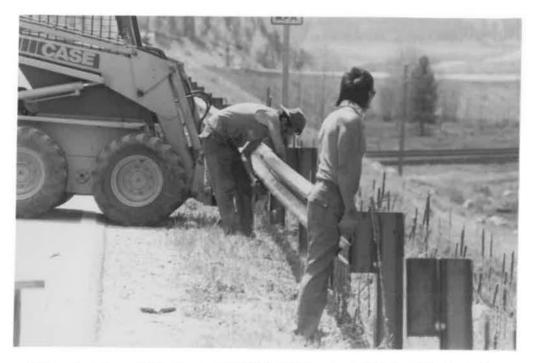
Photo A5. Two men positioning a guardrail panel for installation.

One other observation made while installing the 10-gauge guardrail was that the panels, being heavier, also took more time in handling (Photo A5). Each 25-foot panel of 10-gauge corrosion resistant steel weighs 221 pounds compared to 12gauge that weighs 170 pounds; galvanized panels weigh 234 and 185 pounds respectively. Panels also were difficult to install around tight curves where, being less flexible, they had a tendency to kink.

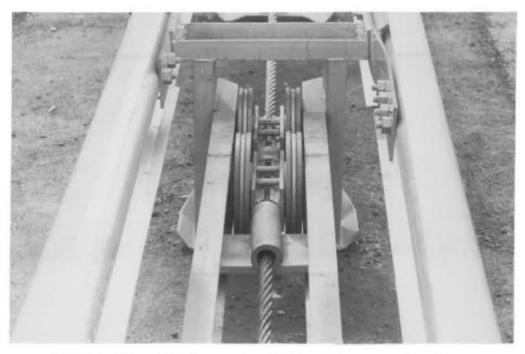
Photo B1. Brakemaster's braking mechanism.

The Brakemaster End Terminal, designed for use in lowfrequency impact areas and for easy installation, is another safety device under evaluation (Sketch, Page 19). At a bid price of \$5000 per terminal, this system's construction includes W-beam guardrail panels and a braking mechanism (Photo B1, - Sketch, Page 20). The design is such that the terminal moves back telescopically during a head-on impact bringing a vehicle to a controlled stop. Brakemaster also can redirect vehicles in low angle side hits.

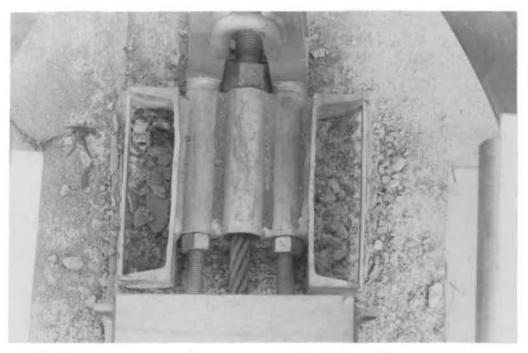
Photo B2. Top view of embedded terminal anchor.

Preparation for installing the Brakemaster End Terminals began during the week of July 22. This included the contractor having to dig six, 5 feet deep by 2 feet diameter holes at the head of each terminal section. Filled with concrete, these bases hold the embedded terminal anchors (Photo B2). This job took about two days to complete.

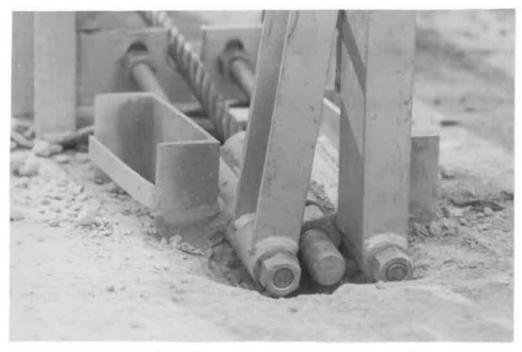
The two anchors in question had come from the manufacture with a slight fabricating error. The error was that the sleeve pipes came positioned on the uprights about one-half an inch lower than they should have (Sketch, Page 21). This made attaching the nuts to the threaded end of the cable assembly impossible. To solve this problem, the contractor chiseled out the concrete around the anchors. Doing this provided enough clearance to accommodate the nuts (Photo B3).

Photo B3. Side view of embedded terminal anchor.

The next day, Tuesday, an engineer flew out from Energy Absorption's California facility to inspect the anchors and concrete bases. He concluded that they would be acceptable to use as they were. Upon receiving the engineers approval, the contractor then completed the job by installing the two remaining end terminals.

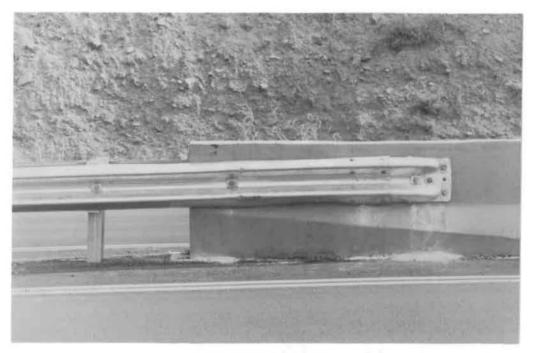
Photo B4. Brakemaster transition section fastened to concrete barrier.

All six terminals have transitions that fasten to the ends of concrete barrier (Photo B4). These transitions consist of two overlapping W-beam guardrail panels on each side, giving the section added strength. The steel posts (Photo B5), spaced approximately 3 feet apart, support the weight of the transition panels (Photo B6).

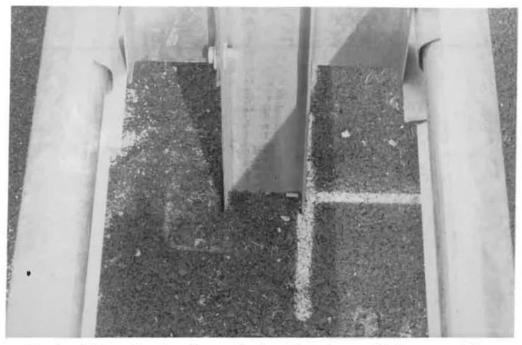
Photo B5. A steel post in the transition section.

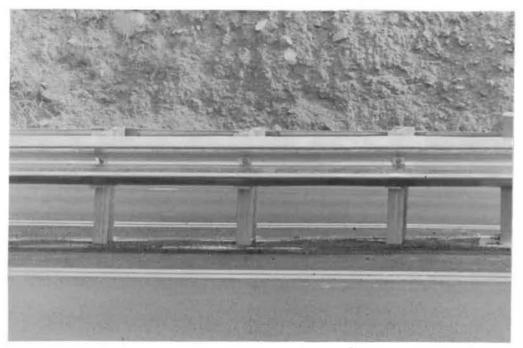
Photo B6. The transition section with overlapping panels on each side.

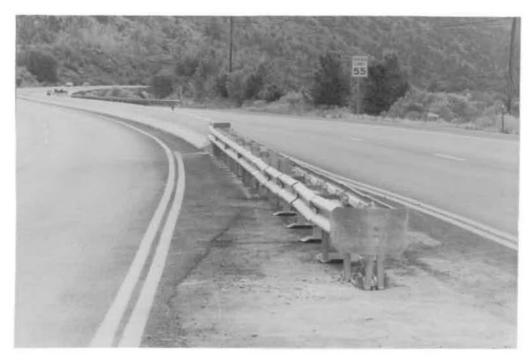
Photo B7. Completed Brakemaster End Terminal.

Physically, the terminals are on horizontal alignments that vary slightly from almost straight to a gentle curvature. They are in narrow medians in bidirectional four-lane traffic where the road is almost flat (Photo B7).

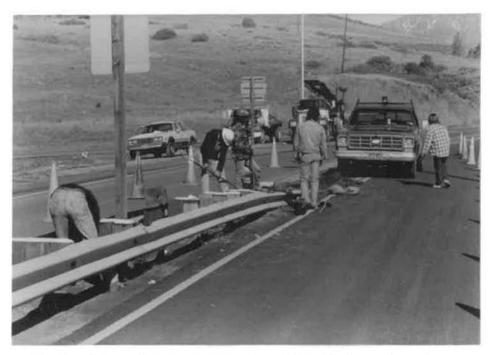
Photo C1. Crew removing old end treatment.

Tuesday, October 16, 1990, Haco Construction started installing the CAT system (Sketch, Page 22). This job began with the contractor first having to remove an existing end treatment (Photo C1). They first started by unscrewing the nuts and bolts from the panels and posts, easily done with a set of crescent wrenches. Then they removed the embedded posts from the ground.

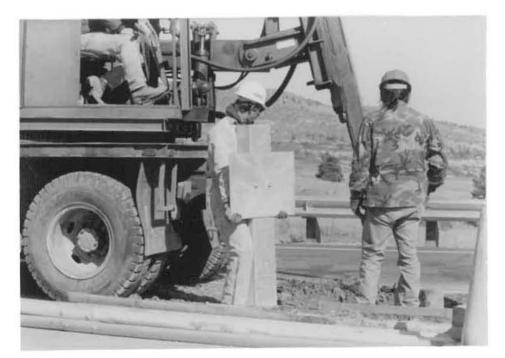
Photo C2. Vertical soil plate and sleeve that is placed over wooden post.

After removing the old end treatment, the crew began the terminal assembly. They first started by driving the holes with the punch truck and then dropping the posts into the ground. They also used the punch truck to drive a required sleeve with vertical soil plate over each post (Photo C2). Driving this sleeve plate worked out fine because of the soft clayey soil. Lastly, they attached the panels and hardware to the post.

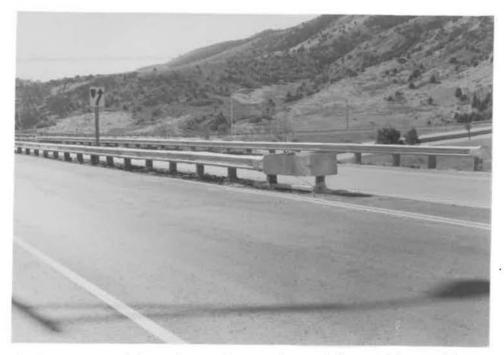
Photo C3. Side view of Crash-Cushion Attenuating Terminal (CAT) system.

Haco's removal of the existing terminal system and installation of the new CAT system (Photo C3) took about a day and a half to complete. This all at a bid price of \$6510, \$4000 of which they spent on the system itself.

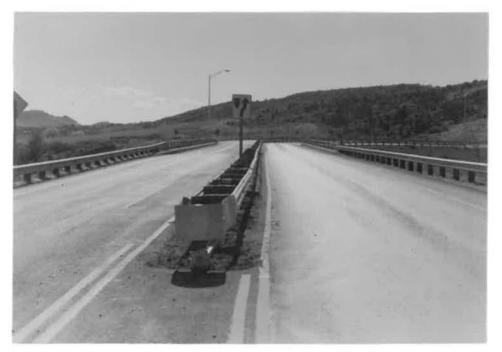
Photo C4. Front view of CAT Terminal.

This system is on the north side of the bridge approach (Photo C4). It is in the middle of a two-lane road that carries bidirectional traffic. The median that separates the two lanes is 5.5 feet wide.
