Report No. CDOT-DTD-R-91-3

SYNTHETIC VS WOODEN SNOW FENCE

Final Report

July, 1991

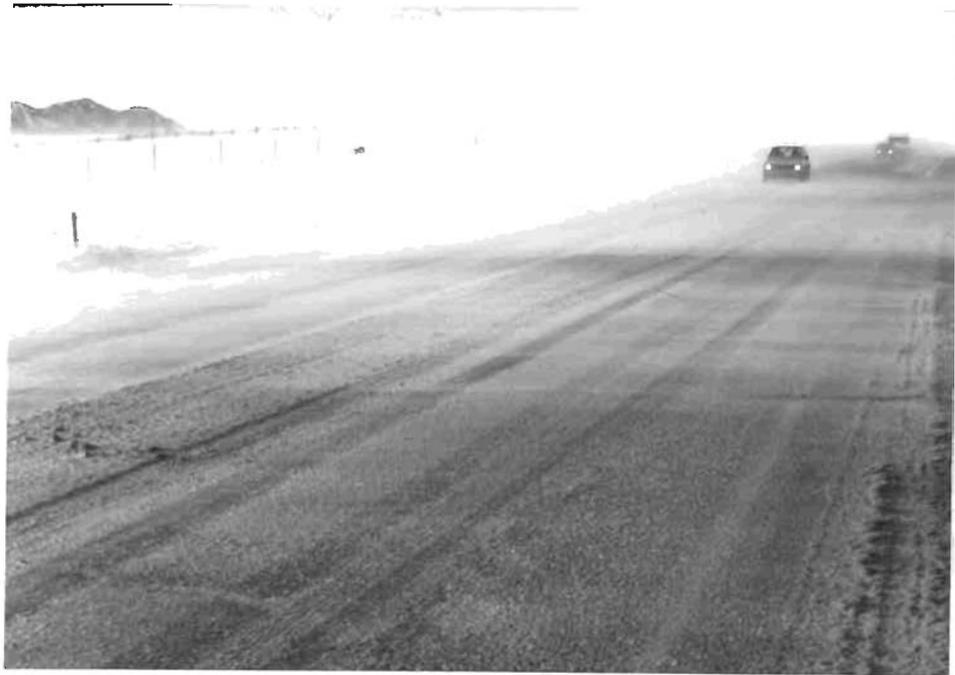
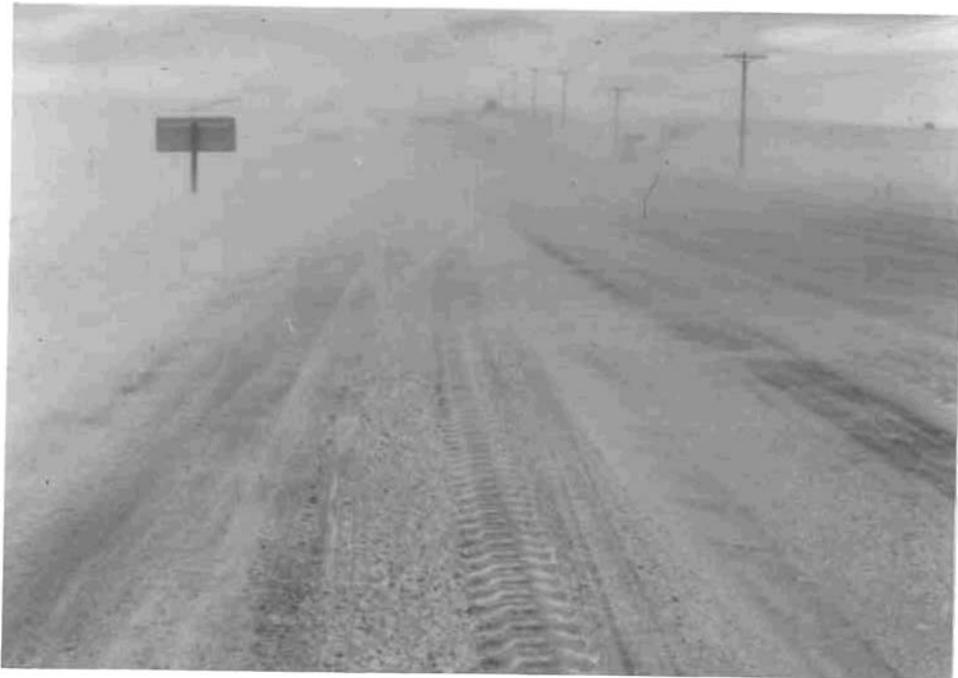
Photograph 1 & 2: Poor visibility caused by blowing snow even when it was not snowing.

There are many areas prone to strong gusty wind along this stretch of highway, which has required constant plowing and sanding during the winter months. The wind can gust up to 100 miles per hour creating a hazardous driving condition for the motorist during a snow storm (photograph 1 and 2). On occasions the maintenance crew close the highway at this location due to poor visibility caused by ground blizzards.

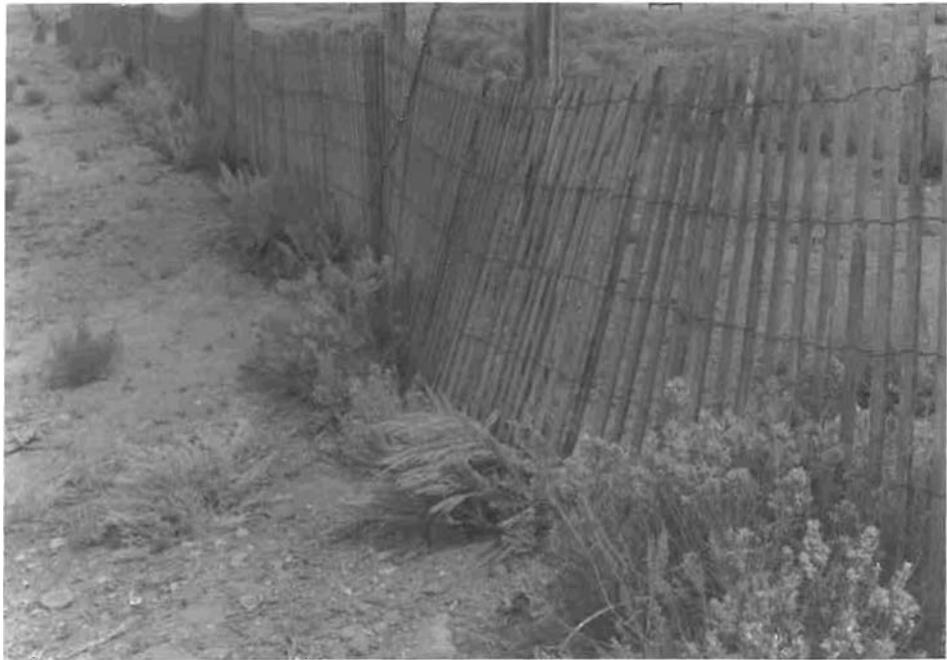
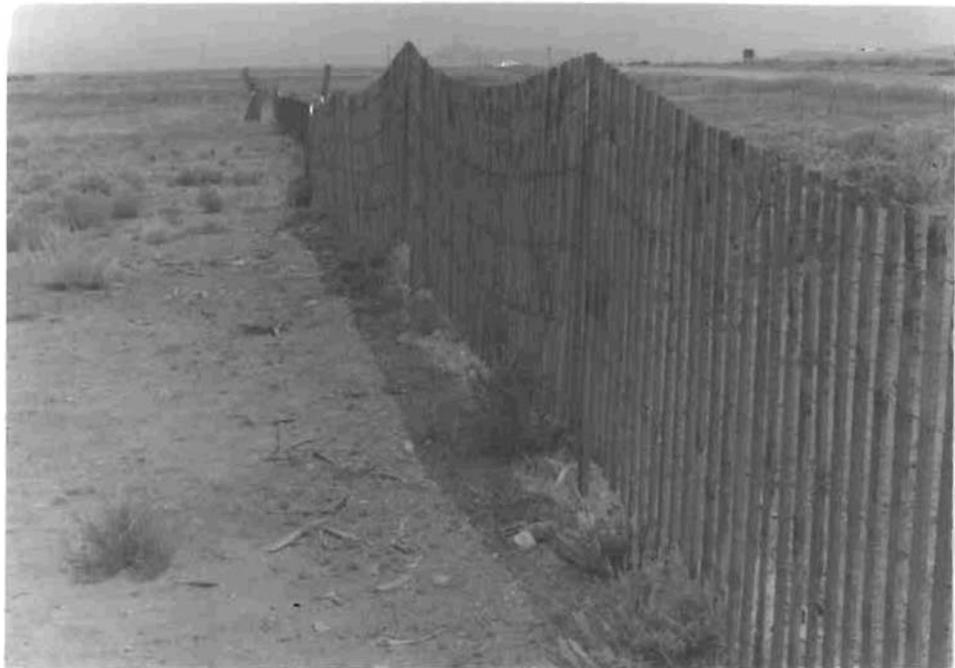
Photograph 3 & 4: Wooden fences lose their effectiveness within a few years.

Wooden snow fences have been used effectively to control the formation of snow drifts at this location. However, they lose their effectiveness after a few years, and require maintenance or replacement (Photograph 3 and 4).

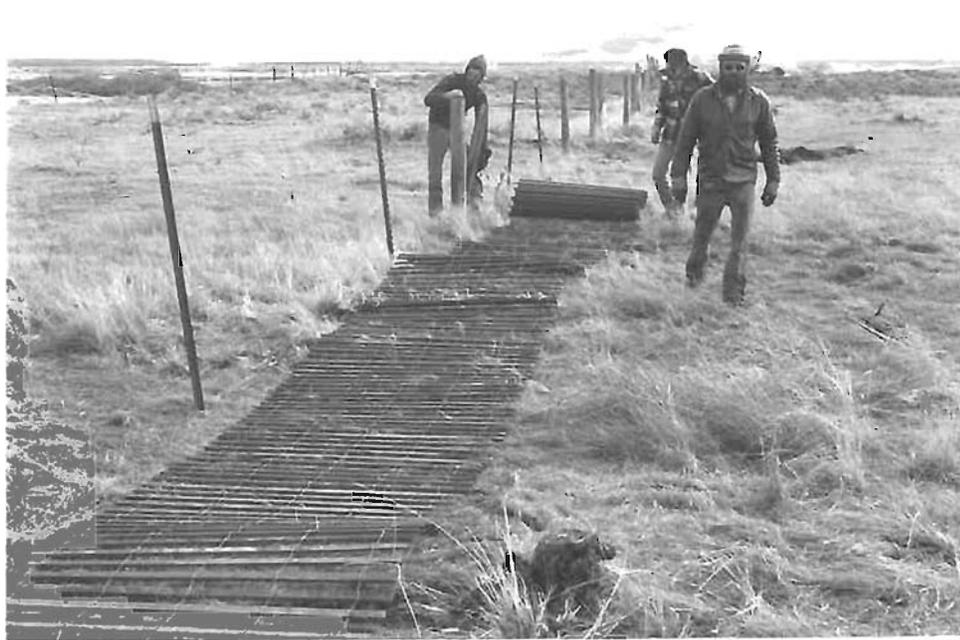
Potograph 1: Erection of wooden and steel posts prior to the installation of the fence

The installation of the fences began with the erection of wooden and steel "T" posts every seven feet. The heavy wooden posts were used at either end of the fences mainly for proper tensioning. The fences were stretched in two ways, using a hand stretcher and a truck. However, for most part a truck was used, because of the ease of its operation and proper stretching capability.

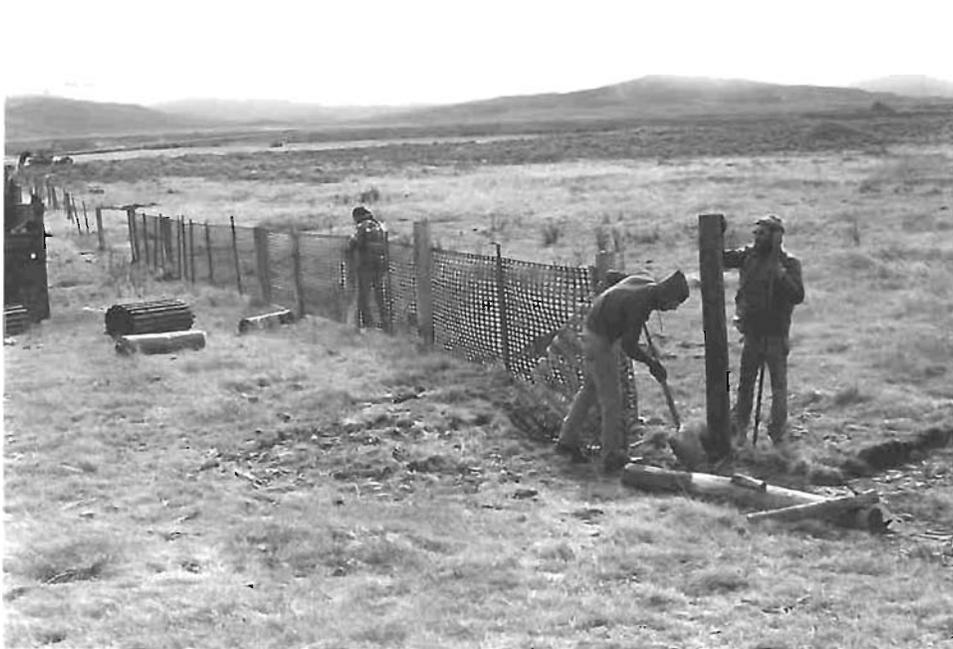
Photograph 2: Heavy wooden posts were used at each end of the fence for proper tensioning. Notice the size of the wooden fence vesus the si ze of other two fences.

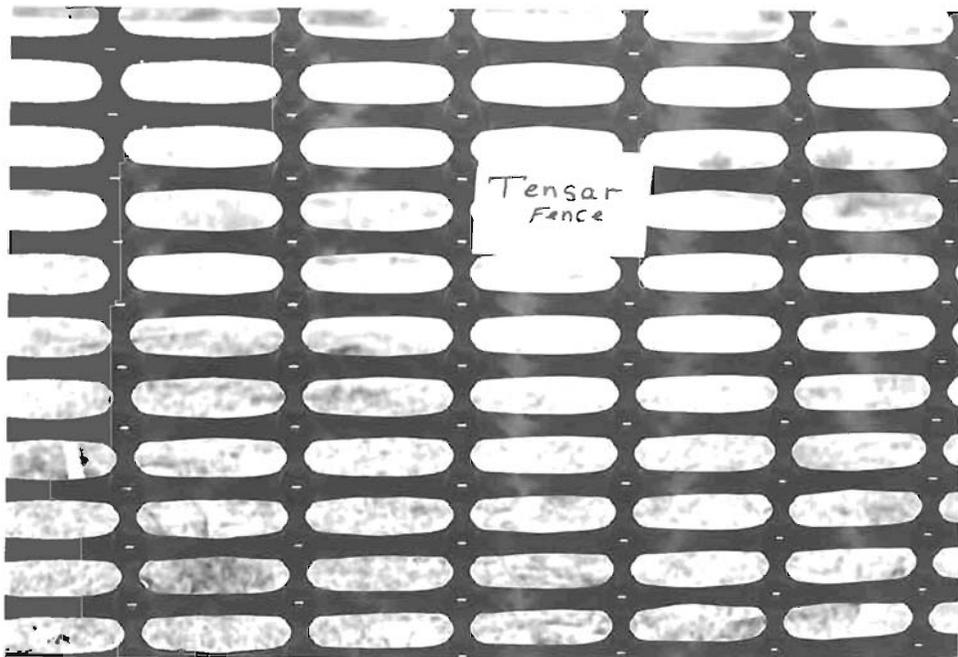
Photographs 3 and 4: Tensor and Tenex fences. Their porosity is the same (50%), but their designs are different.

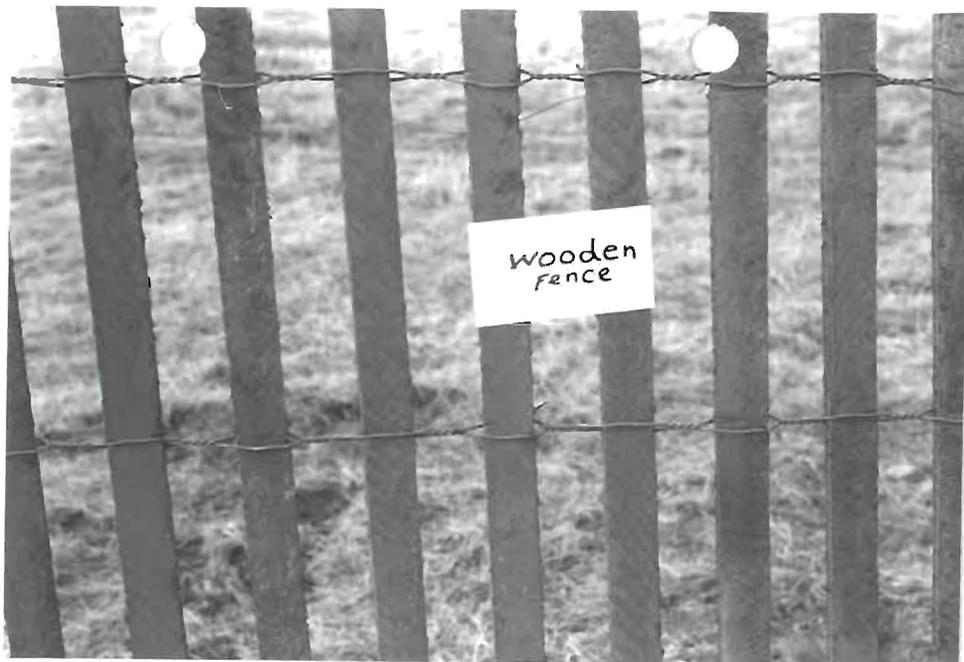
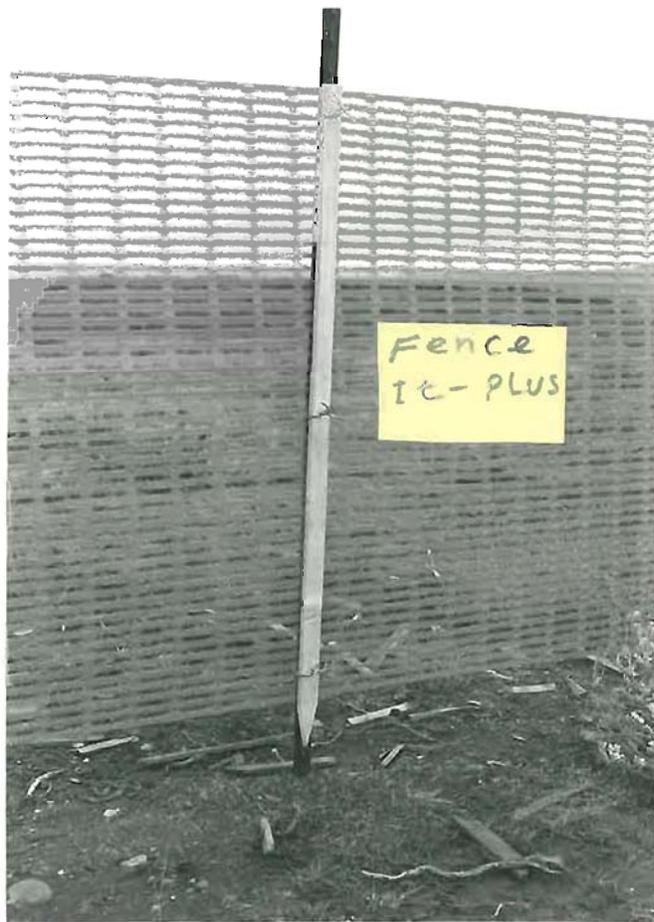
Photographs 5 and 6: Wooden fence and Fence It-Plus

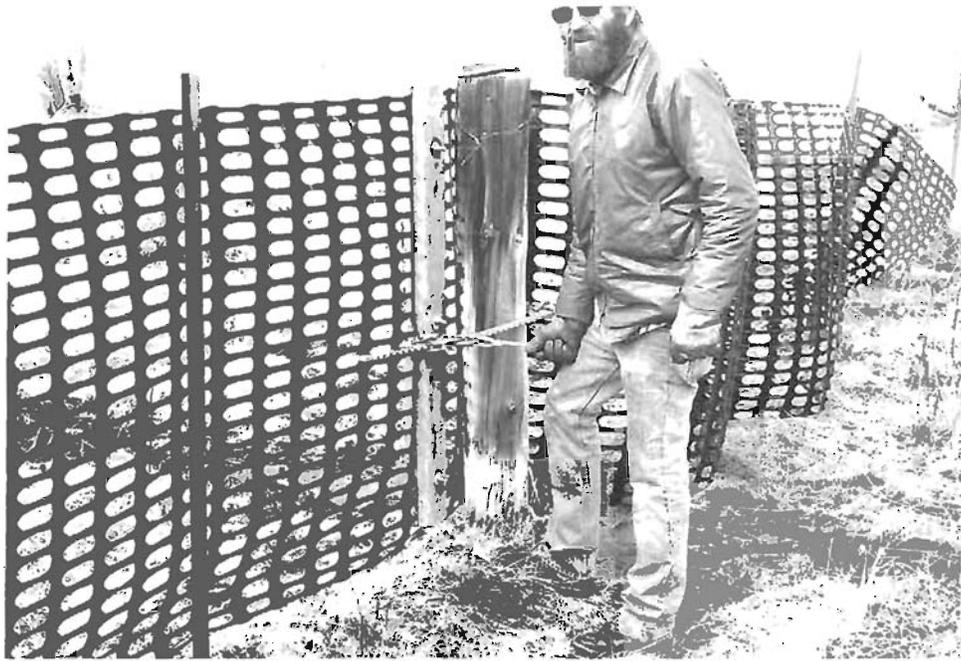
Photographs 7 and 8: The fences were stretched in two ways, using a stretcher and a truck.

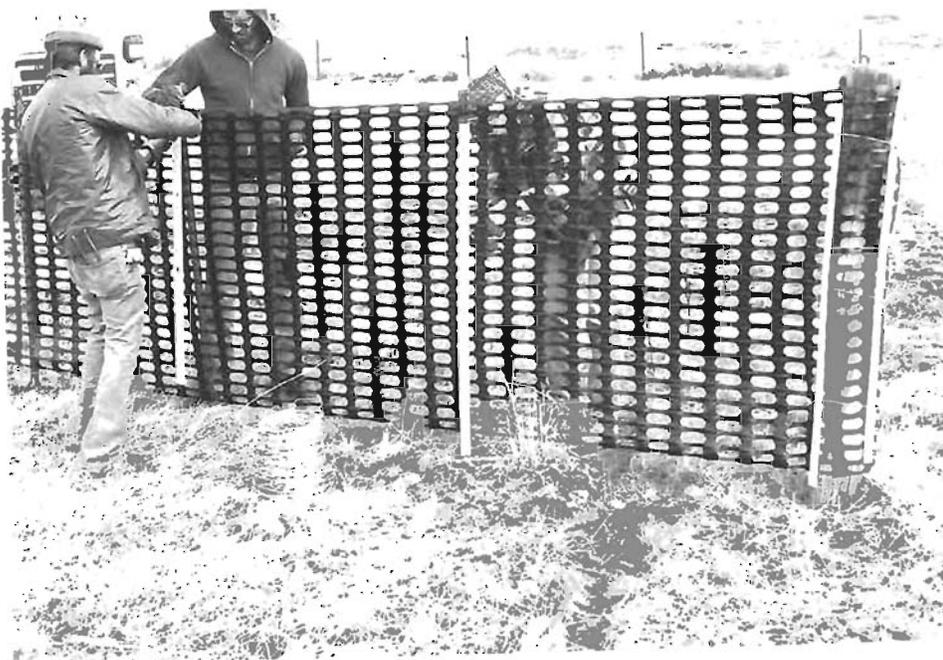
Photograph 10:

After stretching, the fence was sandwiched between a wooden slat and the flat side of a post. The wooden slat was used to prevent abrasion of the fence by the wire.

A bottom gap of six inches was established for all the fences. According to Dr. tabler "leaving a space between the bottom of a fence and the ground surface reduces the tendency for the fences to become buried in the drift". Burial reduces effective fence height, with a commensurate loss in effectiveness, and often cause structural damage to the fence because of the large forces exerted by snow settlement and creep (3). After stretching, the fences were sandwiched between a wooden slat and the flat side of a post. The wooden slat was used to prevent abrasion of the fence by the tie wire.
