**Long-Term Performance of
Accelerated Rigid Pavements, Project
CXMP 13-0006-07**

Final Report
October, 1996

13. ABSTRACT (Maximum 200 words) This report describes the post-construction evaluation of the fast track pavement in Sterling Colorado.. The field evaluation consisted of visual inspection, fault measurement, profile measurement and distress survey. A set of falling weight deflectometer (FWD) measurements was also acquired to assess the structural responses and to evaluate load transfer efficiency between the slabs. The results of this study demonstrated that fast track concrete can be as durable as the conventional concrete pavement. After seven years of being in service the pavement has shown no sign of fatigue, only some minor distresses unrelated to fast track techniques. Implementation: The use of fast track techniques, where suitable, is recommended.

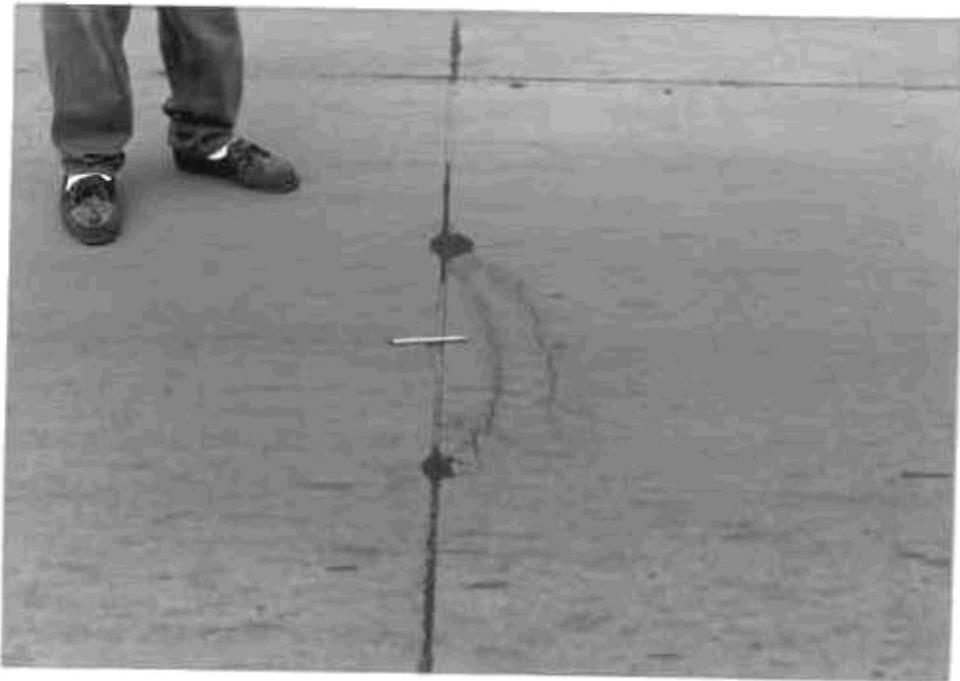
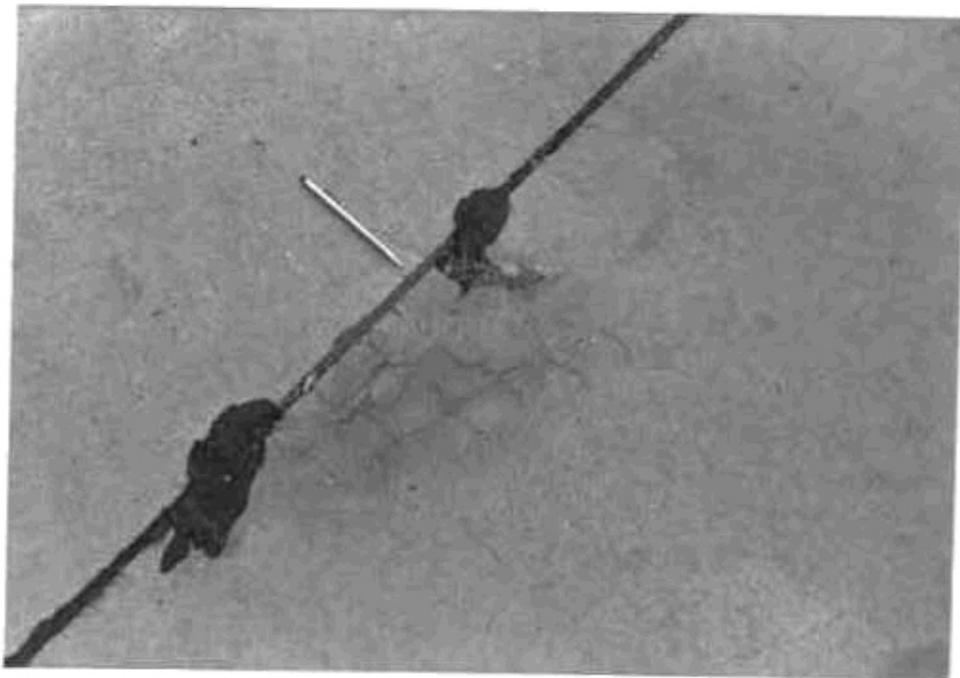
Photo 1&2: Localized Shrinkage Cracking.

Hairline cracks adjacent and approximately parallel to transverse joints were detected at three isolated locations as shown in Photographs 1 through 3. This type of distresses are primarily attributed to over-working or over-finishing the concrete paste and are referred to as shrinkage cracking. Shrinkage cracks are shallow, fine cracks extending approximately 6 millimeters (1/4 of an inch) through the upper surface of the concrete (3). Discoloration of the immediate area, surrounding the cracks yield the presence of calcium hydroxide residue.

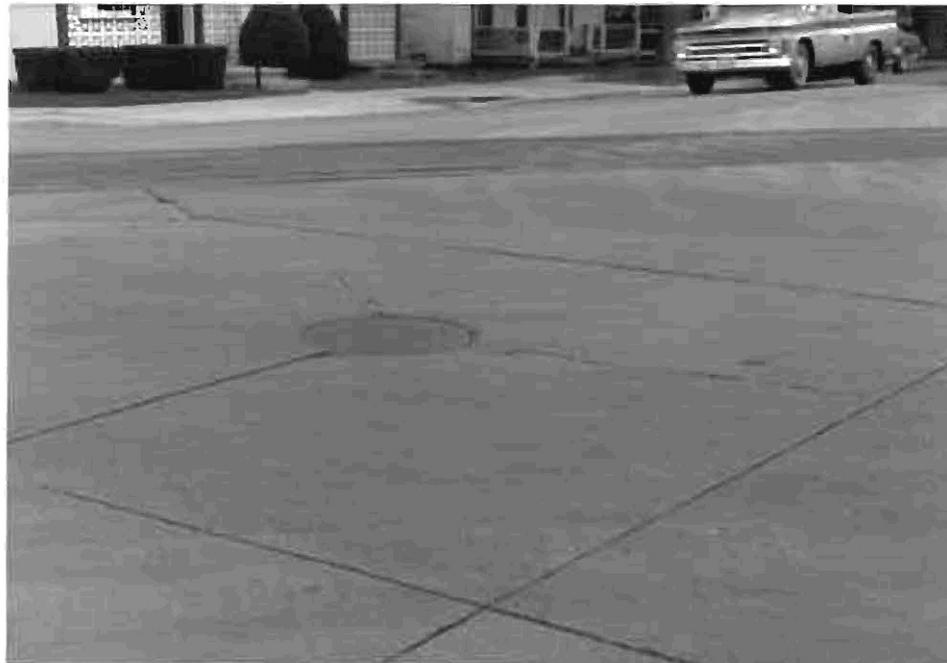
Photo 4: Formation of diagonal cracks due to presence of manhole and/or irregular joint spacing.

Photograph 4 shows some diagonal cracks which are believed to be caused by the irregular spacing of the joints at the transition between the manhole and the adjacent slabs.

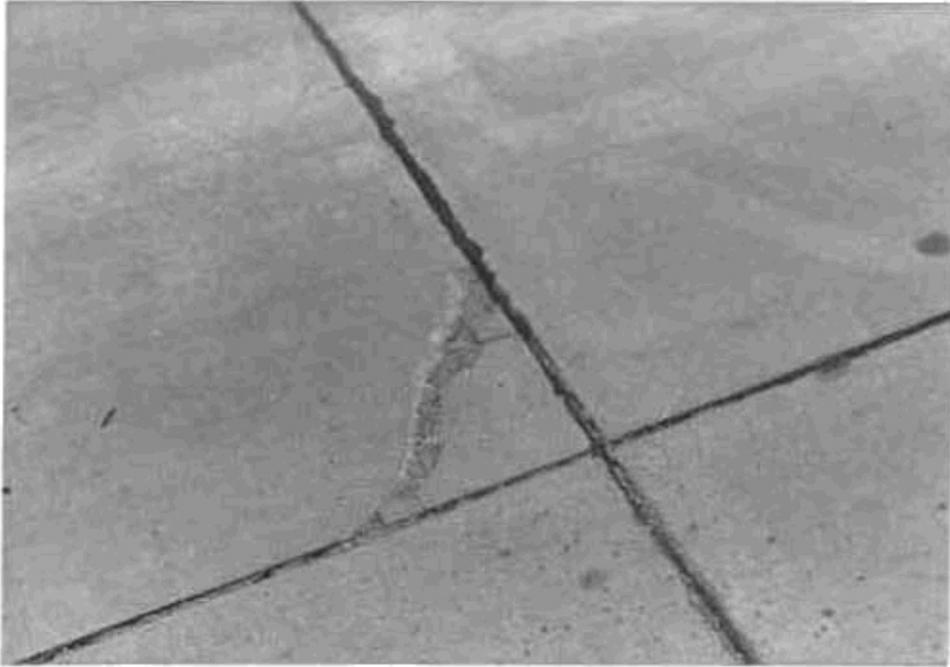
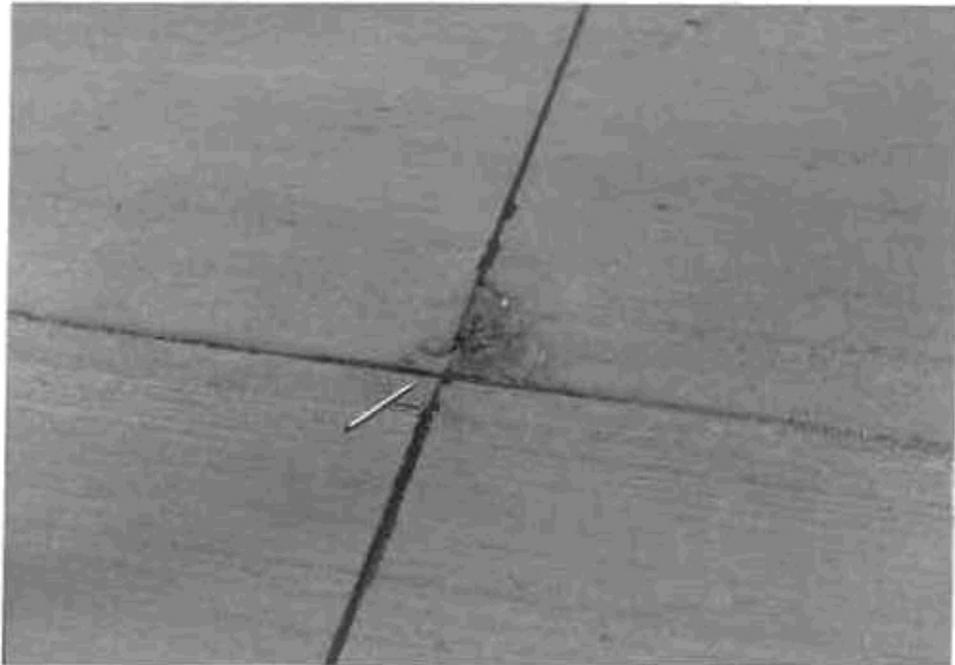
Photo 5&6: Minor corner breaks noted at two locations.

Minor corner breaks were noted at few isolated locations (Photograph 5 and 6). These types of failures are primarily attributed to the lack of support or poor load transfer (non-doweled concrete slabs). It is CDOT's standard practice to not use load transfer devices for facilities with speed limits of less than 45 mph.

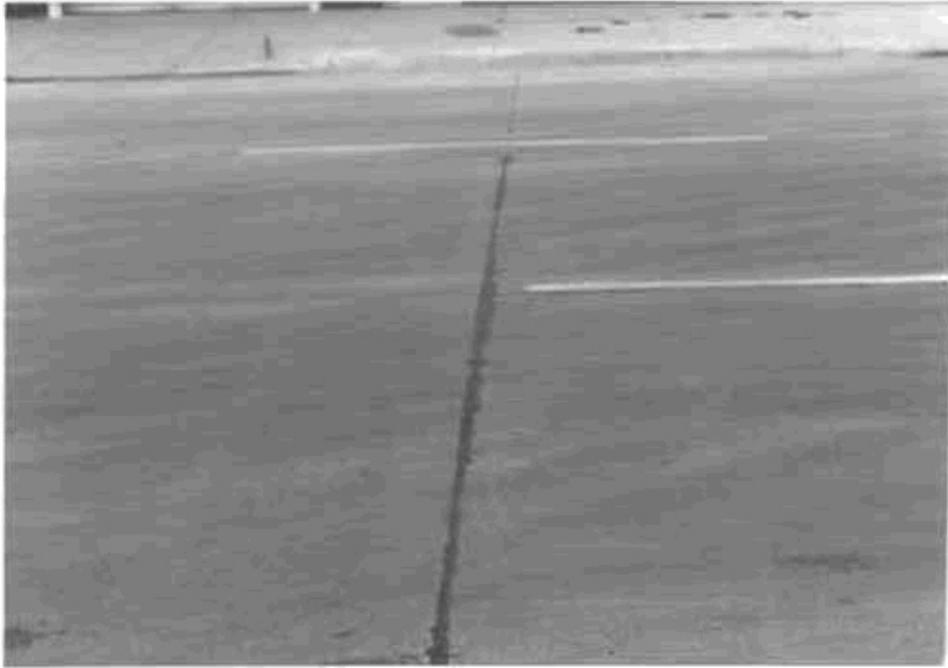
Photo 7: Example of an overfilled joint.

related failures. The joints were overfilled with sealant material in many places (photograph 7). Cohesion, adhesion and extrusion failures were quite evident throughout the project as shown in Photograph 8.

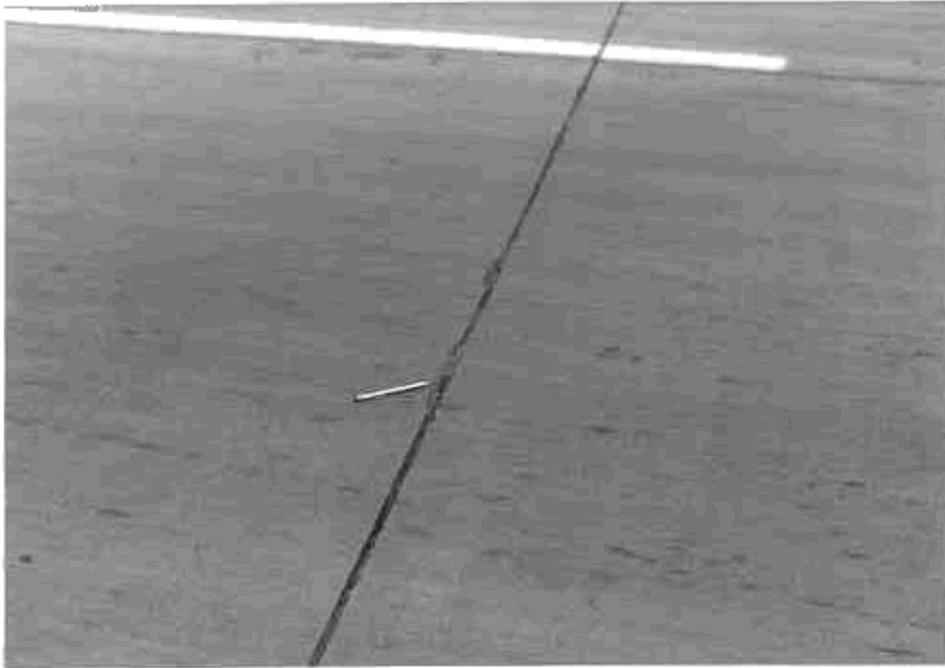
Photo 9: Minor joint spalling

Spall-related failures caused by the intrusion of incompressibles were also evident in few locations (Photograph 9).

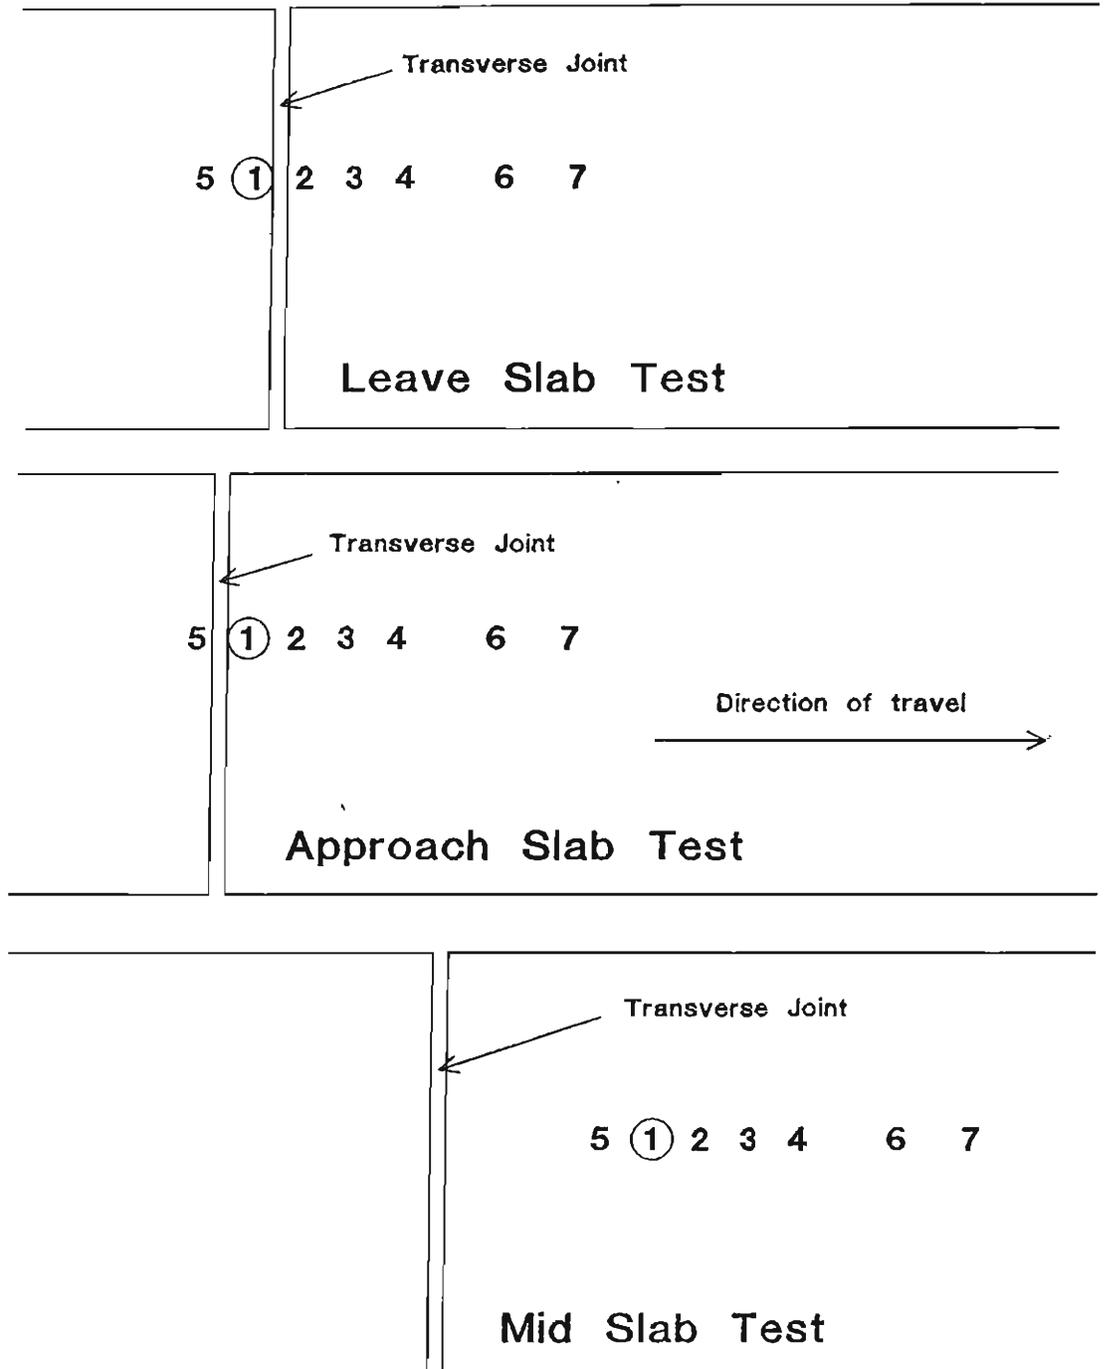
Figure 1

To assess the structural response and the load transfer efficiency across the joints, deflection measurements were acquired using a falling weight deflectometer (FWD) at the leave-slab, approach-slab and at the mid-slab (Figure 1).

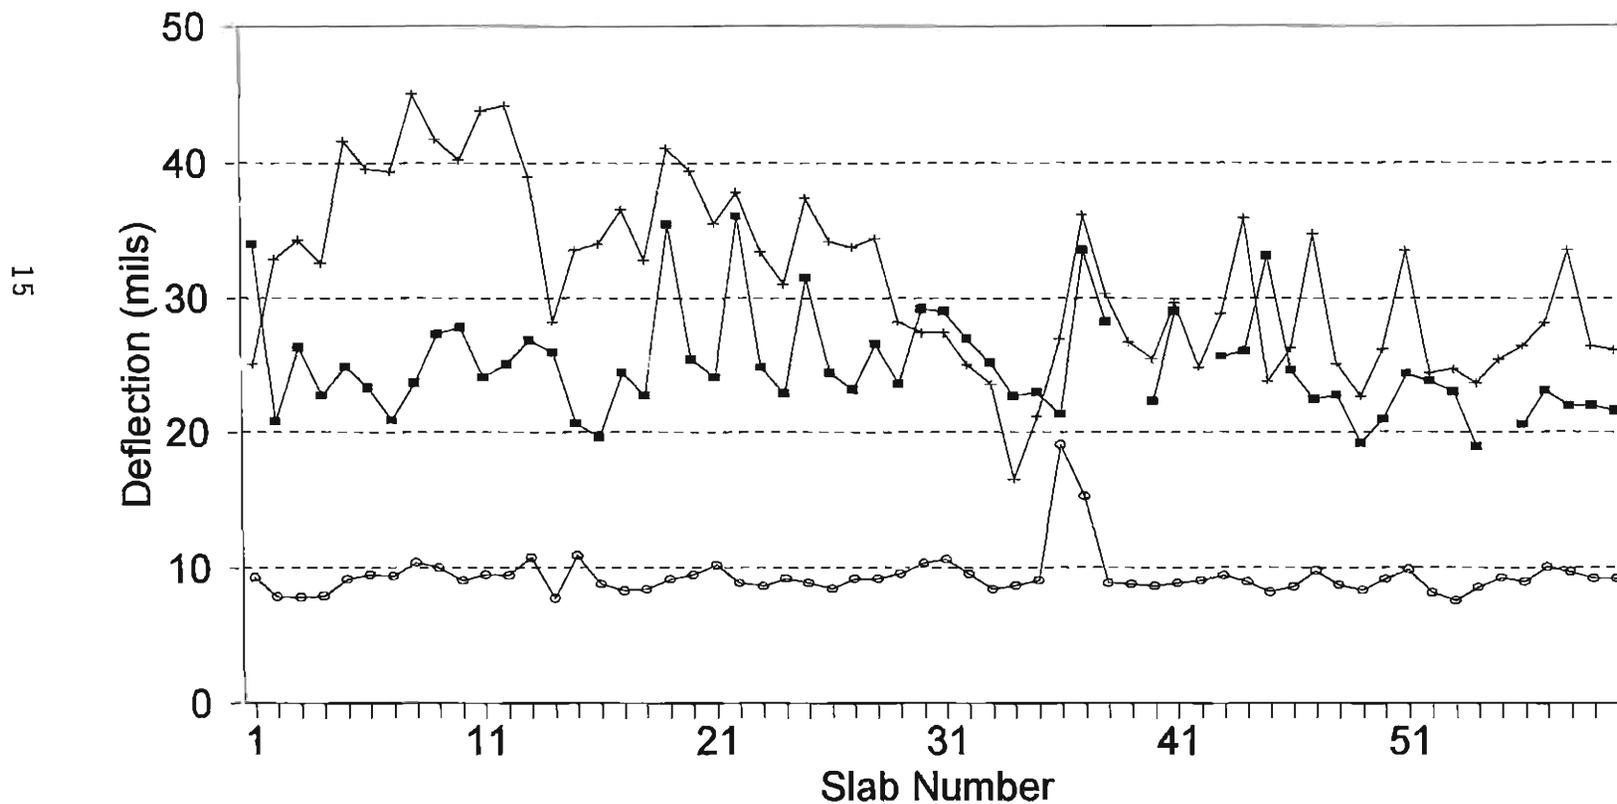
Maximum deflections (normalized to 9,000 lb) and load transfer efficiency rates between the slabs are shown in Figure 2 and 3. It appears that the slabs are structurally sound with an average deflection of 9.4 mils at mid-slabs. However, because the slabs were not equipped with load transfer devices (no dowel bars), the average deflection at the approach and at the leave-slabs measured high (25.0 and 31.5 mils respectively) indicating poor rate of load transfer between the slabs.

Deflections (normalized to 9000 lb)

AVERAGES: LEAVE SLAB 25.0 APPROACH SLAB 31.5 MID SLAB 9.4

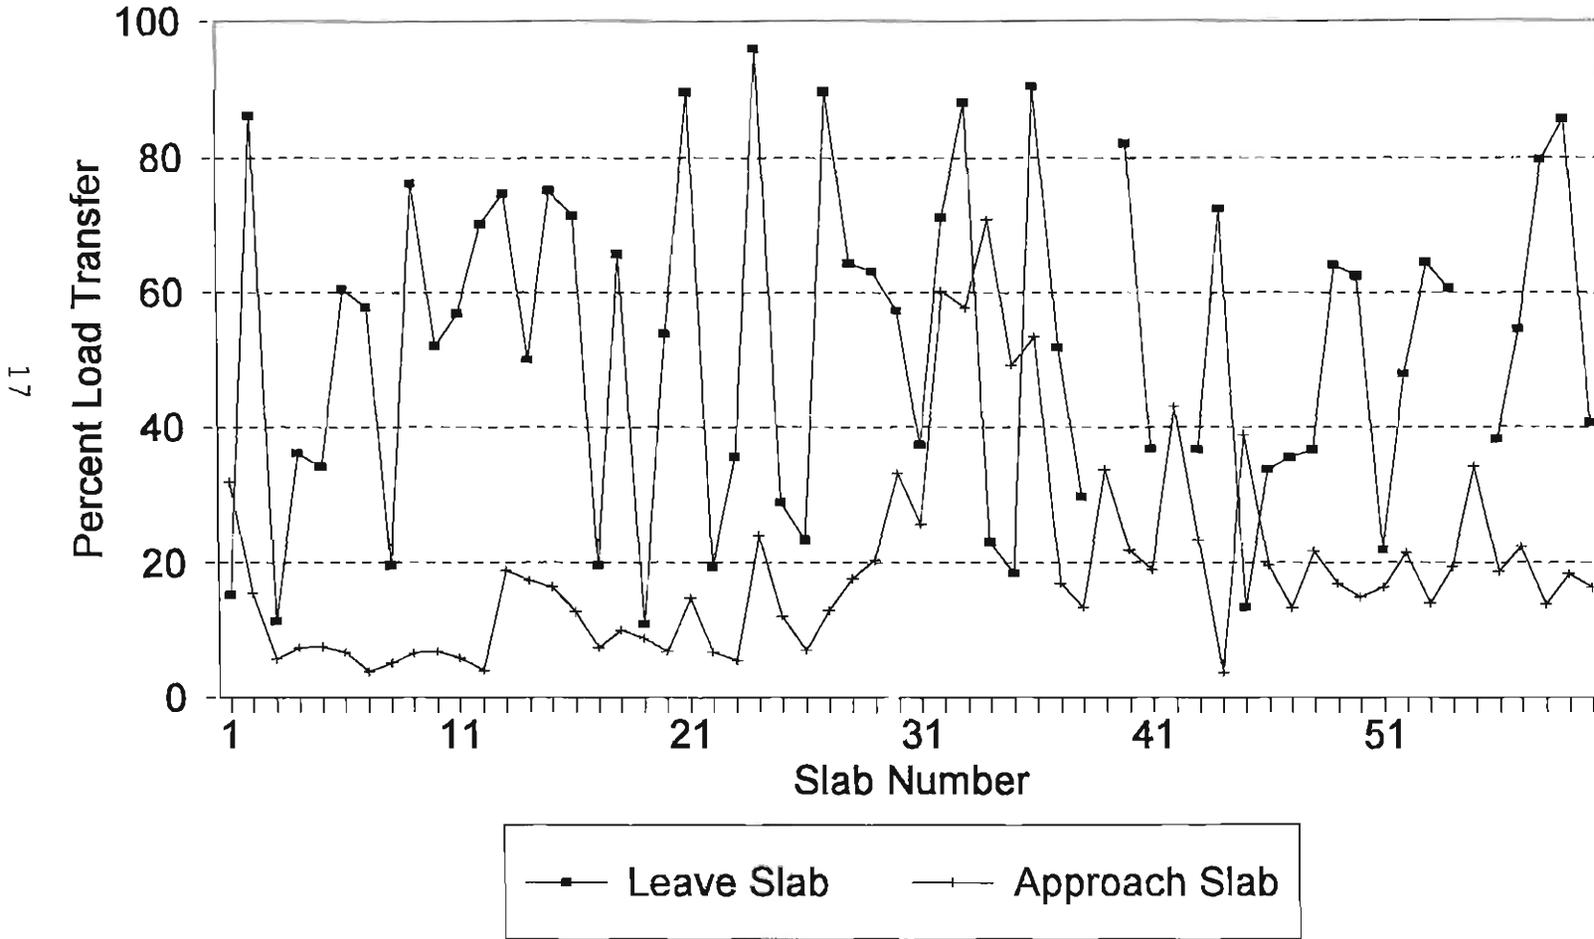
Figure 3

As it can be seen on figure 3 the average rate of load transfer from the leave-slabs to the approach-slabs are approximately 52 percent. The average rate of load transfer from the approach-slabs to the leave slabs were only 20 percent. The poor rate of load transfer between the slabs are primarily attributed to the lack of dowel bars. For a complete review of the maximum deflections and load transfer efficiency rates refer to table 2.

Load Transfer Efficiency (LTE)

AVERAGE LTE: LEAVE SLAB 52% APPROACH SLAB 20%
