**Report No. CDOT-DTD-R-2001-8**  
**Interim Report**

## **CENTERLINE RUMBLE STRIPS**

**COLORADO DEPARTMENT OF TRANSPORTATION  
RESEARCH BRANCH**

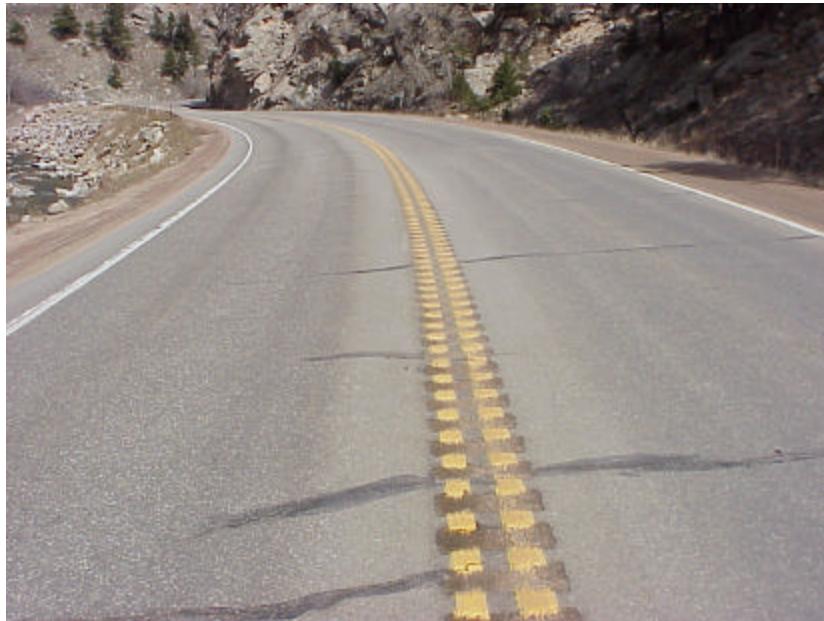
**Figure 1. State Highway 119 in Boulder Canyon winds through Forest Service land.**

The centerline rumble strip site is located in Boulder Canyon on SH 119 from Milepost (MP) 23, just east of Nederland, to MP 40, about two miles west of Boulder. This is a winding stretch of two-lane highway that has limited site distance and a double yellow "no passing" center stripe for most of its length (Figure 1). In the 17-mile stretch through the canyon, centerline rumble strips were placed at all no passing locations except through intersections. In areas where sufficient sight distance allowed safe passing, no rumble strip was installed.

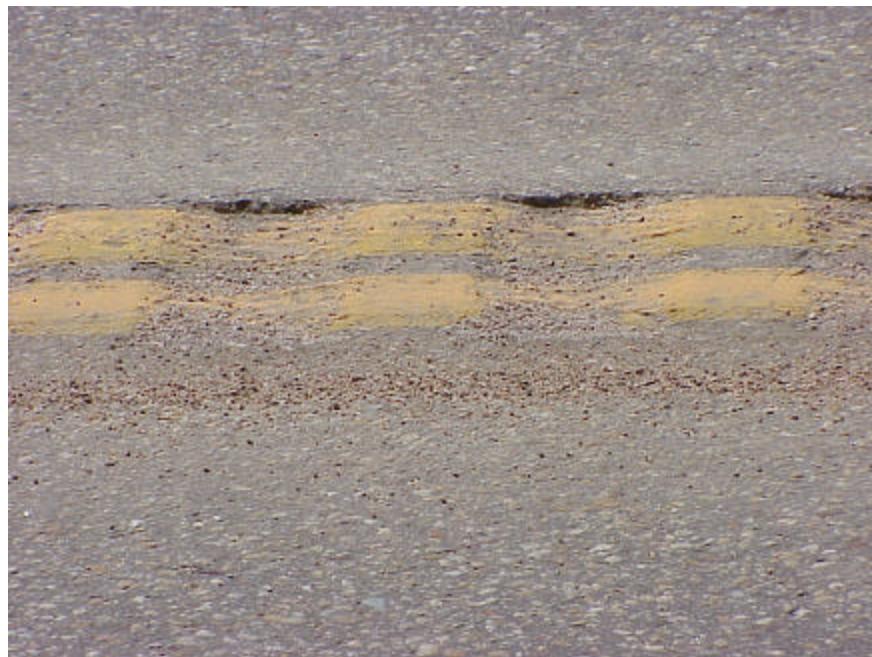
During the winter, the grooves in the strip tend to collect some of the sand that is applied during snowstorms (Figure 4). The sand does not completely fill the grooves, however, it does obscure

**Figure 4. Sand collects in the bottoms of the rumble strip grooves.**

the part of the paint stripe at the bottom of the grooves. The level of sound generated when a vehicle drives in the rumble strip does not seem to be affected by the sand. The action of traffic eventually clears most of the sand out of the grooves.

Before the installation of the rumble strips, there were concerns about water standing in the grooves: Would it increase the rate of deterioration of the pavement at the grooves? Sand accumulated in the grooves tends to stay damp in cool weather, but by the time the rest of the surface of the pavement is dry there is no standing water in the grooves. Air movement caused

by passing traffic dries the grooves fairly rapidly. There does not appear to be any deterioration in the asphalt at the bottom of the grooves.

There does not appear to be any reduction in the effectiveness of the rumble strips caused by the accumulation of sand and debris in the grooves during the winter. The driver and passenger made subjective evaluations as a vehicle was intentionally driven over the rumble strips. The rumble strips functioned very well under these circumstances with no apparent reduction in sound and vibration level inside the vehicle.
