**Report No. CDOT-DTD-R-2002-4
Final Report**

Corrosion Effects of Magnesium Chloride and Sodium Chloride on Automobile Components

**COLORADO DEPARTMENT OF TRANSPORTATION
RESEARCH BRANCH**

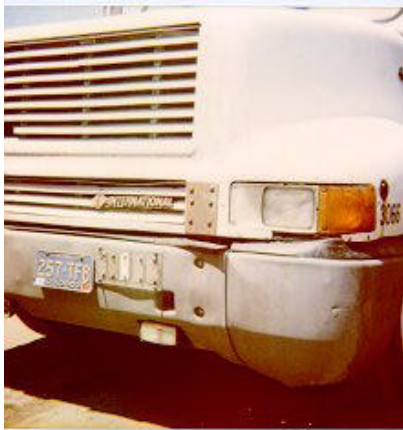
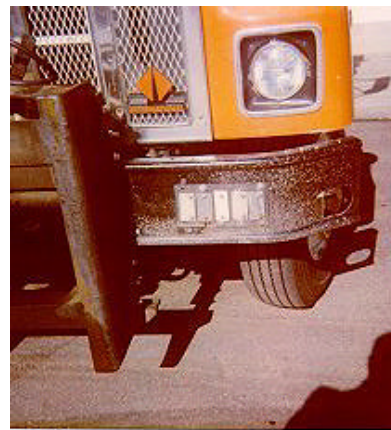
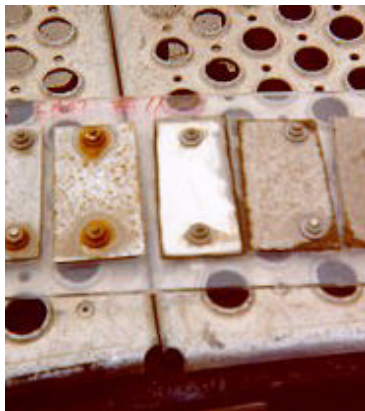
Fig.4 Coupons on the trucks

Four plates were mounted on CAST Transportation trucks; three plates were mounted on HVH Transportation trucks, and the remaining three plates were mounted on CDOT Region 6 Maintenance trucks. While both CAST and HVH have interstate operations, the participating carriers were asked to mount the plates on trucks that ran miles only in Colorado to guard against exposure to other state's deicing chemicals.

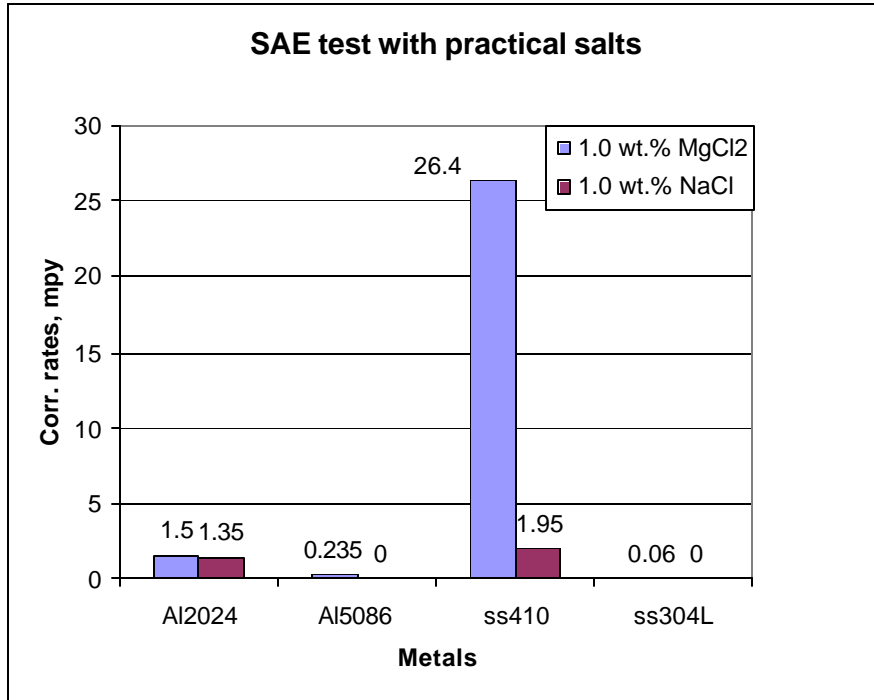
Fig.6 SAE test with the practical salts

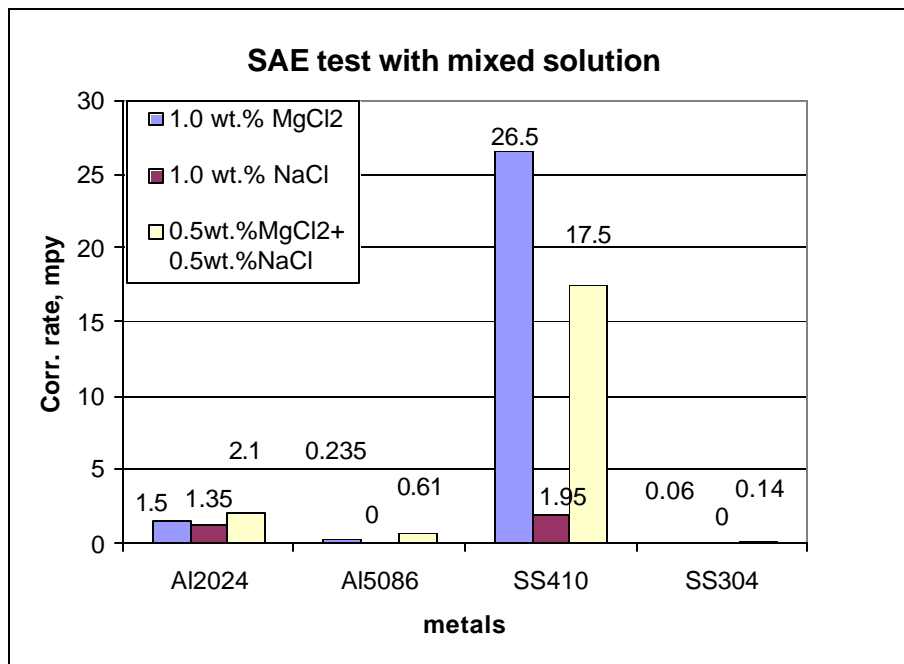
Fig.7 SAE tests with mixed solution

The experimental results of the cyclic test Run 5 with mixture of NaCl and MgCl₂ (practical salts) are given in Table 8 (Appendix 1) and shown in Fig.7. Mixed solution was used to compare with single salt, in order to assess the possibility of a possible coupling effect between MgCl₂ and NaCl. Intuitively, the mixed solution of NaCl and MgCl₂ should be less

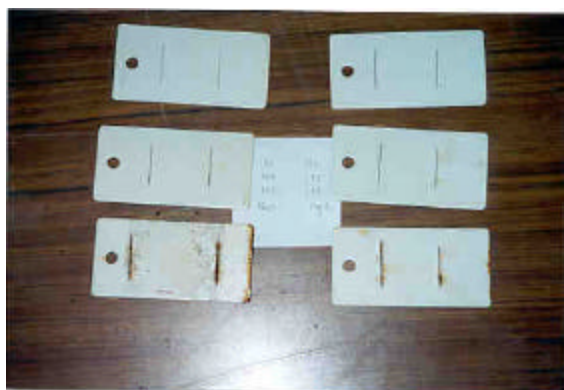
Figure 8: Coupons Corroded by a mixture of NaCl and MgCl_2 (practical salts)

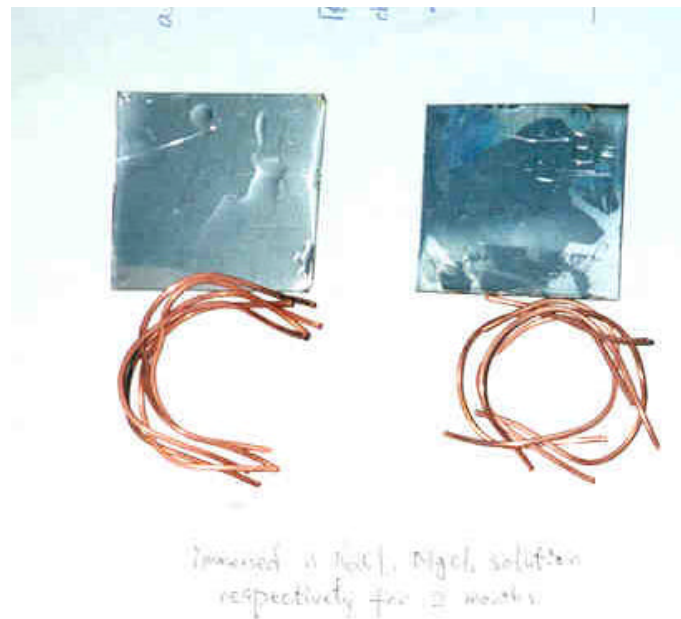
Figure 13: Immersion tests of SS410 and copper wires.

In order to confirm the role of oxygen in the electrochemical corrosion process, another experiment was performed, in which SS410 and copper wires were immersed in 30 wt.% NaCl solution and 30 wt. % $MgCl_2$ solutions for two months, respectively. Although the two materials suffered severe corrosion under other test environments, hardly any corrosion occurred in the immersion test (Figure13). This indicates the importance of oxygen in the corrosion process.

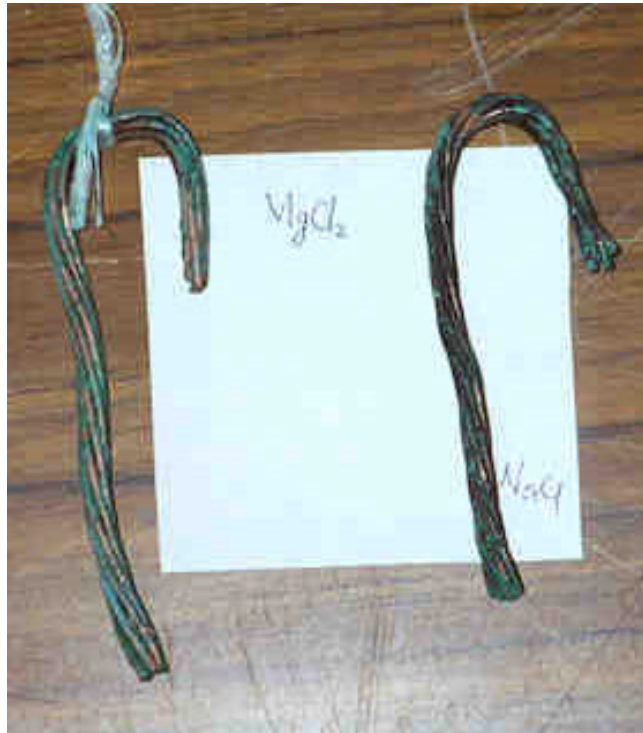
Figure 14: Corroded copper wires after SAE J2334 testing

The corrosion tests for copper tubes by both SAE J2334, In the test, two different chloride solutions were used with the same concentration (3.0 wt.%). Different corrosion damages were observed. The corroded coupons are shown in Figures 14. The photo indicate that $MgCl_2$ causes more severe corrosion to the copper specimens than $NaCl$. The coupons subjected to $MgCl_2$ solution had more green rust (CuO) on the corroded surface than that subjected to $NaCl$ solution.

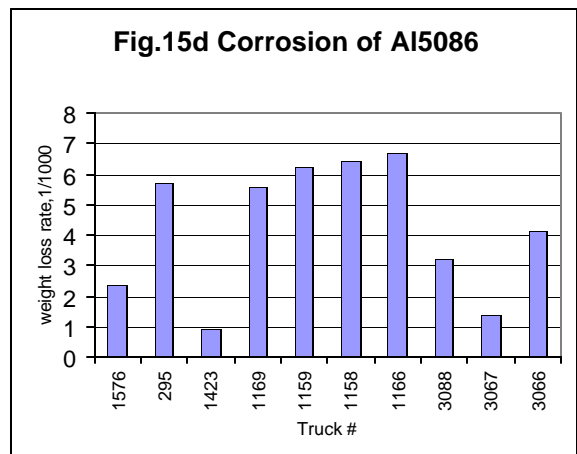
Figure 15 Corrosion rates of the coupons mounted on the trucks

Since the records of the salt application on these roads were not available. This in-service experiment did not lead to further conclusion.

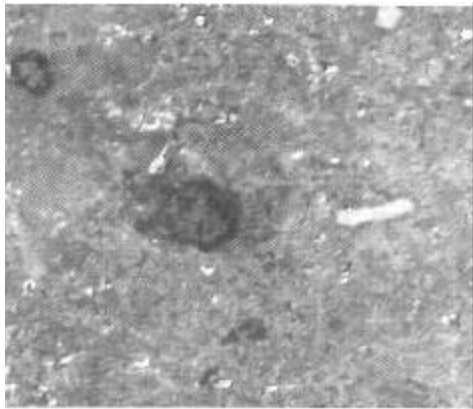
Figure 16a, SS410, $MgCl_2$, x150

Figure 16b, SS410, NaCl, x150

Figure 16c SS304L, $MgCl_2$, (x 150)

Figure 16d SS304L, NaCl, (x 150)

Figure 16e Al2024, MgCl₂, (x 150)

Figure 16f Al2024, NaCl, (x 150)

Figure 16g Al 5086, MgCl₂, (x 150)

Figure 16h Al 5086, NaCl, (x 150)

Figures 16: Microscope photographs of the corroded coupons subjected to the cyclic exposure corrosion test

In order to understand and further explain some of the test results, chemical and microscopic analyses were performed. Figure 16a through Figure 16h are the microscope photographs of the corroded coupons subjected to the cyclic exposure corrosion test. It can be seen that regardless of the corrosion medium used, the same morphological feature of the corrosion products is observed for the same metal. Different amounts of the corrosion products can be seen for different metals under attacks by different chlorides. All corrosion products are in amorphous or glass states.

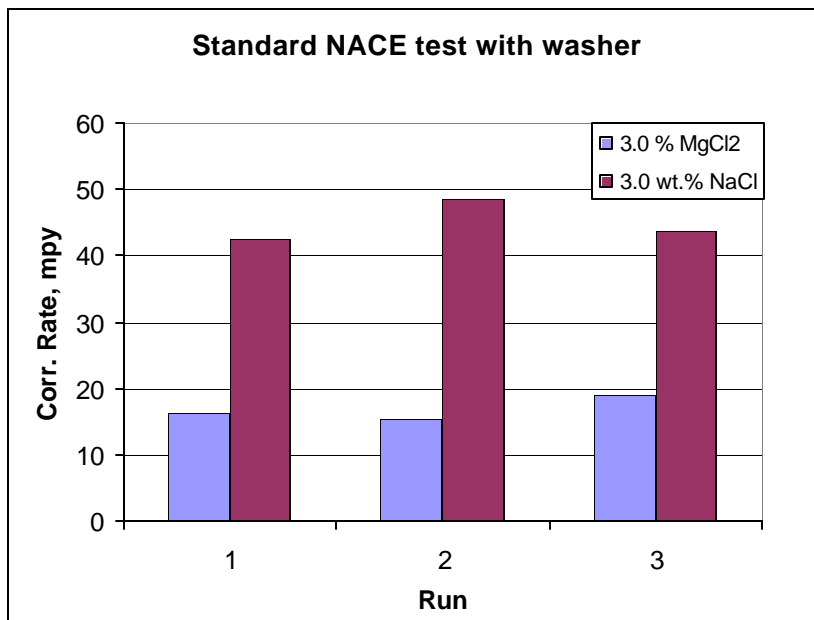
Fig. 2-2 Standard NACE test with washer as coupons

The results of three NACE tests were given in Table 2-1 (Appendix II) and diagrammatically shown in Fig. 2-2. The room temperatures of the testing laboratory were $26 \pm 1.0 \text{ }^\circ\text{C}$ ($79 \pm 1.7 \text{ }^\circ\text{F}$). One can see that MgCl_2 with inhibitor is less corrosive than NaCl , but not 70% less.

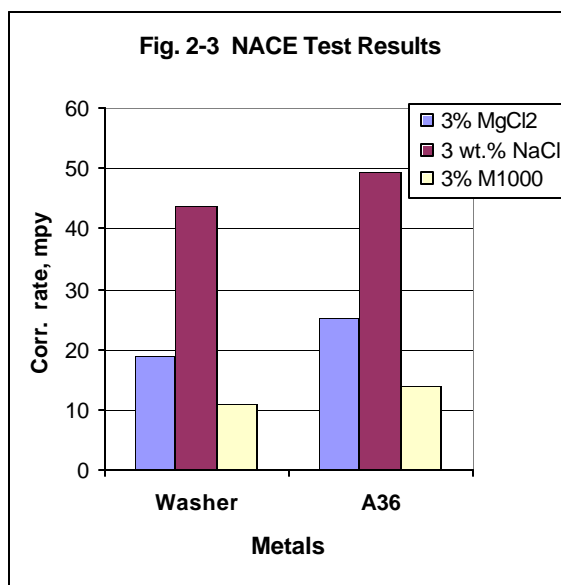
Fig.2-3 NACE test Results with washers and A36

In addition to the standard NACE test as shown above, modified NACE tests were carried out in the Phase II study. The modifications included the use of A36 steel coupons, and the use of various concentrations of $MgCl_2$ solutions. The test results are given in Figs. 2-3 and 2-4. Detailed test data can be found in Table 2-2 (Appendix II). From Fig. 2-3, one can see that NaCl caused the highest level of corrosion among the three deicing chemicals, and M1000 the least. The changes in the concentration of $MgCl_2$ solution in the range of 3% to 12% (or 0.84 wt.% to 3.36 wt.%) do not increase the corrosion rates of A36 and washer. To the contrary, a decreased tendency is observed (Fig.2-4). This may be due to the effect of inhibitor in the $MgCl_2$ solution, which has an increased concentration in the solution of 12% $MgCl_2$. It is now very clear that using the NACE test, NaCl is more corrosive than $MgCl_2$, even $MgCl_2$ solution is increased to the same level of the 3.0 wt. % as NaCl solution.

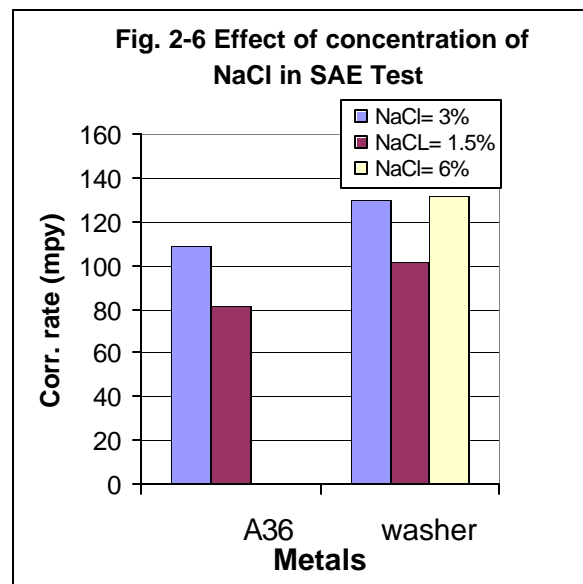
Fig. 2-6 Effect of concentration of NaCl in the SAE test

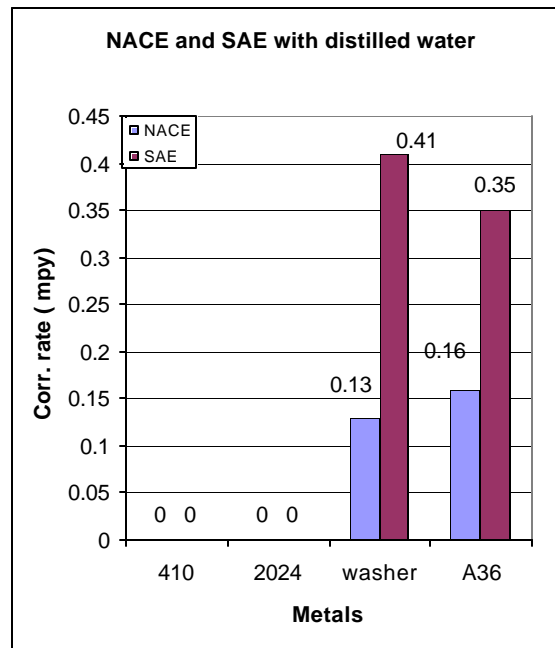
Fig. 2-9 Comparison of the NACE and SAE tests with distilled water

The SAE test with distilled water was started from August 18, 2001. After 81 days of testing, a very thin layer of rust appeared on the surfaces of A36 coupons and NACE washers. There was almost no visible rust on the surface of SS410 and Al2024 coupons. The water used as corrosion medium was clear without significant rust accumulation (Fig.2-8), which is an indication of the absence of rust accumulation.

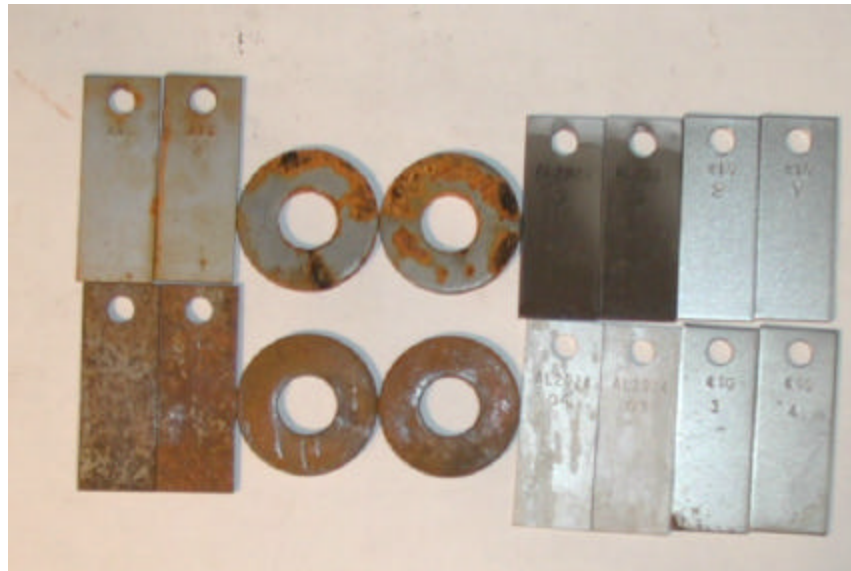
Fig. 2-10 Coupons exposed to distilled water
(Upper: from the NACE test of 109 days, lower: from the SAE test of 81 days)

The NACE test with distilled water was started from July 22, 2001. The testing period of the NACE test was extended significantly to compare with the testing period of the SAE test. After 109 days, the NACE test was stopped and the corrosion rate was measured. The calculated corrosion rates for the two tests are shown in Fig. 2-9. Comparing the SAE test to the NACE test with distilled water, it is evidenced that the SAE test had resulted in one to two times higher degrees of corrosion to the washers and A36 coupons. This suggests that the SAE test provides a much more aggressive testing environment than the NACE method, which may be due to the elevated temperature or high humidity, or the combination of the two. The appearance of the coupons before cleaning is shown in Fig. 2-10.

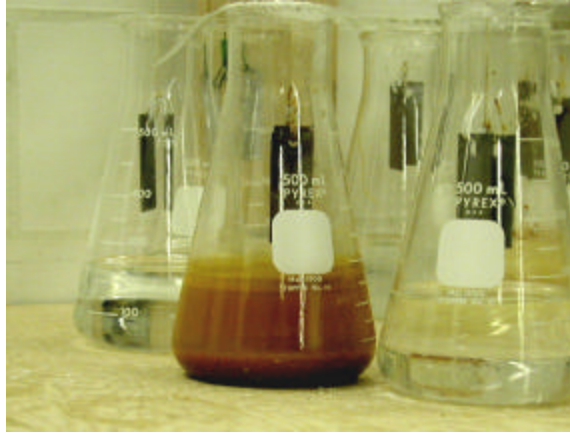
Fig. 2-11a. The NaCl solution in the NACE test (at 69 days)

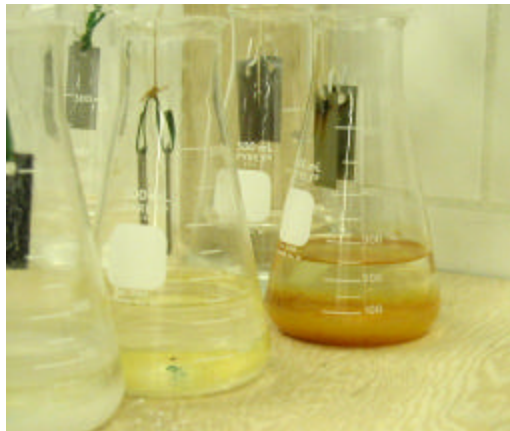
Fig.2-11b The MgCl₂ solution in the NACE test (at 69 days)

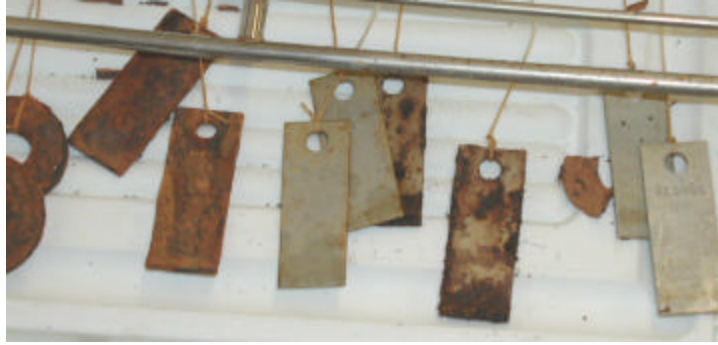
Fig. 2-12 The coupons of the SAE test at 20 days

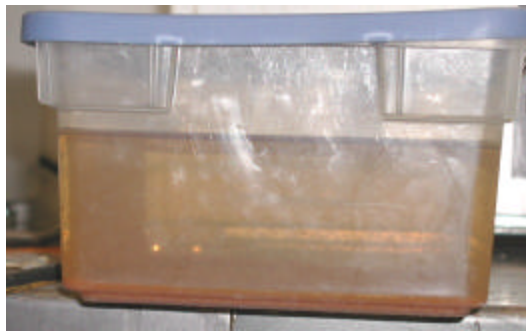
Fig. 2-13a The 3 wt.% MgCl_2 solution used in the SAE test after 20 days

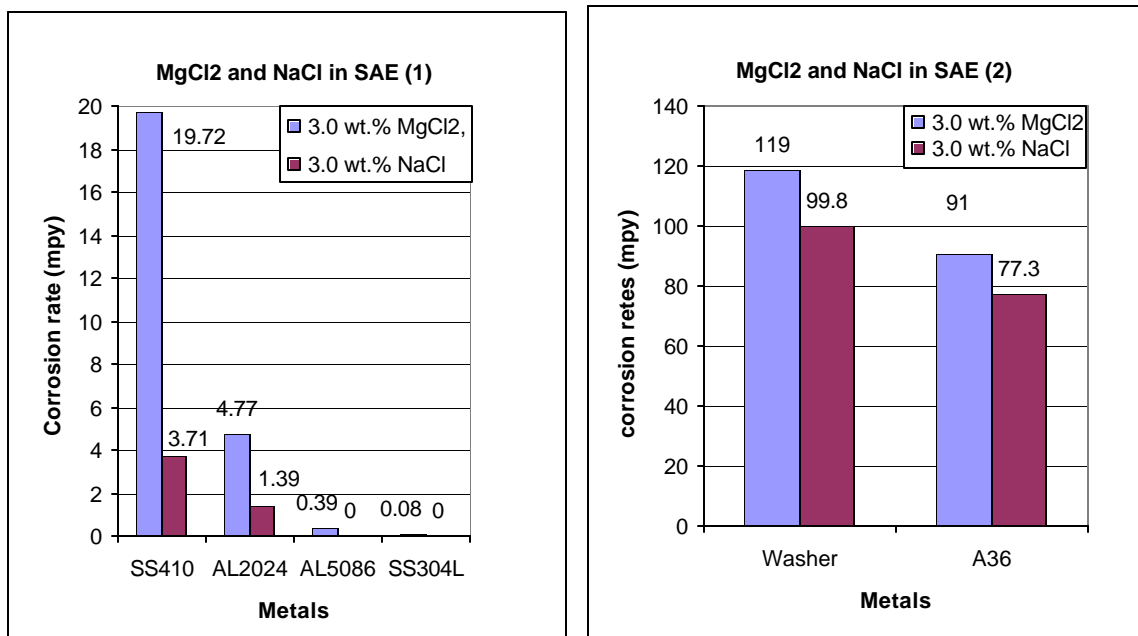
Fig. 2-14 Comparison of the corrosion rates by the SAE test after 81 days

When the results from 1.5 wt. % NaCl solutions and 3.0 % MgCl₂ (or 0.84 wt. %) are compared, as shown by Fig. 2-7, MgCl₂ has a higher corrosion rate than NaCl. Therefore, the SAE test leads to a conclusion that MgCl₂ is more corrosive than NaCl for all three concentrations used in the tests (1.5 wt.%, 3.0 wt.%, and 6.0 wt.%). This conclusion, different from the NACE test, was further confirmed later by long term SAE tests of 81 days (see Fig. 2-14).

From the NACE test, the MgCl₂ with inhibitors is much less corrosive than the NaCl (Fig. 2-15), regardless of the concentration of the solution and the testing duration used in the test. From the SAE test, however, the MgCl₂ with inhibitors is more corrosive than the NaCl (Fig. 2-14); the same results as obtained in the Phase I study.

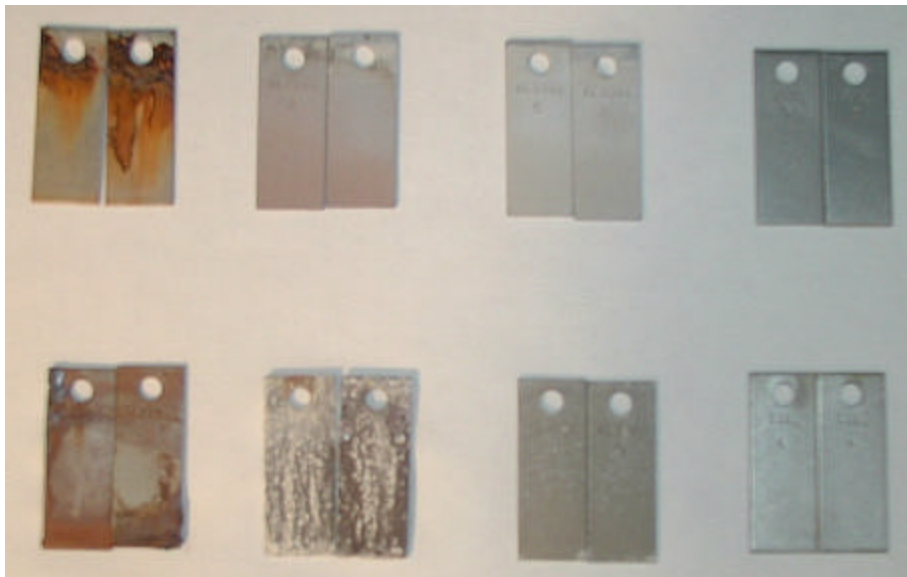
Fig. 2-16 Coupons after the NACE test
 (Upper: exposed to the MgCl₂ solution, lower: exposed to the NaCl solution)

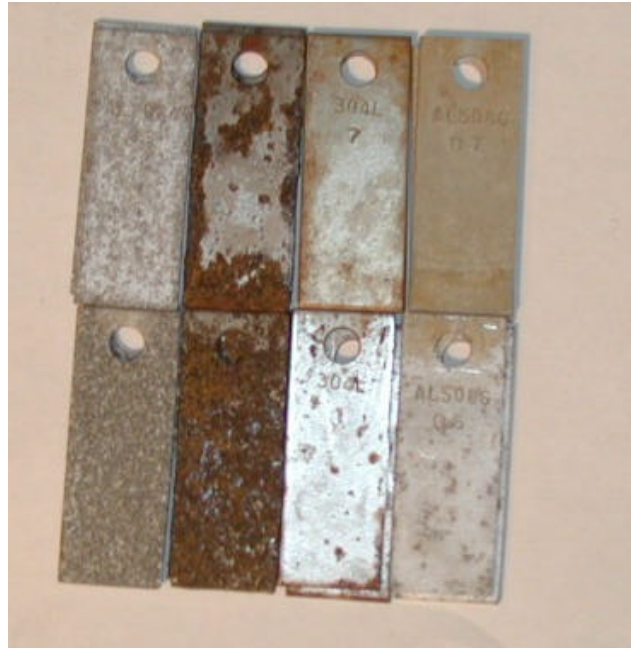
Fig.2-17 Coupons after the SAE test
(Upper: exposed to the NaCl solution, lower: exposed to the MgCl₂ solution)

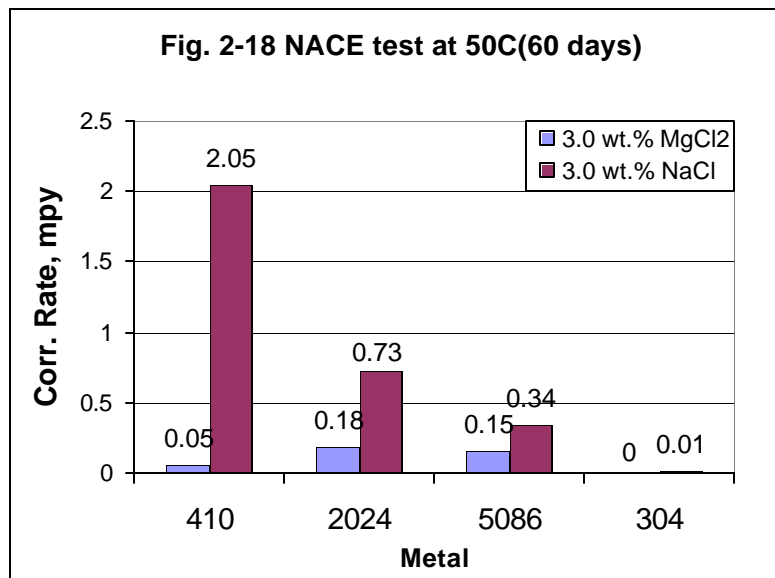
Fig.2-18 NACE test at 50°C (60 days)

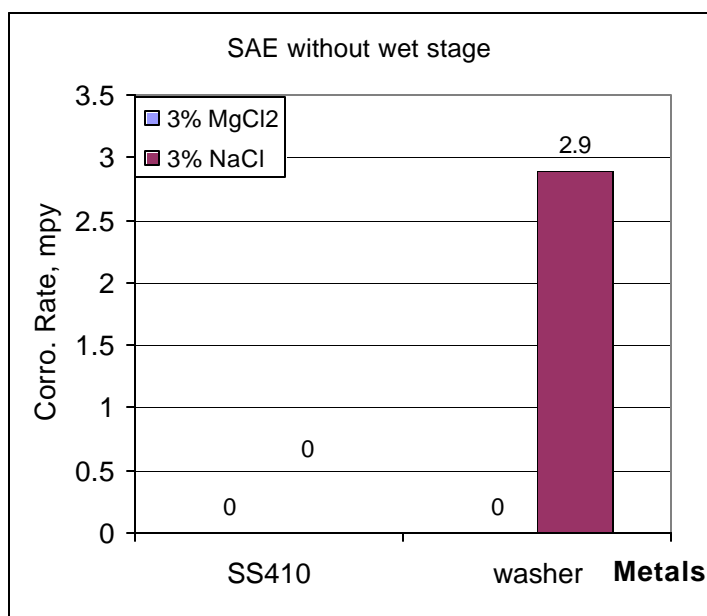
Fig. 2-23b Corrosion rates by the SAE test without the wet stage after 7 days

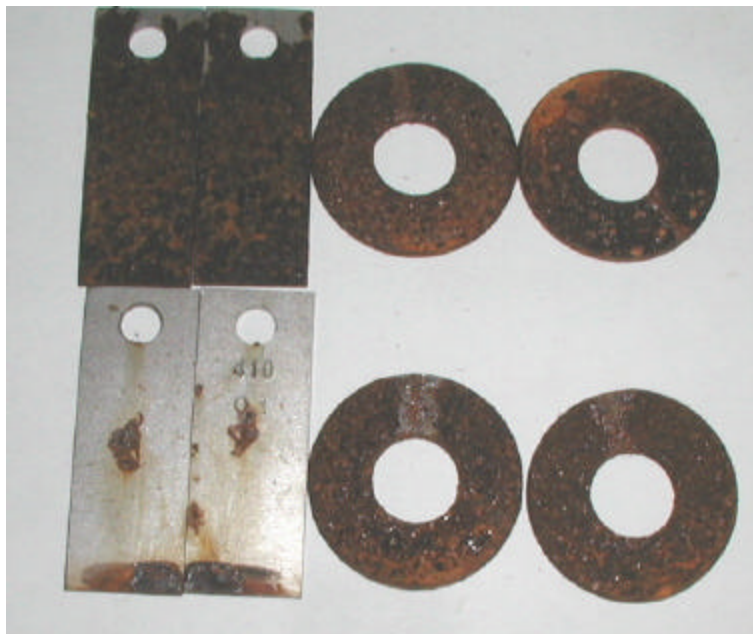
Fig. 2-24a Coupons by the SAE test without the dry stage after 7 days
(upper: by $MgCl_2$; lower: by NaCl)

This test consists of two stages in every 24-hour cycle: 15 min. dip in 25°C solutions, followed by a wet chamber stage (50°C, 100%RH) of 23hr. and 45 min., i.e., the SAE J2334 test without the dry stage. Compared to the modified NACE test at 50°C and 100% RH (Section 13.1), this test has shorter dip period and at lower temperature: only a 15 min. dip period every 24 hours under 25°C. It can be seen from Figs. 2-24a and 2-24b that the results obtained by this test are different from those present in Section 13.1. The difference reflects the importance of immersion stage and its condition to the corrosion results. In the NACE test, the coupons are immersed in hot solutions of 50°C and have a total immersion time of $10 \times 24 = 240$ min. every 24 hours. As result, NaCl resulted in severe corrosion, as observed from Fig. 2-22a. In the case of the SAE test without the dry stage, the coupons have only a 15 min. dip period in 25°C solutions every 24 hours, as a result, the corresponding corrosion is much less severe than the NACE test (compare Fig. 2-22a and Fig. 2-24a).
