Report No. CDOT-DTD-R-2004-03
Final Report

**LONG-TERM DURABILITY OF FIBER-REINFORCED
POLYMERS (FRPS) AND IN-SITU MONITORING OF FRP
BRIDGE DECKS AT O’FALLON PARK BRIDGE**

**COLORADO DEPARTMENT OF TRANSPORTATION
RESEARCH BRANCH**

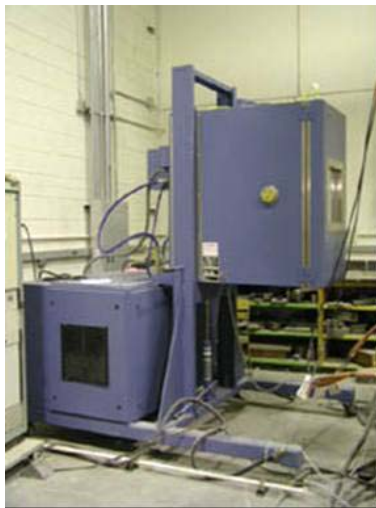
Figure 1. The environment chamber used in the project

ASTM C666 (Standard Test Methods for Resistance of Concrete to Rapid Freezing Thawing) was used in the present study for the freeze-thaw conditioning of GFRP specimens, although the testing procedures specified by ASTM C666 were originally designed for the durability of concrete. An environmental chamber manufactured by Russells Technical Products was used for the freeze-thaw conditioning. It is shown in Figure 1.

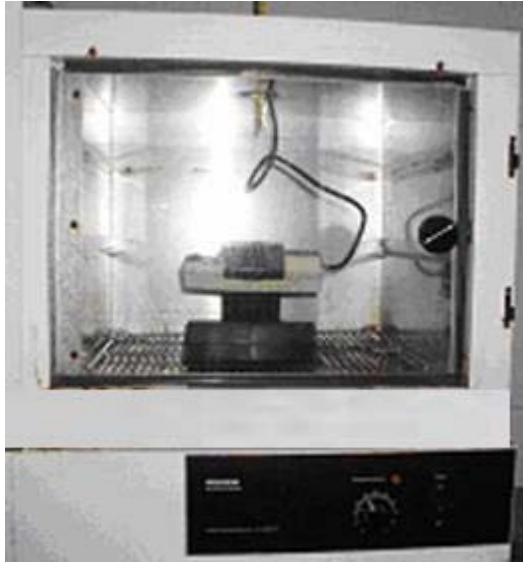
Figure 5. Ultraviolet Radiation Apparatus

A standard ultraviolet (UV) resistance test based on ASTM G53 was used to simulate the weathering effect, particularly the deterioration of GFRPs caused by sunlight. The testing cycles are specified in ASTM D 5208. Three specimens were exposed to the cyclic fluorescent ultraviolet radiation in an environmental chamber for 90 days based on the Cycle C procedure of ASTM D 5208. The temperature in the chamber was kept at 50°C. The test chamber and the ultraviolet light are shown in Figure 5.

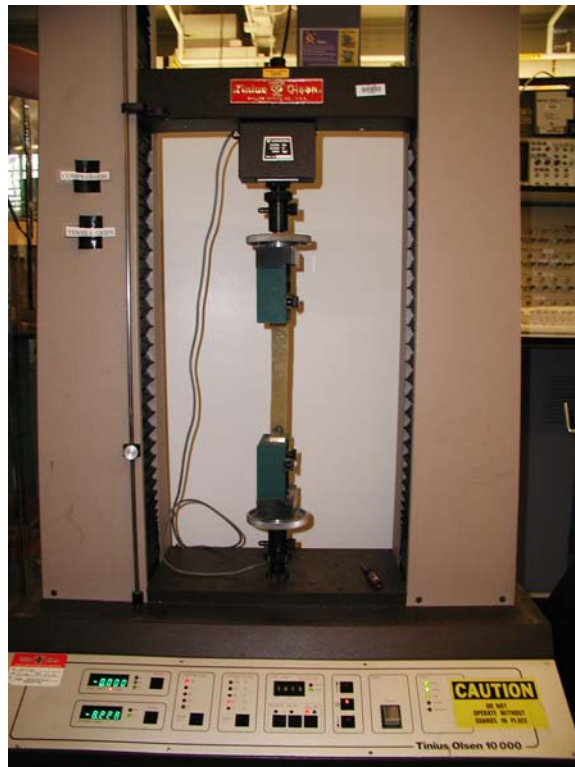
Figure 6. Experimental setup for uniaxial tension test of a GFRP specimen

The uniaxial tension test was carried out after the conditioning of the specimens was complete in order to investigate the degradation of the GFRPs exposed to environmental conditions. The uniaxial tension tests were performed on a Series 10,000 Bench UTM (Tinius Olsen Machine), as shown in Figure 6. The machine was equipped with a 10,000 lb load-cell. The specimens were inserted between the two grips of the testing machine and then loaded in tension until fracture occurred. To prevent any possible slip during loading, lateral pressure was applied at the grips. The tensile load was applied in the longitudinal direction, as shown in Figure 6. The specimens were subjected to uniaxial loading in tension with a displacement rate of 10 in/min. The load P and the elongation of the specimens were recorded. After the nominal stress and nominal strain were calculated, the Young's modulus and the tensile strength of the specimens were obtained.

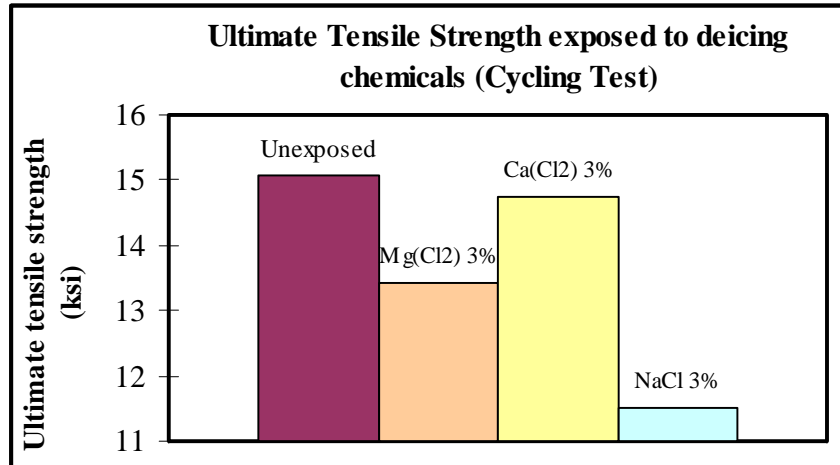
Figure 11. Comparison of mechanical properties of a GFRP bar exposed to deicing chemicals (Ponding test) (a) Ultimate tensile strength; and (b) Young's modulus

The reductions of Young's modulus by cyclic exposure of deicing chemical were more significant than ponded exposure, from 28% to 32% as shown in Table 4. In terms of each individual deicer, NaCl has the strongest effect on the tensile strength of GFRP specimens, which is 24%; Ca(Cl₂) has the strongest effect on Young's modulus, which is 32%. The ultimate tensile strengths and Young's modulus exposed to each deicing chemicals are compared in Figure 11.

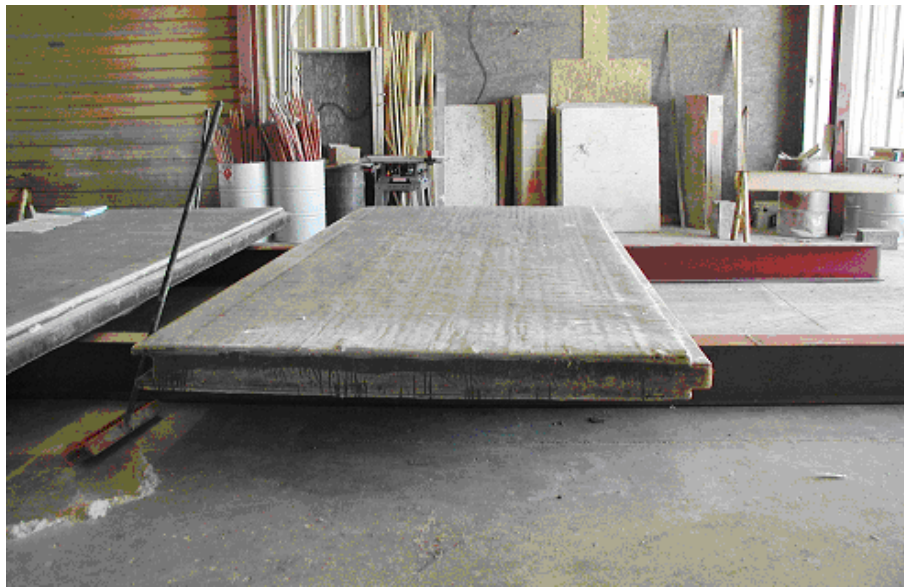
Figure 12. Fiber-Reinforced Polymer Honeycomb (FRPH) Sandwich Panels

In May 2003, the O’Fallon Park Bridge was built over Bear Creek in Denver Mountain Parks in the state of Colorado. The bridge is 41’-3 7/16” long and about 16’ wide. The new bridge is composed of six GFRP honeycomb composite deck panels of 16’ 3” length and 7’-31/2” width. The FRP Honeycomb (FRPH) panels were constructed by Kansas Structural Composites, Inc (KSCI) and are shown in Figure 12.

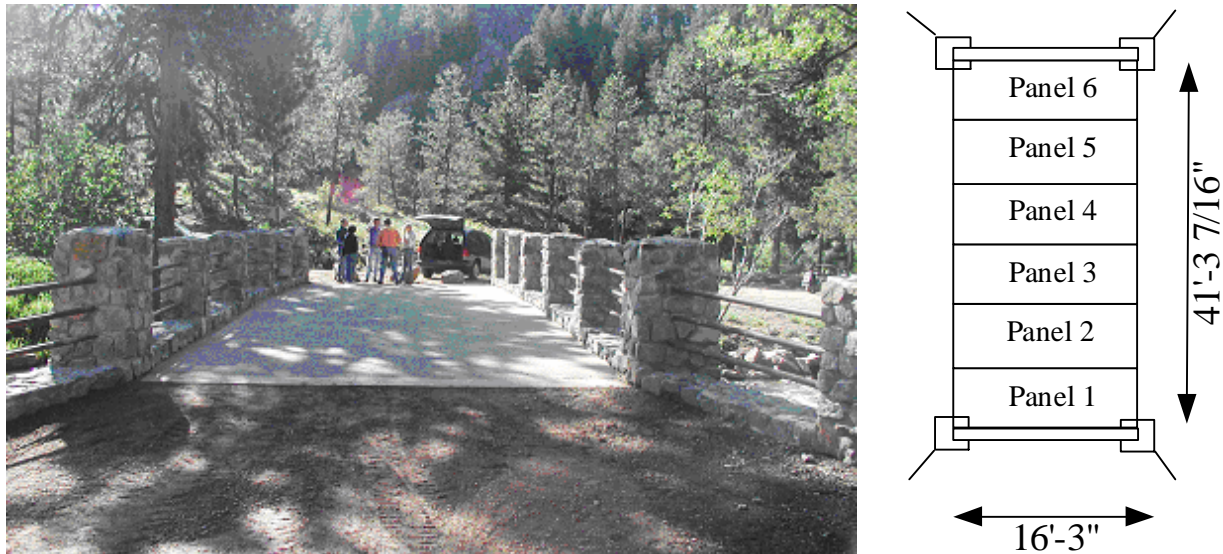
Figure 13. The bridge in O’Fallon Park, Denver, Colorado

1, 500, 000 pounds). Permanent fiber optic sensors were embedded into Panel 6 during the manufacturing of the panels. A plan view and the dimensions of the bridge are sketched in Figure 13. Design details can be seen in Reference 21.

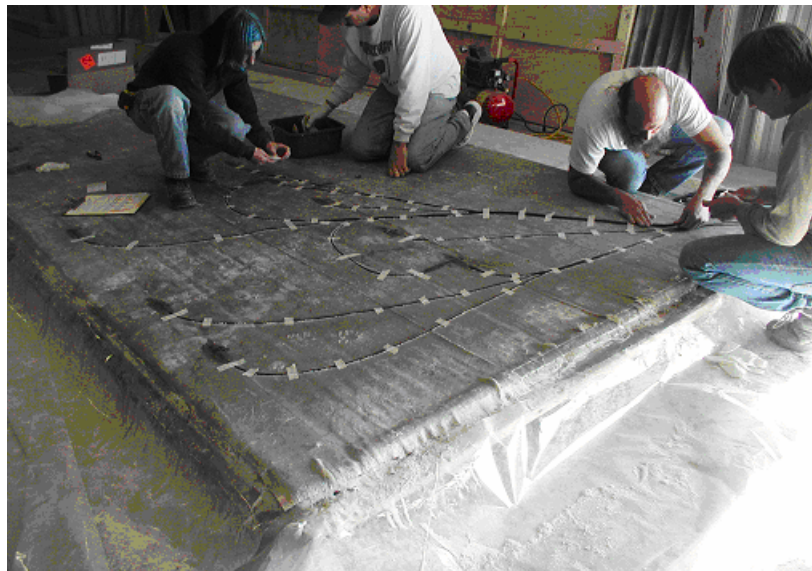
Figure 15. Installation of fiber optic sensors in the FRPH panel

A Fabry-Perot fiber optic strain sensor was chosen in the project. When a gage is bonded to a substrate, a strain variation in the axial direction of the strain gage will produce a variation of the cavity length, which can be converted into a numerical strain value. A total of twenty strain sensors were embedded at Panel 1 (seen in Figure 13) longitudinally and transversely so that various load effects could be observed, including dead loads, live loads, snow loads and wind loads. The gages were permanently installed as shown in Figure 15 so that long-term effects due to settlement and creep can also be monitored over time. The detail of placement of fiber optic sensors on the panel is shown in Figure 16.

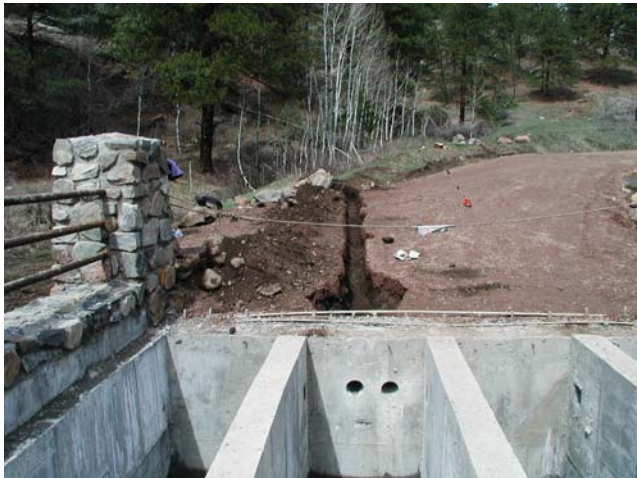
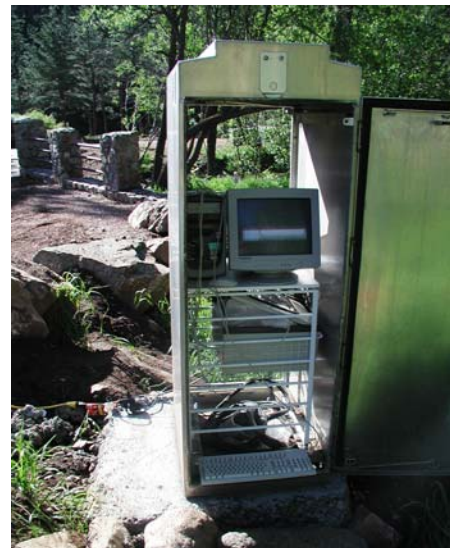
Figure 17. Installation of the fiber optic strain gage monitoring system

The monitoring system is illustrated in Figure 17. The fiber optic cables were used to connect the sensors with the digital logger called DMI Multi-Channel Fidel Data Logger. The readout in terms of strain values can be displayed directly on the Window-based data acquisition software called FISO Software.

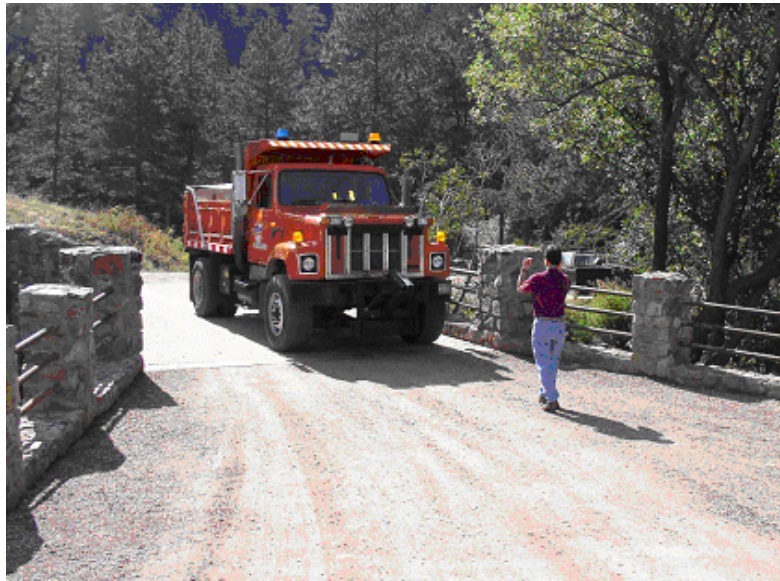
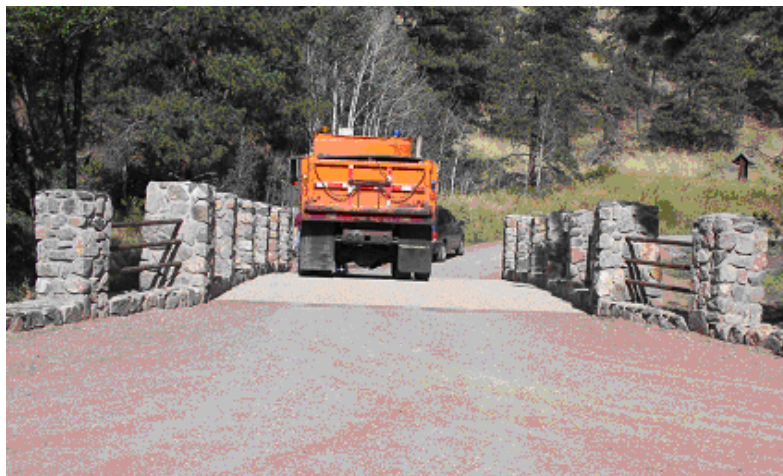
Figure 18. Load test for the bridge (a CDOT dump truck)

A loading test was performed using an empty CDOT dump truck to determine the FRPH deck panel behavior for the actual live load, as shown in Figure 18.

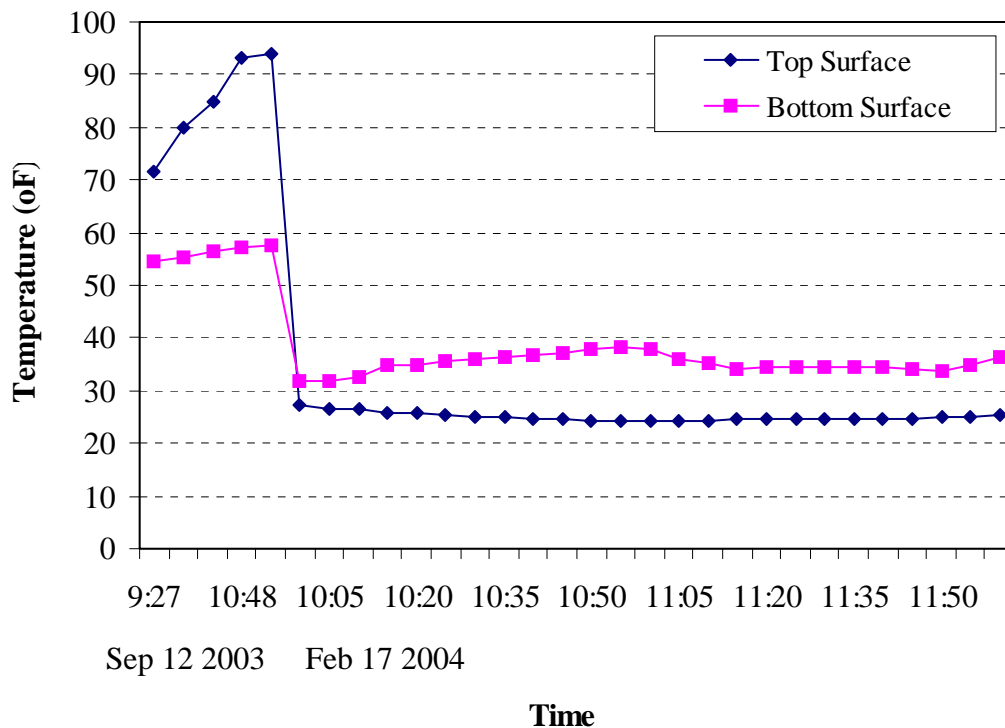
Figure 28. Temperature profiles at the top and bottom surfaces of the panel (September 12, 2003 and February 17, 2004)

In Figure 28, the surface temperature is higher than the bottom temperature in the summer, which is due to the direct, heavy sunshine in the summer. The surface temperature is lower than the bottom temperature in the winter, which is due to the relatively stagnant air under the arch of the bridge, and there is no direct cold wind.

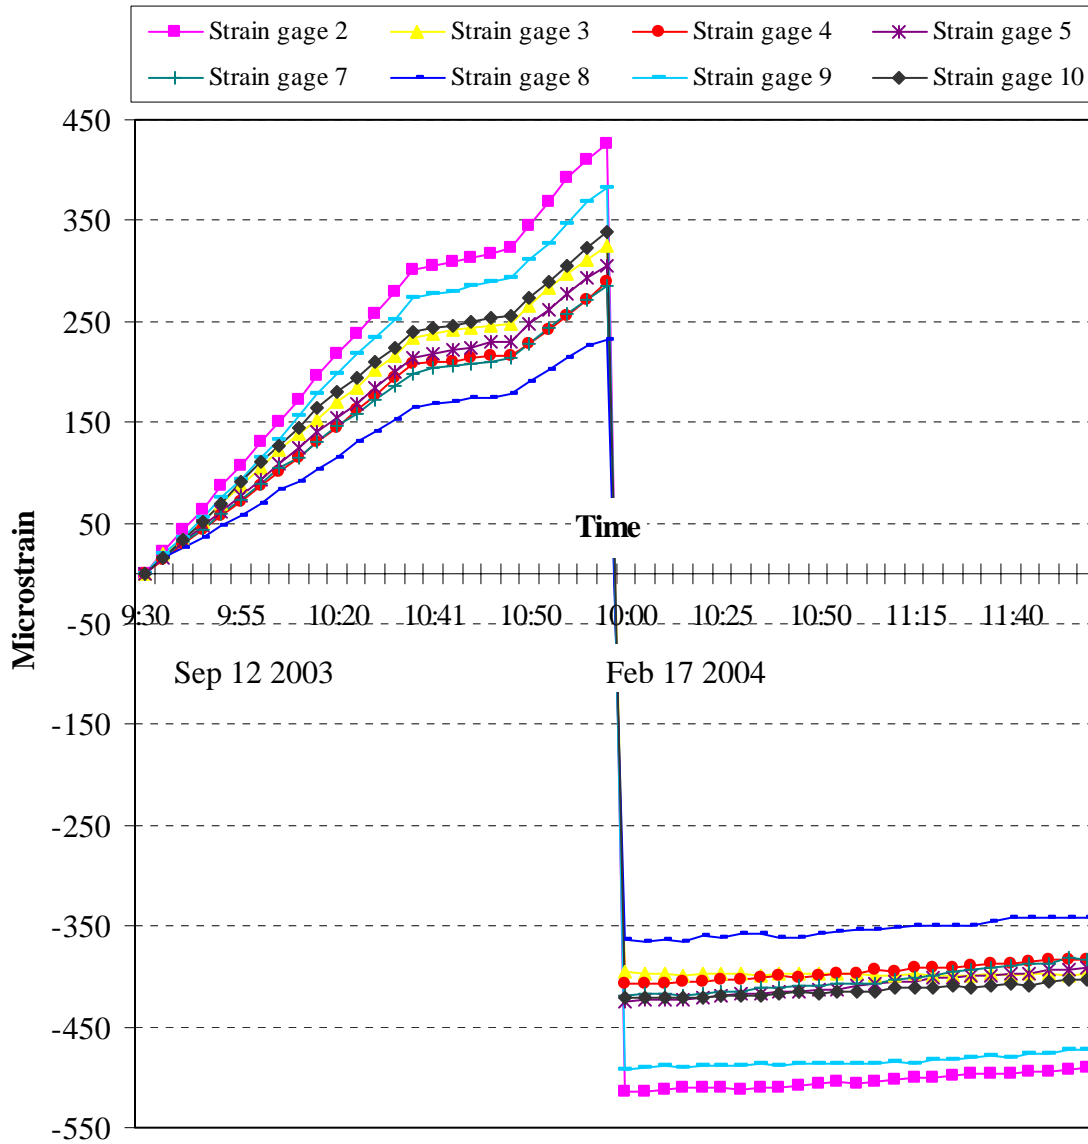
Figure 29. Longitudinal microstrains versus time in the top of the panel due to the temperature effect

The FRPH panels are subjected to significant variations of environmental conditions during the initial fabrication process and the service period. Among the many environmental conditions, temperature effect is a very important one. To monitor the effect of temperature variation on the internal strain/stress of the panel, two readings were taken, one in the summer and one in the winter. The strains were measured continuously for 110 minutes from 9:30 a.m. to 11:10 a.m. on September 12, 2003 and for 120 minutes from 10:00 a.m. to 12:00 p.m. on February 17, 2004. Temperatures were measured from the top surface and the bottom surface of the panel. The temperature readings of the top surface were taken in the wearing surface (gravel overlay, 1/2”), and the temperatures of the bottom surface were taken from underneath the precast concrete arch near the sensor locations. The temperature profiles are shown in Figure 28, and the strain variations are shown in Figures 29, 30, and 31.

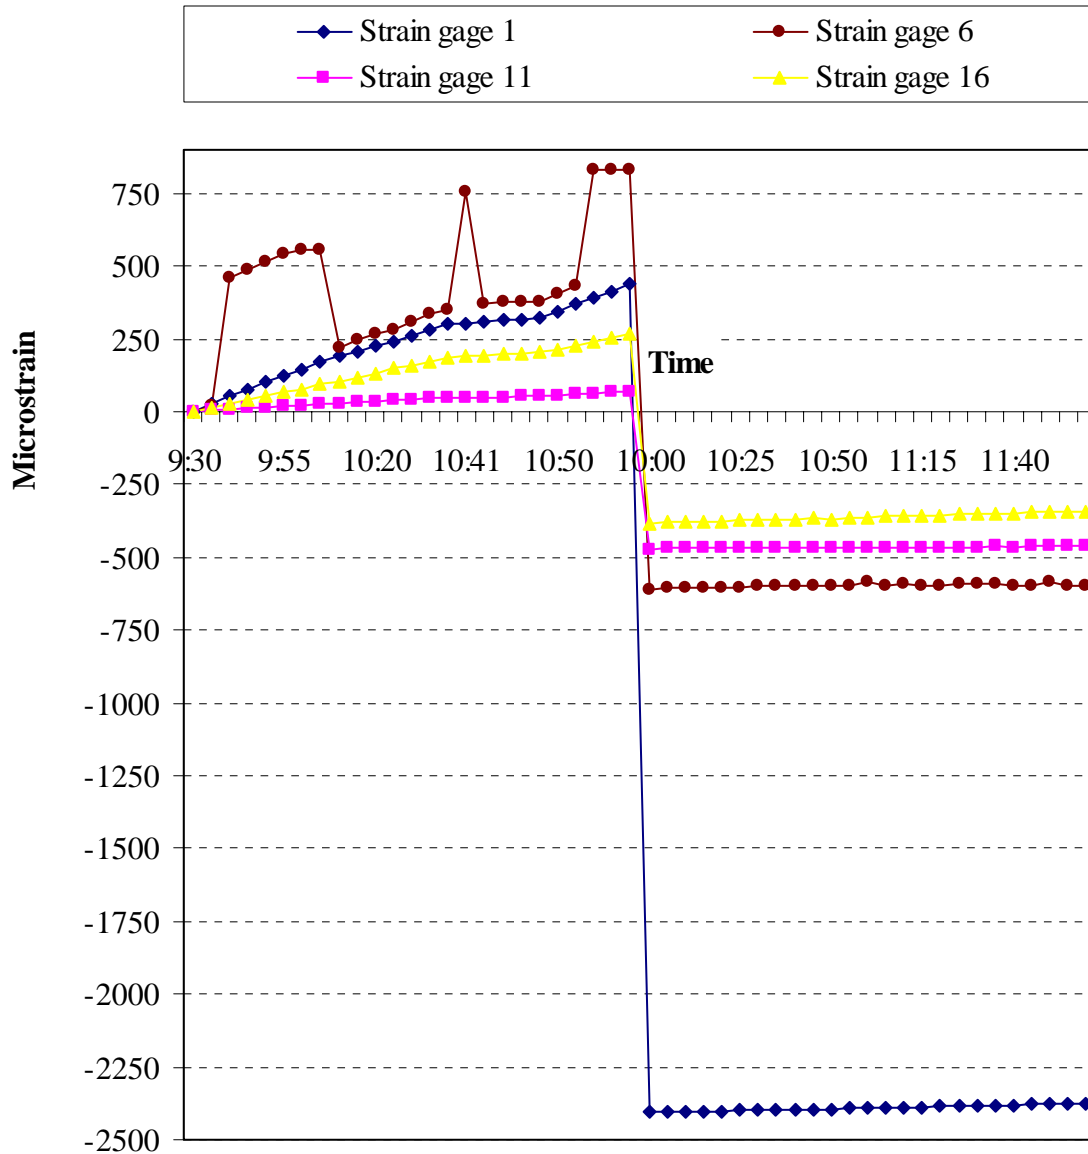
Figure 31. Transverse microstrains versus time in the panel due to the temperature effect

In Figure 31, the strains from gage 6 in the summer, and the strains from gage 1 in the winter look abnormal. Taking the gage 1 as an example, the strains of gage 1 during the reading period were quite stable, about 2400 $\mu\epsilon$. Using the Young's modulus of unexposed GFRP specimen, 662 ksi (see Table 5), the corresponding stress is about 1600 psi, which is only about 10% of the ultimate strength of the unexposed specimen. Therefore, the gage 1 may have recorded the actual strain in the location. More readings are needed in the future.
