Applied Research and Innovation Branch

# EVALUATION OF BRIDGE DECK SEALERS

Report No. CDOT-2014-6

June 2014

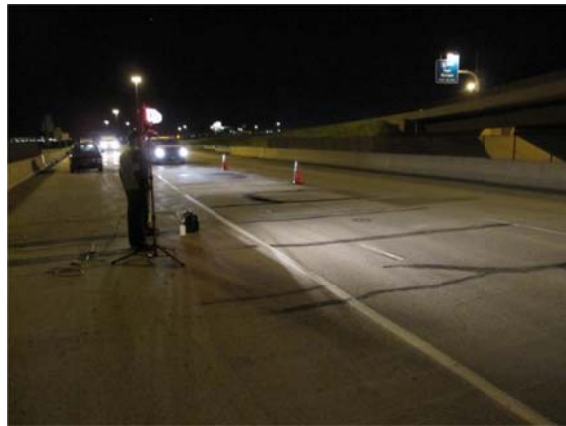
Fig 3.3 One shoulder lane and two traffic lanes of Bridge E-17-QM

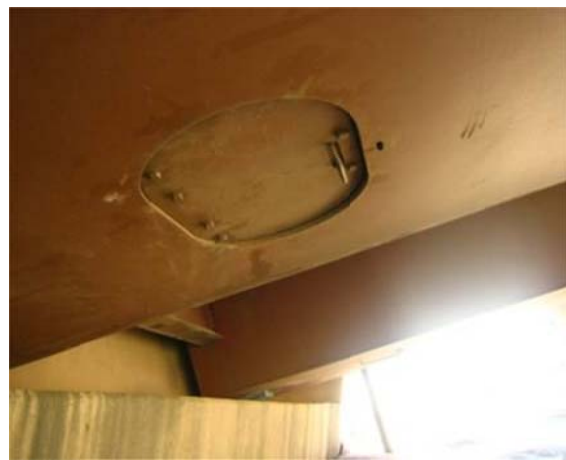
Fig 3.4 A hatch beneath the bridge for accessing the steel box girder

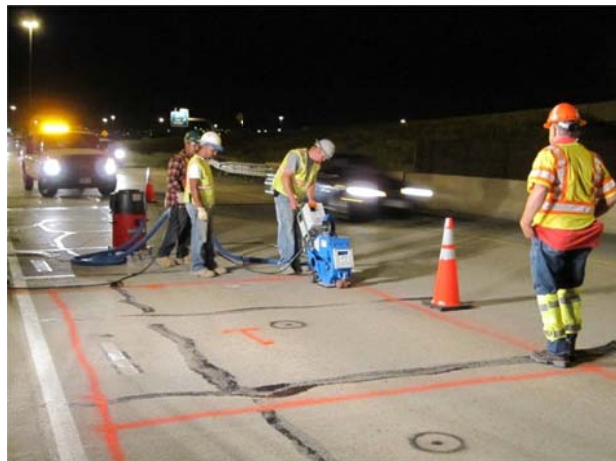
Fig 3.5 Cleaning the deck surface

Prior to installing sealer products on the bridge deck, the concrete substrate was inspected. There were no major contaminants at the location of surface cracks and there were no major cracks on the surface of concrete decks. For surface preparation, in general, the manufacturer's recommendations were followed. The sealers were installed by professional contractors hired by the sealer manufacturers or suppliers. The decks were washed and power swept to remove all dirt, sand, clay and other debris prior to applying the sealers (Fig 3.5). Proper chemical solutions were used to form the sealer products (Fig. 3.6), placed on deck surfaces (Fig. 3.7). Finally, fine sand was spread on the surface (Fig. 3.8). Figs 3.5 - 3.8 show the installation process of the sealers.

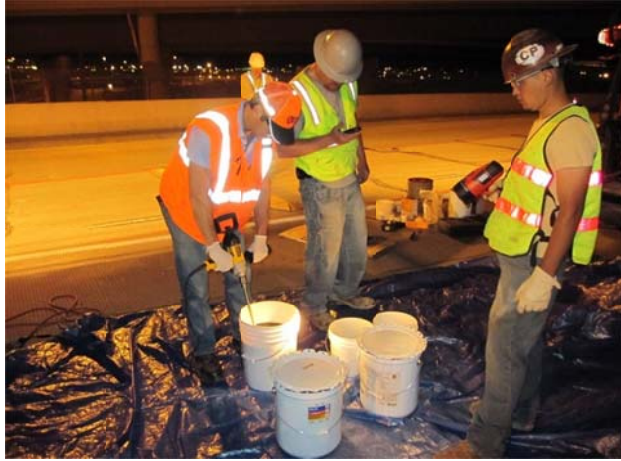
Fig 3.6 Mixing chemical solutions

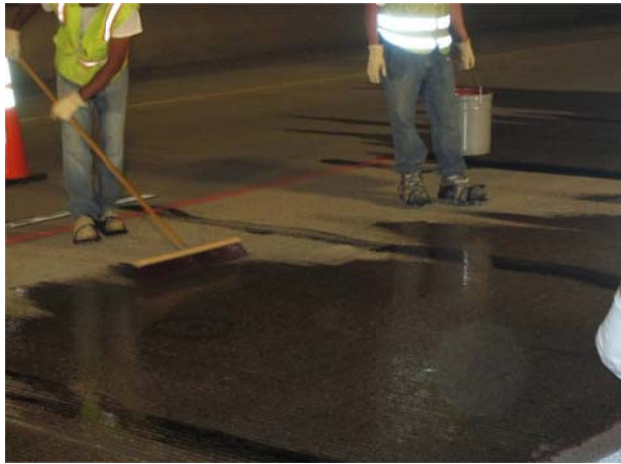
Fig 3.7 Sealer application

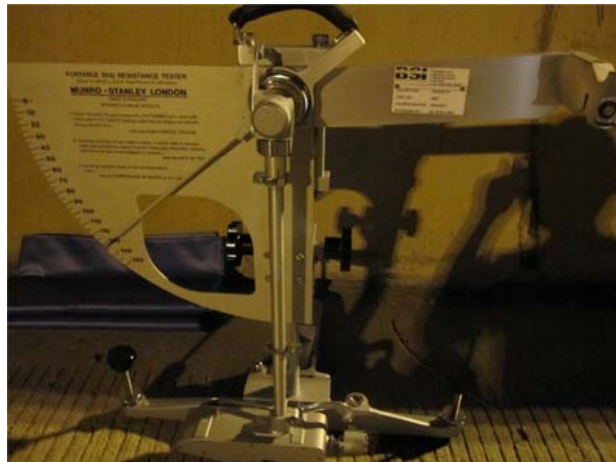
The British Pendulum Tester (BPT) was selected from the four previously mentioned tests for evaluating the skid resistance of sealed concrete surface in this project. The BPT is a stationary type of skid testers. It comprised a support frame that can be leveled on the road. Attached to the support frame is a swinging arm, at the bottom of which is a spring loaded ASTM rubber measuring foot. This swinging arm, when released from a fixed point, sweeps across the surface underneath. The skid resistance of the surface determines how far the arm swings up on the follow-through. The arm also moves a measuring that gives a value on the attached scale. Fig 3.10 and Fig. 3.11 show the BPT purchased and used for this project.

Fig 3.10 British Pendulum Tester

The test method described in ASTM E303 (1993, reapproved 2013), *Standard Test Method for Measuring Surface Frictional Properties Using the British Pendulum Tester*, uses the BPT to measure the frictional properties of the micro texture. The result from the BPT is the British pendulum number (BPN), which relates to skid resistance obtained in the field.

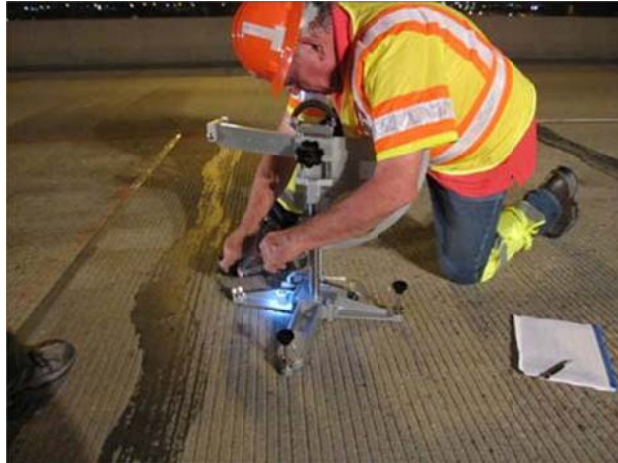
Fig 3.11 CDOT engineer conducting a skid resistance test

For this research project, we use a BPT to take measurements when sealers were initially applied and again one year later. The purpose of the first measurement is to determine which sealer product can provide the best skid resistance immediately after installation and prior to traffic loading. From the second measurement, we can gather information on the skid resistances of the sealed surfaces after one year traffic loading. According to ASTM E303-93 (reapproved 2013), the greater the friction between the slider and the test surface, the more the swing is retarded, and the larger the BPN reading. In another word, a slippery surface produces readings close to zero, and an anti-slip surface impedes the motion of the pendulum arm, giving results further from zero, thus a high BPN indicates higher skid resistance.

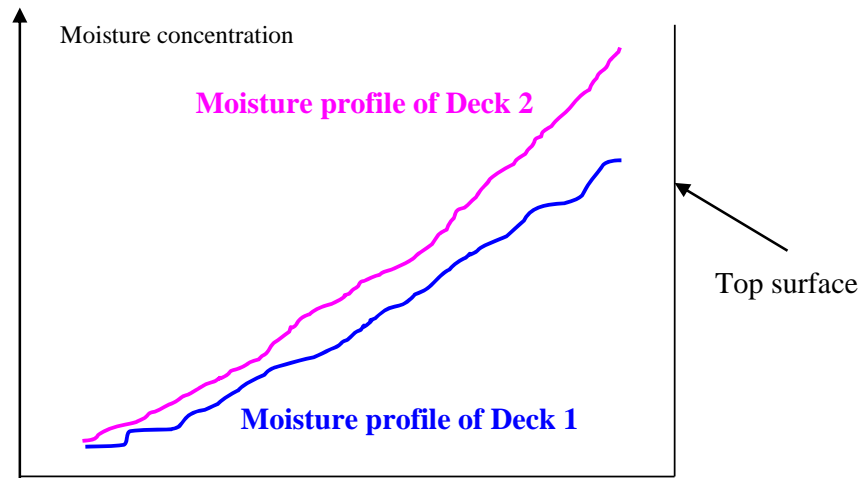
Fig 3.12 Continuous wet condition on the top surface of bridge decks

For example, when considering two concrete decks both under continuous wet conditions on the top surface, two moisture profiles obtained from the two decks may look like those shown in Fig 3.12. Profile 1 has lower concentration than Profile 2, and we may conclude that the permeability of the concrete of Deck 1 is lower than that of Deck 2. However, under the complicated service condition (or the condition of first wet and then dry on the top surface), the two profiles in Fig 3.12 may change to those shown in Fig 3.13. At some depths especially in the shallow part of the concrete, the moisture in Deck 1 maybe higher than Deck 2 because the moisture

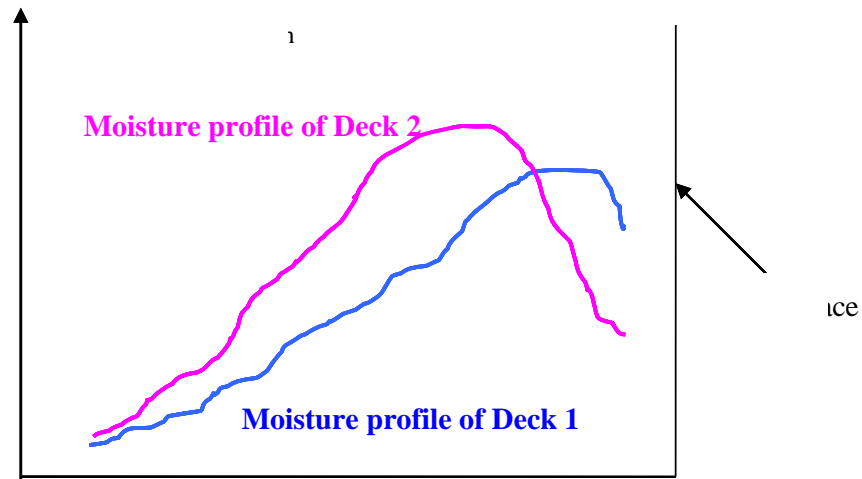
penetrates faster into the concrete of higher permeability when the top surface is wet, and the moisture also diffuses out of the concrete faster when the top surface is dry. In this case, if we only use one sensor, different conclusions would be reached on the permeability of the concretes depending on the location of the single sensor.

Fig 3.13 Condition of first wet and then dry on the top surface

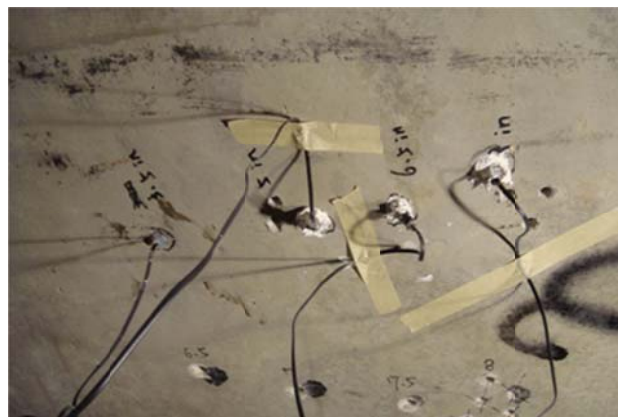
Fig 3.14 Integrated sensors installed in the deck.

The total depth of the bridge decks is approximately 9.5 in and the written numbers next to sensors in Fig 3.14 represent the drilling distances. For example, the third number from the left, 6.5 in means that the depth of the sensor is 3 inches from the top surface. The variation of internal moisture and temperature in deck is mainly caused by the environmental conditions at the surface of the bridge deck. All comparisons and analysis of those readings are based on the distance from the deck surface to the location of the sensors.

Although the example shown above is for evaluating the permeability of concrete, it can also be used for evaluating the permeability of concrete covered by a chemical sealer. All sensors were installed from underneath the decks inside the steel box girder, and the holes were drilled upwards into decks for installing the sensors (Fig 3.14).

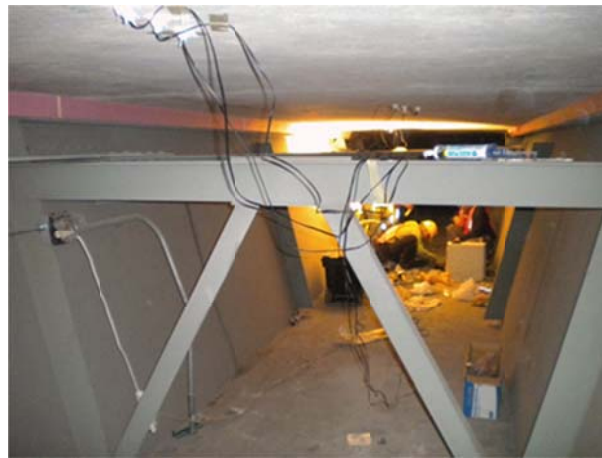
Fig 3.15 Sensor wiring from inside of the steel box girder

The data logger (EK-H3)/evaluation kit, designed for the sensor SHT7X, was used for the data acquisition. The data logger allows for simultaneous reading of 20 sensors. 18 sensors were installed in the five testing sections on the bridge. The instrumentation is shown in Fig 3.15 and Fig 3.16.

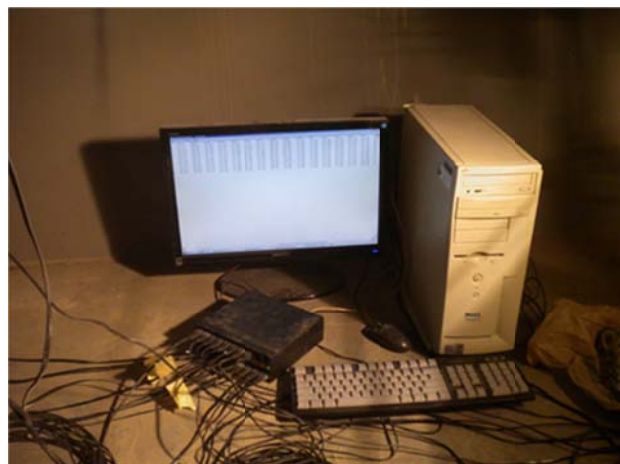
Fig 3.16 The data logger recording data for the integrated sensors

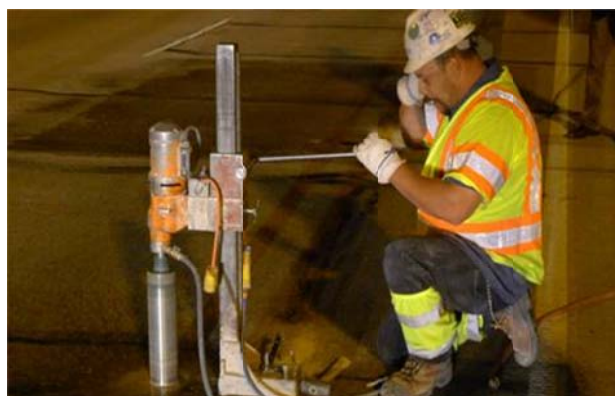
Concrete cores (4 inches in diameter) were taken from test sections to determine chloride contents at different depths with an interval of 0.25 in below the surface following ASTM C1218M-99. Fig 3.17 shows the process of taking concrete cores from bridge decks.

Fig 3.17 Taking concrete cores from bridge decks

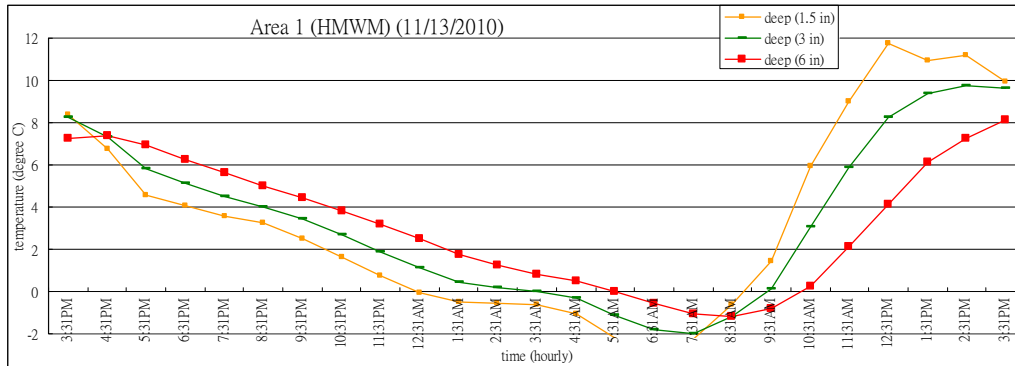
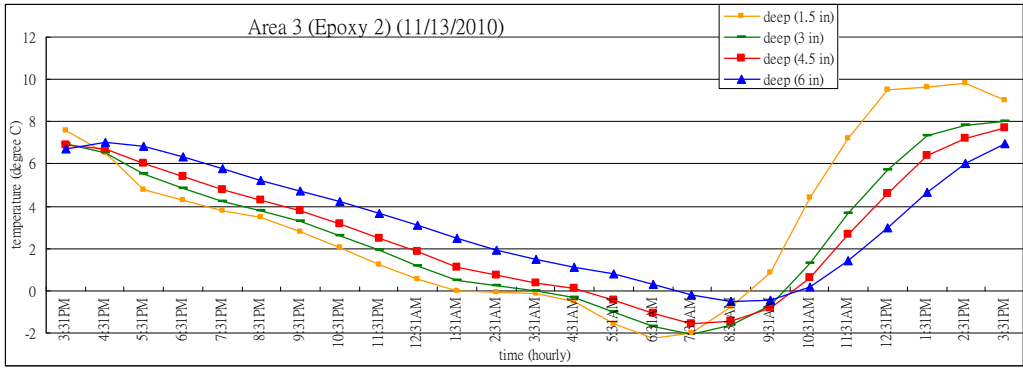
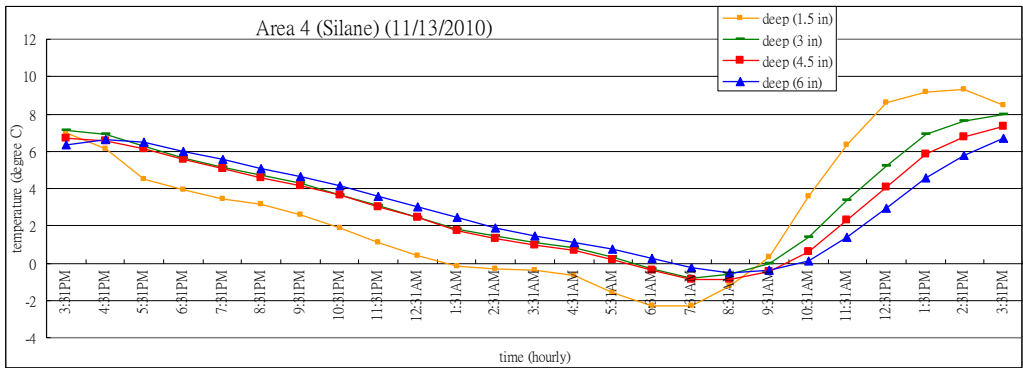
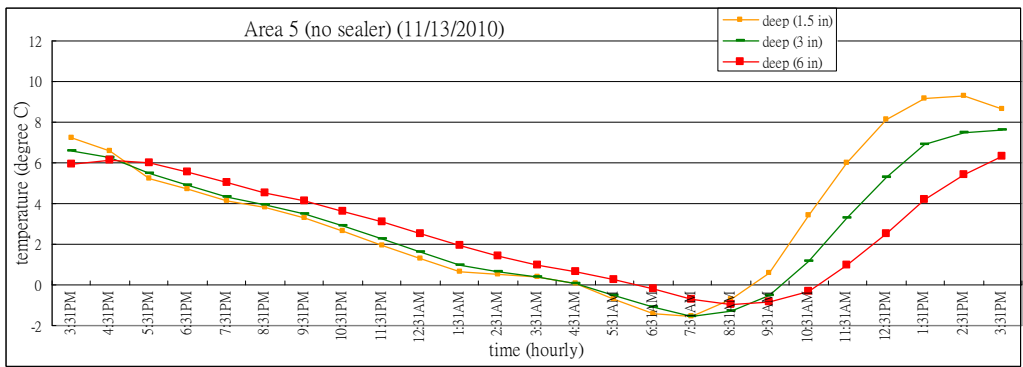
Figs 5.6 - 5.10 show hourly readings for the five testing areas over a 24-hour period starting from 3:31 pm on 11/30/2010. Again, the temperature difference at different depths is important.

Fig 5.6 Comparison of temperature variations at different depths over 24 hrs. (HMWM)

Fig 5.7 Comparison of temperature variations at different depths over 24 hrs. (Epoxy 1)

Fig 5.8 Comparison of temperature variations at different depths over 24 hrs. (Epoxy 2)

Fig 5.9 Comparison of temperature variations at different depths over 24 hrs. (Silane)

Fig 5.10 Comparison of temperature variations at different depths over 24 hrs. (no sealer)

From these five figures, we can observe that:

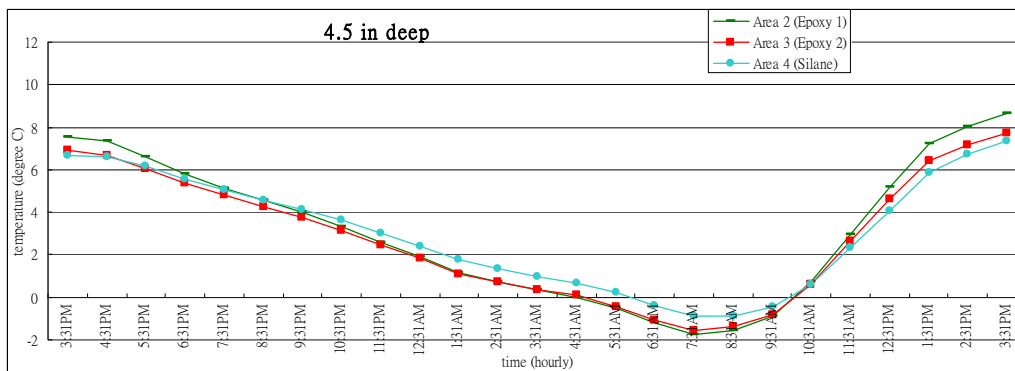
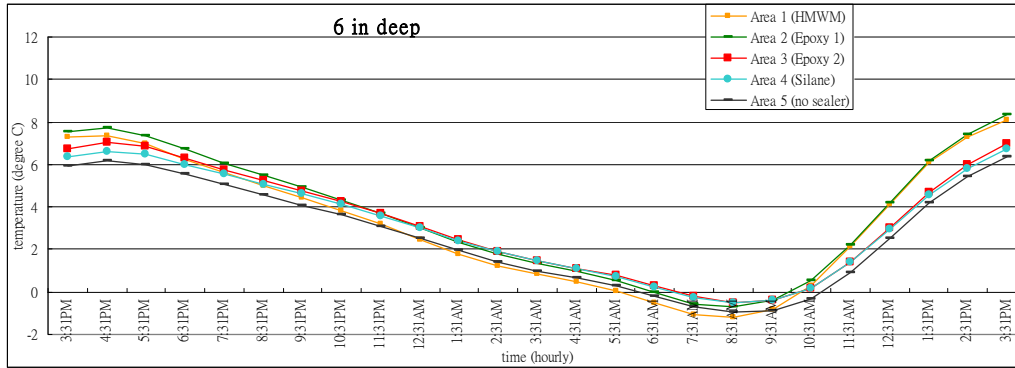
Fig 5.11 Comparison of different sealer areas at the depth of 1.5 inches

Fig 5.12 Comparison of different sealer areas at the depth of 3.0 inches

Fig 5.13 Comparison of different sealer areas at the depth of 4.5 inches

Fig 5.14 Comparison of different sealer areas at the depth of 6.0 inches

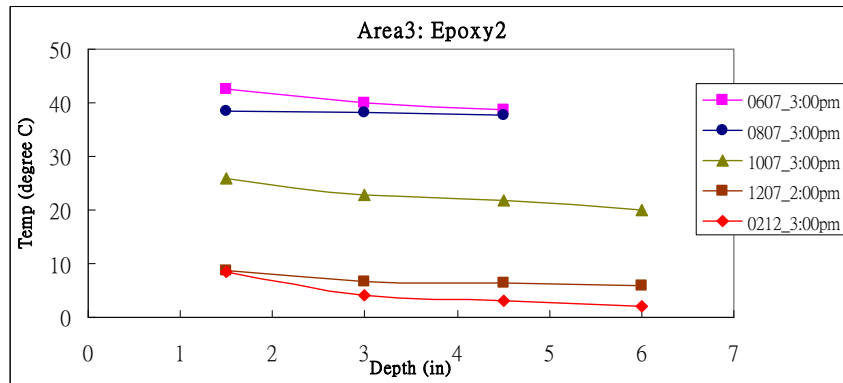
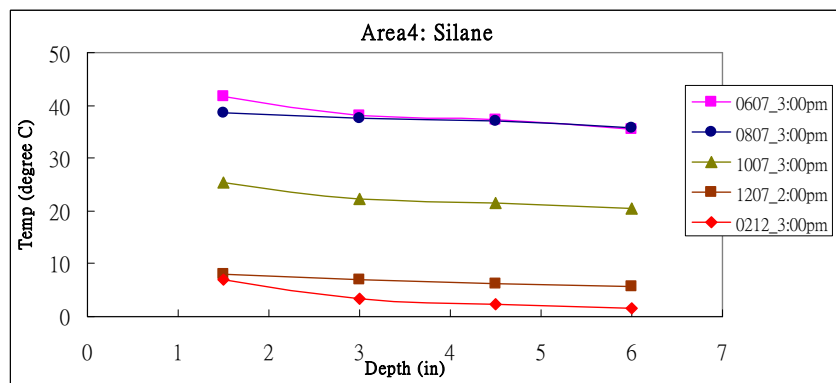
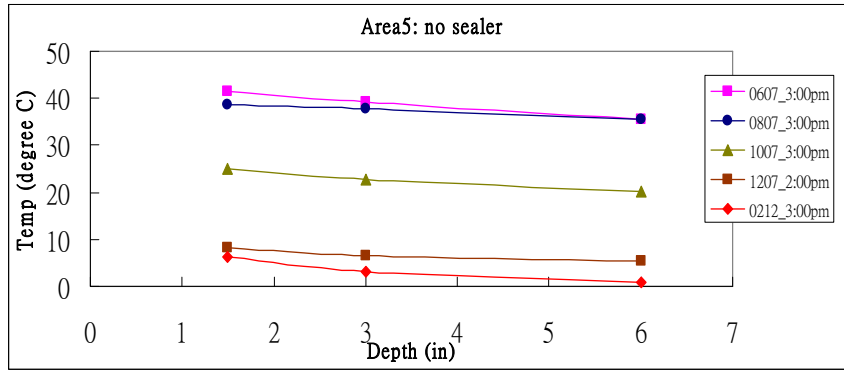
- (1) The highest temperatures and lowest temperatures are in July and February.
- (2) Near rebar location, the temperature varies between 3-40°C.
- (3) The largest temperature variation is in the testing area 2 (Epoxy 1).
- (4) In the summer, the order of temperature range is Silane < no sealer < Epoxy2 << HMWM < Epoxy1.
- (5) In the winter, the order of temperature range is no sealer < Silane < Epoxy1 < Epoxy2 <<HMWM.

Fig 5.15 Comparison of bimonthly temperature profiles (HMWM)

Fig 5.16 Comparison of bimonthly temperature profiles (Epoxy 1)

Fig 5.17 Comparison of bimonthly temperature profiles (Epoxy 2)

Fig 5.18 Comparison of bimonthly temperature profiles (Silane)

Fig 5.19 Comparison of bimonthly temperature profiles (no sealer)

Fig 5.20 Summary of bimonthly temperature profiles

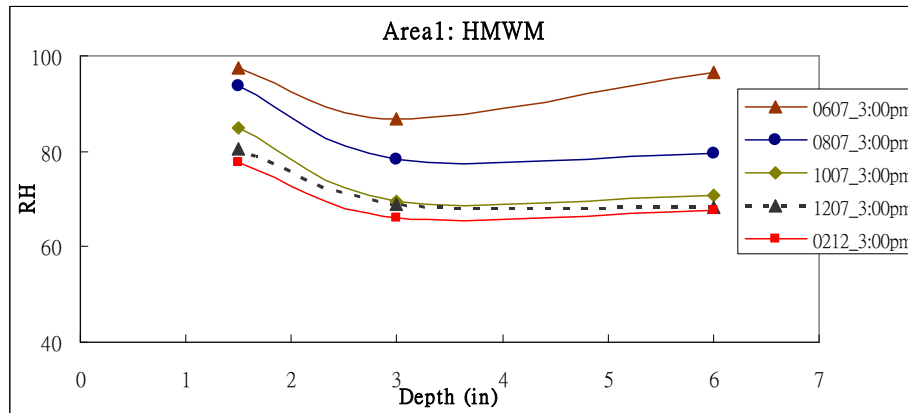
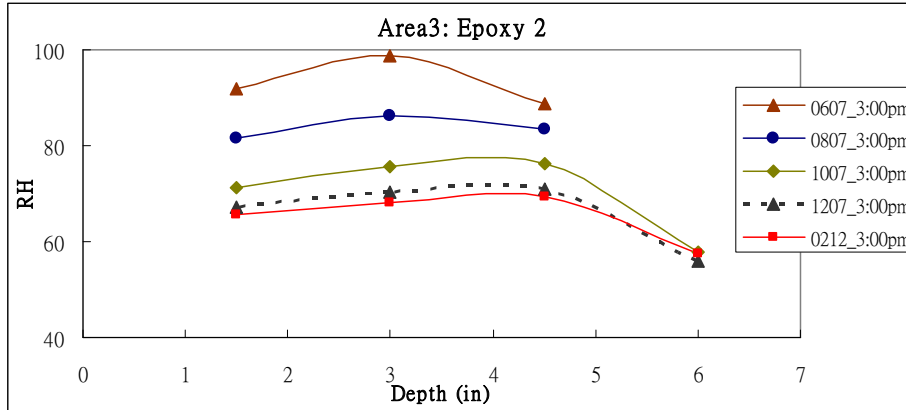
Therefore, the sealers are quite effective in blocking the moisture movement into and out of the concrete. The large variation of moisture level at 6.0 in. shown in the four figures is caused by a different mechanism, which is the diffusion (drying) of moisture from the bottom surface of the concrete decks. The bottom surface is exposed to the inside space of steel box girders, which is a confined space all the time and thus the RH value in the box girders can be considered as a constant, which is shown to be about 40% in Fig. 6.1 through 6.5 (the initial reading at 6 in. on 05/27/2010). From these figures, we can conclude that the sealers are effective to block moisture movement, but we cannot determine which sealer is more effective than others.

Fig 6.6 Comparisons for bimonthly readings (HMWM)

Fig 6.7 Comparisons for bimonthly readings (Epoxy 1)

Fig 6.8 Comparisons for bimonthly readings (Epoxy 2)

Fig 6.9 Comparisons for bimonthly readings (Silane)

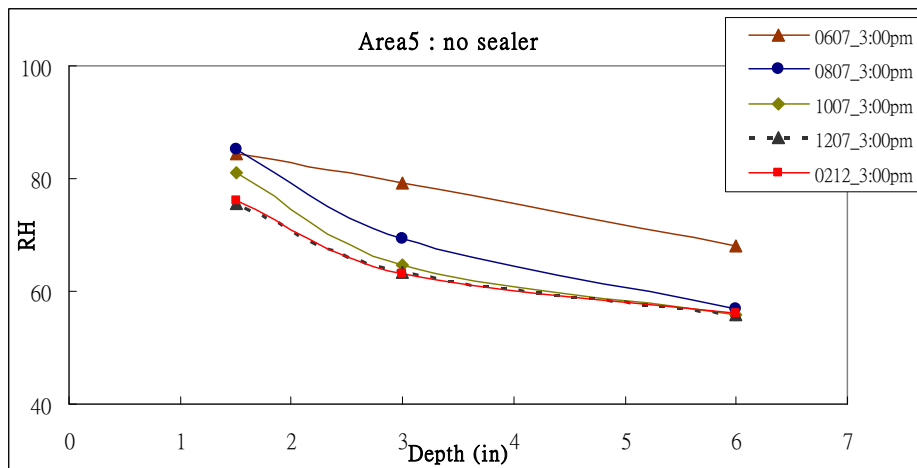
Fig 6.10 Comparisons for bimonthly readings (no sealer)

Fig. 6.10 shows the moisture profile in the unsealed testing section. The curves exhibit typical moisture profiles due to moisture diffusion in concrete. The boundary condition at the top surface is the environmental moisture variation. As explained earlier, the moisture level on the top surface is very high when there is a precipitation. The boundary condition at the bottom surface inside the steel box girder is a constant RH value (about 40%). The moisture distribution in between looks like those curves shown in Fig. 6.10: higher RH on the left (toward the top surface) and lower RH on the right (toward the bottom surface). The variation of profile depends on the amount of precipitation of the year. At the depth of rebar, about 2 in., the steady state moisture levels are about 70% to 85% in the deck, which is high enough to start the steel corrosion process if all other necessary conditions are available, such as high chloride and oxygen concentrations and low pH value in pore solution (Suwito and Xi 2008).
