Applied Research and Innovation Branch

PERFORMANCE OF THIN BONDED EPOXY OVERLAYS ON ASPHALT AND CONCRETE BRIDGE DECK SURFACES

Report No. CDOT-2014-2
June 2014

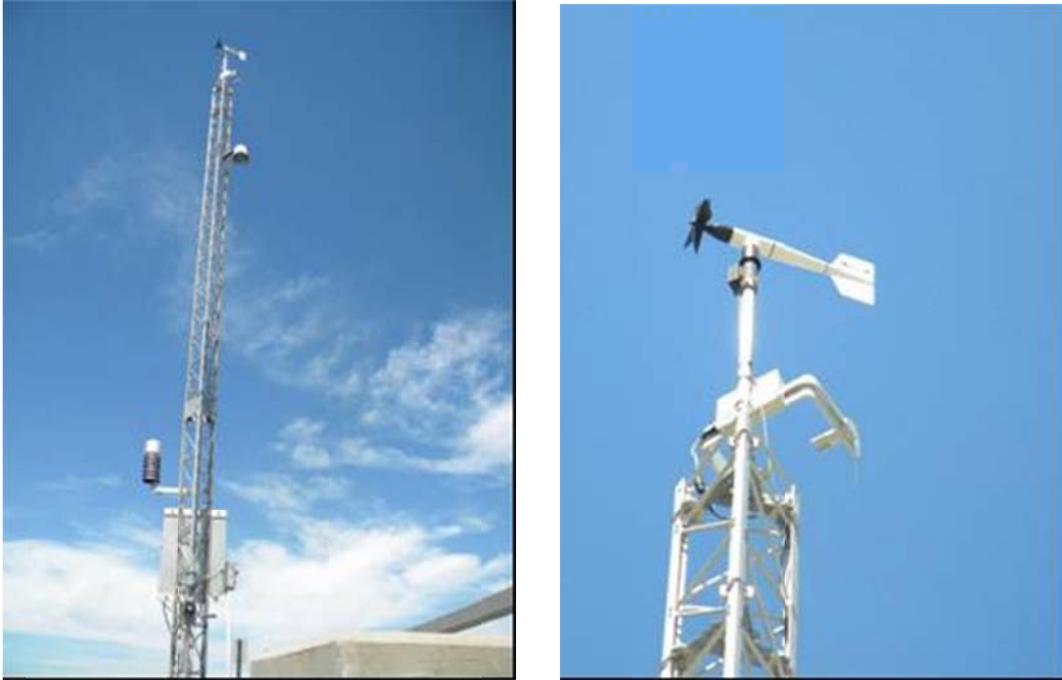
The site has extensive instrumentation including a weather station which measures wind speed and direction, as well as a Road Weather Information System (RWIS) which includes temperature, humidity, and barometric sensors. Figure 5.1.1.4 shows the weather station mast and wind sensor.

Figure 5.1.1.4: Weather Station at I-76 / WCR-53

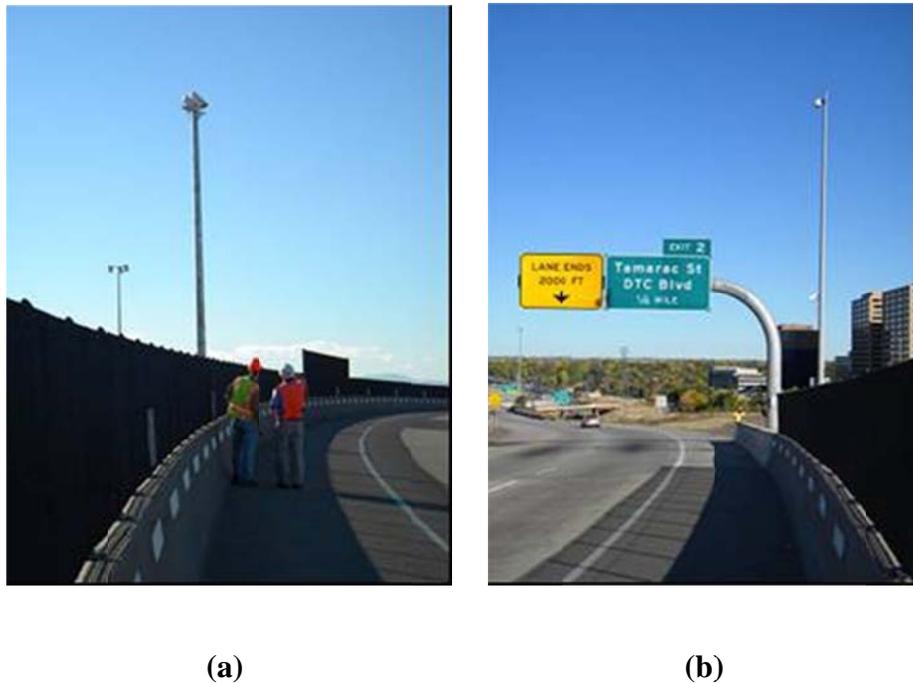
The spray system was installed at the same time as the Flexogrid overlay. This site consists of a camera that takes still photos of traffic on the bridge. Figure 5.1.3.4 shows both the (a) infrared sensor mast, and (b) camera mast.

Figure 5.1.3.4: Sensor Masts on I-25 / I-225 (a) Infrared, and (b) Camera

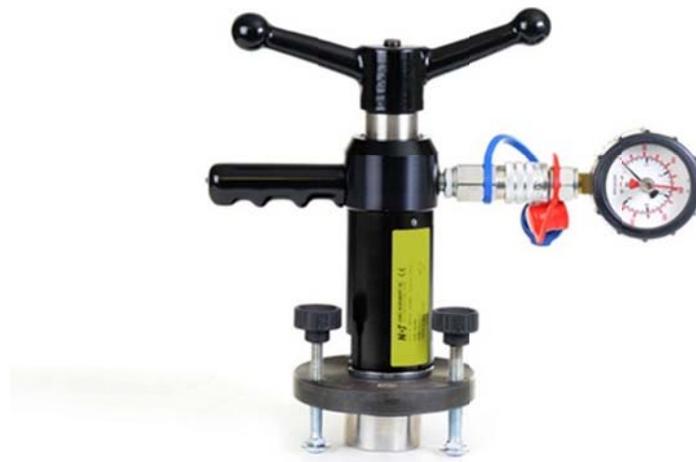
The bond test was conducted using a handheld testing apparatus that is manufactured by James Instruments called the 007 James Bond Tester. The tester uses a hand screw to pull a plate attached to the testing surface. Mounted on the side of the device is a force gauge so that the pull strength at failure can be recorded. Figure 5.2.3.1 below shows the James Bond Tester.

Figure 5.2.3.1: James Bond 007 Tester (James Instruments, 2011)

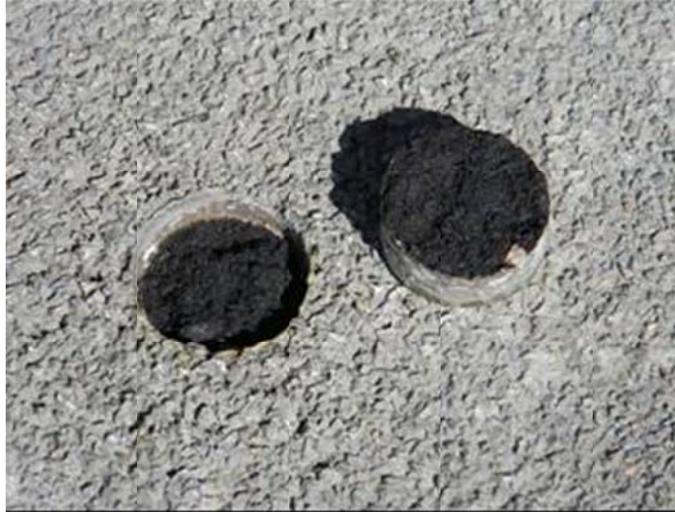
The screw handle is twisted until failure of the testing surface occurs. The force that is required for this failure is indicated on the gauge. This force divided by the area of the failure plane yields the failure in force per square area. The failure of the asphalt under the overlay is shown in Figure 5.2.3.8. The holes are patched with additional overlay material after the test area is cleaned (James Instruments, 2011).

Figure 5.2.3.5: Failure of the Asphalt Under SafeLane Overlay

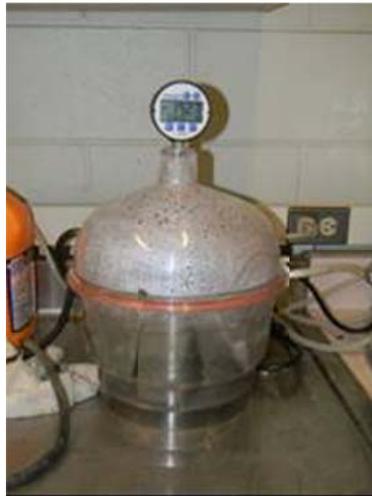
chamber and placed under vacuum for three hours. At the end of 3 hours, the chamber is flooded with water by being drawn up the fill hose from the vacuum. Figure 5.2.4.1 shows the concrete samples in a flooded desiccation chamber while still under vacuum.

Figure 5.2.4.1: Samples in Flooded Desiccation Chamber Under Vacuum

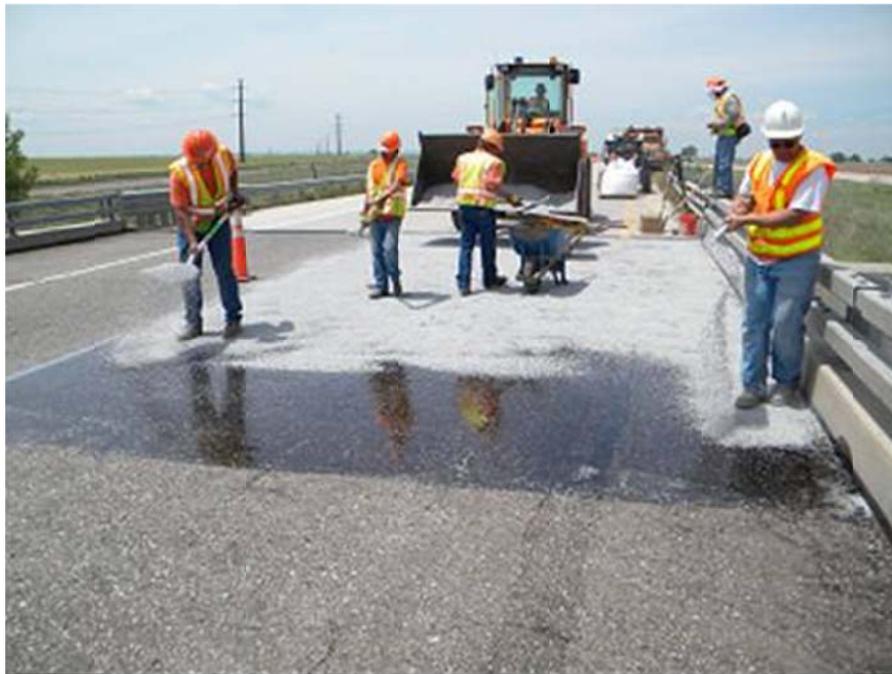
With the first batch of epoxy spread evenly on the deck, the aggregate application can begin. The standard way of applying the aggregate is to use a shovel and disperse an even layer down. It is possible to use an auto-spreader to disperse aggregate for larger bridge decks. Aggregate should be placed until a few feet from the most freshly spread epoxy in a uniform manner. Figure 6.1.2.2 shows the epoxy leading the aggregate layer.

Figure 6.1.2.2: SafeLane Aggregate Being Placed by Hand

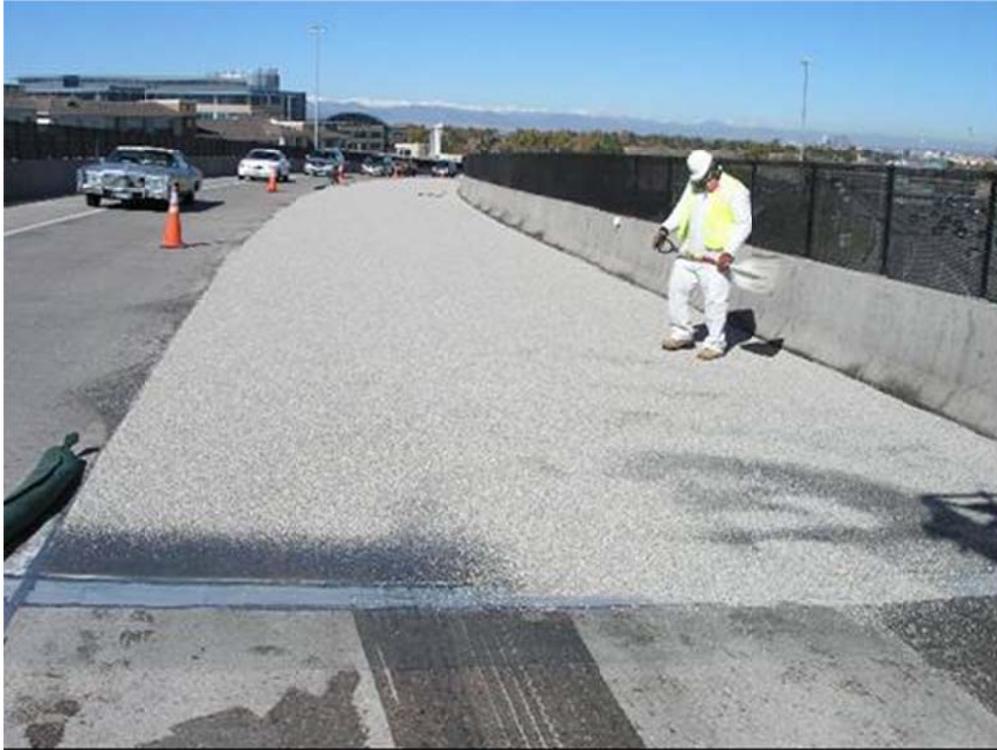
Figure 6.2.3.3 shows the aggregate being spread by a hand crew.

Figure 6.2.3.3: Flexogrid Aggregate Being Spread by Hand

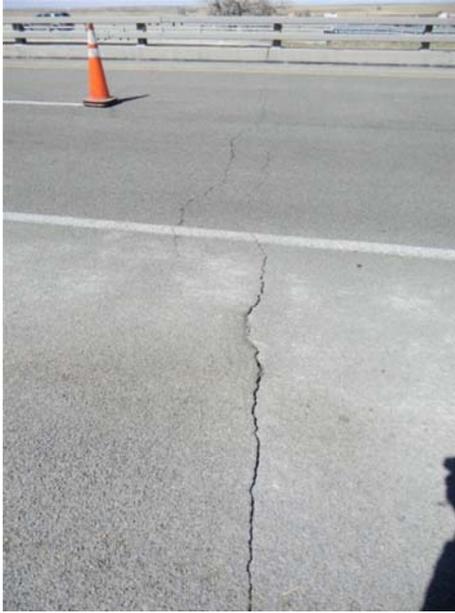
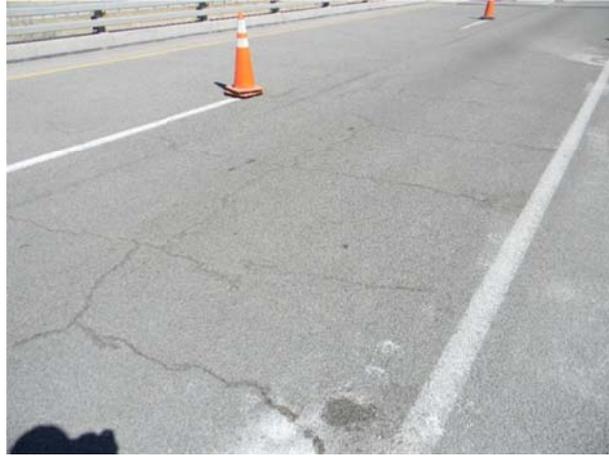
Subsequent inspection during the second round of testing revealed the abutment cracks came back. Deck reflection cracks are visibly coming through the overlay. This is important since cracks in the overlay essentially negate its effect as bridge deck protection. Figure 7.1.1.2 (a) shows the major cracks over the abutment and (b) the deck reflection cracking. The visual inspection in 2012 revealed the development of the abutment cracks and deck reflection cracks.

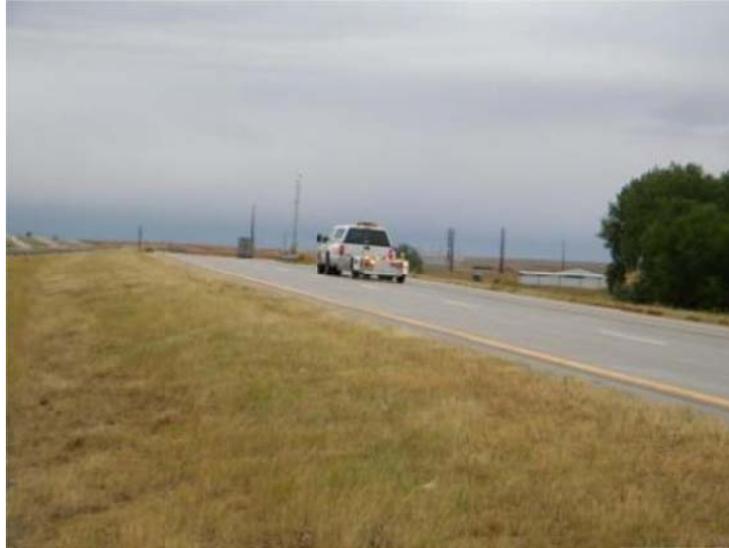
Originally, skid resistance testing on the I-76 / WCR-53 bridge was attempted in September 2009. However it was discovered that the I-76 and WCR 53 bridge deck was too short to obtain quality data using the traditional fixed wheel skid tester. Figure 7.1.1.3 shows the skid resistance testing being performed. In April 2010 CDOT purchased a portable skid tester. This instrument was used to measure the skid resistance of the bridge deck prior to, and after overlay application between June 7 – 9, 2010.

Figure 7.1.1.3: Skid Resistance Testing on I-76 / WCR-53

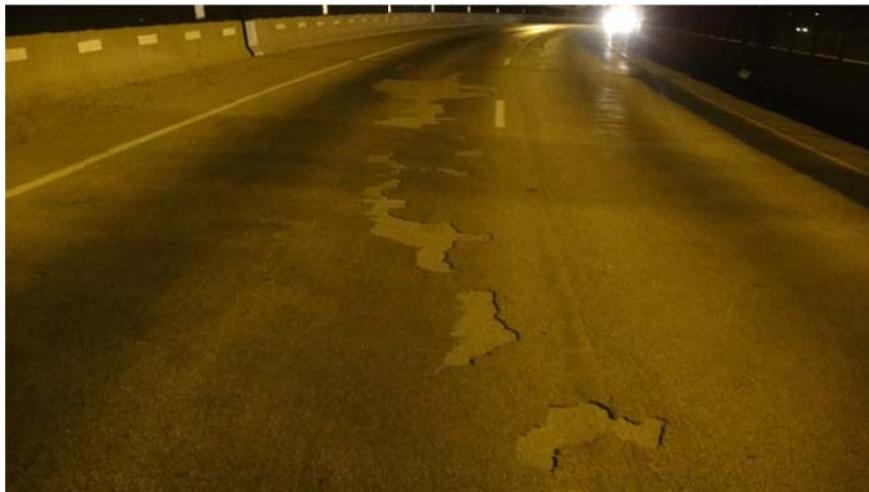
No problems during installation or testing of the I-25 / I-225 overlay were recorded. All cores were taken, and inspection of the overlay shows that it was in good condition in 2011. The delamination of the Flexogrid product was reported in 2012. Figure 7.1.1.4 shows the delaminated area on the bridge. The overlay was replaced in October 2012. However, it delaminated again in July, 2013.

Figure 7.1.1.4 Delaminated Flexogrid Overlay

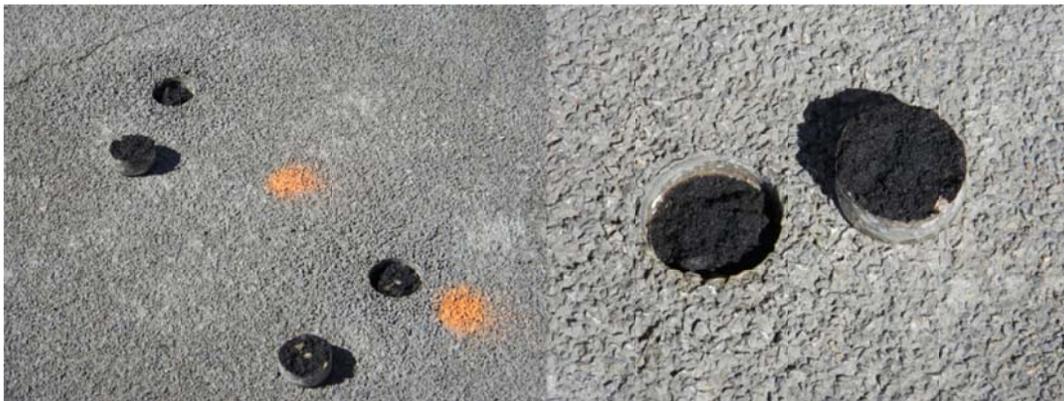
Figure 7.4.1.2: Asphalt Bond Test Failure Modes

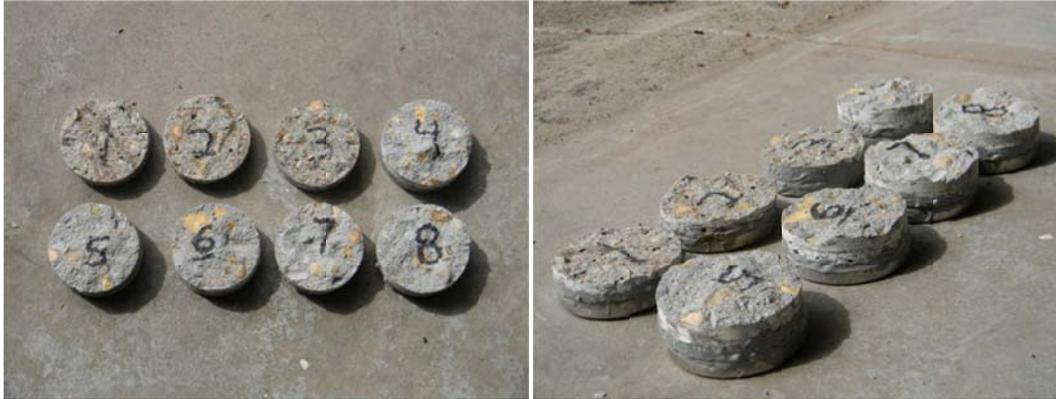
Figure 7.4.2.2: Test Cores from Parker Road / I-225 Bond Testing

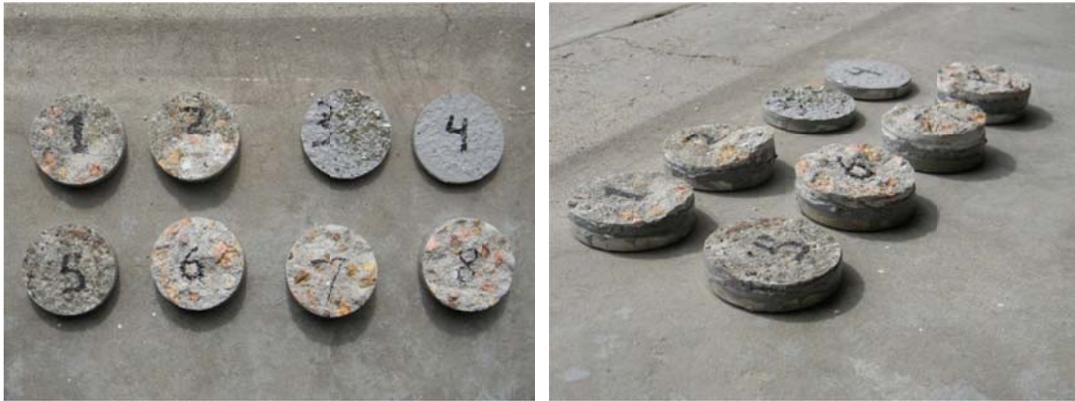
Figure 7.4.3.2: Test Cores from I-25 / I-225 Bond Testing

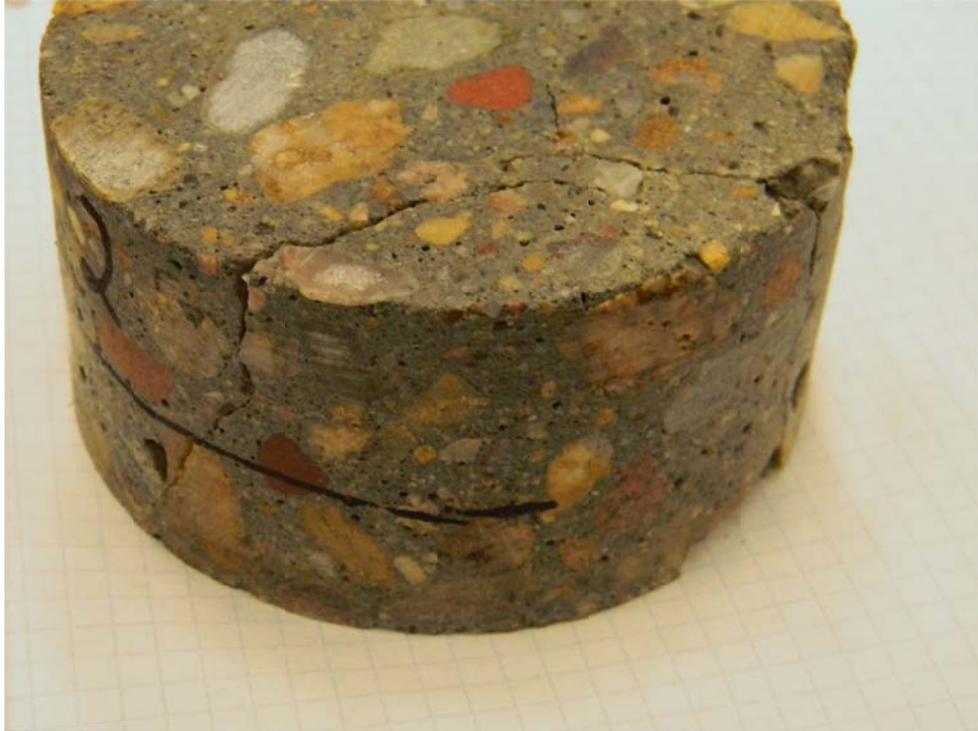
Figure 7.5.2.2: Cracked Permeability Sample R7

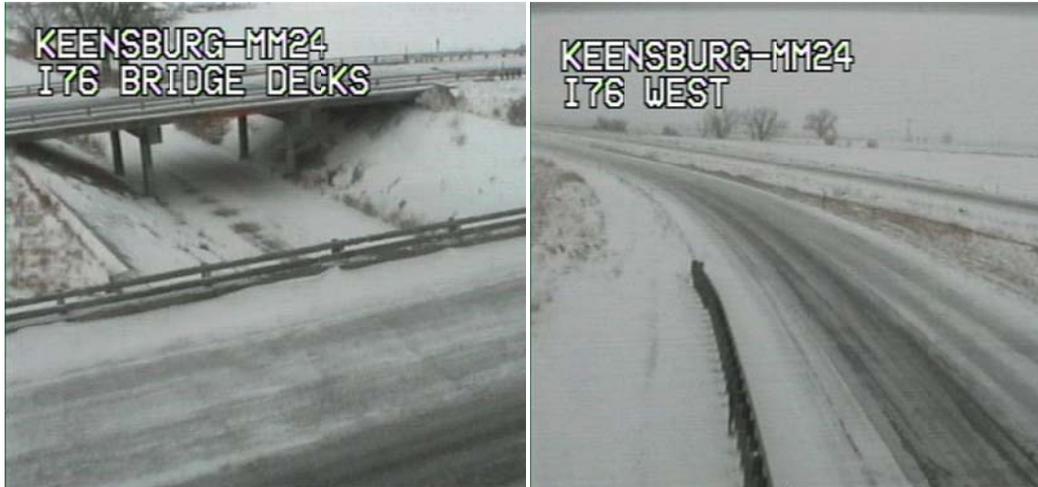
Figure 7.7.1.3: Surface Conditions Around 15 °F on 2/8/2011 at 10:26 AM
