Department of Transportation

# **FINAL REPORT**

## **Effectiveness of Two Reflection Crack Attenuation Techniques**

**Report No. CDOT-2015-10**

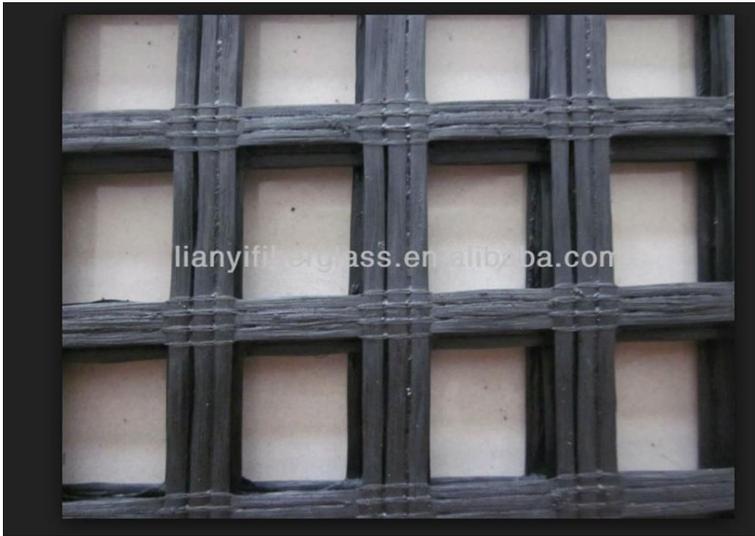
**Figure 1. GlasGrid®**

This is a patented product of Saint-Gobain ADFORS, distributed for use in the U.S. by Tensar International Corporation. Saint-Gobain describes this product as a “Pavement Reinforcement System composed of fiberglass strands coated with an elastomeric polymer and formed into a grid structure” as shown in Figure 1.

The theory behind attenuation of reflection cracks using this type of system regards the mechanics of crack tip energy. The idea is that when GlasGrid is sandwiched between a leveling course and the surface course in an asphalt overlay the energy at the tip of a vertical crack in the substrate is dissipated horizontally at the GlasGrid interface, causing the crack to stop propagating upward to the surface of the new overlay.

The test sections placed in this section consisted of removal by milling of 3.0 inches of the existing asphalt pavement, a tack coat, then a one inch leveling course of SX(75) PG(64-22), then GlasGrid followed by a 2.0 inch lift of SMA (1/2 in NMS).

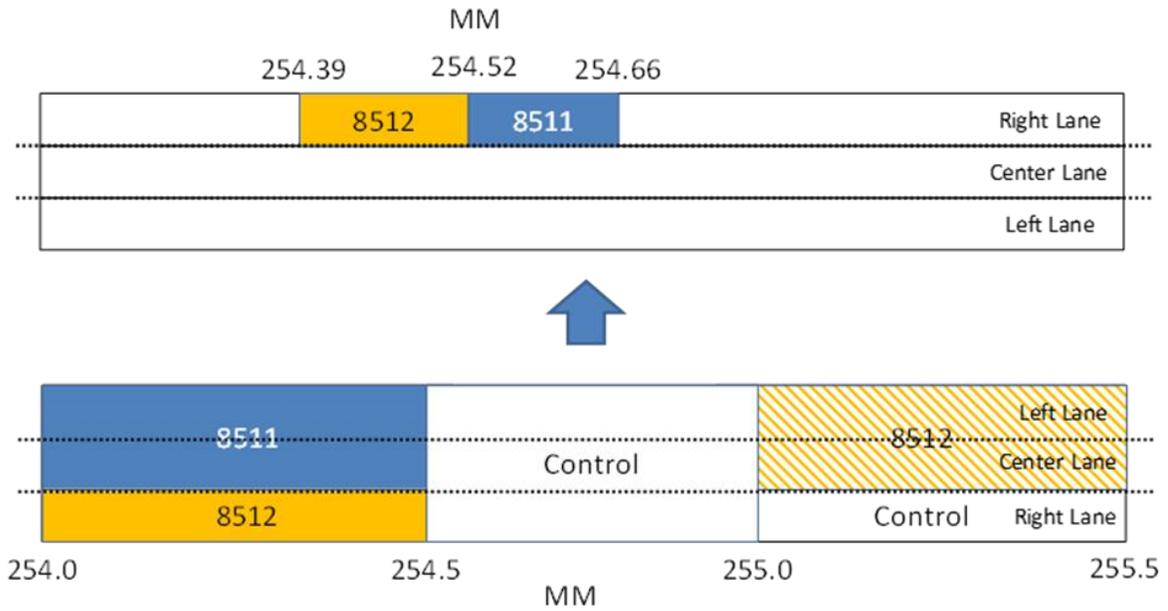
**Figure 5. I-70 Test Section Locations**

The first project constructed is on I-70 east of Golden. Test sections containing two types of GlasGrid and installed using two methods are located in the east and westbound lanes as shown on Figure 5. The two types of GladGrid installed are identified as 8511 and 8512. Both types of GlasGrid were installed the full width of the pavement lane except between milemarker 255 and 255.5 in the center and left (median) lane where it was installed only over the transverse cracks.

Test and control sections are located as shown in Figure 5. Performance is presented based on the lanes and traffic direction where the sections are located. This is done to eliminate variability associated with traffic direction and traffic volume between lanes.

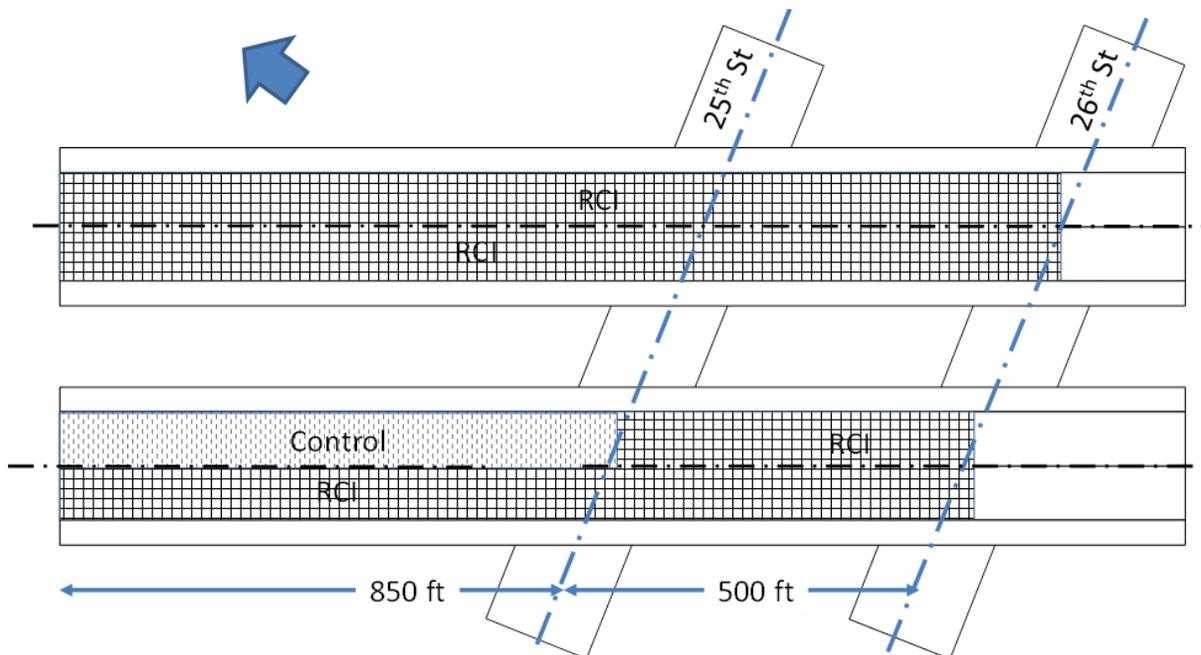
**Figure 6. US85 Test Section Locations**

The second test sections were constructed on US85 in Greeley as shown in Figure 6. These test sections were constructed with an RCI system in the northbound lanes between 24<sup>th</sup> and 26<sup>th</sup> Streets, in the southbound driving lane, and in the passing lane from 25<sup>th</sup> to 26<sup>th</sup> Streets. A control section was included in the southbound passing lane from 24<sup>th</sup> to 25<sup>th</sup> Streets.

This section consists of a 3.0 inch hot mixed asphalt surface course and a 1.0 inch RCI layer placed over the original jointed concrete pavement.

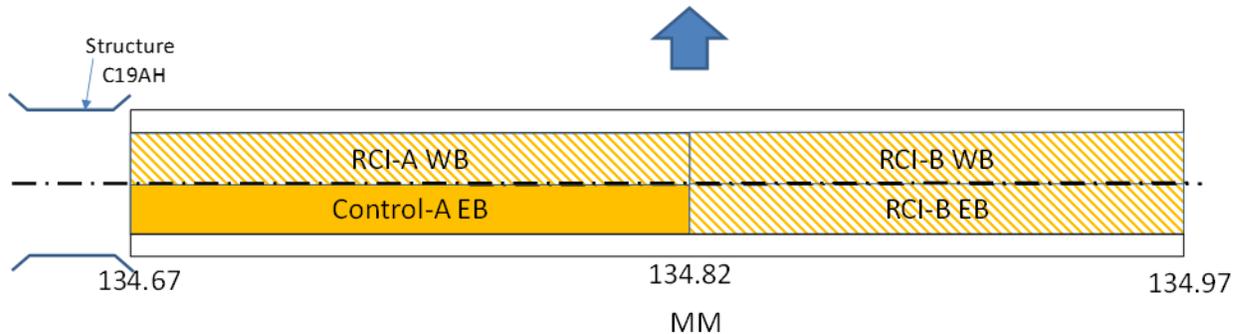
**Figure 7. US34 Test Section Locations**

The third experimental location was constructed on US34 east of Kersey as shown in Figure 7.

These test sections were constructed with RCI in the westbound direction from milemarker 134.97 to the east edge of the C19AH bridge structure and in the eastbound direction from milemarker 134.82 to 134.97. The control section was placed in the eastbound direction from the C19AH bridge structure to milemarker 134.82.

This section consists of a 1.0 inch hot mix asphalt levelling course followed by the 1.0 inch RCI layer, followed by 3.0 inches of SX surface course.

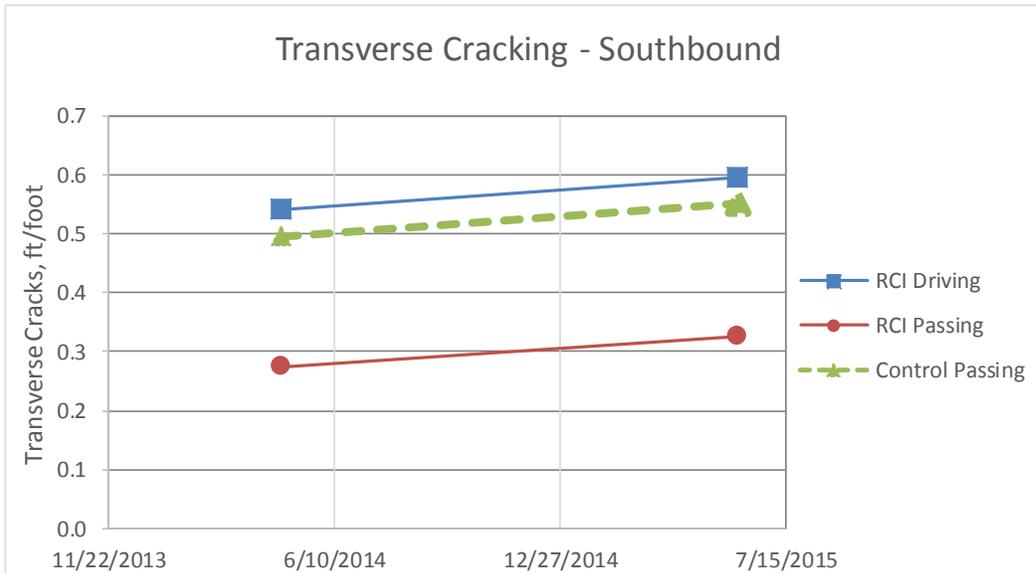
**Figure 18. Transverse Cracking in Southbound Lanes of US85**

This site has been subdivided into five segments for analysis. These segments are based on the direction of travel and the lane. For example, three segments are in the southbound lanes. One segment is the control which is in the southbound median (left) lane. The corresponding RCI segment is in the same lane. The third segment is the RCI constructed in the southbound driving lane. The other two segments are in the northbound driving and median lanes, respectively. Performance of these test sections are presented normalized with respect to the

length of the test sections. That is, the total length of cracking observed is normalized relative to the length of the test section. For example, the control section is 850 feet in length while the corresponding RCI section in the same lane is 500 feet in length. So, the length of cracks observed for each test section is divided by the length of the test section to provide an index represented as length of cracks per foot of test section. The only distress observed at this site was transverse cracking.

The RCI on US85 is outperforming the control in the southbound passing lane by approximately a factor of 2. That is, there are approximately half the number of reflected transverse cracks in the RCI section as there are in the control. However, the RCI in the driving lane southbound is performing approximately equal or slightly poorer than the control in the passing lane. A similar conclusion can be drawn regarding the RCI in both northbound lanes. The passing lane is performing more than two times as well as the driving lane, but both northbound lanes are performing better than their counterparts in the southbound direction.

4. The RCI on US85 in the southbound direction is outperforming the control section in the passing lane by a factor of two. However, the RCI in the driving lane adjacent to the control is performing slightly poorer than the control. RCI in the northbound passing lane is performing more than two times as well as the RCI in the driving lane, but both northbound lanes are performing better than their counterparts in the southbound direction.

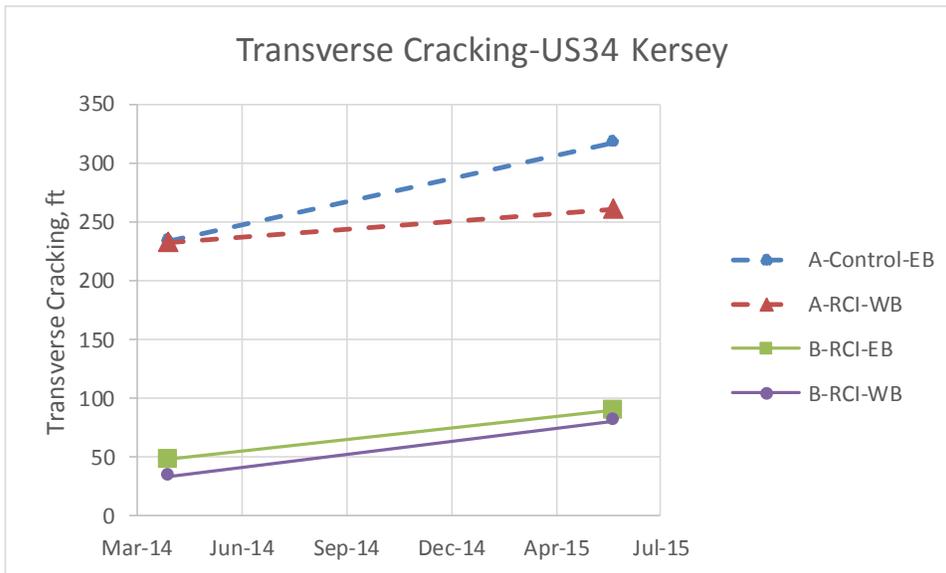
Figure 20. Transverse Cracking on US34

This site has been subdivided into four segments for analysis. These segments are based on the direction of travel and whether east or west of the center of the evaluation area. Each segment is the same length, so normalization of data was not required as for US85. Transverse cracking and alligator cracking are the only distresses present, to date. Since the amount of cracking seemed to be significantly lower near the east end of the test area, the analysis has been divided into two portions labelled ‘A’ and ‘B’ for the west and east portions, respectively. The control section in the eastbound lane and the corresponding RCI section in the opposite lane is the ‘A’ portion immediately east of the bridge structure. The RCI sections to the east of the control are the ‘B’ portions. Performance of these sections are shown in Figures 20 and 21.

The RCI on US34 is outperforming the control with respect to transverse cracking but is performing poorer with respect to alligator cracking. However, the rate of increase in alligator cracking from 2014 to 2015 was about the same for the RCI as for the control, while the rate of increase in transverse cracking was approximately flat for the RCI during this period but increasing for the control.

5. The RCI on US34 is outperforming the control with respect to transverse cracking but is performing poorer with respect to alligator cracking.
