IN-SITU MONITORING OF INFILTRATION-INDUCED INSTABILITY OF I-70 EMBANKMENT WEST OF THE EISENHOWER-JOHNSON MEMORIAL TUNNELS, PHASE II

Authors: ALEXANDRA WAYLLACE, NING LU, JONATHAN GODT

Report No. CDOT-2017-12
December, 2017

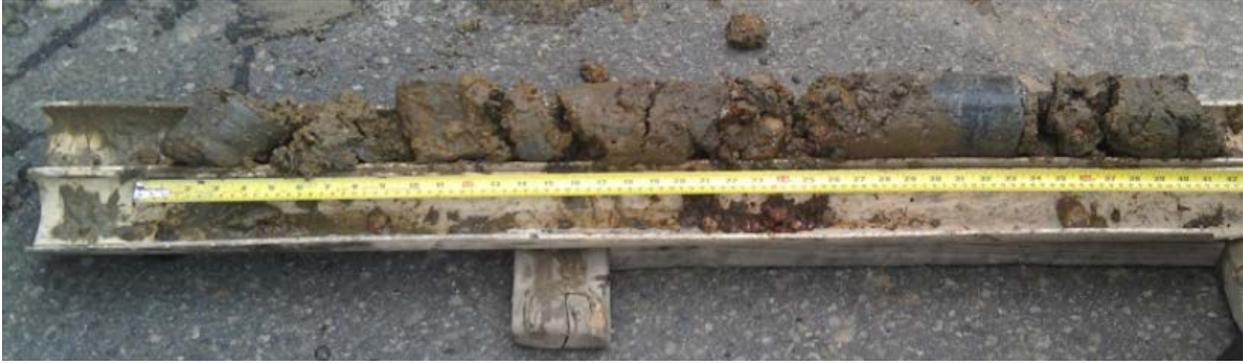
Figure C.1. Dark brown silty sand obtained from 0 to 47 ft

From 0 to 14.3 m (0 - 47.0 ft) below the pavement, the material extracted was mostly a dark brown silty sand with some fines (<10%), as well as cobbles of weathered black gneiss and weathered pink, quartz monzonite. Cobbles ranged in size from cm-scale to dm-scale boulders (Figure C.1). At 14.3 to 27.7 m (47 to 91.5 ft) depth the regolith became yellow-brown silty clay with about 30% gravel-sized grains, with a higher abundance of weathered quartz monzonite boulders and cobbles. Boulders of fractured quartz monzonite contained cm-scale inclusions of biotite. Fractures within the rock were filled with the yellow-brown silty clay. At 22 m (72.5 ft) depth the quartz monzonite became extremely weathered, breaking off in cm- and mm-scale grains with the slightest effort. The weathered rock was mixed in with the silty clay, and the rock increased in competence - measured by ease of breakability and occurrence of large clasts - with depth from 22.9 to 27.9 m (75 to 91.5 ft) (Figure C.2). After 27.9 m (91.5 ft) depth, a very competent quartz monzonite (100% recovery, ~80% RQD) was extracted from the borehole. The more competent quartz monzonite became a foliated, black (~70% dark minerals) gneiss at 30.2 m (99 ft) depth. The relatively competent (~100% recovery, ~80% RQD) gneiss was found until the base of the borehole drilled to 33.5 m (110 ft) (Figure C.3).

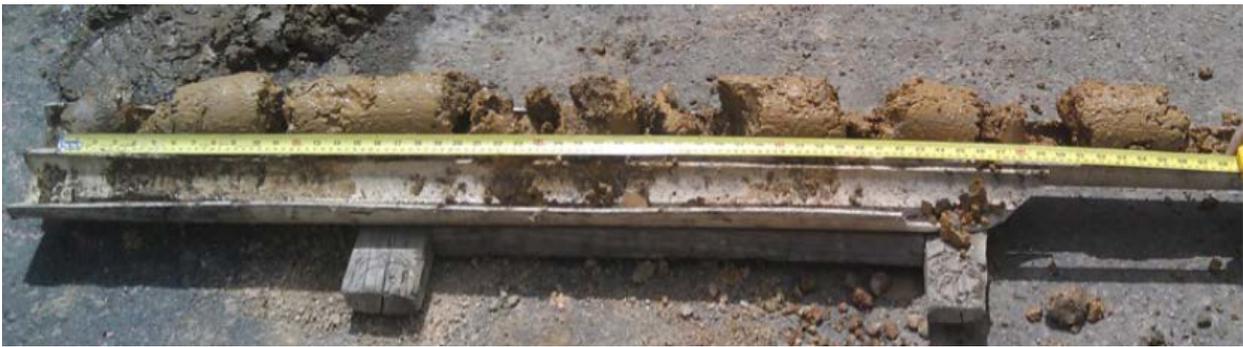
Figure C.2. Yellow brown silty clay obtained from 47 ft to 91.5 ft

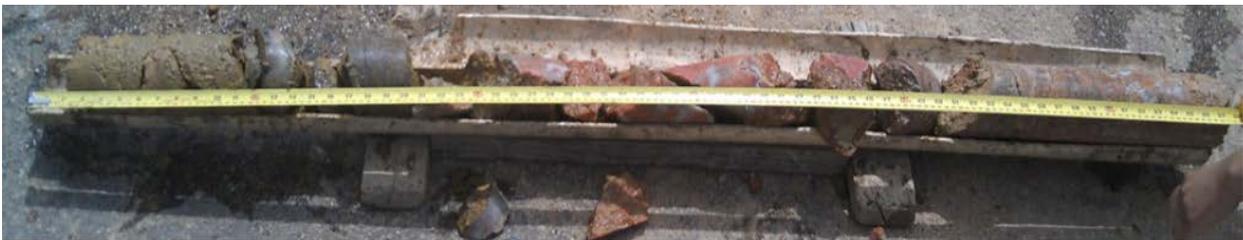
Figure C.3. Sharp transition between clay/weathered bedrock layer and bedrock at 91.5 ft

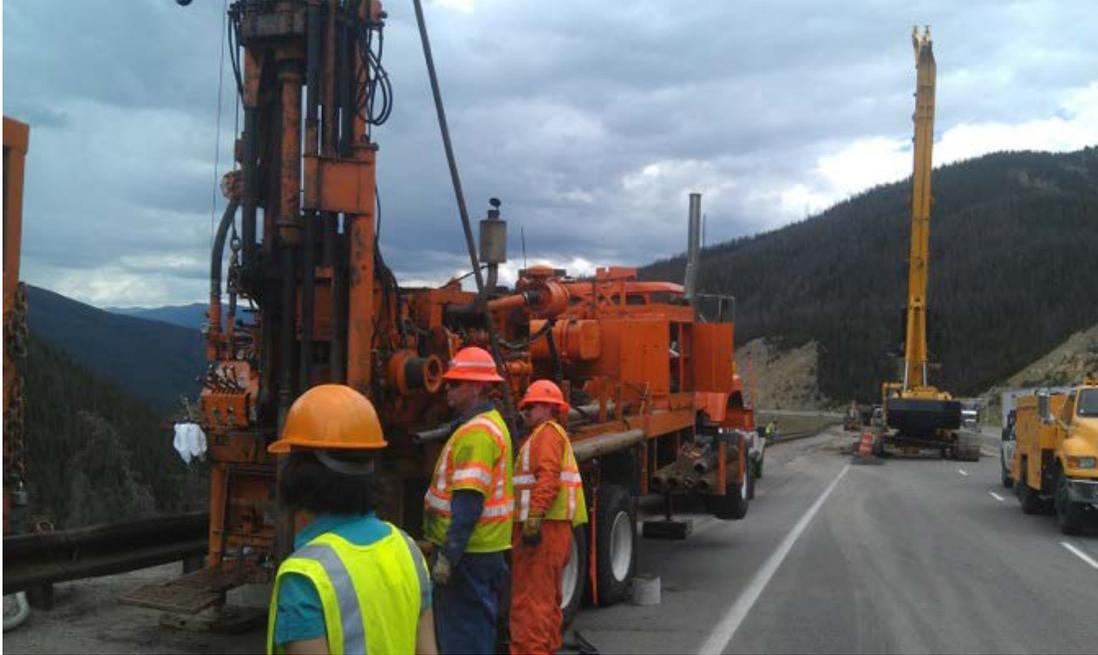
Figure C.4. Drilling on shoulder of East bound of I-70, August 3rd, 2012

Some of the steps during the piezometer and inclinometer casing installation are provided in Figures C.4. and C.5.

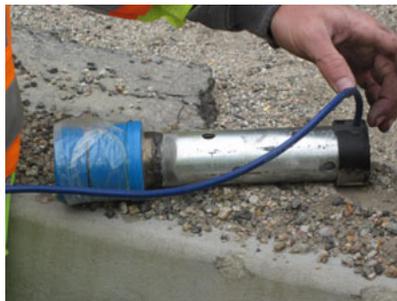
Figure C.5. Piezometer installed in a cage on the tip of the inclinometer casing

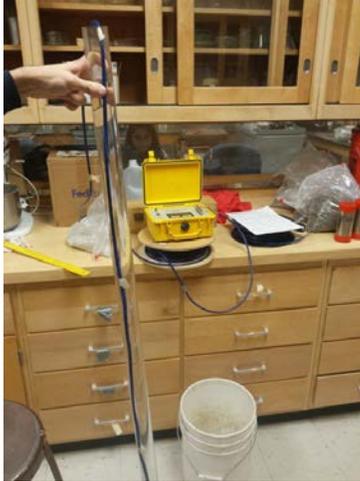
1. Calibrate piezometer in laboratory to obtain polynomial coefficients (see Geokon 4500S manual)

Figure C.7 Laboratory calibration of vibrating-wire piezometer

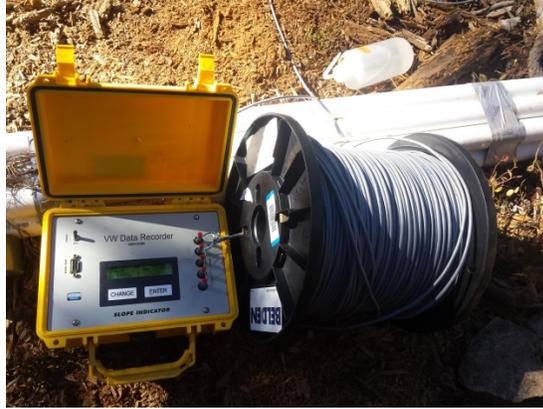
3. Field calibrate piezometer in borehole prior to installation and test accuracy of instrument with simultaneous water table indicator or similar device.

Figure C.9 Field calibration and accuracy check of piezometer in borehole

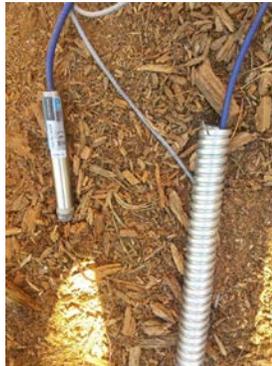
4. Run piezometer cable through aluminum conduit to protect from animals, weather, etc.

Figure C.10 Piezometer cable protected with aluminum conduit

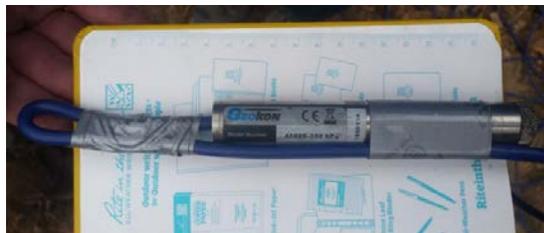
5. Install piezometer in borehole, tip up to allow any air to escape instrument.

Figure C.11 Piezometer oriented to stay tip-up when installed in borehole
