# US 160 Dry Creek Wildlife Study

**COLORADO**  
Department of Transportation

1. Report No. CDOT-2021-07	2. Government Accession No.	3. Recipient's Catalog No.	
4. Title and Subtitle  US 160 DRY CREEK WILDLIFE STUDY		5. Report Date August 2021	6. Performing Organization Code

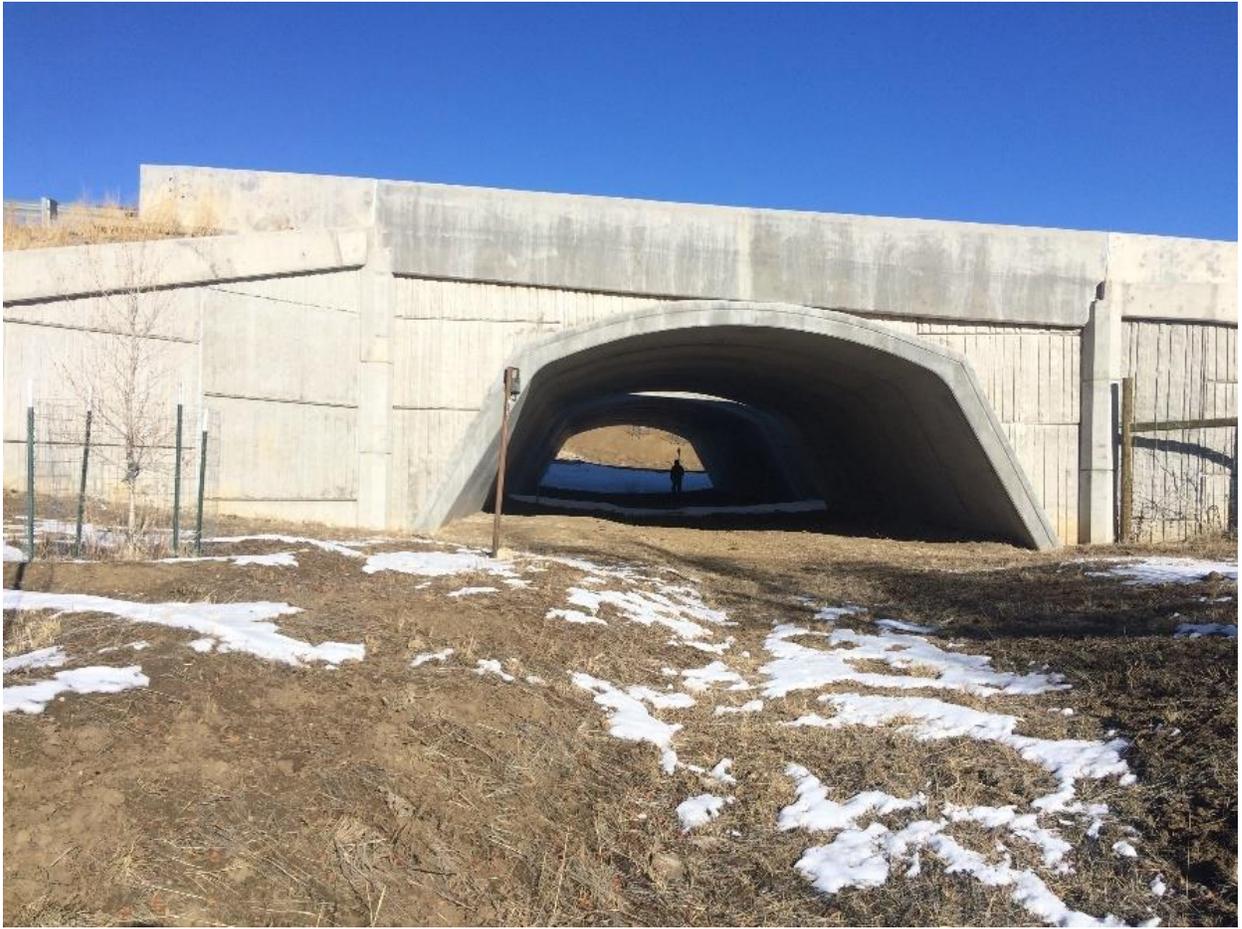
The wildlife crossing structure was an underpass, and consisted of two concrete arches, each 13 feet high by 39 feet wide. The north arch was approximately 70 feet long and the south arch was approximately 52 feet long. The median opening between the arches was approximately 13 feet long (Figure 3). Total length was approximately 135 feet.

**Figure 3. Monitored Wildlife Crossing Structure US 160 MP 97.42. The Monitoring Camera and Post at the South Entrance are in the Foreground. Cameras Faced the Entrances.**

Three Reconyx PC800 cameras were installed on August 14, 2018. Two Structure Cameras were placed at the structure, one at each entrance (approximately 30 feet from the structure's openings, perpendicular to the northeast and southwest abutments, and aimed at the center of the openings). The Wild Camera was placed at the north right-of-way fence, approximately 130 feet from the center of the structure's north opening, aimed to the west-northwest. The purpose of the Wild Camera was to capture photos of wildlife beyond the right-of-way that may not have moved near the entrances of the wildlife crossing structure. The cameras were programmed to take five pictures per trigger, rapid fire, with no delay. The three cameras were removed on March 12, 2021.

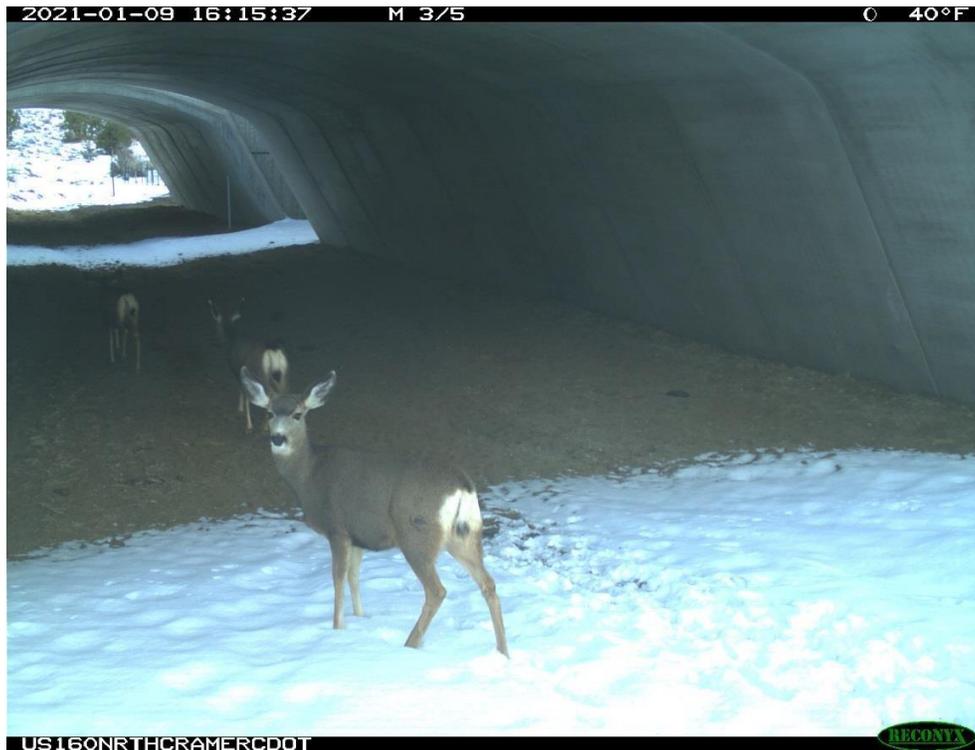
Mule Deer success movements through the wildlife crossing structure.

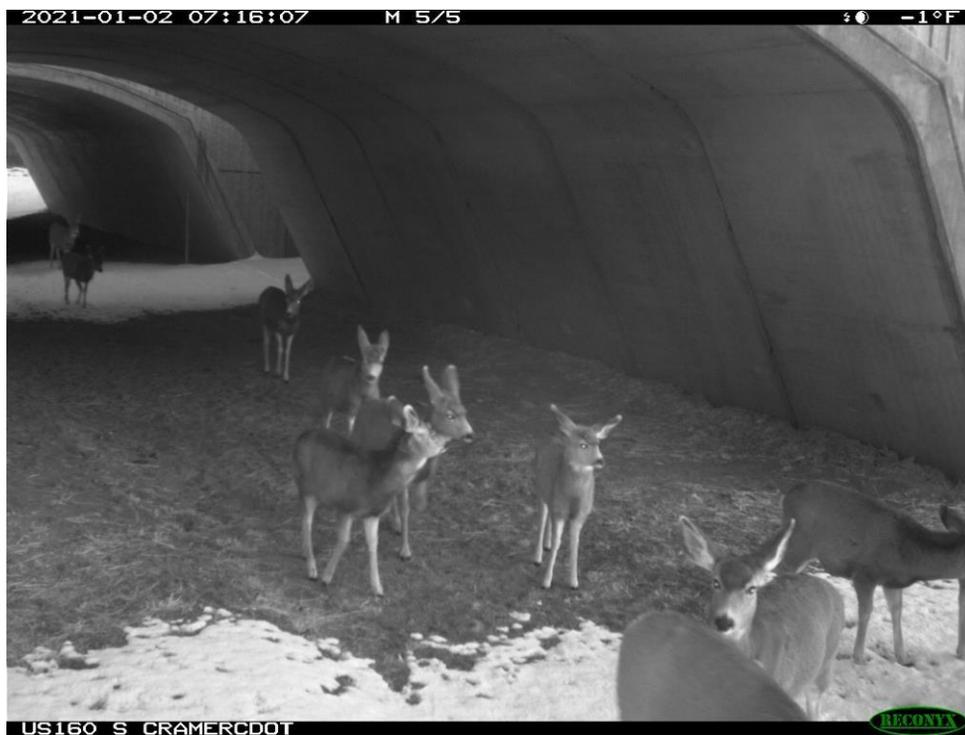
Mule Deer success movements through the wildlife crossing structure.

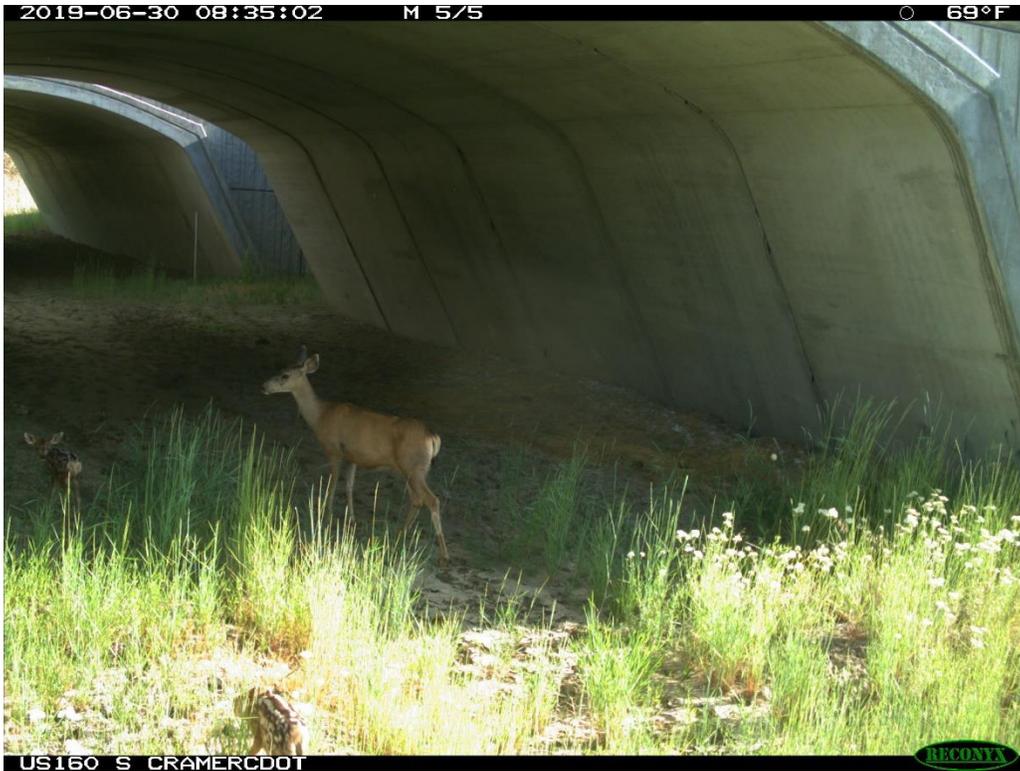
Mule Deer does brought fawns through the structure.

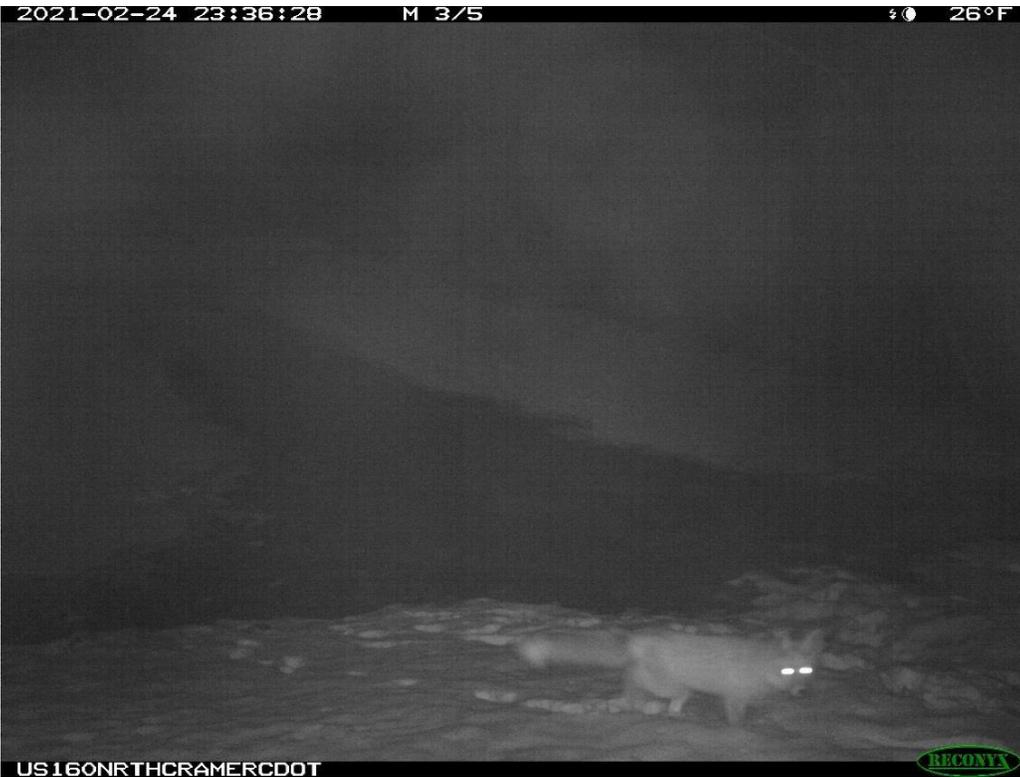
Red Fox success movement through the wildlife crossing structure.

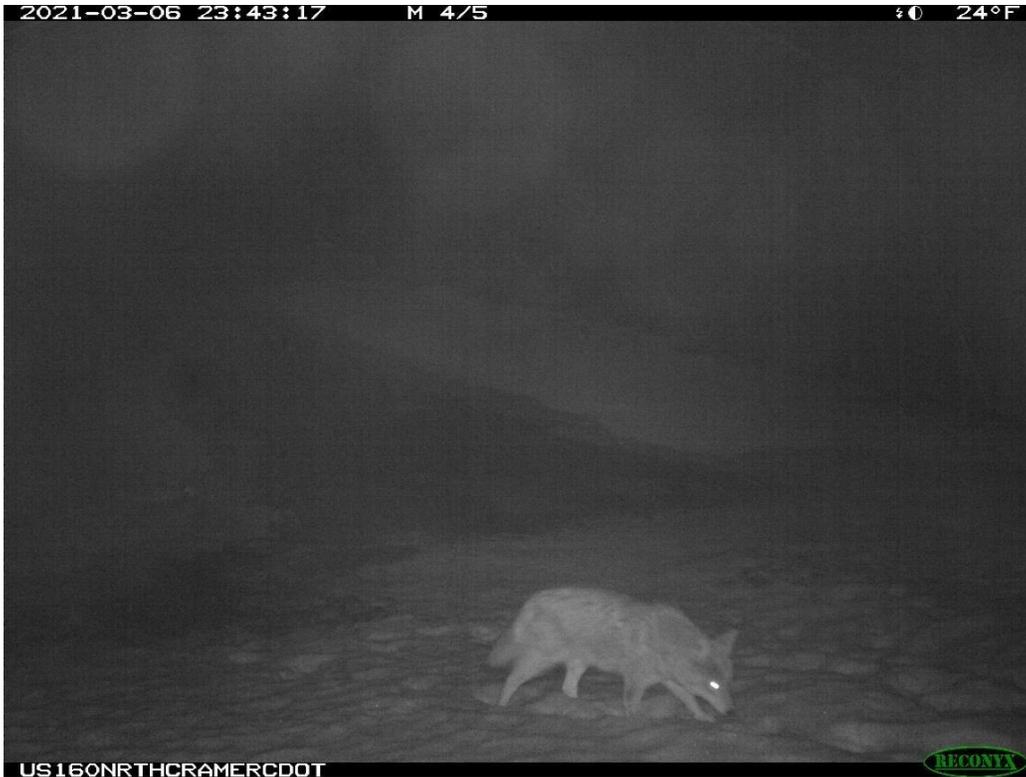
Coyote success movement through the wildlife crossing structure.

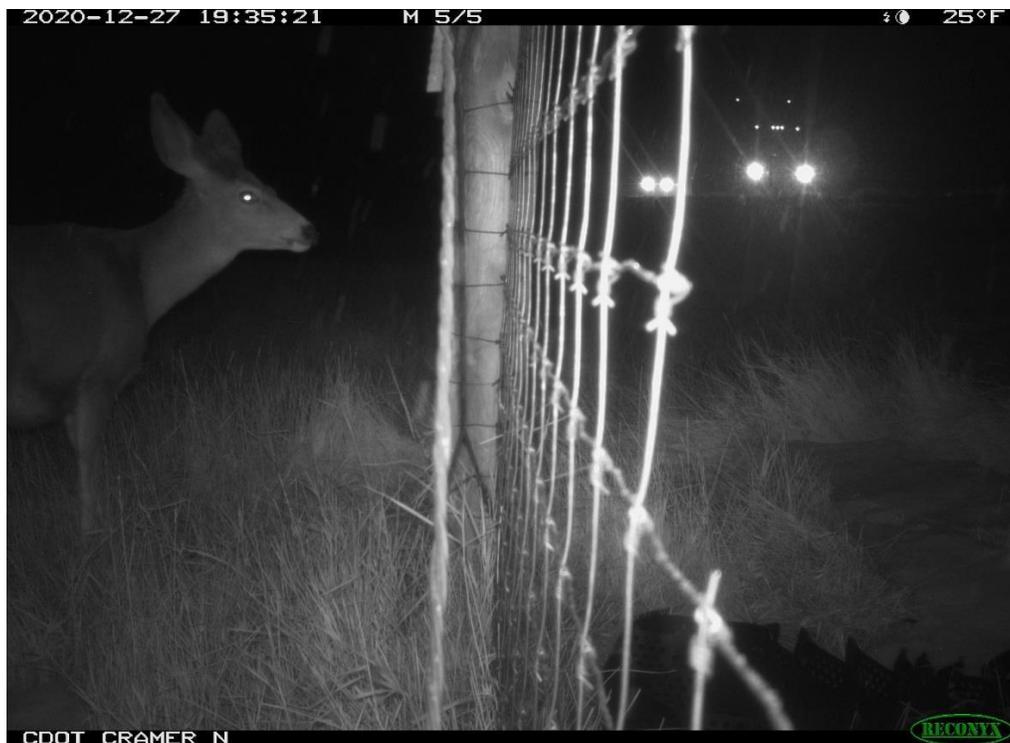
Mule deer success movement over US 160 at the EnviroGrid® Geocell treatment, north fence-end camera, non-interactive movement.

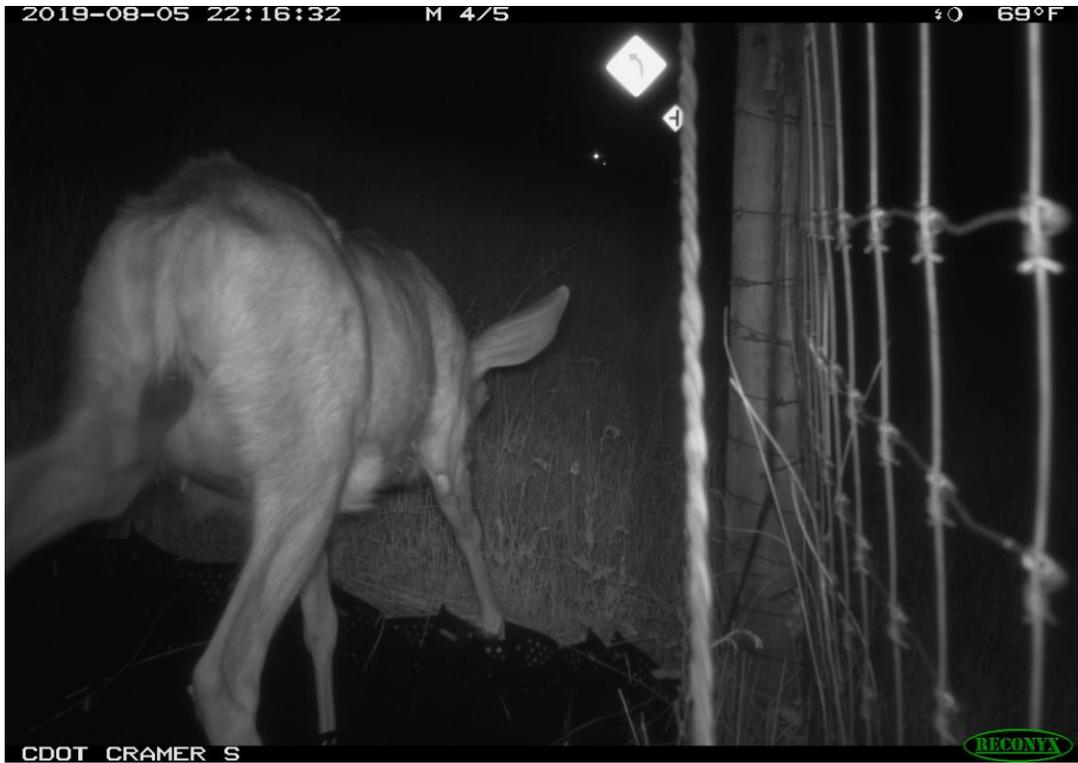
A mule walking over the EnviroGrid treatment to escape the Right-of-Way fenced area.

Mule deer escaped from the fenced mitigated area by moving from west to east over the EnviroGrid® Geocell treatments on four occasions (three escape movements at the north EnviroGrid® Geocell and one escape movement at the south EnviroGrid® Geocell).

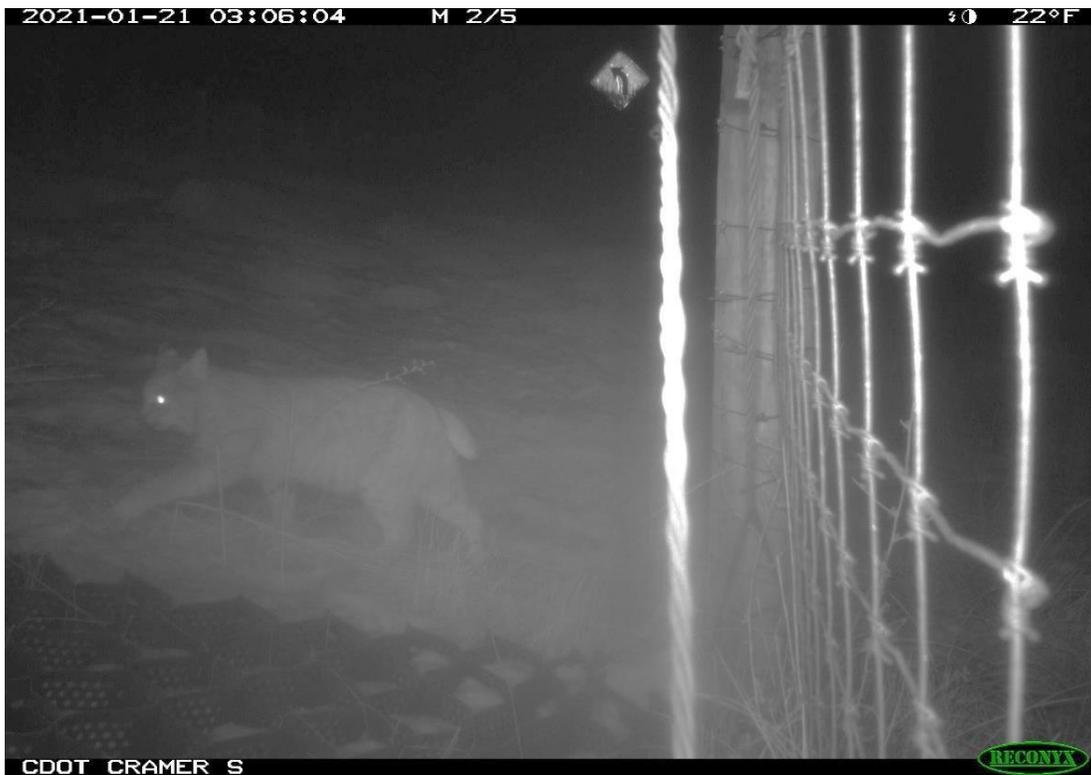
Bobcat movement at the EnviroGrid® Geocell treatment, south fence-end camera.

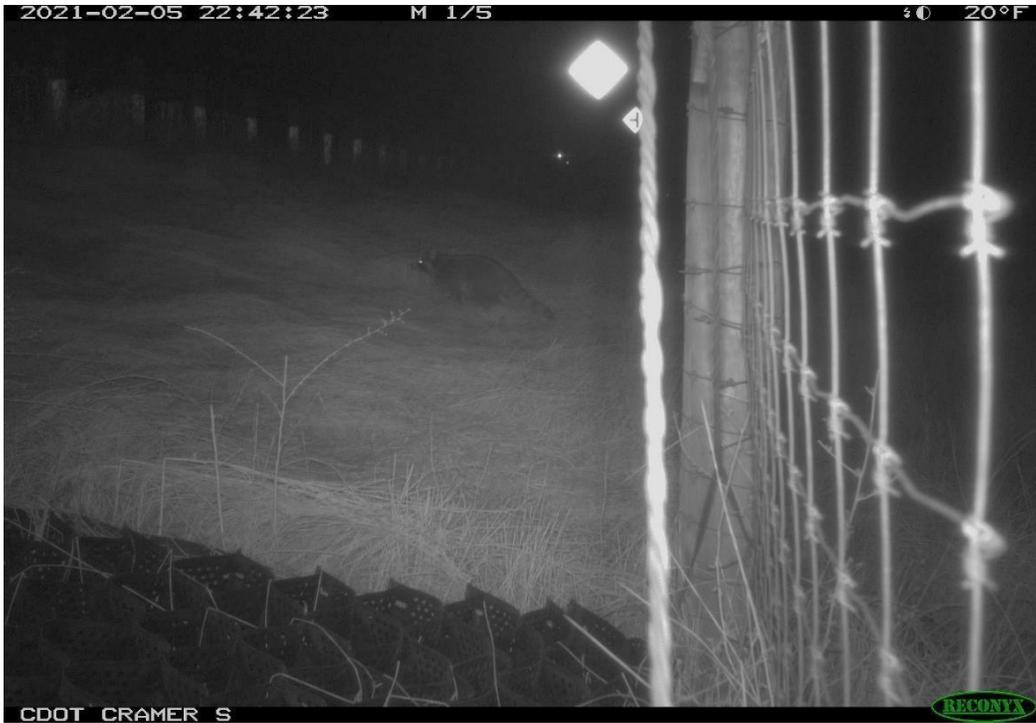
Raccoon success movement over US 160 at the EnviroGrid® Geocell treatment, south fence-end camera, non-interactive movement.
