1. Introduction

Rocky Flats National Wildlife Refuge
 Addendum to Eastern Slope and Plains Wildlife Prioritization Study

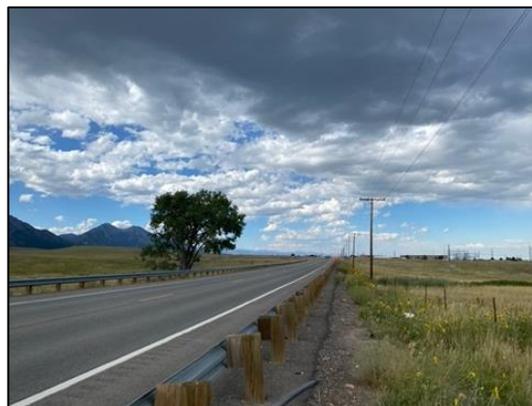
Figure 3-1. SH 93 around MP 8, looking North

This segment of SH 93 between SH 72 and SH 128 runs to the west of the Refuge along the tablelands at the base of the Front Range foothills (Figure 3-2) and, at the northern portion of the segment, crosses the Coal Creek drainage. In addition to Coal Creek, the highway crosses over several smaller drainages and a canal. Table 3-2 summarizes the general roadway characteristics, target species movement patterns, and impacts of WVCs on these populations. WVCs on SH 93 are highest in the northern portions of the segment from MPs 9 to 11.8, but still average fewer than two reported crashes per mile per year. WVCs with elk are highest around MP 9. Barbed-wire right-of-way fence is present on either side of the roadway, and, on the western side, there is also a long stretch of snow fence.

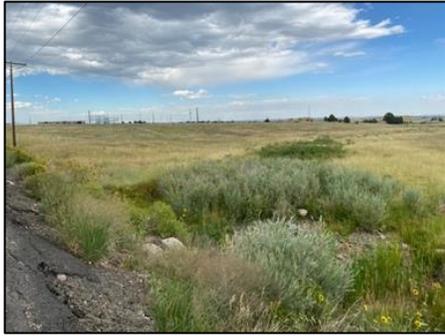
Milepost	Existing Conditions	Mitigation Recommendation	Milepost Photo
8.5	Woman Creek is a small, ephemeral drainage. At this location there is a small pipe in low fill slope. This location is within the highest-ranking segment in the Refuge study area.	Evaluate this location for a low, wide bridge suitable for elk passage. Restore riparian corridor for Preble’s meadow jumping mouse. Investments in a crossing structure in this area would also likely require a conservation easement east of the highway.

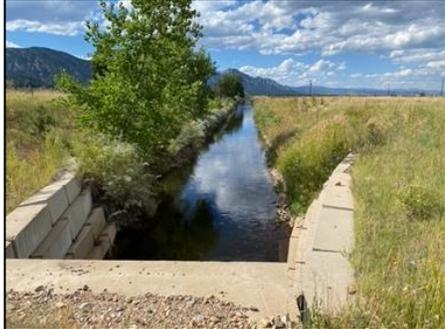
9.2	Walnut Creek irrigation canal. Culvert is skewed relative to roadway. This location is within the highest-ranking segment in the Refuge study area.	Install a small mammal bench and pipe through the culvert.

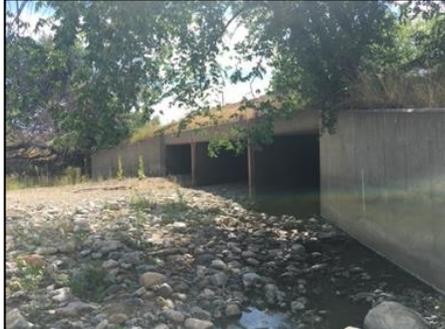
10.9	Coal Creek three-cell box culvert	Replace with a low, wide bridge to facilitate wildlife movement and accommodate high water flows. Restore riparian corridor for Preble’s meadow jumping mouse.

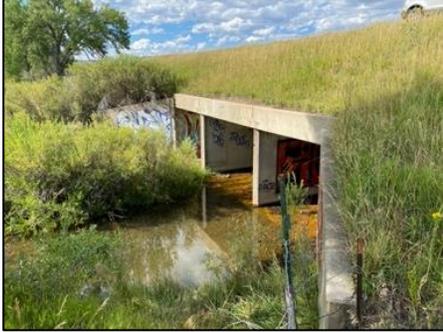
Milepost	Existing Conditions	Mitigation Recommendation	Milepost Photo
0.4	Coal Creek three-cell box culvert. This location is within one of the highest-ranking segments in the Refuge study area.	Replace with a low, wide bridge to facilitate wildlife movement and accommodate high water flows. Restore riparian corridor for Preble’s meadow jumping mouse.

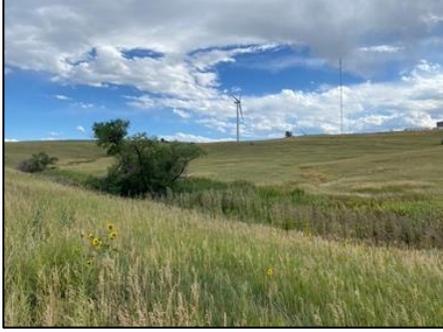
1.1	Low fill slope at small drainage. This location is within one of the highest-ranking segments in the Refuge study area.	Potential location for a large or small/medium fauna crossing.

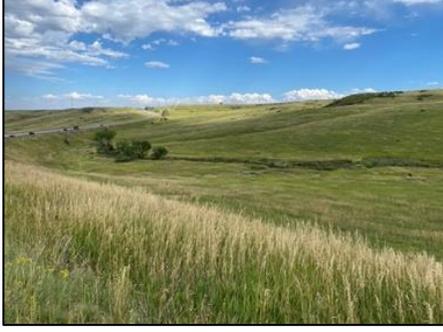
2.5	Large fill slope at Rock Creek drainage with small concrete box culvert. This culvert has been identified as a movement barrier to Preble’s meadow jumping mouse across SH 128.	Install a large bridge underpass suitable for deer, elk, and other wildlife. Restore riparian corridor for Preble’s meadow jumping mouse.
