Report No. CDOH-DTP-R-90-6

# MONITORING A CRIBLOCK RETAINING WALL

Final Report  
December 1990

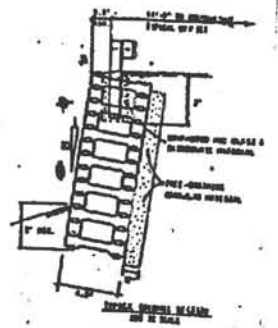
Figure 5. Details of the cribwalls in project BRO 0057(2)

in length, but was designed to be a few feet higher compared to the one on the opposite side. Figure 5 shows the details of the cribwalls for this project.

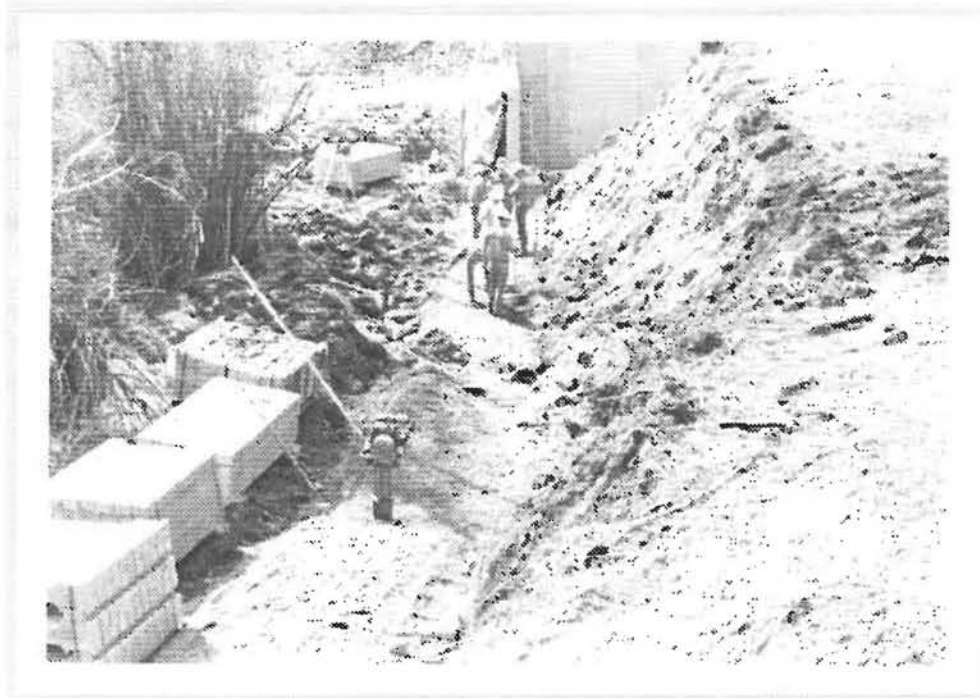
Figure 6. Foundation preparation for the east wall

The base of the walls was cleaned and compacted using vibratory hand compactors as shown in Figure 6. Additional soil, gravel, or a mixture was placed and compacted to create the four vertical to one horizontal slope at the wall base. During this project, four to five inches of sandy gravel was used as base material at the bottom of the walls due to the high ground water elevation encountered at the river level. Figure 7 shows the sandy gravel blanket prior to construction of the walls.

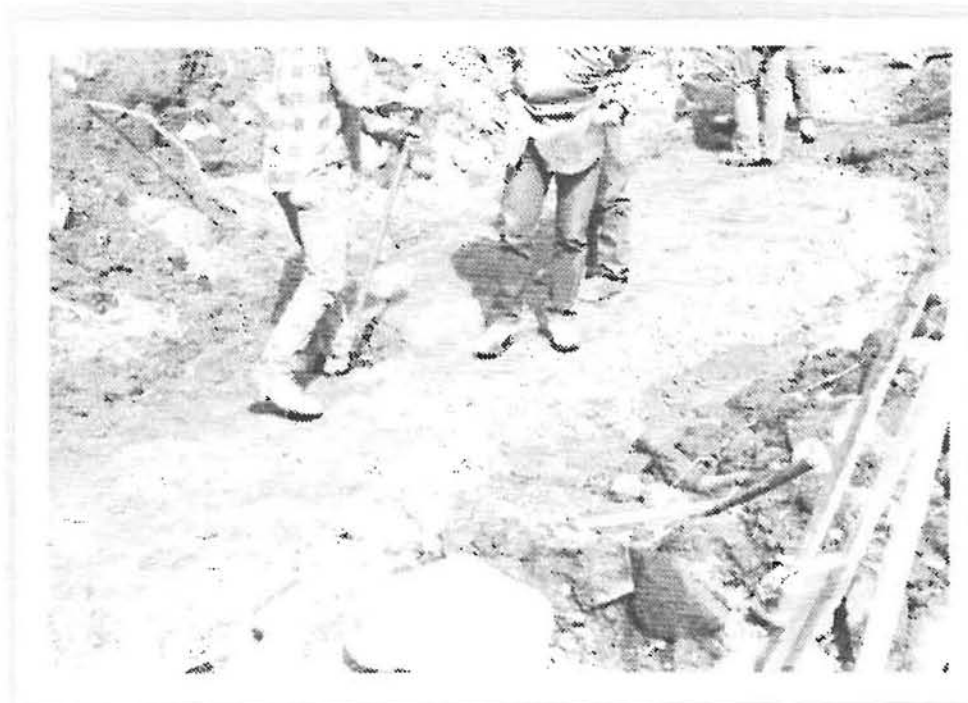
Figure 7. Placement of granular soil at the base of the wall

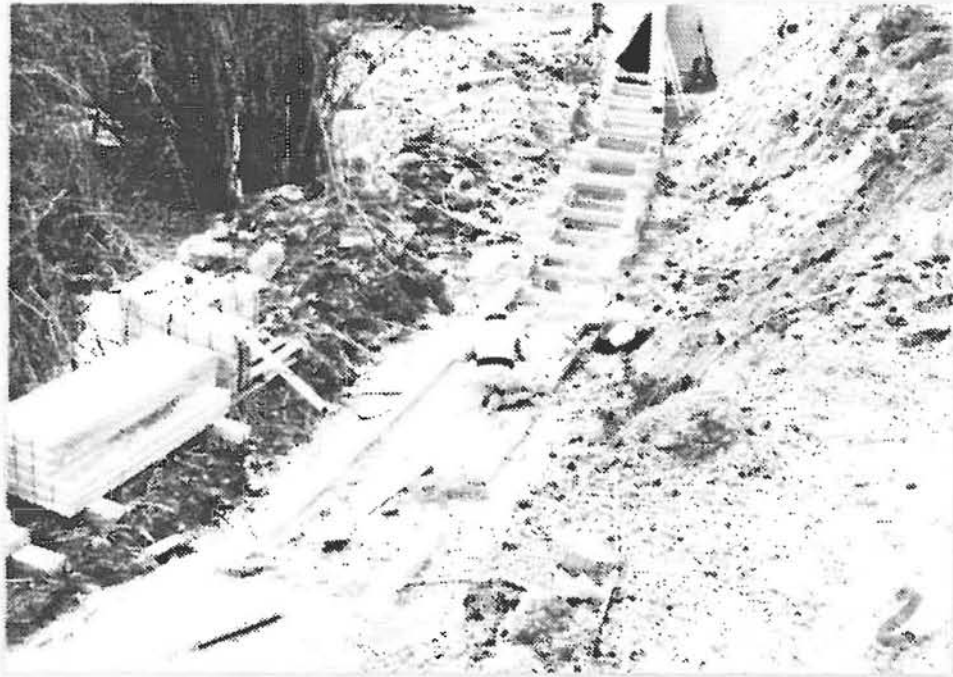
Figure 8. Placement of the front and back stretchers for the east wall

The first course of cribwall units was the front and back stretchers (or closers). This step was carefully done to ensure firm bedding against the base soils. Figure 8 shows the placement of front and back stretchers at the east end of the large cribwall.

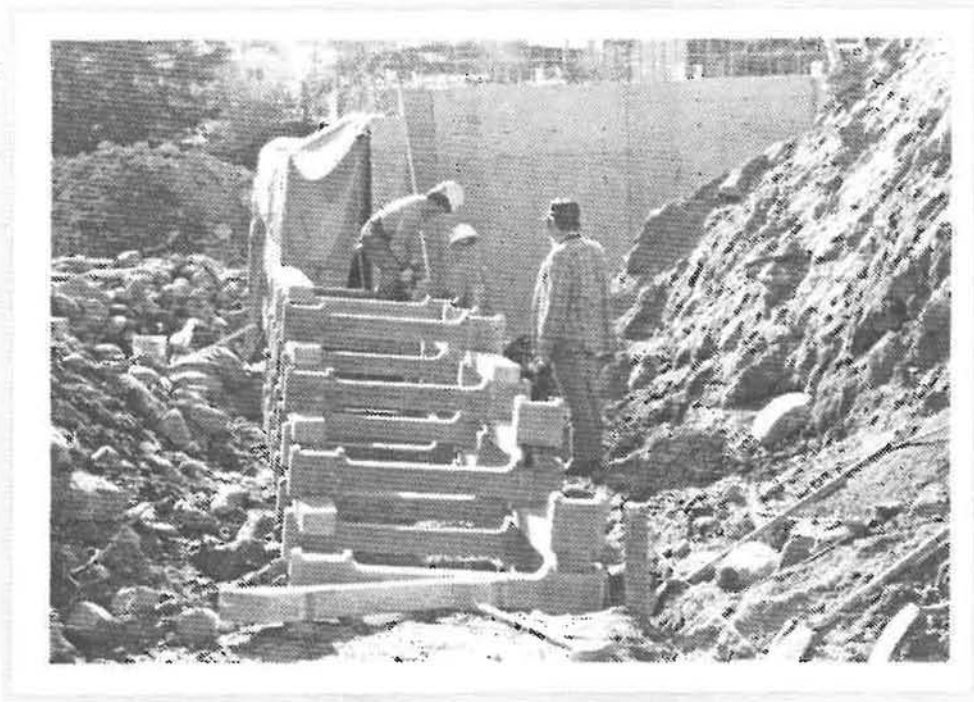
Figure 9. Close-up view of the concrete cribwall components

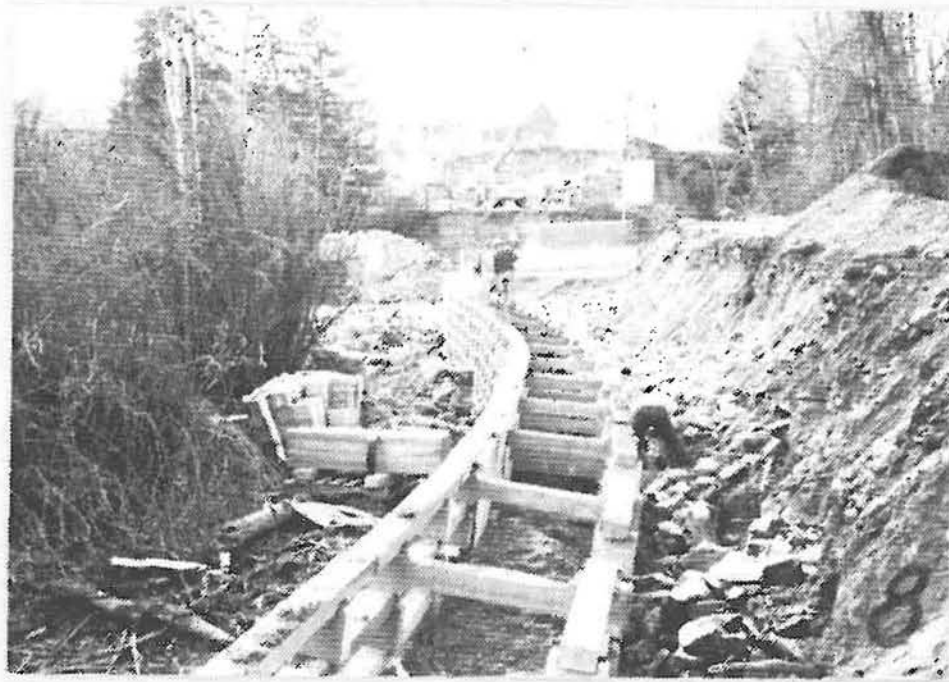
Figure 12 progress of the east cribwall

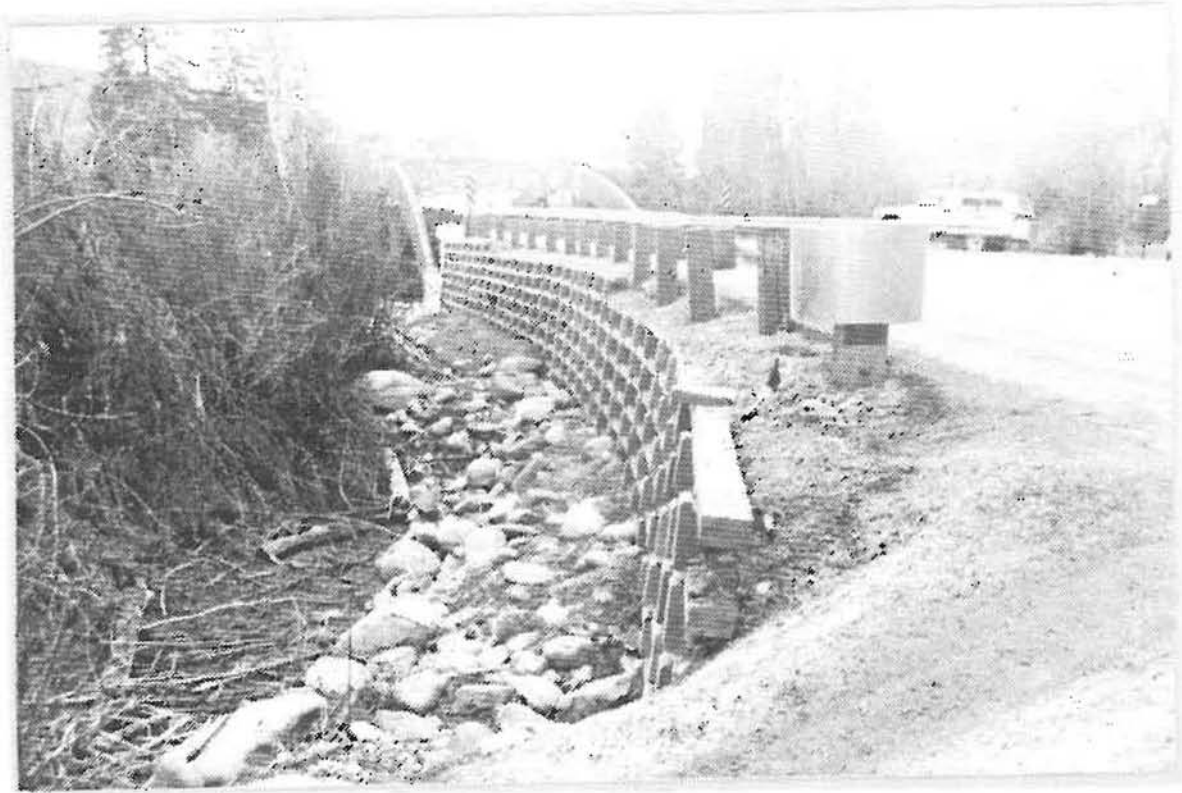
Figure 14. completed east cribwall

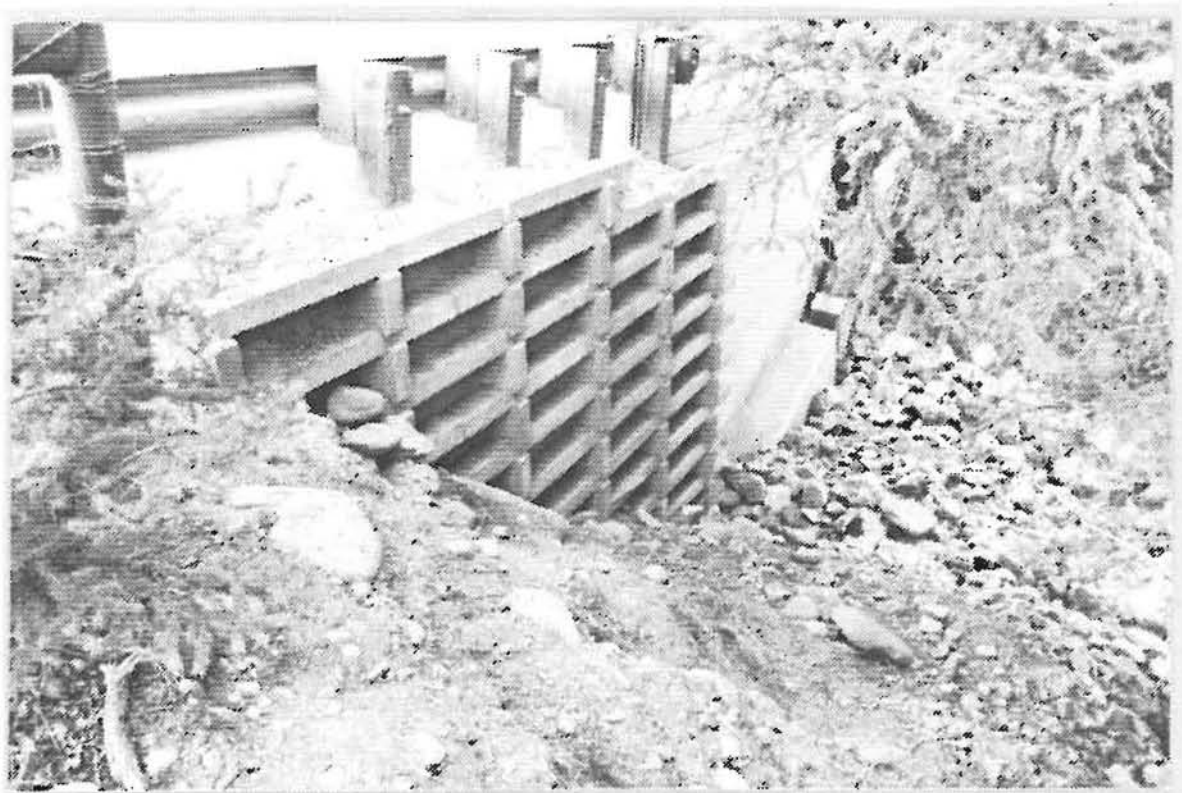
Figure 15. completed west cribwall

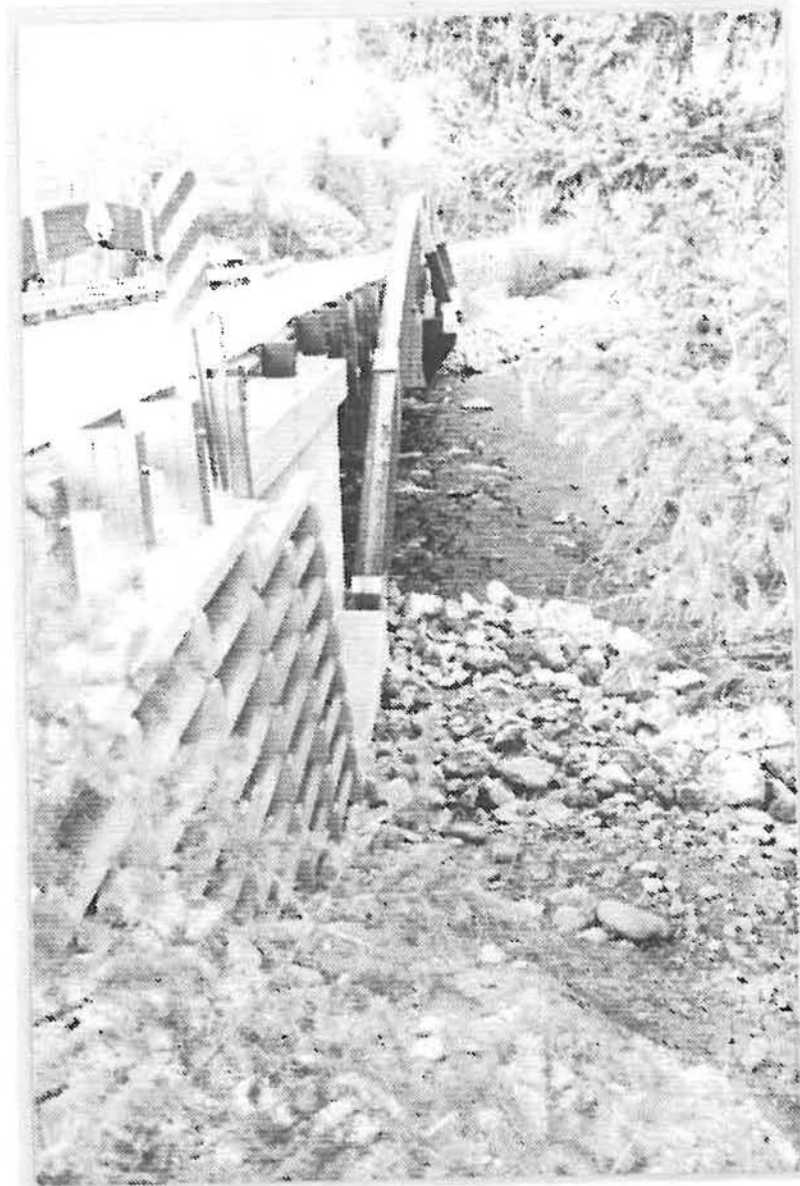
Figure 16 view of the completed structures on project BRO 0057(2)

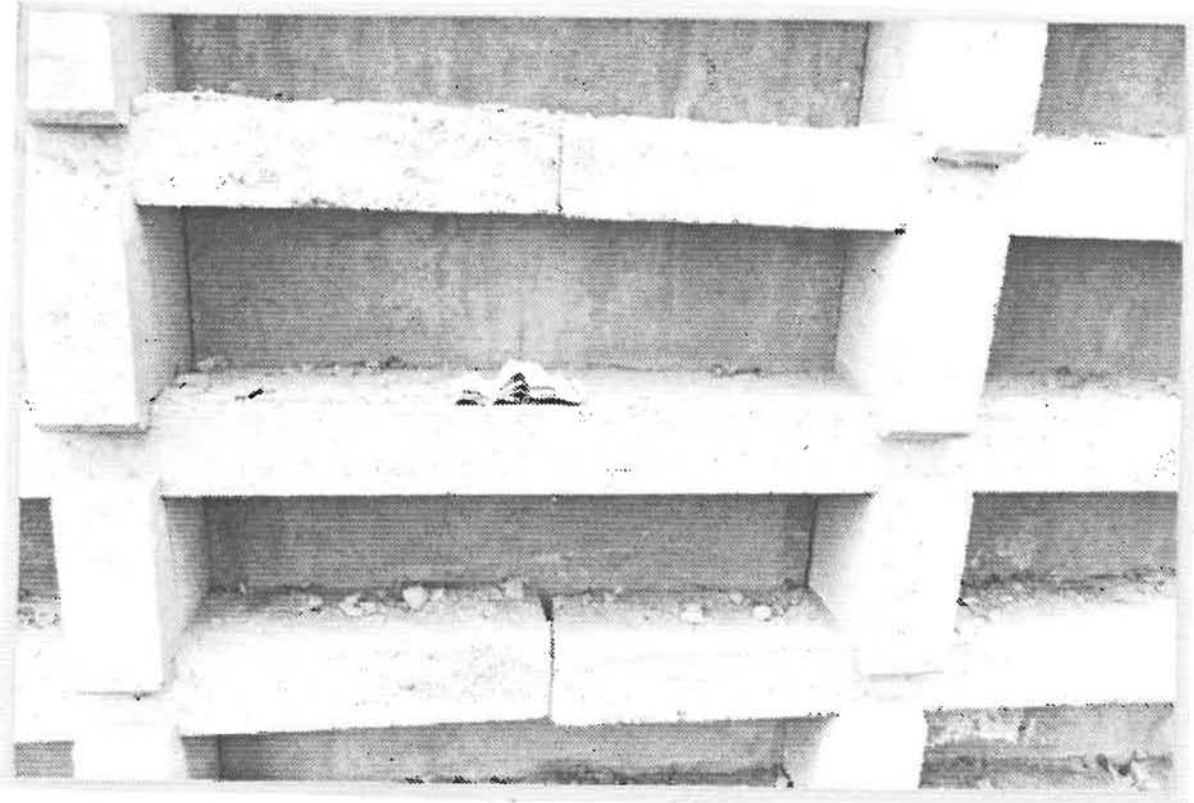
The crib members at the face of the walls (front stretchers) appeared to be in good shape except for two locations where they had lost some alignment due to local settlement and adjustment of the backfill soils behind the walls. This can be seen in Figure 18. These local realignments occurred immediately after the walls were completed, and they did not improve during the 14 months monitoring period.

Figure 18 separation of the concrete blocks due to settlement of the foundation soils

Based on the experienced gained during this study, the cribwall system is suitable where the subsoils beneath the wall are stable and will not experience significant settlement due to the weight of the wall. Therefore, this retaining wall system should be included as an alternative design in the CDOH Retaining Wall selection process.
