Investigation of Premature Distress in Asphalt Overlays on IH-70 in Colorado

Robert B. McGennis
Asphalt Institute
Lexington, KY

Timothy B. Aschenbrener
Colorado DOT
Denver, CO

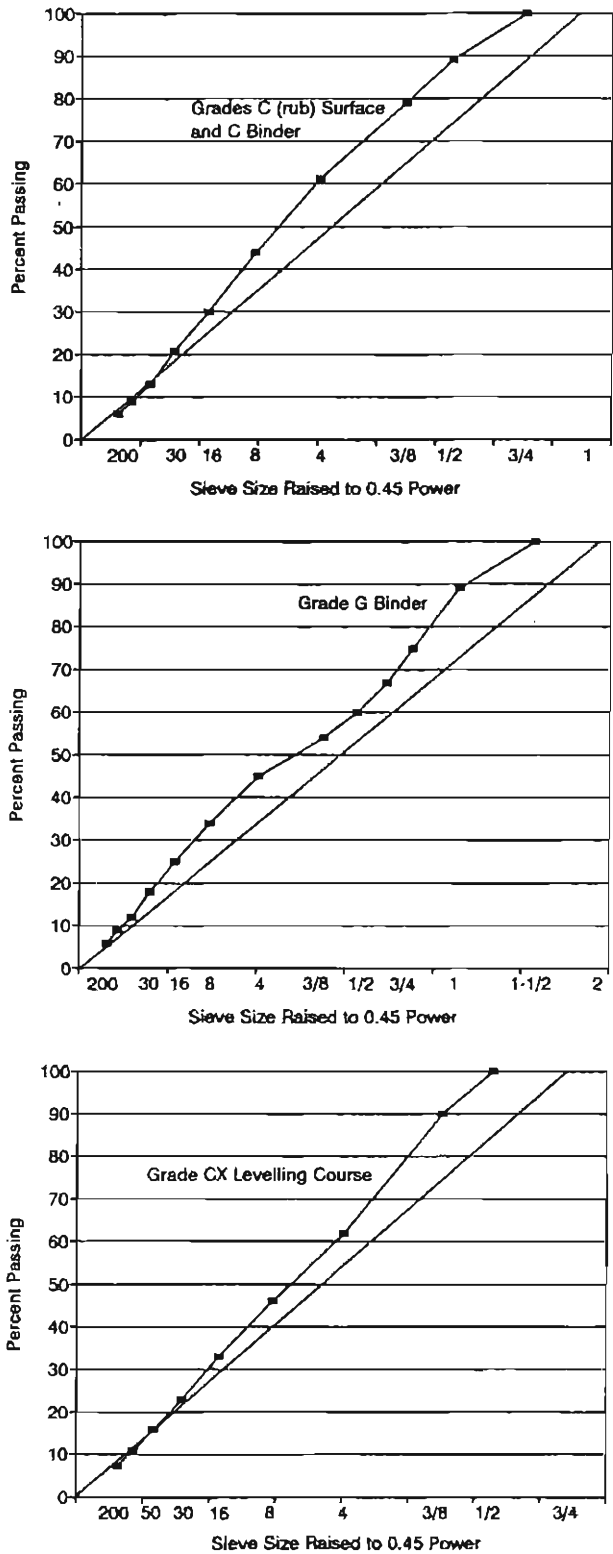
Figure 1. Job-Mix Formula Gradations for Overlay Materials, IH-70

the entire gradation exists on the fine side of the maximum density gradation. Of the fine fraction between about the No. 4 and No. 200 sieve, the gradation is slightly deficient in the material between the No. 4 and No. 30 sieve.

The Grade CX rut filling course (Fig 1) is very dense. Its gradation plots in a straight line on the fine side of the maximum density gradation. Because this mixture was expected to be placed in very thin lifts, mostly less than 1-inch, it was designed to be entirely finer than 1/2-inch. If covered immediately by a binder or wearing course, it would likely serve its only intended function: rut filling and levelling.

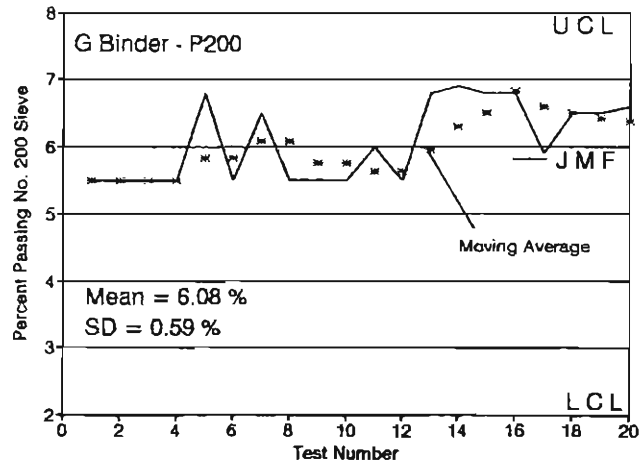
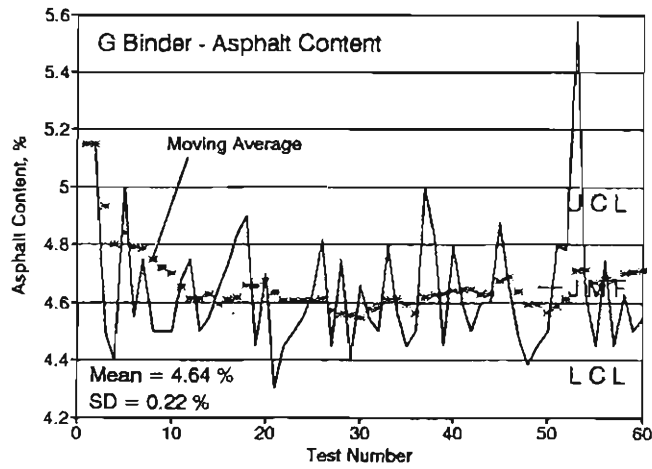
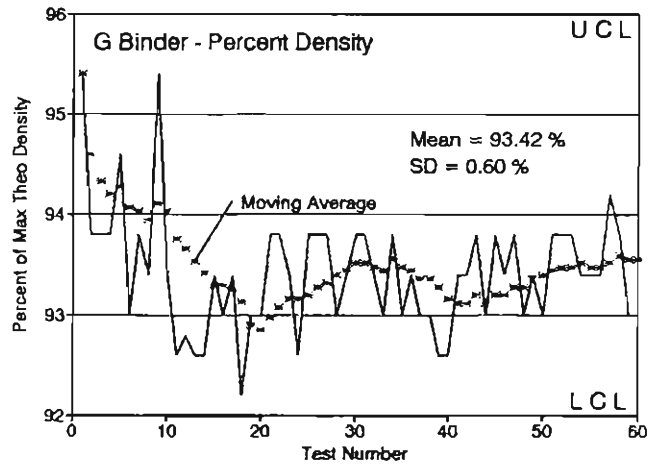
Figure 5. Quality Control Test Results for G Binder Course, IH-70

G Binder. Figure 5 illustrates contractor quality control test results for the G binder course. As produced, this asphalt mixture did not possess significantly more P200 than the design value. Twenty test results showed the P200 to average about 6.1 percent as compared to the design value of 5.8 percent. The average asphalt content shown by the test results in Fig 5, 4.64 percent, was practically the same as the design value, 4.65

The other notable feature of the CDOT test results is the low TSRs for the G binder course. TSR values for the G binder course were highly variable with two of four values lower than desired. These values suggest that the G binder course was, at times, moisture susceptible.

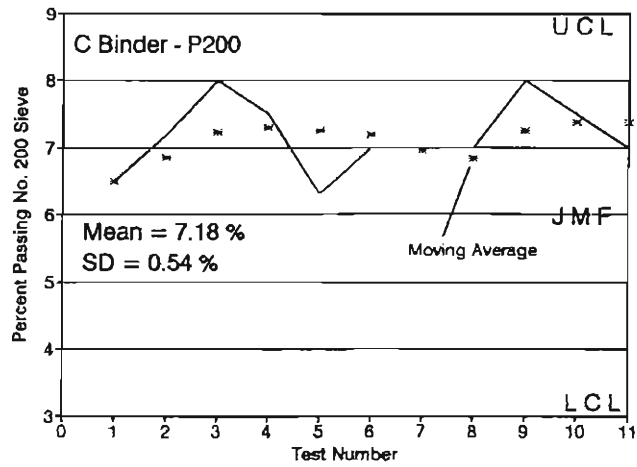
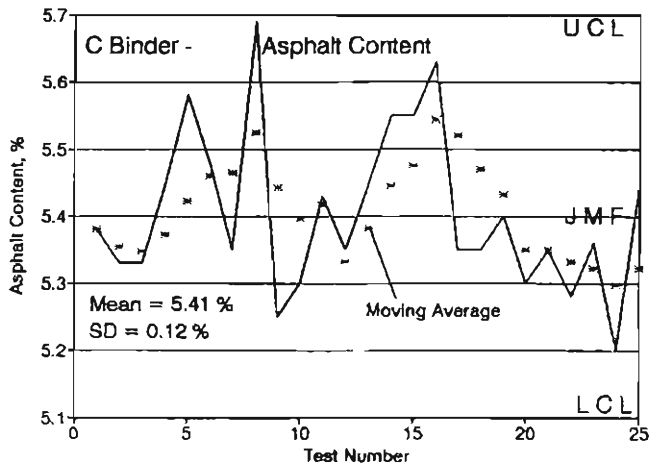
Figure 6. Quality Control Test Results for C Binder Course, IH-70

C Binder. Contractor quality control test results are shown in Fig 6. Test results on the C binder course exhibited similar trends to the C (rubberized) surface. The P200 averaged about 7.2 percent which is 1.2 percent higher than the design value, 6.0 percent. The measured asphalt content was identical to the design value, both at 5.4 percent. In-place density averaged over 93 percent.

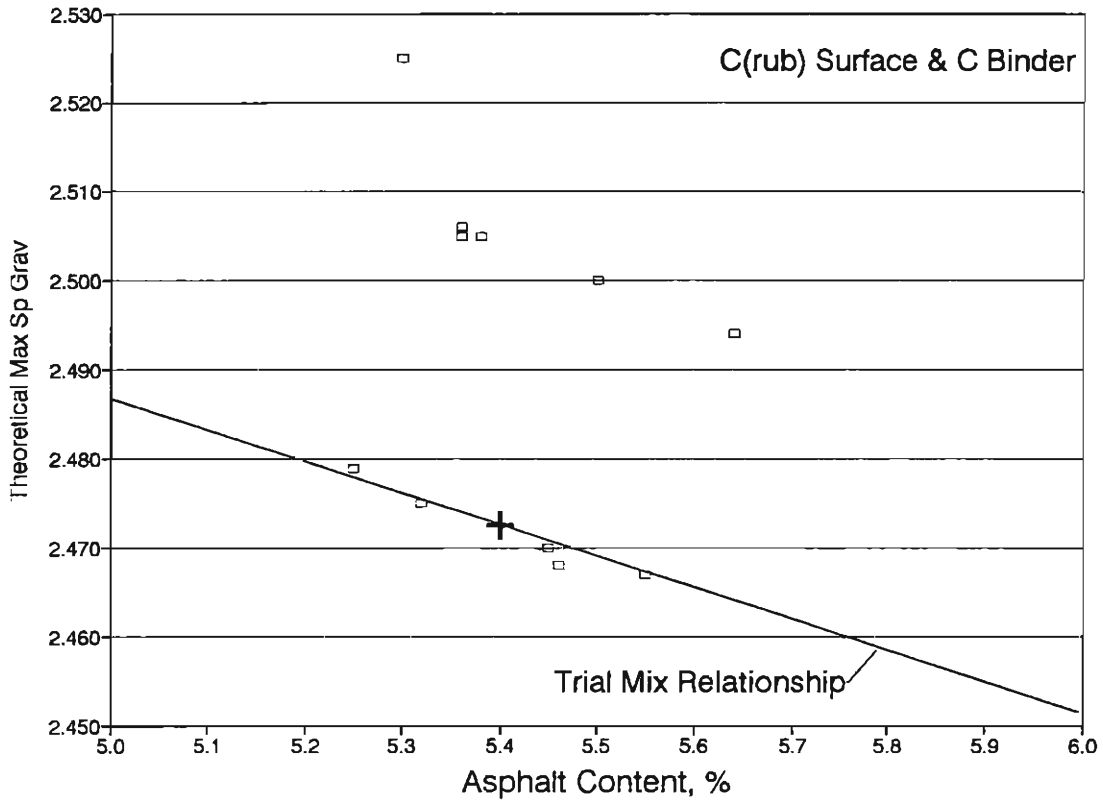
Figure 7. TMSG Independent Assurance Test Results for C Mixtures, IH-70

One perplexing aspect of the CDOT test results is the relatively high air void content for the C (rubberized) and C mixtures shown in Table 6. The mix design for these two materials indicated an air void content of 3.4 percent at the design asphalt content of 5.4 percent. However, the P200 during design was about 1 percent lower than what was actually produced and measured by both CDOT and the contractor on cold feed belt samples. Recent findings by the FHWA (Ref 2) would have suggested a corresponding decay in air voids with this increase in P200 at the same asphalt content.

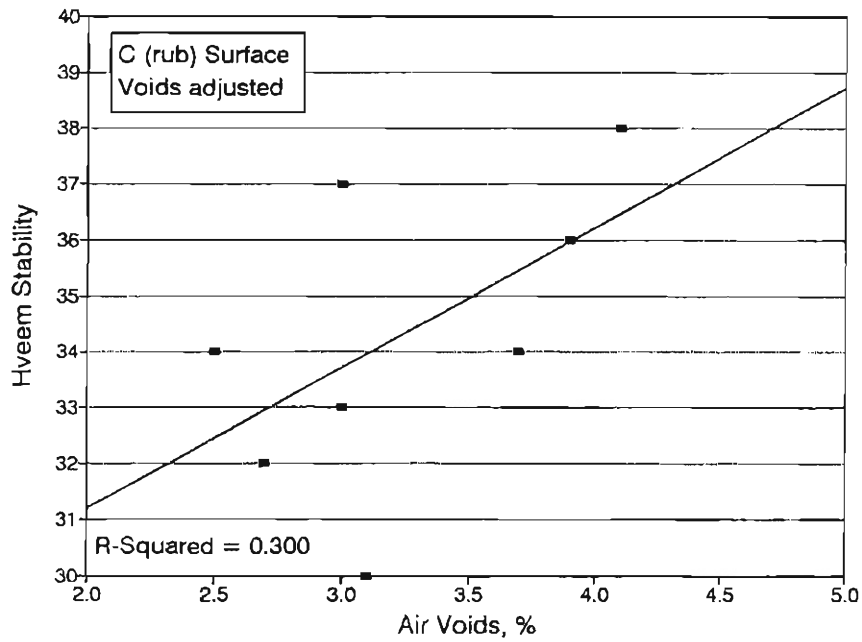
Figure 8. Hveem Stability versus Non-Adjusted and Adjusted Air Void Content, IH-70

Support for this theory is provided by Figure 8 which shows plots of Hveem stability versus air void content for the original and adjusted air void contents. The plot of stability versus original air void content exhibits no correlation ($R\text{-squared} = 0.01$). None of the variation in stability is explained by the air void content and stability appears to be insensitive to air voids. The plot of stability versus adjusted air void content indicates a

better correlation ($R\text{-squared} = 0.30$). At least some of the variation in stability is explained by air void content. In addition, the shown trend is logical; that is, stability is proportional to air void content.

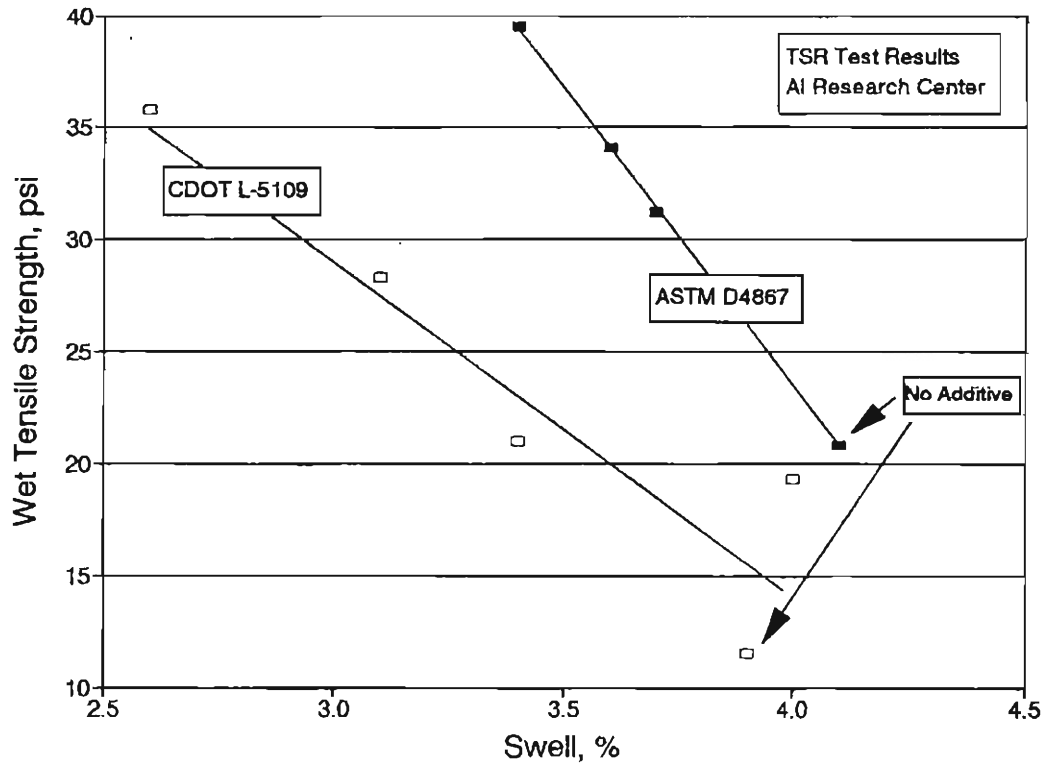
Figure 20. Wet Tensile Strength Versus Swell for AI Moisture Susceptible Tests, IH-70

Final swell values were in the range from about three to four percent. These values are very high when compared with other mixtures tested at the AI Research Center. Partial swell values, that is, measured after vacuum saturation, were within the range normally encountered by the AI Research Center. One partial swell value, 0.5 percent, was unusually high. These results indicate that the freeze-thaw conditioning cycle caused an abnormally high volume change in the specimen.

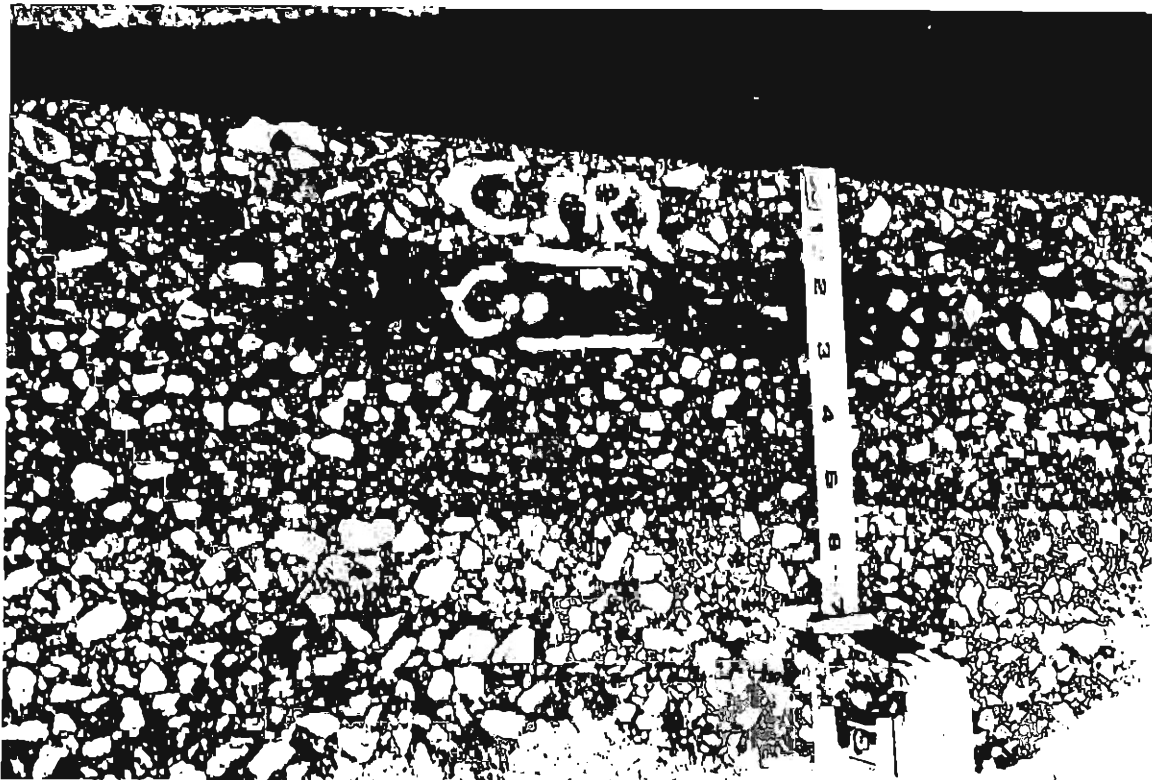
Figure D. Trench Cross Section at MP 375 WB, IH-70
(Note wet, damaged C binder layer.)

During this investigation, this information was conveyed to CDOT. Joint discussion arrived at a consensus that a trench should be excavated to gain a more thorough observation of the failed pavement structure. A trench was excavated at MP 375 WB in the driving lane and outside shoulder. Observations of the pavement section corroborated the findings of the core observations. That is, the C binder layer was damaged. This layer also tended to retain moisture from wet sawing. Alternatively, it may have been wet prior to sawing.
