Report No. CDOT-DTD-R-92-11

**COMPARISON OF RESULTS OBTAINED
FROM THE FRENCH RUTTING TESTER
WITH PAVEMENTS OF KNOWN FIELD
PERFORMANCE**

Timothy Aschenbrener
Colorado Department of Transportation
4340 East Louisiana Avenue
Denver, Colorado 80222

Final Report
October 1992

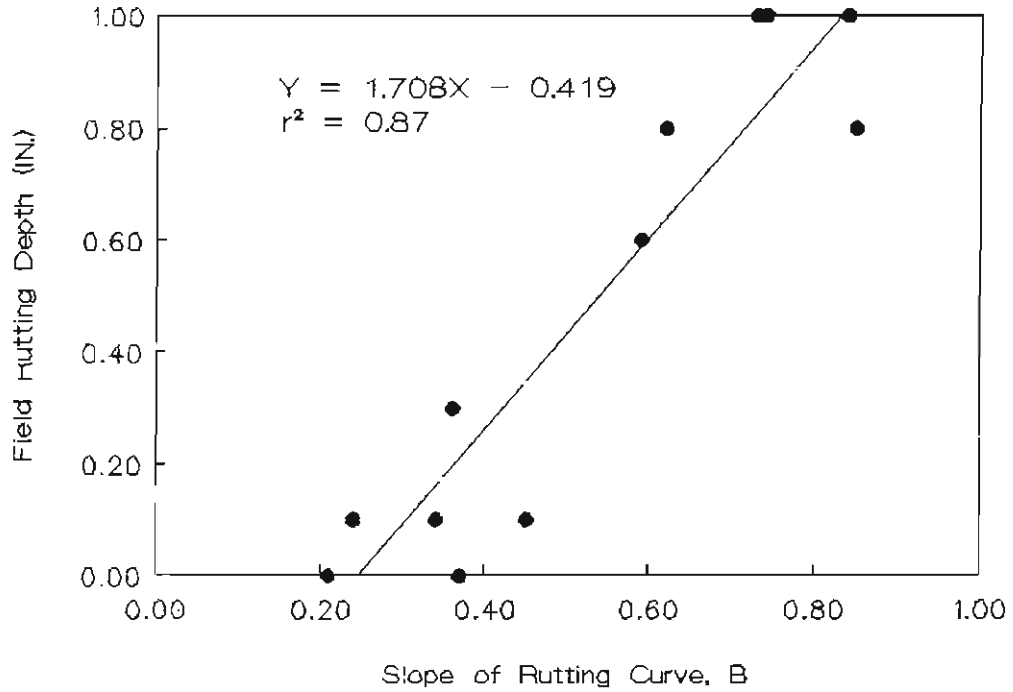
Fig. 2

For High Traffic with 60° C or 50° C Test Temperature

Prediction of Rutting Depth. Additional analysis was performed in order to determine if the test could be extended beyond a "go, no-go" criteria and was used to forecast actual rutting depths. The results from the French rutting tester used in the analysis were the slope of the rutting curve, B, as defined in Equation 1 and the log of the cycles at failure, C. The slopes and cycles were plotted versus actual pavement rutting depths. The regression results as expressed by the coefficient of determination, r^2 , are shown on Table 11. The low temperature sites were not included in these regressions since no testing was performed at 60°C.

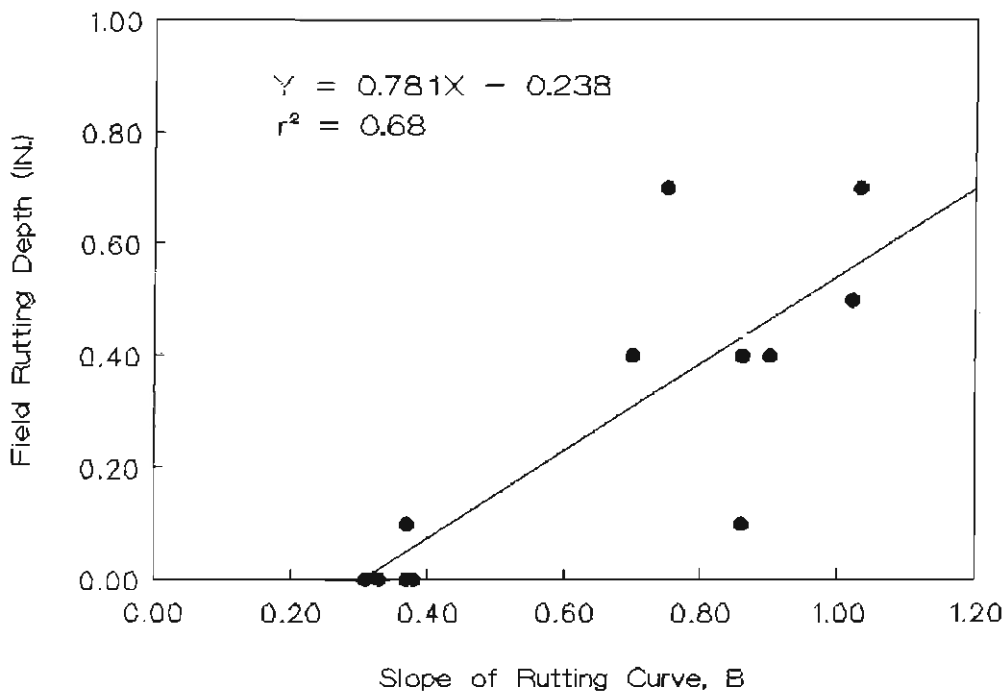
Fig. 3

For Low Traffic with 60° C or 50° C Test Temperature

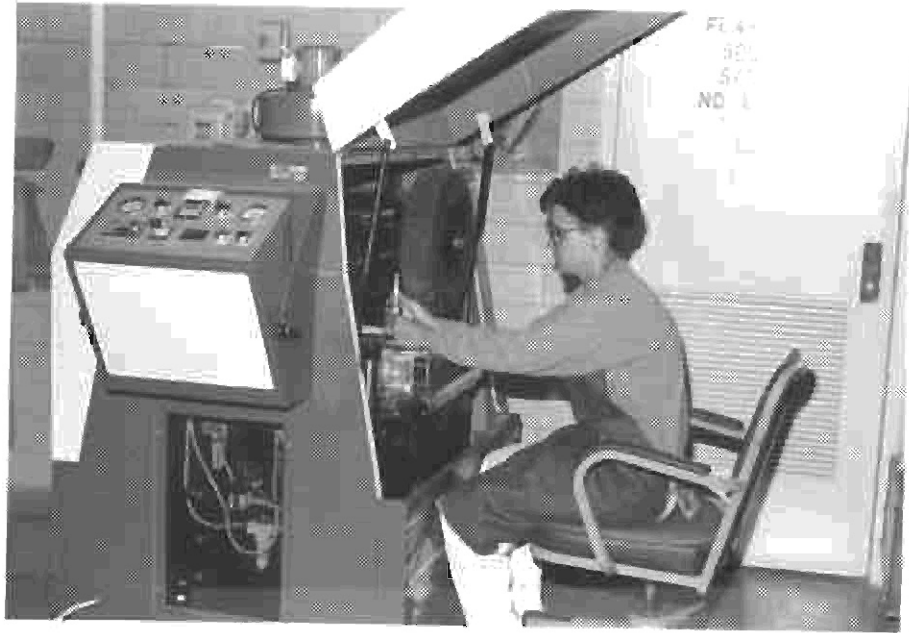
Photo 1

Measuring rutting depths on a slab in the French rutting tester.

Testing Equipment and Procedure. To evaluate resistance to permanent deformation, the French rutting tester (Photo 1, Appendix A) is used on a confined slab. The slab is 50 by 18 cm (19.7 by 7.1 in) and can be 20 to 100 mm (0.8 to 3.9 in) thick. A 100 mm thick slab weighs approximately 15 kg (33 lbs).

Two slabs can be tested simultaneously. The slabs are loaded with 5000 N (1124 lbs) by a pneumatic tire inflated to 0.6 MPa (87 psi). The tire loads the sample at 1 cycle per second; one cycle is two passes. The loading time on any given point on the slab is approximately 0.1 second. The chamber is typically heated to 60°C (140°F) but can be set to any temperature between 35° and 60°C (95° and 140°F).

When a test is performed on a laboratory compacted slab, it is aged at room temperature for as long as seven days. It then is placed in the French rutting tester and loaded with 1000 cycles at room temperature. The deformations recorded after the initial loading are the "zero" readings. The sample is then heated to the test temperature for 12 hours before the test begins. Rutting depths are measured after 100, 300, 1,000, 3,000, 10,000, 30,000 and possibly 100,000 cycles (Photo 1, Appendix A). The rutting depth is reported as a percentage of the slab

thickness. After a given number of cycles, the percentage is calculated as the average of 15 measurements (five locations along the length and three along the width) divided by the original slab thickness. A pair of slabs can be tested in about nine hours.

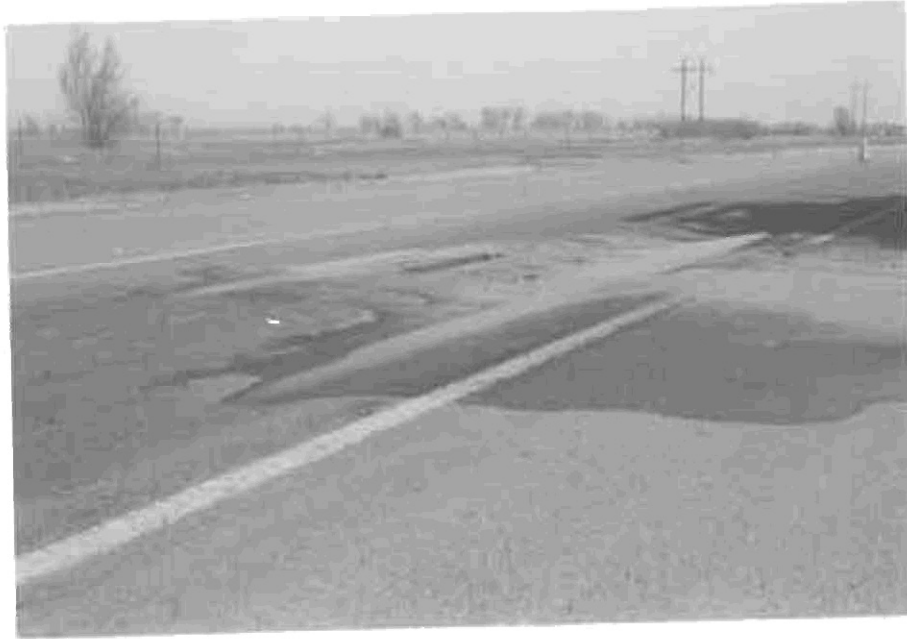
Photo 2

Sites were sawed between the wheels paths and parallel to the direction of travel.

Cores and slabs were obtained from each selected site. Slabs were sawed between the wheel paths and parallel to the direction of travel. Three slabs were obtained at each location (Photos 2 and 3, Appendix A). Five, 4-inch diameter cores were obtained between the wheel paths and three, 4-inch diameter cores were obtained in the wheel paths. The thickness of lifts at each site was identified by observing and measuring the slabs.

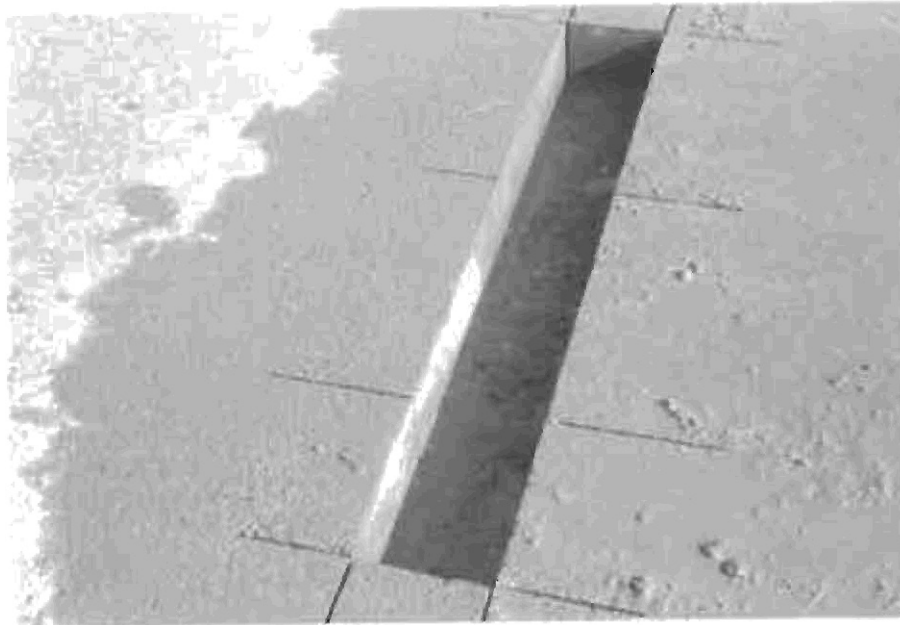
Photo 3

Three slabs were obtained at each location. The slabs cut in the field were 7.1" wide and 19.7" long. The depth of the slab varied depending on the thickness of the pavement.

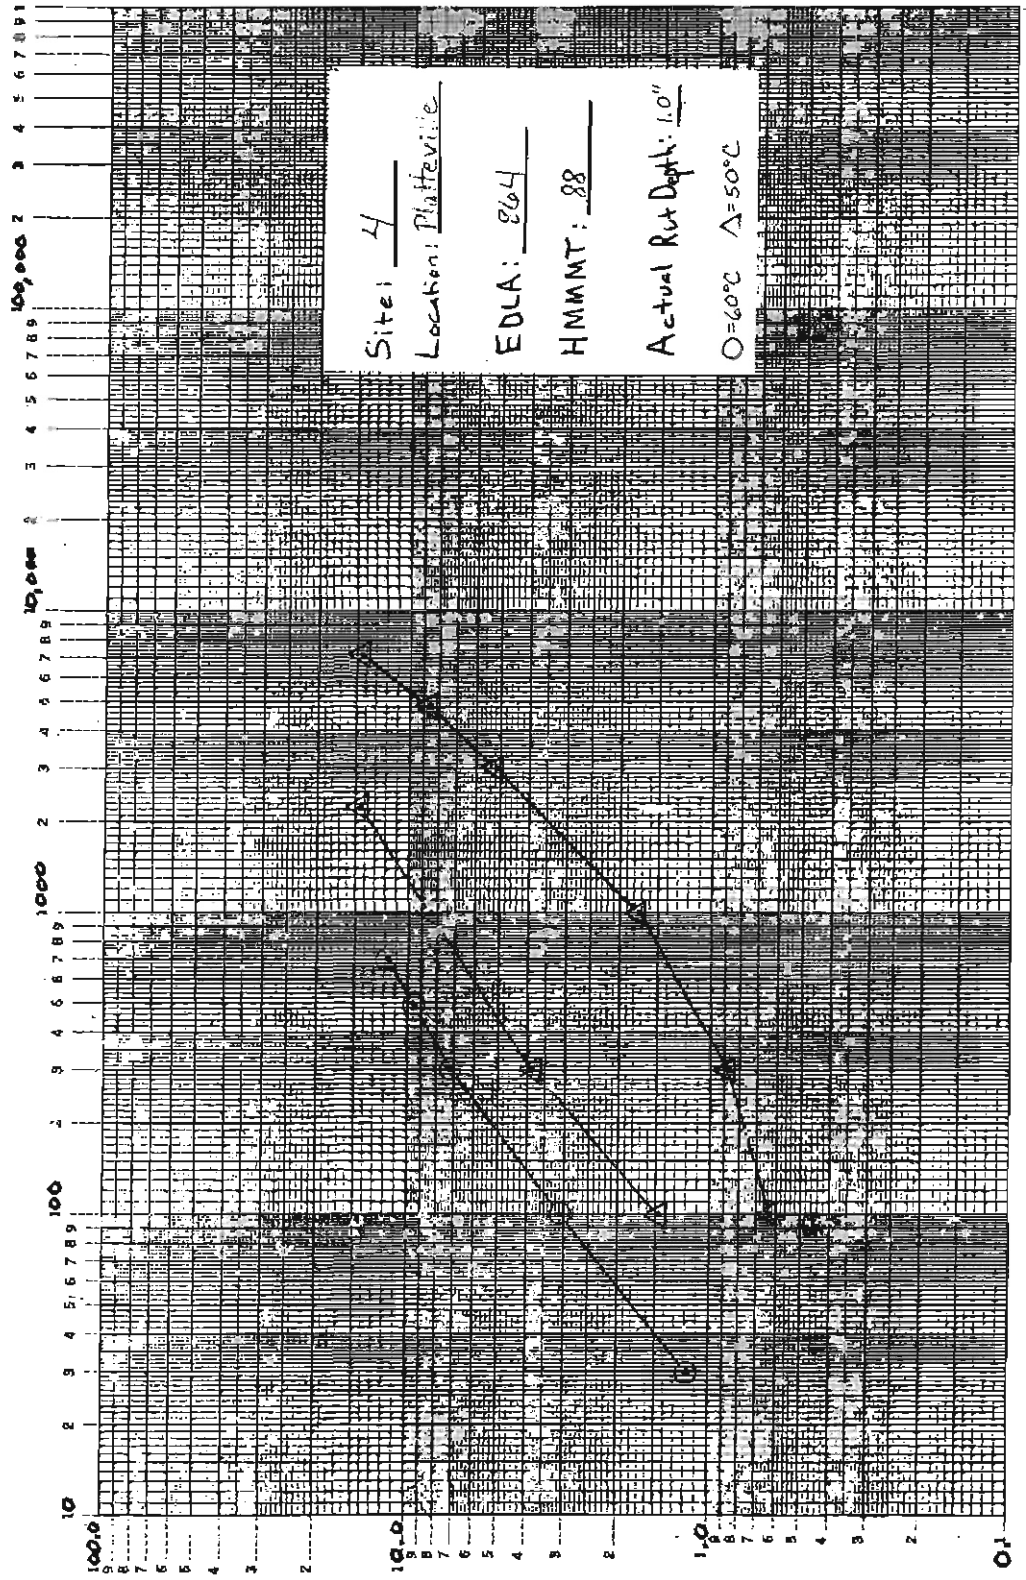
Site: 4
 Location: Platteville
 EDLA: 264
 HMMMT: 88
 Actual Rut Depth: 1.0"
 O = 60°C Δ = 50°C

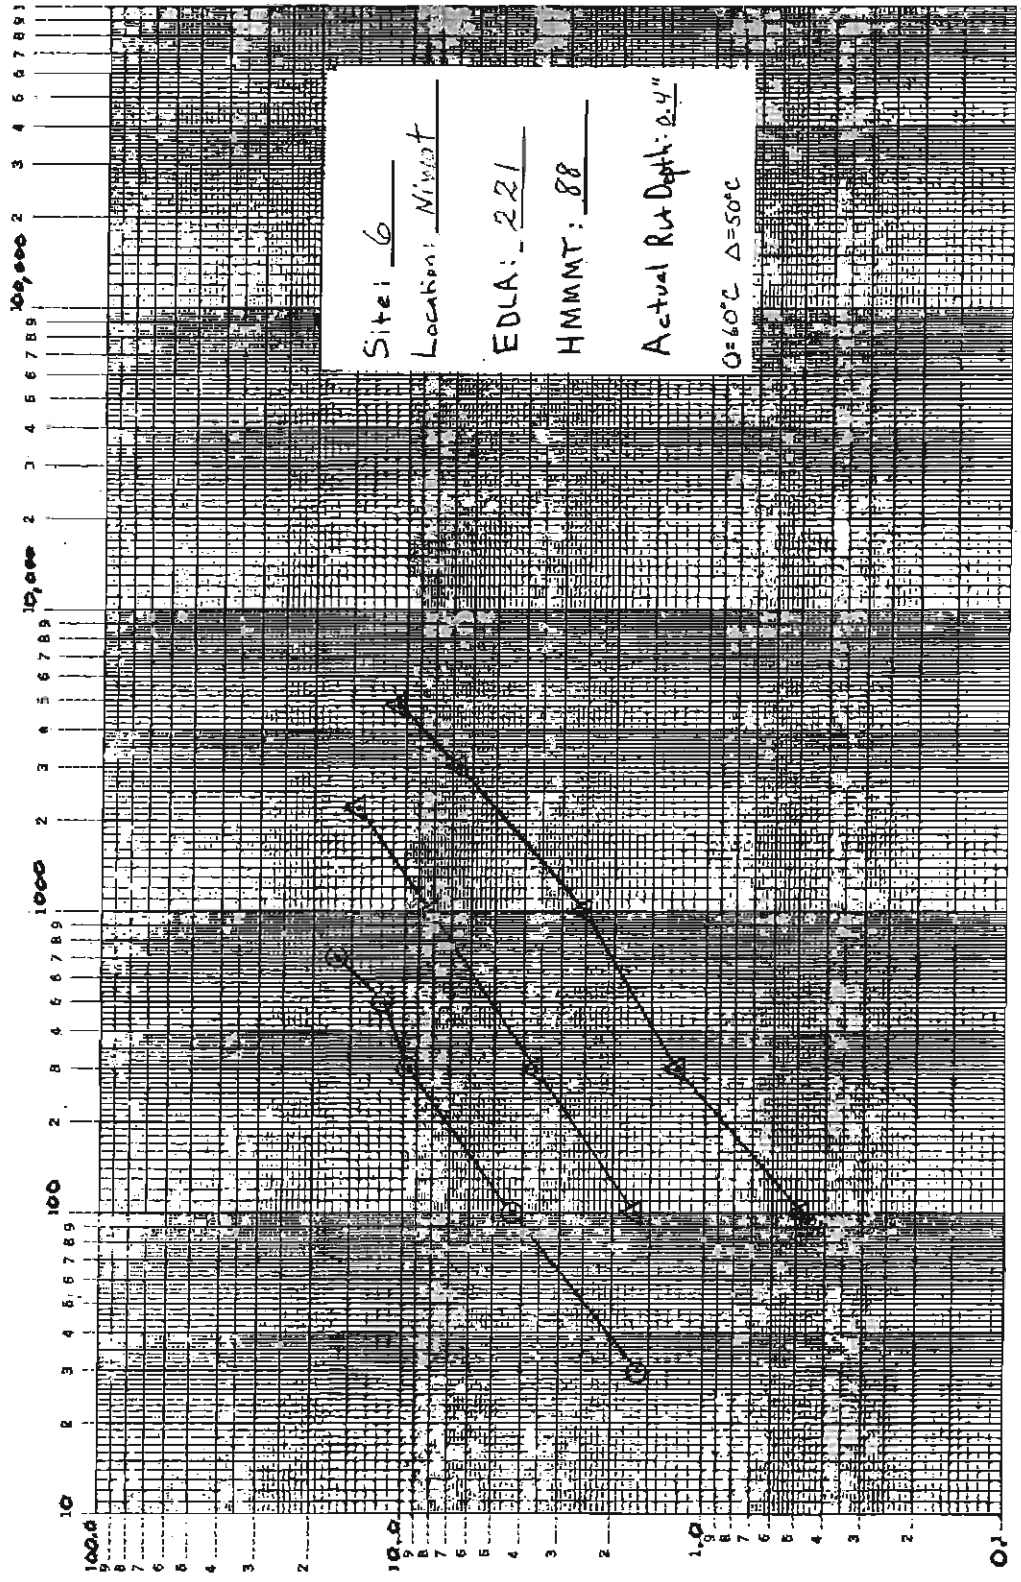
Site: 6
 Location: Nimrod
 EDLA: 221
 HMMMT: 88
 Actual Rut Depth: 0.4"
 $\Delta = 60^{\circ}\text{C}$ $\Delta = 50^{\circ}\text{C}$

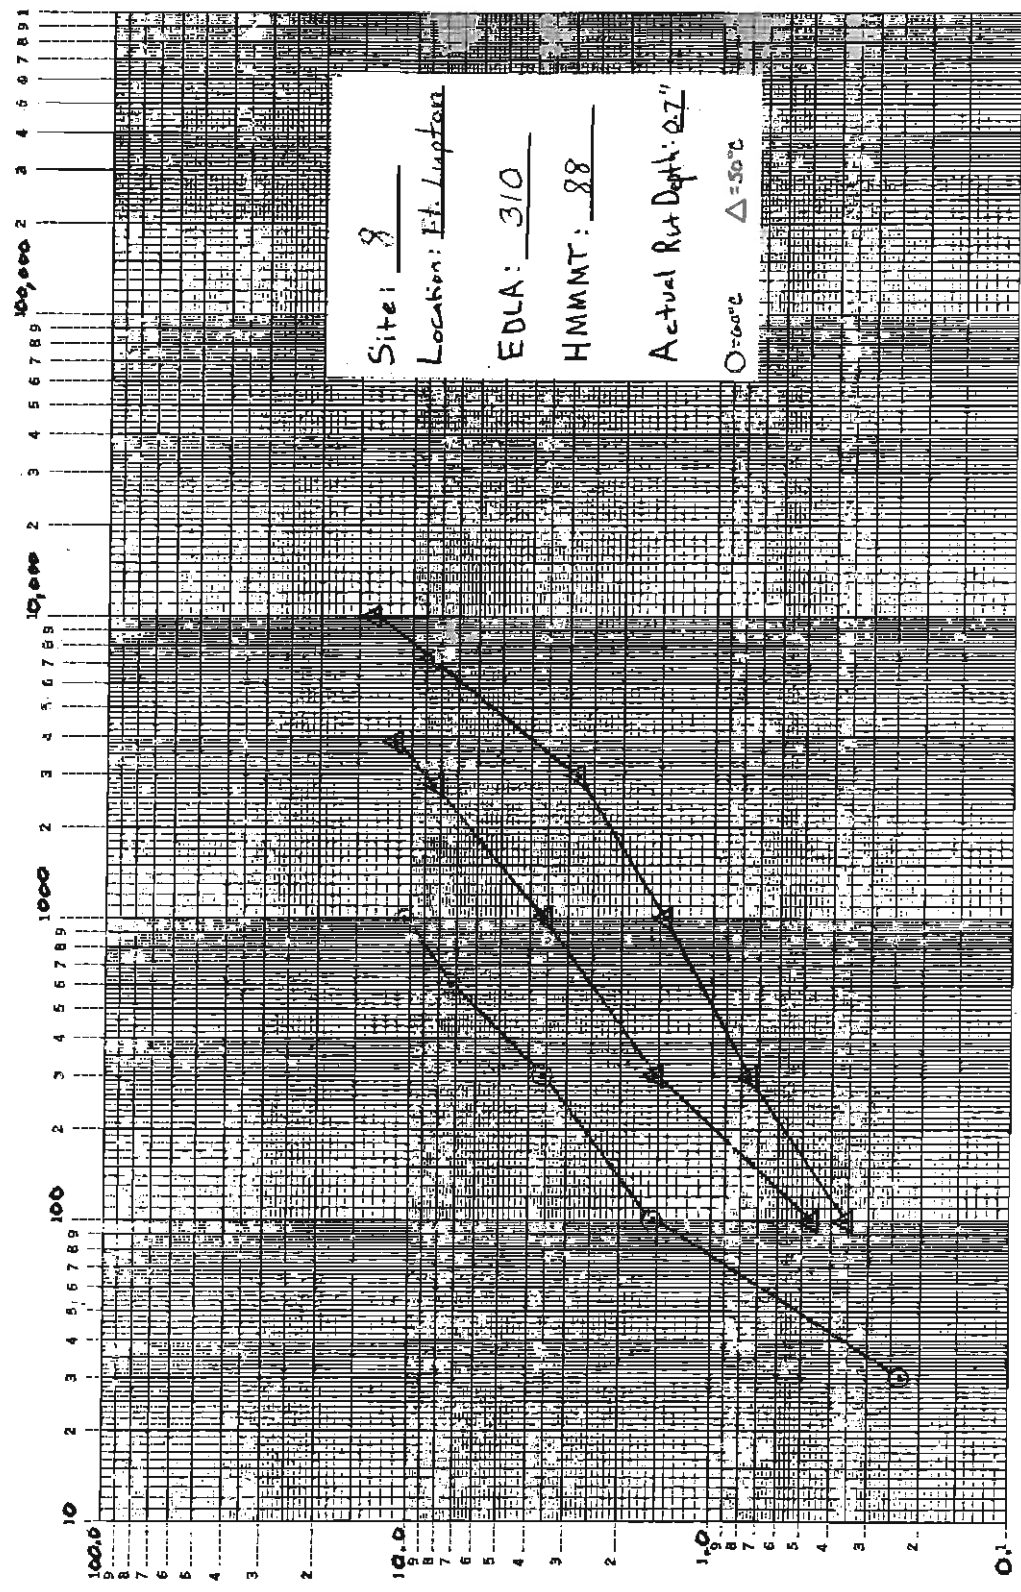
Site: 8
Location: Ft. Leptan
EDLA: 310
HMMNT: 88
Actual Rot Depth: 0.27"
O= 60° C $\Delta=50^{\circ}$ C

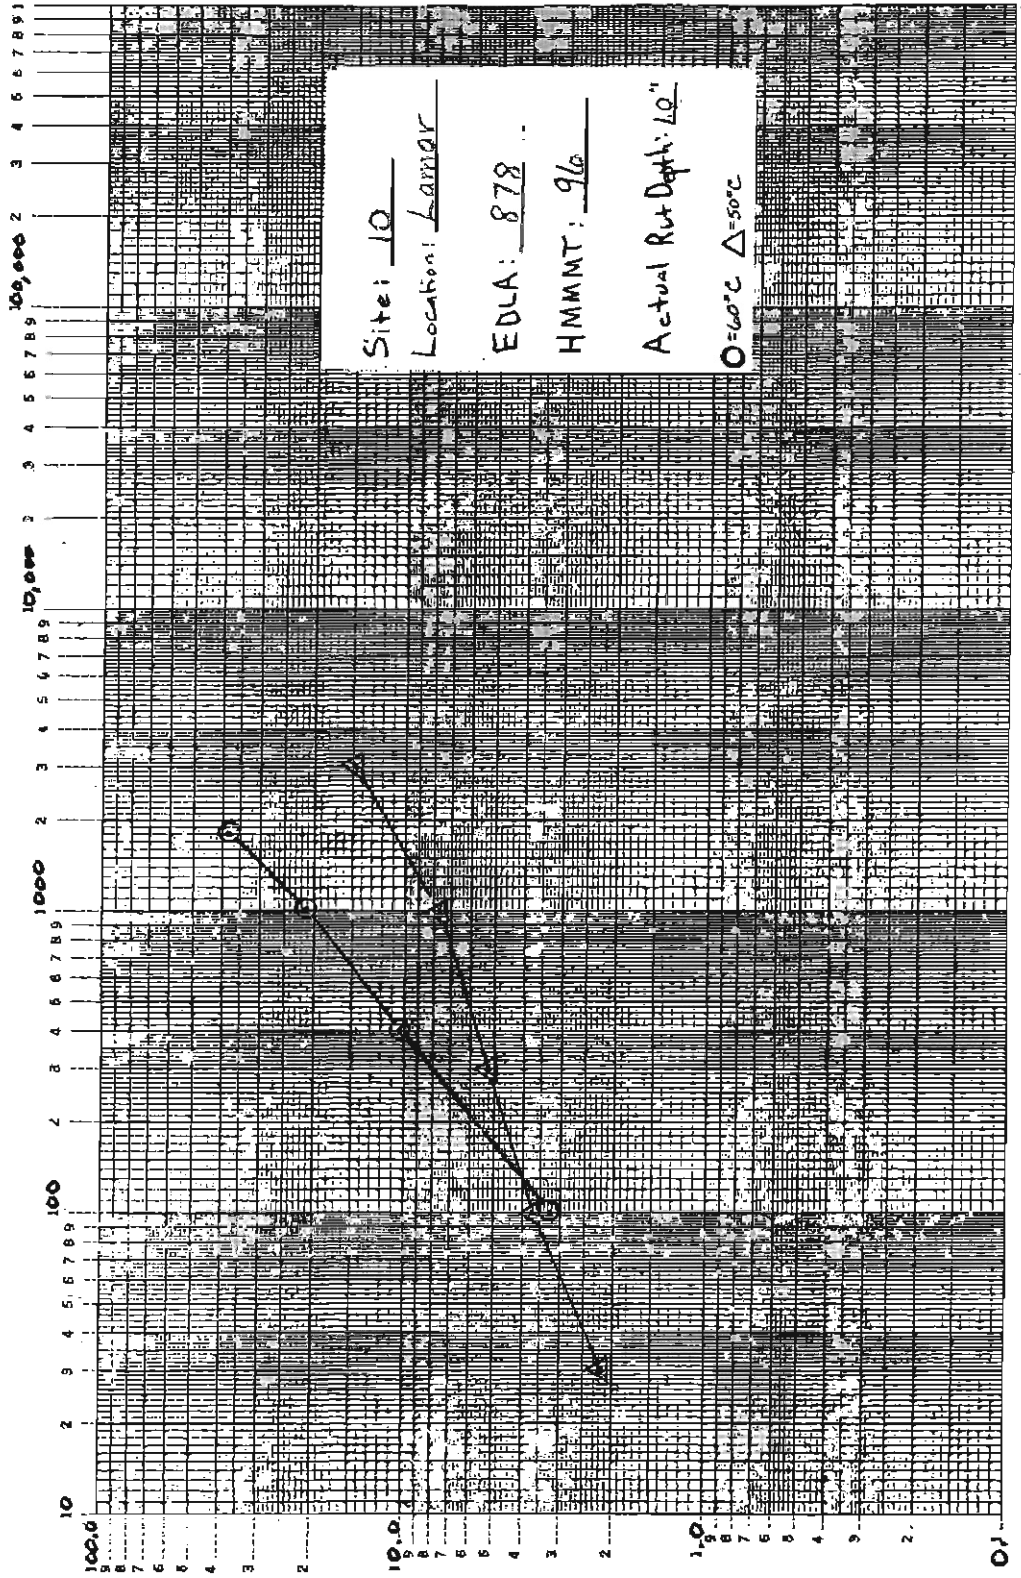
Site: 10
Location: Lamar
EDLA: 878
HMMMT: 96
Actual Rut Depth: 1.0
 $O = 60^{\circ}C \Delta = 50^{\circ}C$

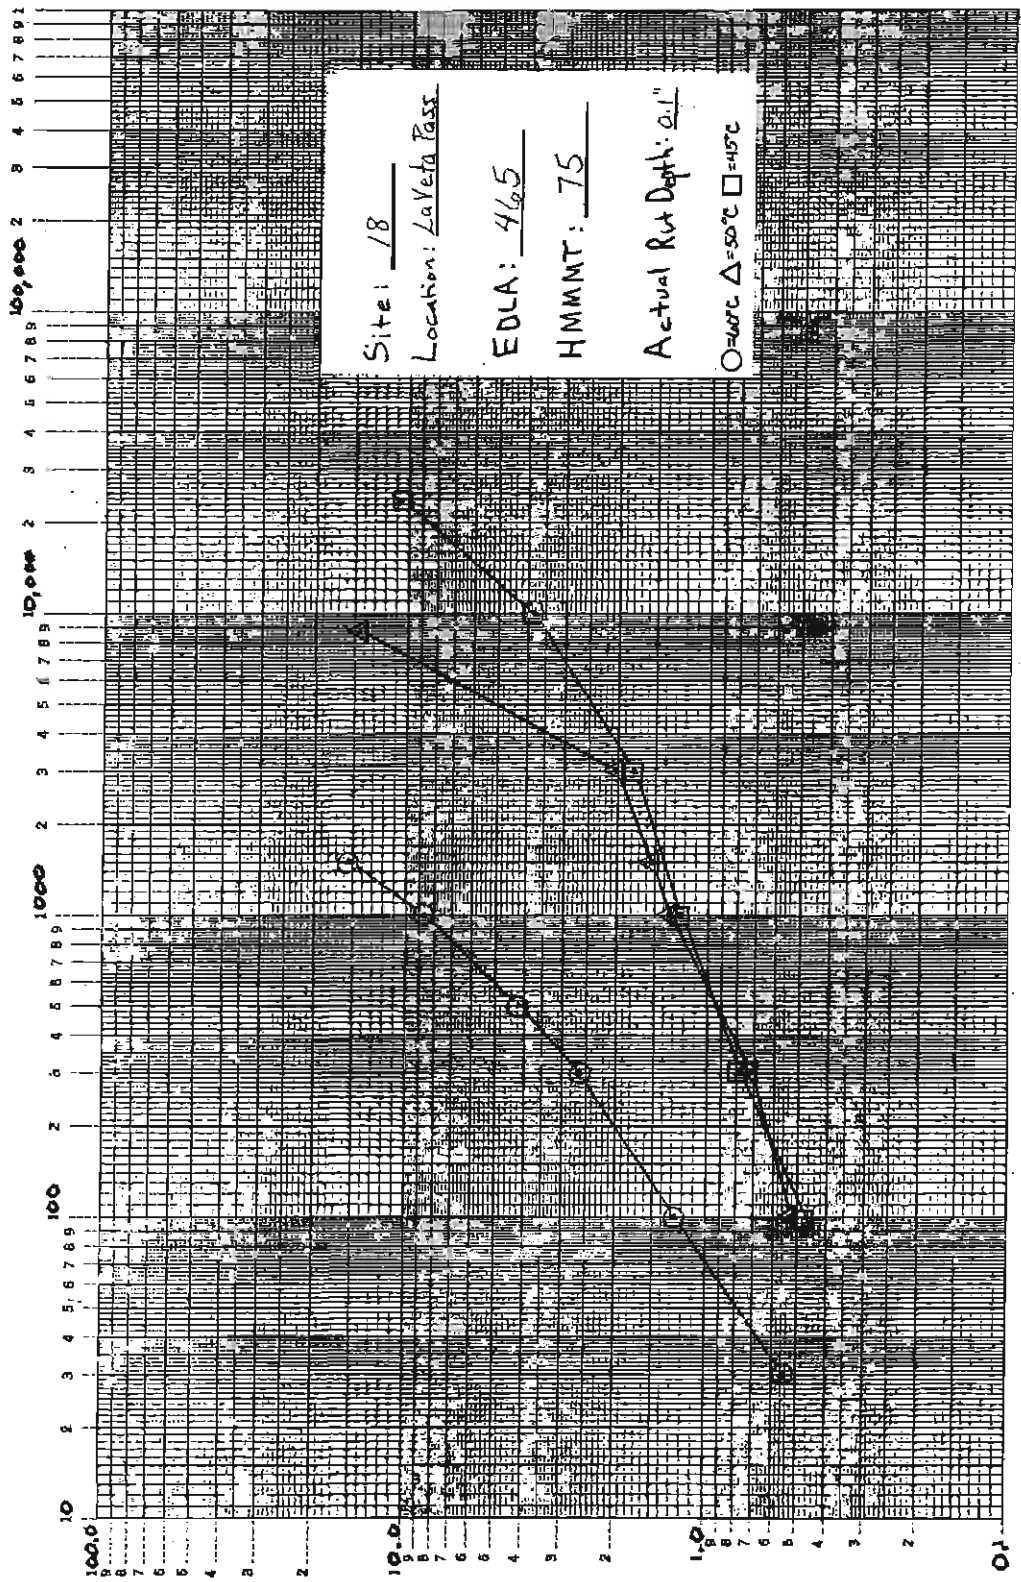
Site: 18
 Location: LaVeta Pass
 EDLA: 465
 HMMMT: 75
 Actual Rut Depth: 0.1"
 ○ = Δ=50°C □ = Δ=15°C

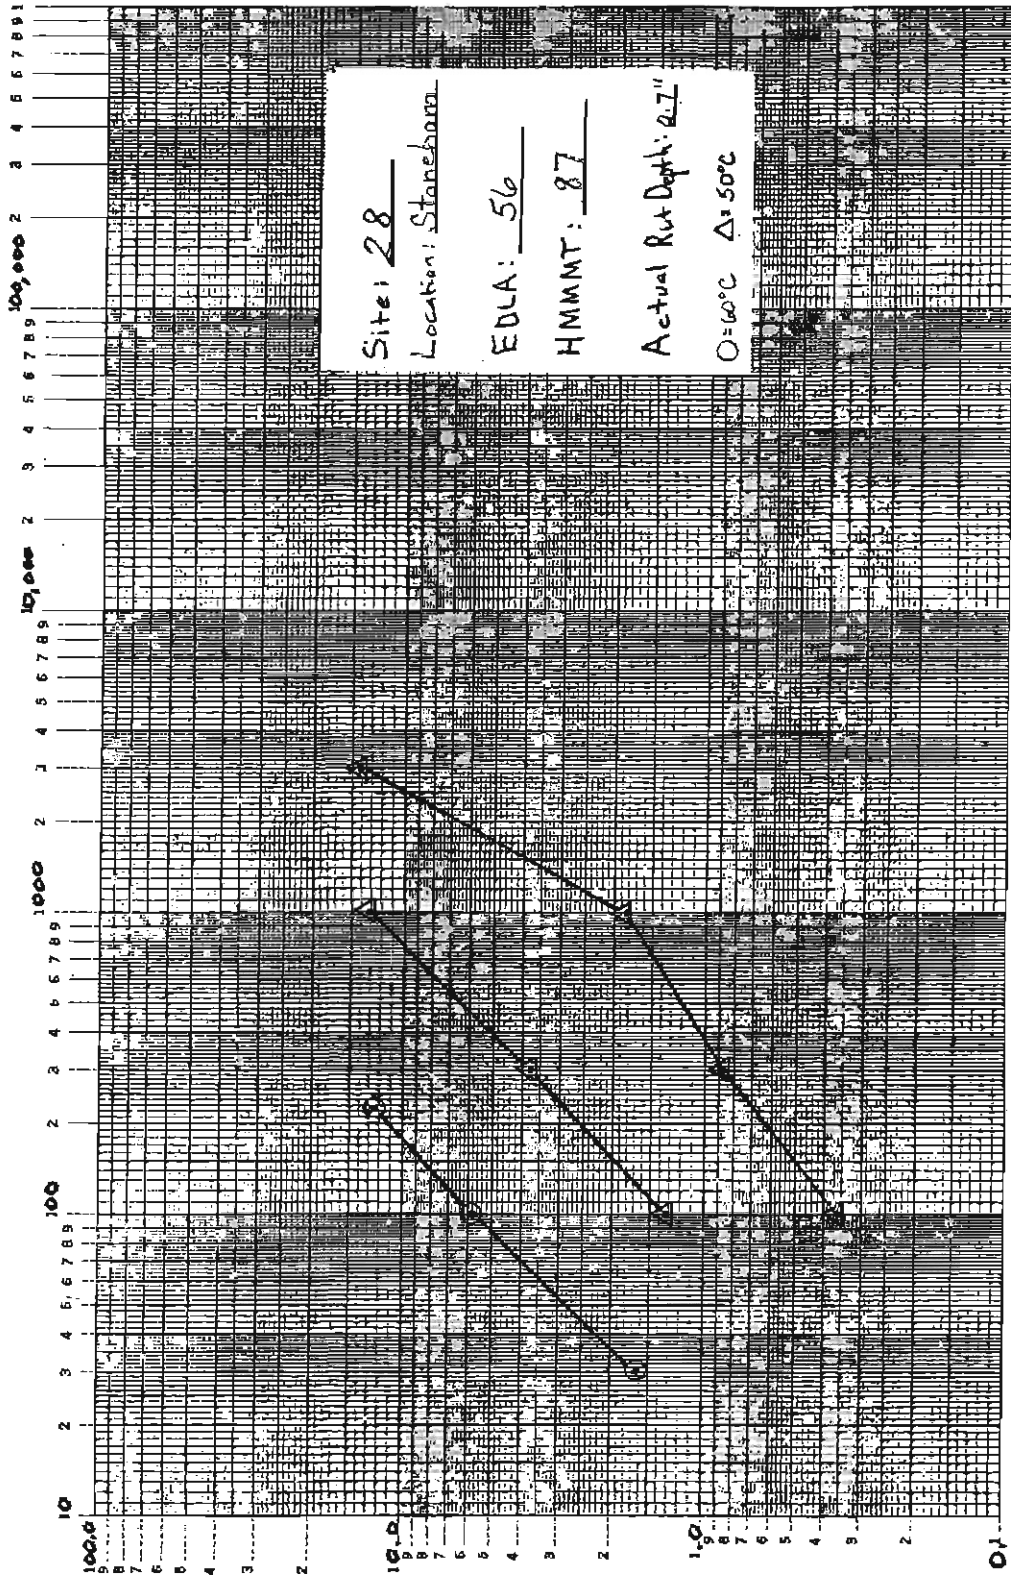
Site: 28
Location: Stoneham
EDLA: 56
HMMMT: 87
Actual Rut Depth: 2.71
O=60°C Δ=50°C
