Report No.CDOT-DTD-R-92-8

**UNBONDED PCCP
OVERLAY
PROJECT IR-25-3(77)**

**Final Report
JANUARY, 1993**

**Evaluation of Unbonded Concrete Overlay
Project IR-25-3(77)**

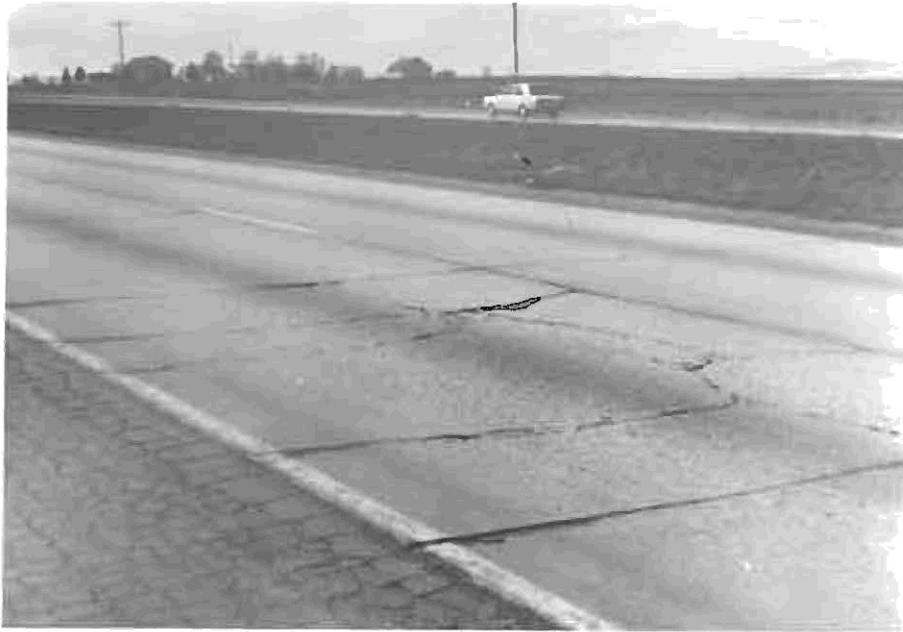
Photo 1: A typical slab that required removal

The twenty-five year old portland cement concrete pavement with high traffic volumes as well as heavy truck traffic performed quite well over the years. Badly broken, shattered, and unstable slabs were removed and replaced as part of construction. Only one percent of the slabs in the travelled lane required removal. Photograph 1 shows a typical slab that required removal. None of the slabs in the passing lane required removal.

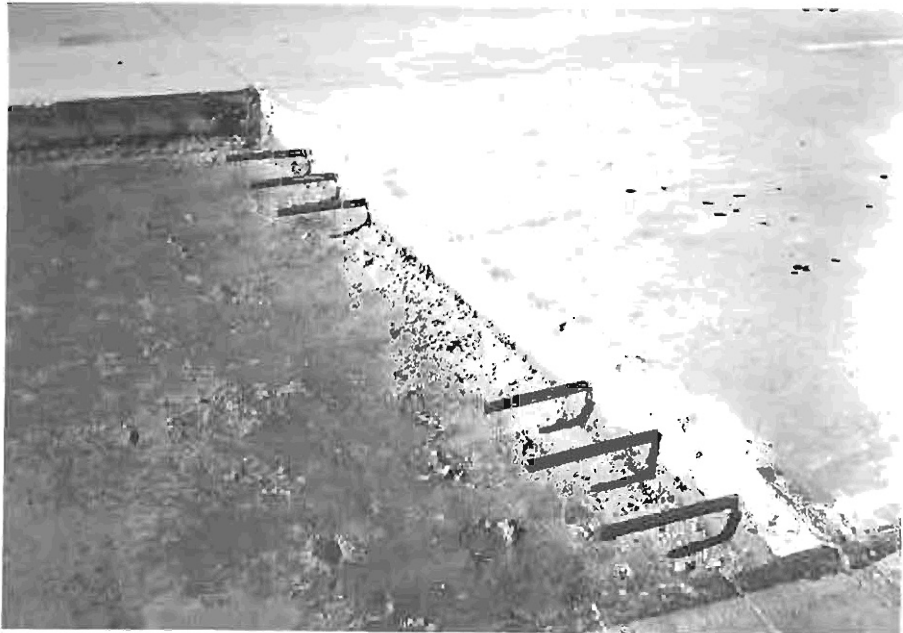
Photo 2: Insertion of dowels - three in each wheel path to improve load transfer for the replaced slabs.

No improvement were made to the underlying base course, but replaced slabs received improved load transfer across their transverse joints with the addition of inserted dowels - three in each wheel path (Photograph 2).

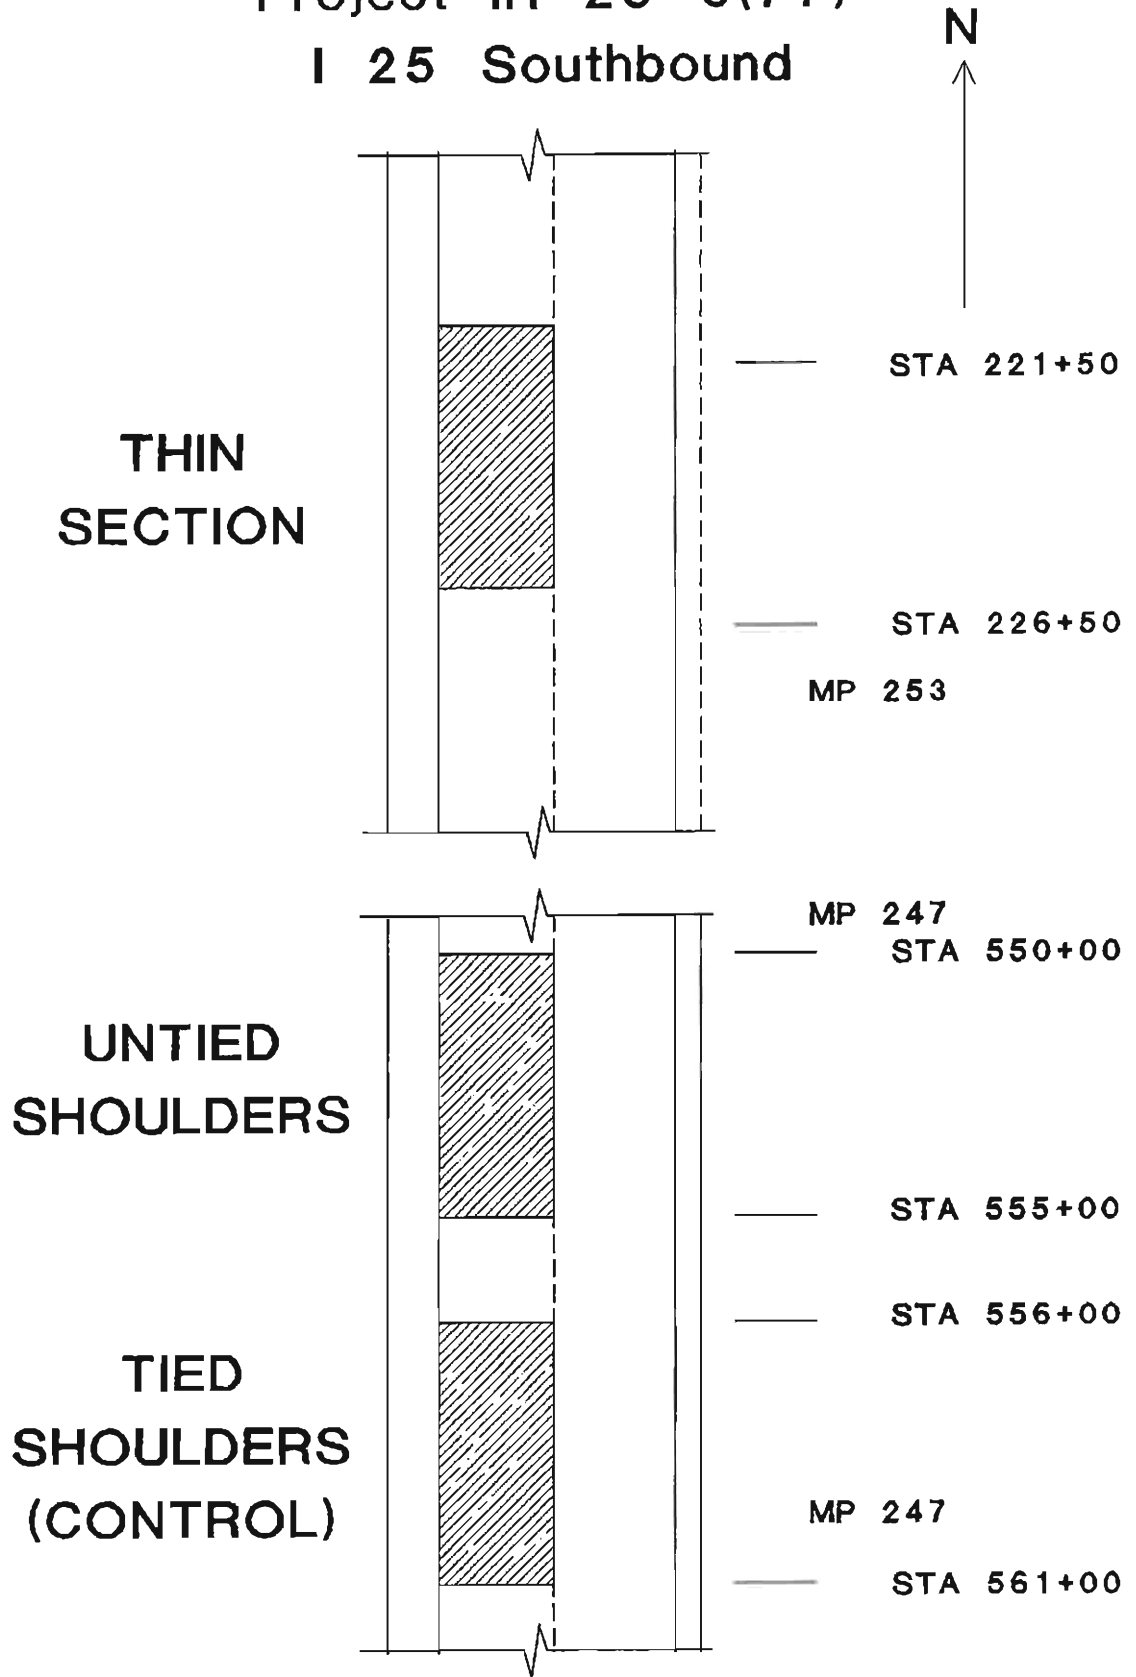
Three test sections were established on the southbound lanes to evaluate and monitor the overlay's performance with and without tied shoulder and also with a "thinner" slab section (Figure 4). These test sections were established in the following order:

Figure 4
Project IR 25-3(77)
I 25 Southbound

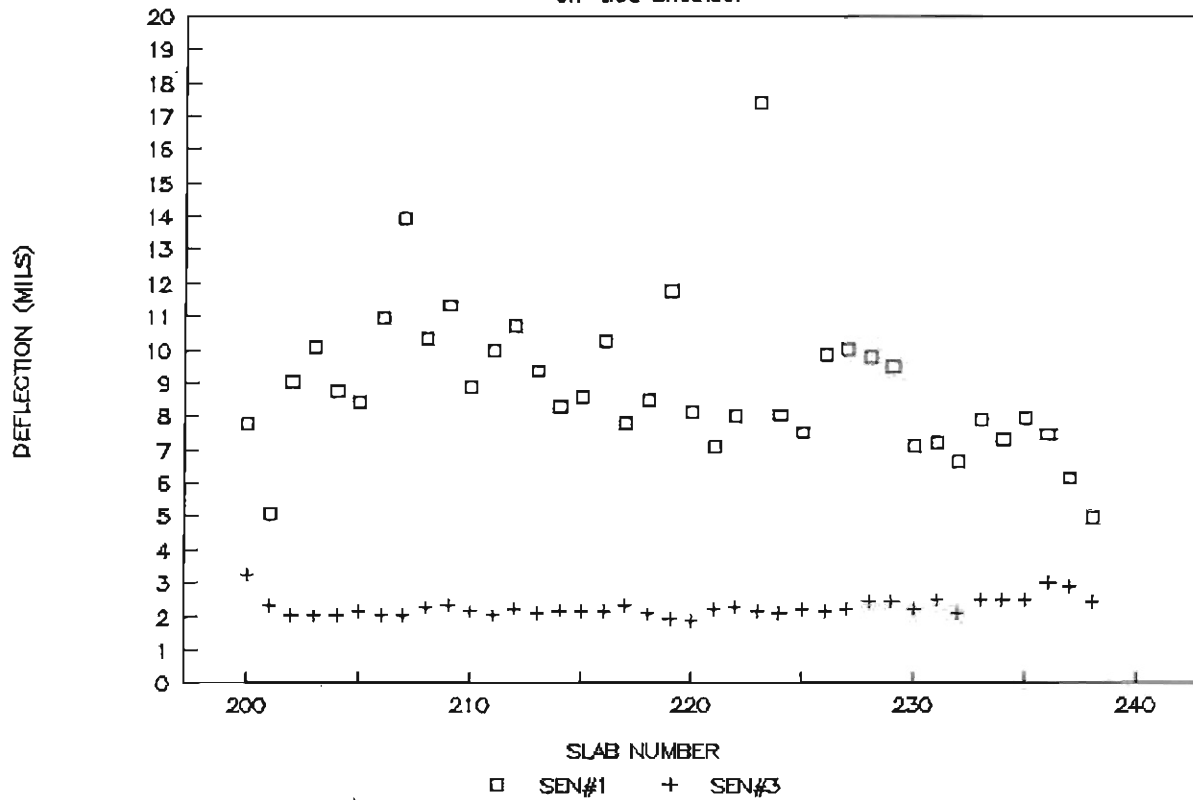
Figure 6, Mid-Slab Deflection

Un-tied Shoulder

As it can be seen the magnitude of the deflections for the tied shoulder section are consistently lower (approximately 73 percent lower) than the magnitude of the deflections in the un-tied shoulder section. In addition, the rate of load transfer for the tied shoulder is significantly higher (approximately 260 percent higher) than the un-tied shoulder section. These findings indicate that tied shoulder is doing what is expected, transferring load to the shoulder and increasing the load-carrying capacity of the driving lane.

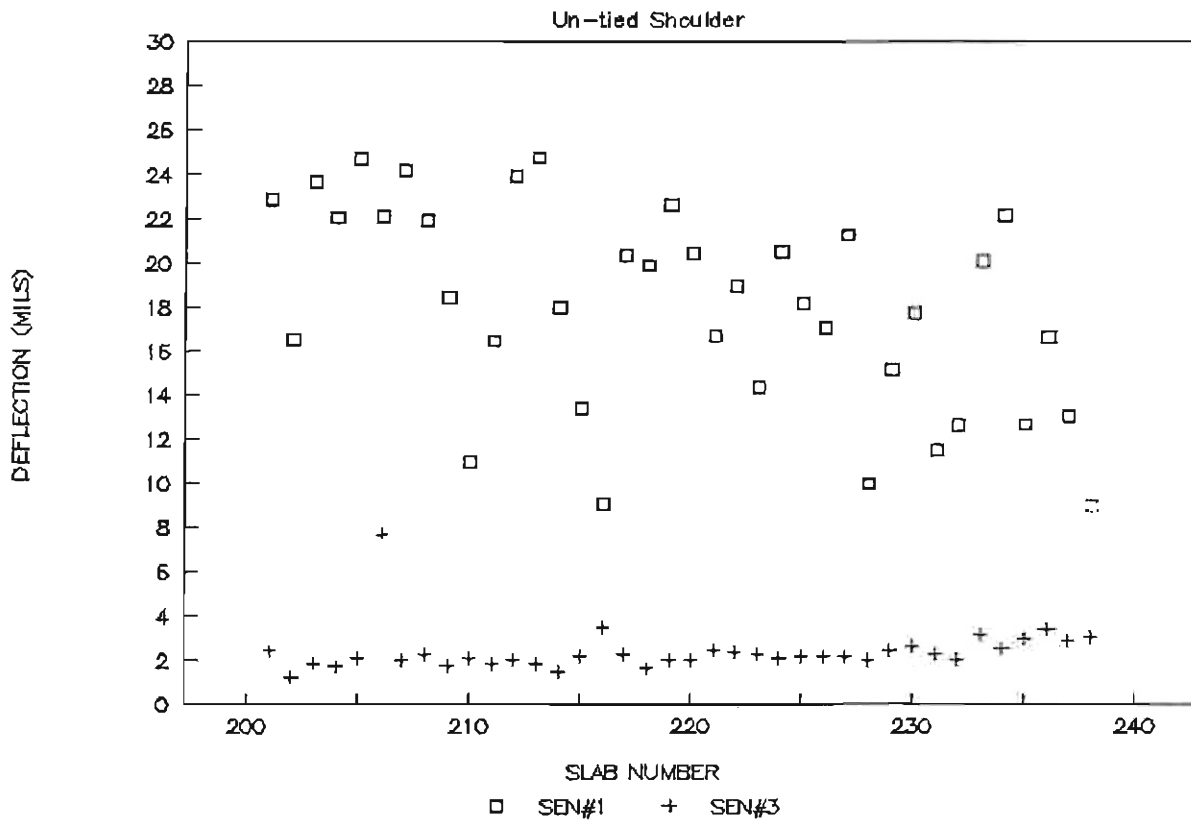
Figure 8, Corner Deflection

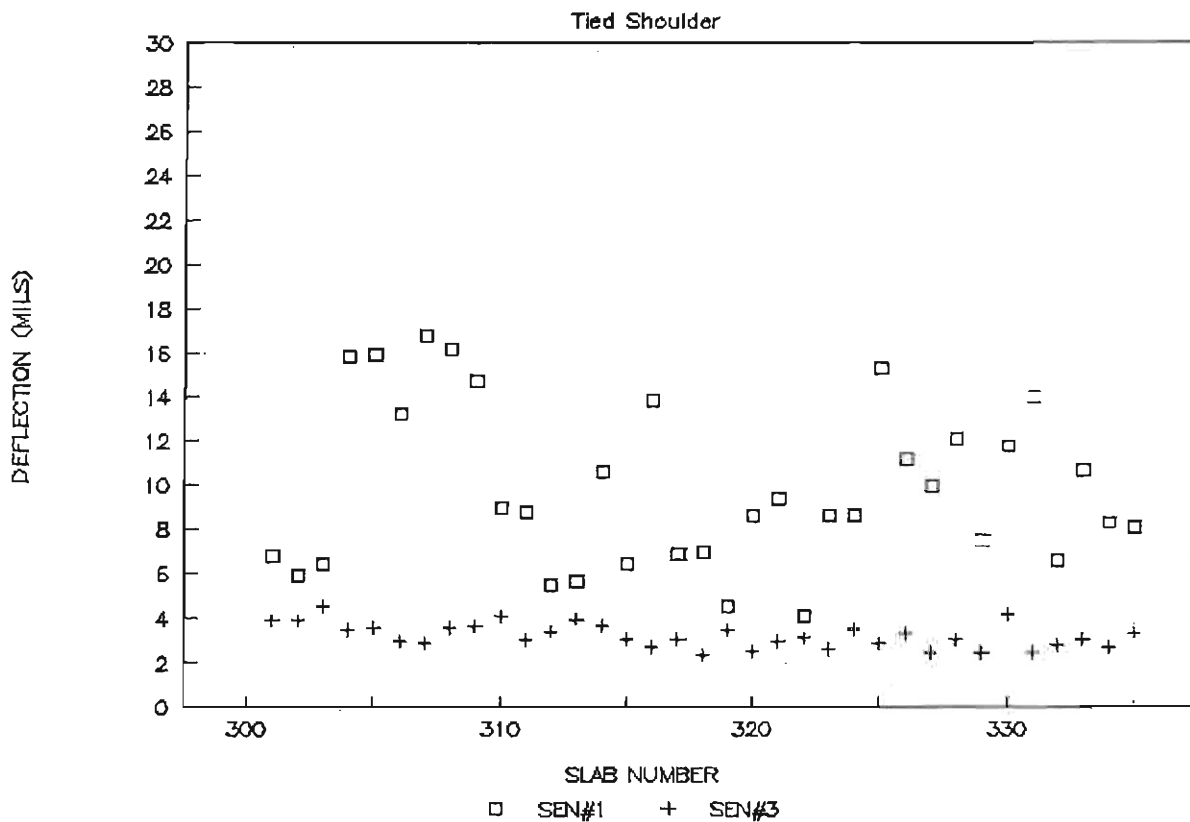
Figure 9, Corner Deflection

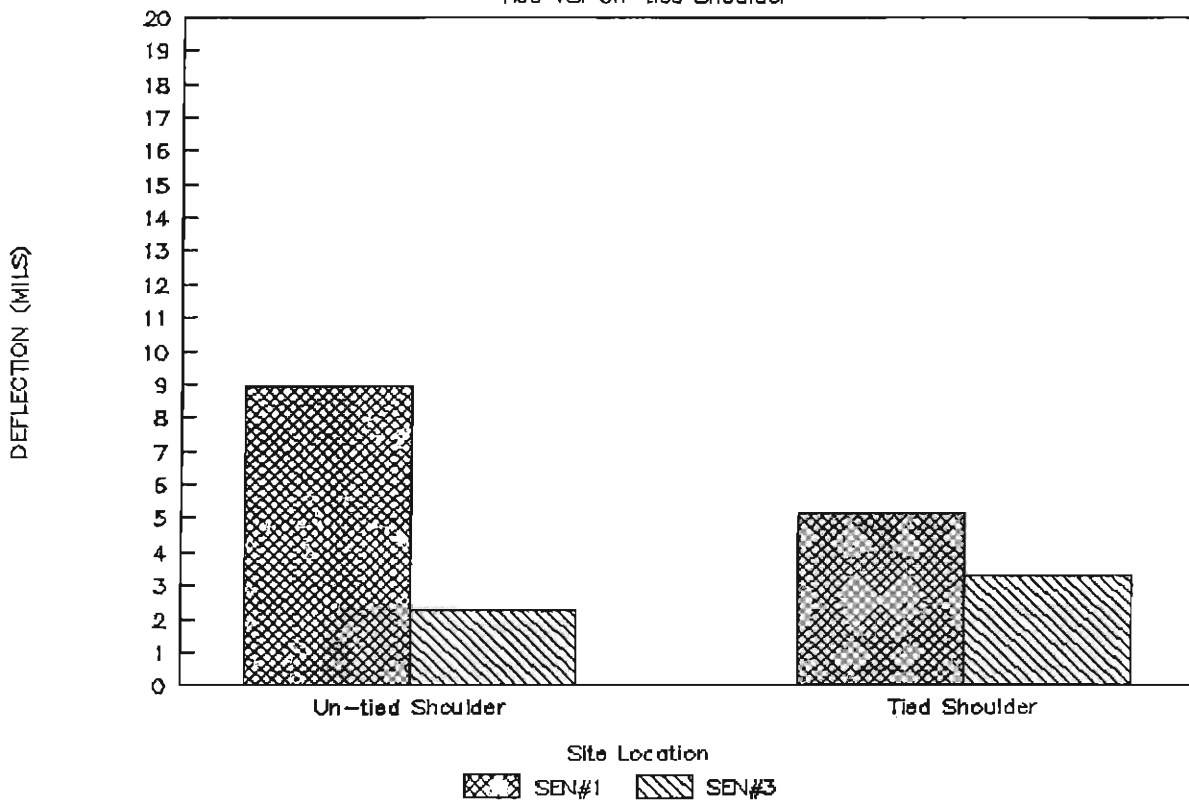
Figure 11, Average Mid-Slab Deflection

Tied VS. Un-tied Shoulder

Tied shoulders increase the load-carrying capacity of the driving lane by transferring load to the shoulder. A review of the deflection data taken in the tied and in the un-tied shoulder revealed consistently lower deflections and higher load transfer for the tied shoulder section. Deflections were approximately 73 percent lower and the rate of load transfer were about 260 percent higher for the tied shoulder section.

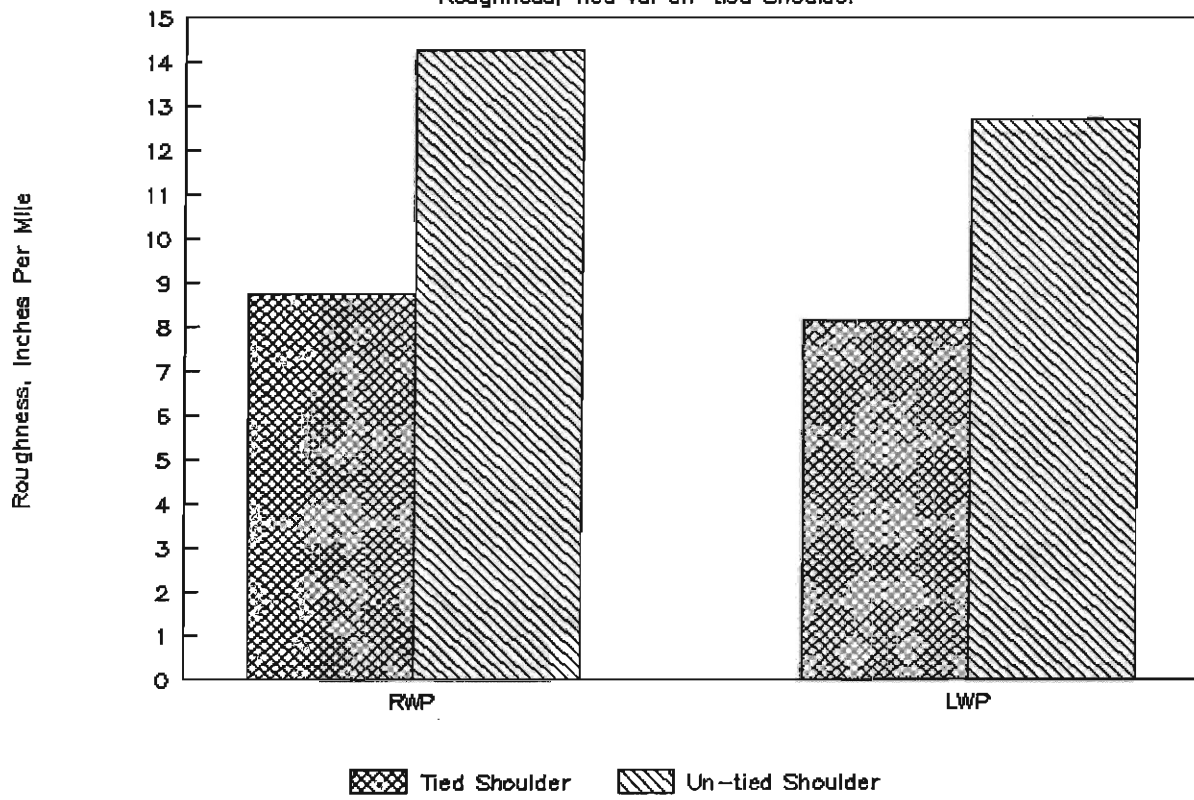
The right wheel path (RWP) and the left wheel path (LWP) roughness was measured using a Ames Profilograph. Figure 12 compares the roughness in the tied and the un-tied shoulder sections. As shown in Figure 12 the magnitude of roughness in the un-tied shoulder section is much higher (approximately 60 percent higher) than the magnitude of roughness in the tied shoulder section. This significant increase in roughness for the un-tied shoulder section suggests that tied shoulder play an important role in keeping the driving lane smooth. The roughness data was acquired 7 years after the construction. There are no roughness data available immediately after the construction.

Roughness, Tied vs. un-tied Shoulder

Roughness data taken using a Ames profilograph showed the magnitude of roughness to be much higher (approximately 60 percent higher) for the un-tied shoulder section.

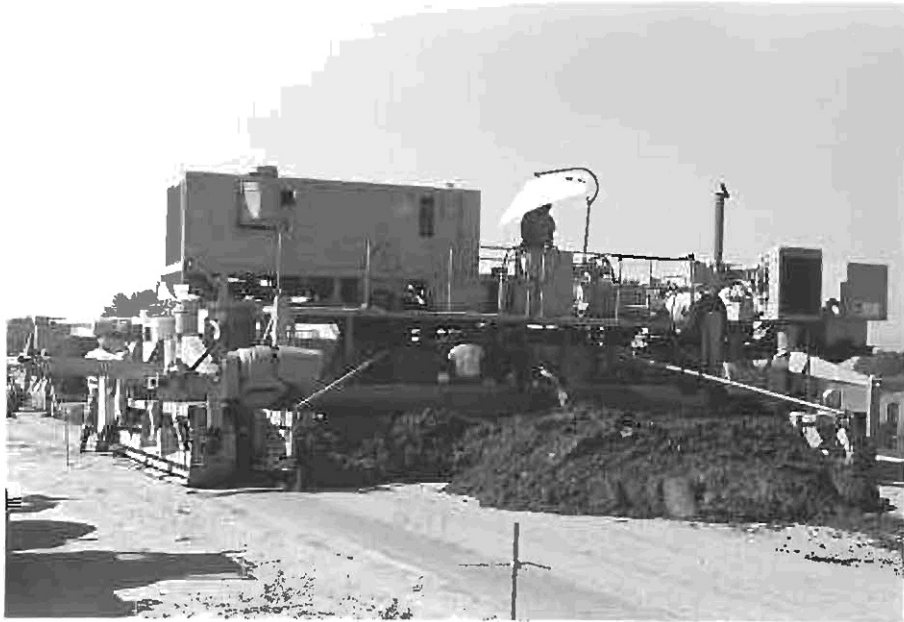
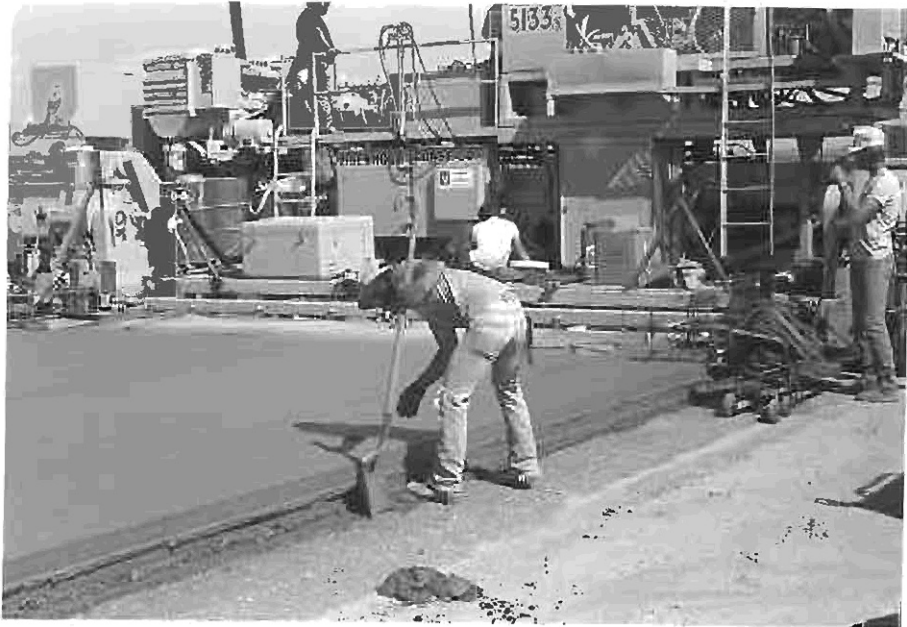
Concrete is mixed, vibrated, leveled, screeded and burlap drug in one operation.

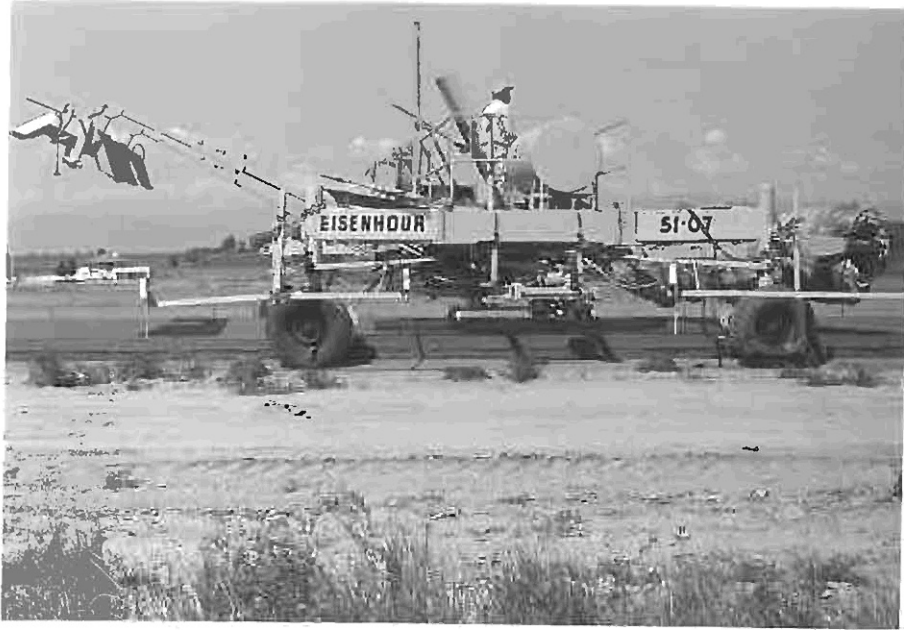
A mechanical tining device provides a textured surface, curing compound is also applied from this machine.

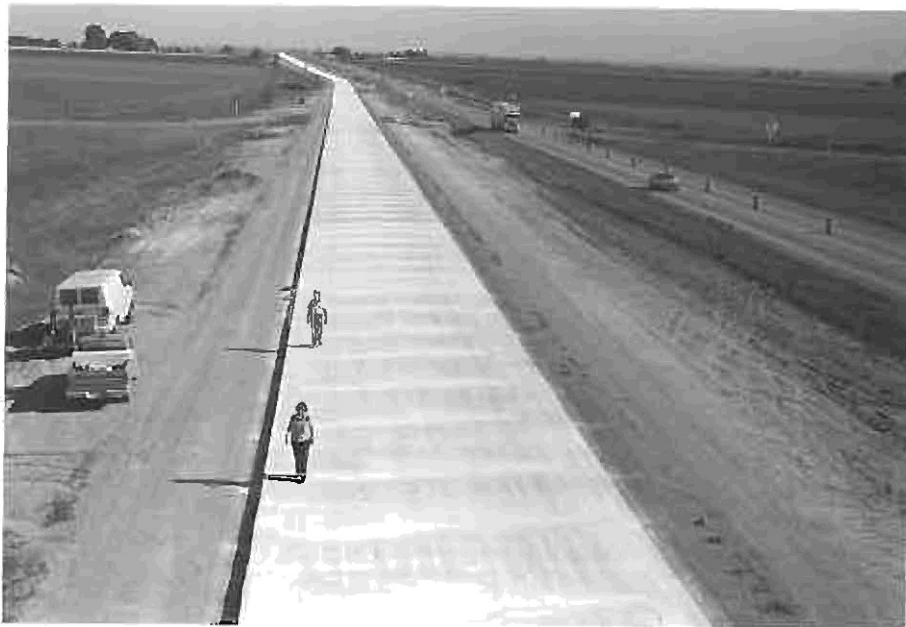
The 24 foot driving and passing lane has been completed, looking north from Johnstown Interchange.

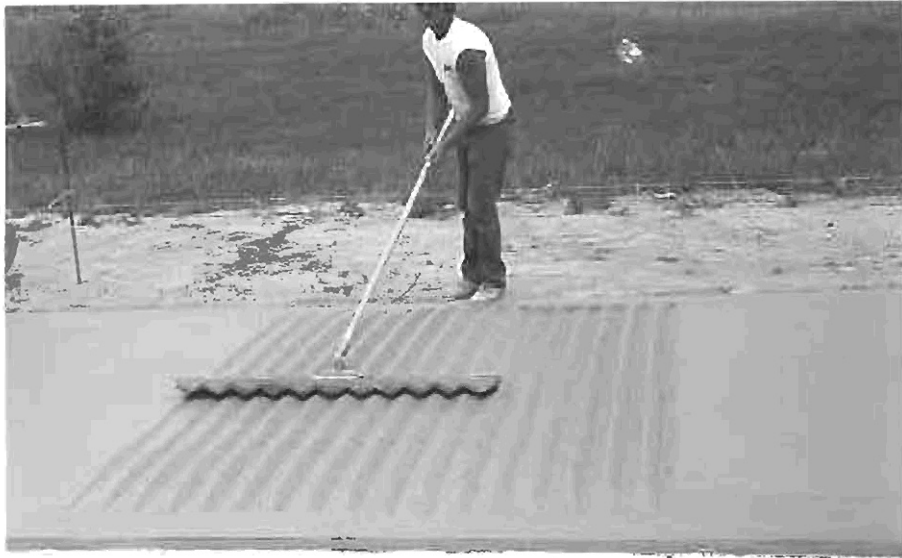
Rumble corrugations were formed using 1" depth by 4 1/2" pitch corrugations.
