Report No. CDOT-R-SM-95-15

EPS, FLOW FILL AND STRUCTURE FILL

BRIDGE ABUTMENT BACKFILL

Final Report
August 1995

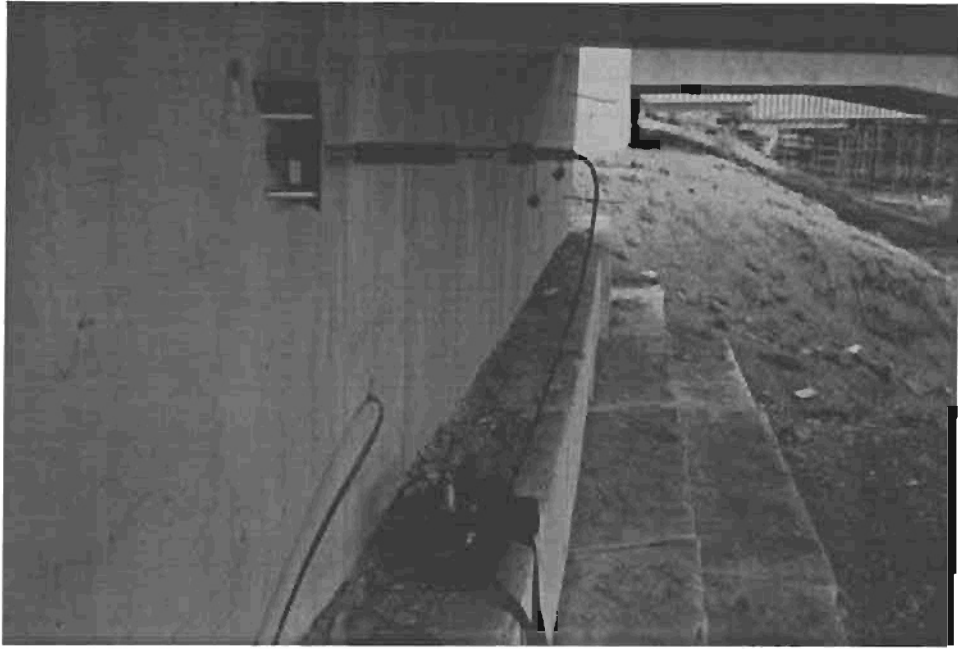
Photo 6: An Extensometer Electrical Sensor Head Installed at an Abutment Wall

The extensometer was installed at the center of each abutment at the same elevation as the earth pressure cell. The installation of the four extensometers was completed in September, 1992. All extensometers were in good working condition. Photo 7 shows an extensometer tube placed on top of the EPS.

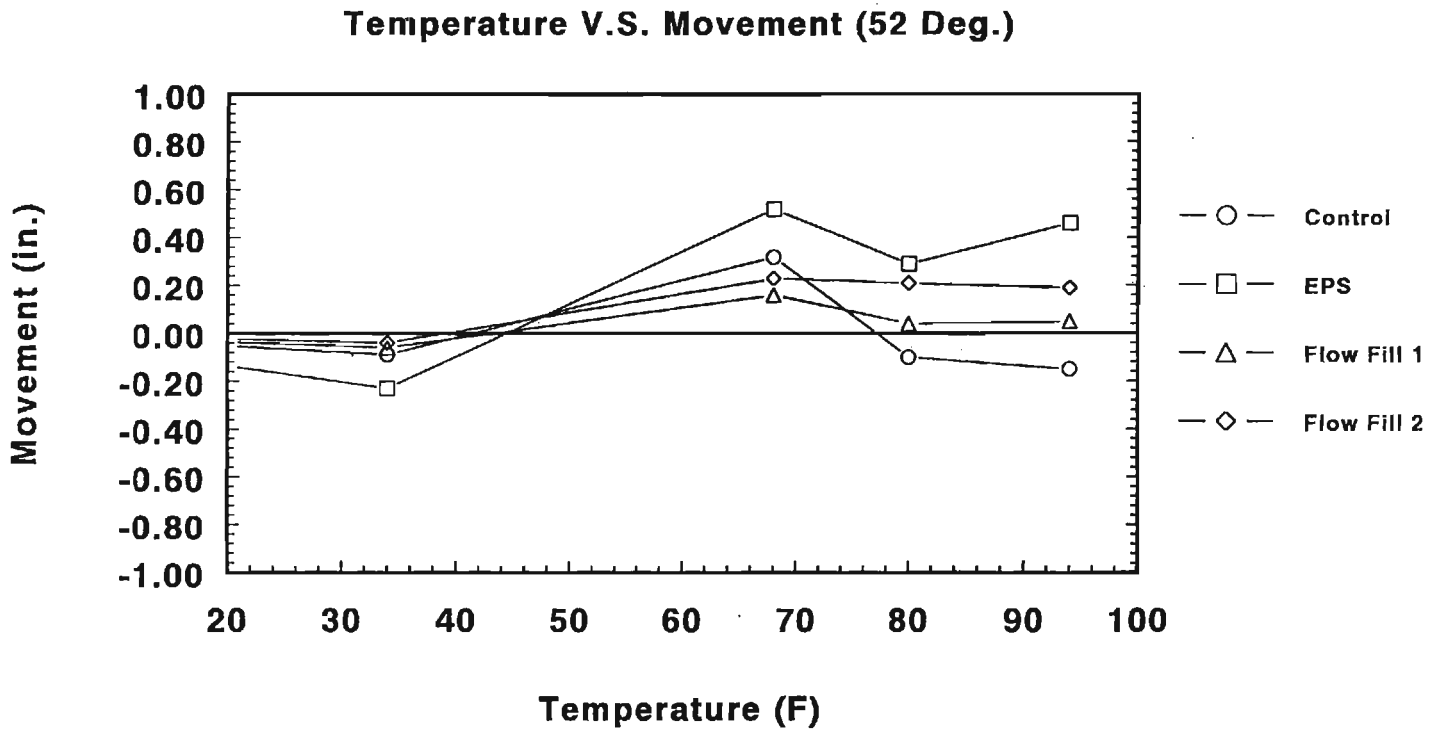
Figure 18: Lateral Movement of Abutment Versus Temperature for Abutments Near Station 372+08

The initial readings were taken in September, 1992. Figure 18 presents the results of the extensometer measurements at four abutments with the extensometers located at a depth of four feet (1.22 m) below the approach slab. The lateral movement shown on the figure has been calibrated to a reference temperature of 52° F. The calibration were made so that the readings could be compared. In general, the measured movements represent the abutment wall movements recorded between the temperature-induced movements and the zero readings taken at a temperature of 52° F.

A positive movement reading as shown on Figure 18 indicates that the abutment wall moved toward the backfill as the bridge expanded at a higher temperature on warm days. On the other hand, a negative movement reading indicates the wall moved away from the backfill when the bridge contracted at a lower temperature in cool weather.

The results shown in Figure 18 indicate that temperature has significant effects on the lateral movement of the abutment. The higher temperature gives more positive lateral movement induced by thermal expansion of the structure toward the abutment. The negative lateral movement of the abutment wall occurred at a low temperature of 34° F for all four abutments.

For the EPS fill abutment, the lateral movement increases somewhat proportionally with the increase in temperature. The effect of temperature on lateral movement of the abutment in the EPS fill appears to be more significant than the others. This implies that the EPS fill has less resistance to the movement of the abutment wall due to the bridge thermal expansion. A smaller lateral earth pressure was therefore measured.

For the abutment backfilled with Class 1 Structure Backfill, the lateral movement becomes relatively small. It appears that the Class 1 Structural Backfill generate higher earth pressure against the facing of the abutment wall. A positive lateral movement was measured on the

facing of the abutment at a higher temperature. It is believed that the structural fill material has been falling into the voids created between the backfill and the abutment by the contraction of the bridge. This restrains the movement of the wall from bridge expansion at higher temperatures. Consequently, a larger earth pressure is measured.
