Report No. CDOT-DTD-R-95-10

High Performance Hot Mix Asphalt Pavements for Intersections

Final Report
April, 1995

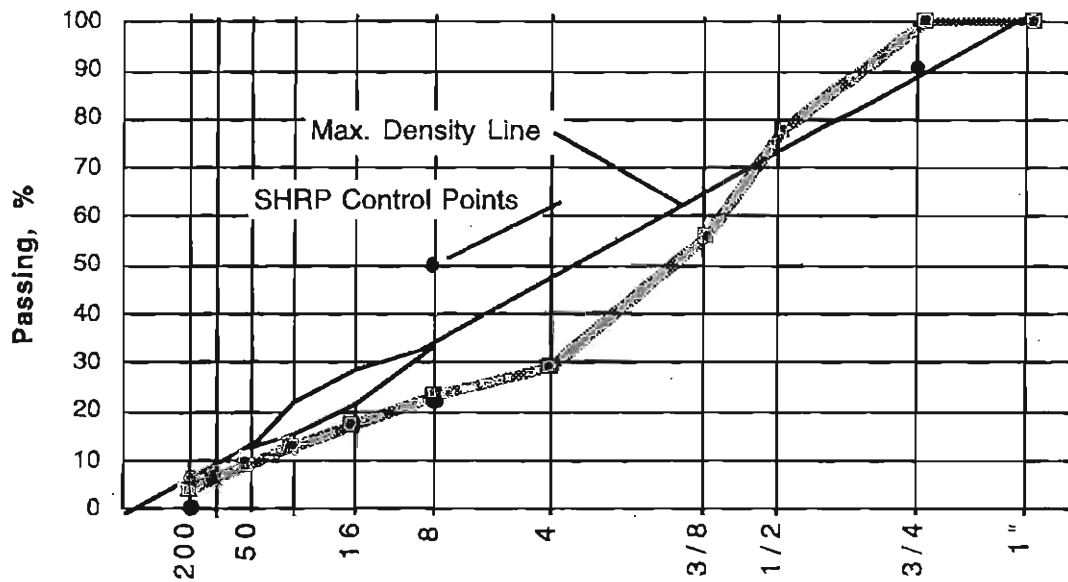
Figure 5. Aggregate Gradation for the Surface Course Mixture.

4.1.1.1 Gradation. The 0.45 power gradation chart is used to define the permissible gradation. The recommended gradation should lie within the control points, and it is recommended the gradation lie outside the restricted zone. The recommended "Master Ranges" for the various top-size aggregate gradations are shown in Appendix B. The aggregate gradation obtained for this intersection is shown in Figure 5.

Sieve Size		Passing
mm	opening	%
25.40	1	100
19.00	3/4	100
12.50	1/2	78
9.50	3/8	56
4.75	4	29
2.36	8	23
1.18	16	17
0.60	30	13
0.30	50	9
0.15	100	6
0.08	200	4

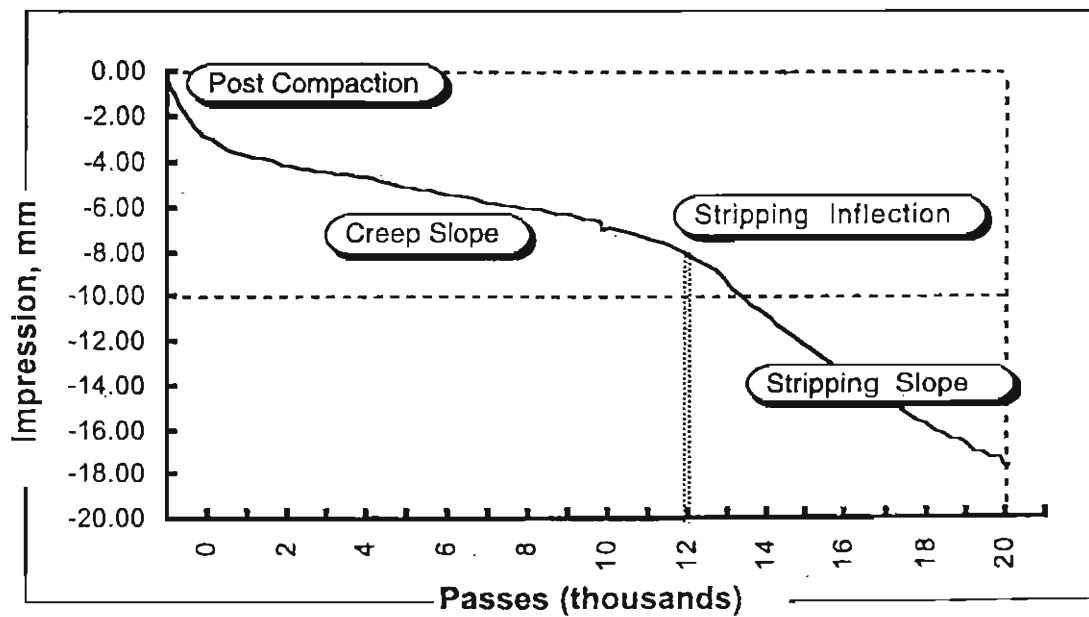
Figure 7. Typical Hamburg Wheel-Tracking Device Output.

The creep slope relates to rutting from plastic flow. It is the inverse of the rate of deformation in the linear region of the deformation curve, after post compaction effects have ended and before the onset of stripping. The stripping slope is the inverse of the rate of deformation in the linear region of the deformation curve, after stripping begins and until the end of the test. It is the number of passes required to create a 1 mm impression from stripping. The stripping slope is related to the severity of moisture damage. The stripping inflection point is the number of passes at the intersection of the creep slope and the stripping slope. It is related to the resistance of the HMA to moisture damage.

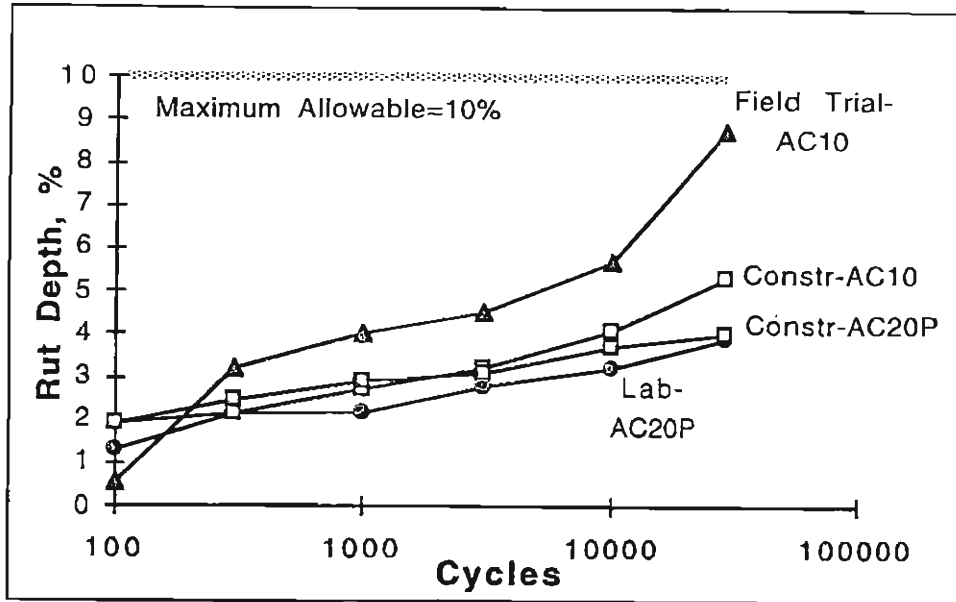
Figure 8. French Rutting Tester Results at 60°C for Surface Course.

Results from the French rutting tester are shown in Table 9 and Figure 8. The French rutting tester results were 8.8% and acceptable: less than the 10% maximum. However, the results were close enough to the maximum criteria that a slightly lower asphalt content was recommended for the actual intersection. It is not uncommon for the plant produced material to be less rut-resistant than the laboratory mixed material. It is precisely because of that phenomena that the field trial was conducted. The asphalt content was verified with extraction testing.
