Report No. CDOT-DTD-R-95-1

# **Demonstration of the Placement of Stone Matrix Asphalt in Colorado**

**Interim Report**

**March, 1995**

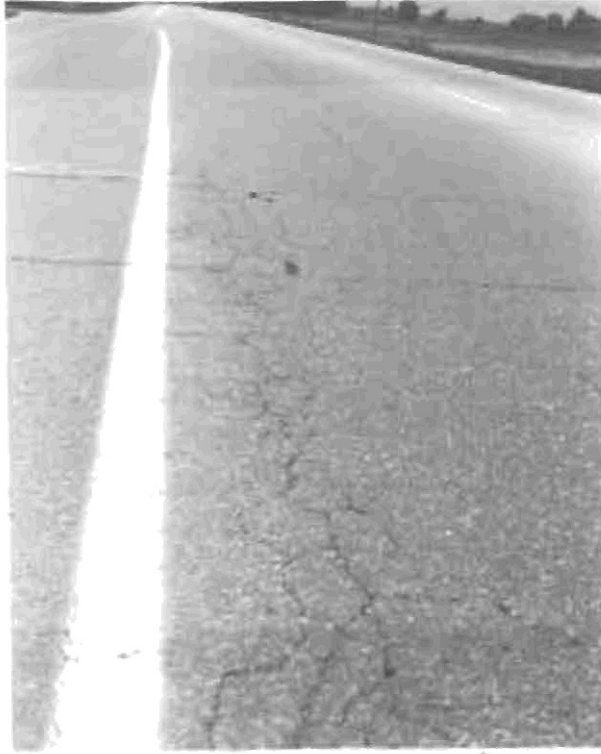
**Figure 3. Overview of Existing Pavement Condition Prior to Construction.**

Crack maps were prepared for each of the evaluation sections. Cracking in the sections was fairly uniform. On the average, transverse cracks could be found every 5-m (15 ft) throughout the sections. Load associated longitudinal cracking was found in the wheel paths of the driving lane. In some areas the longitudinal cracking had deteriorated into block cracking and in other areas alligator cracking. The cracks were wide (up to 25 mm) and many had begun to deteriorate on the edges. Although the pavement in the southbound lanes on the north end of the project had been covered by a thin maintenance blade patch the severity and amount of distress in all the evaluation sections prior to construction were considered to be equal for evaluation purposes. Typical distress found in the existing pavement is shown in Figures 3 and 4.

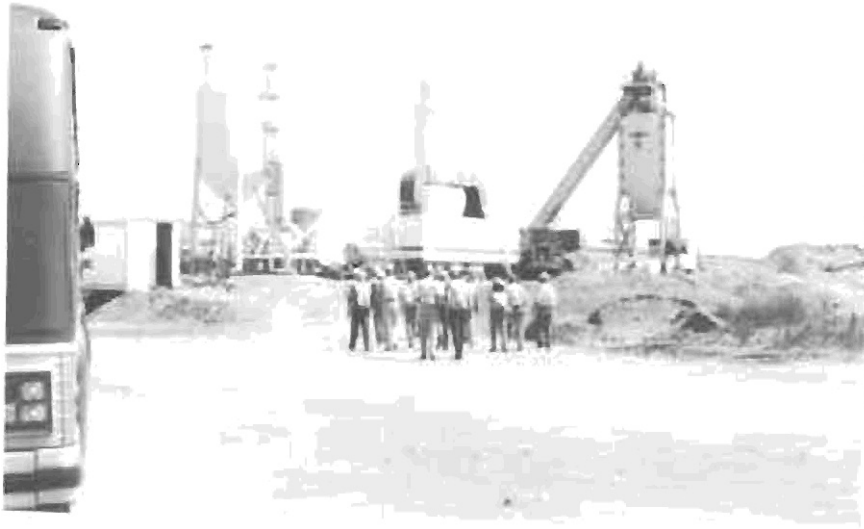
**Figure 5. Plant Layout.**

Photographs from plant and laydown operation taken during the open house are shown in Figures 5 and 6.

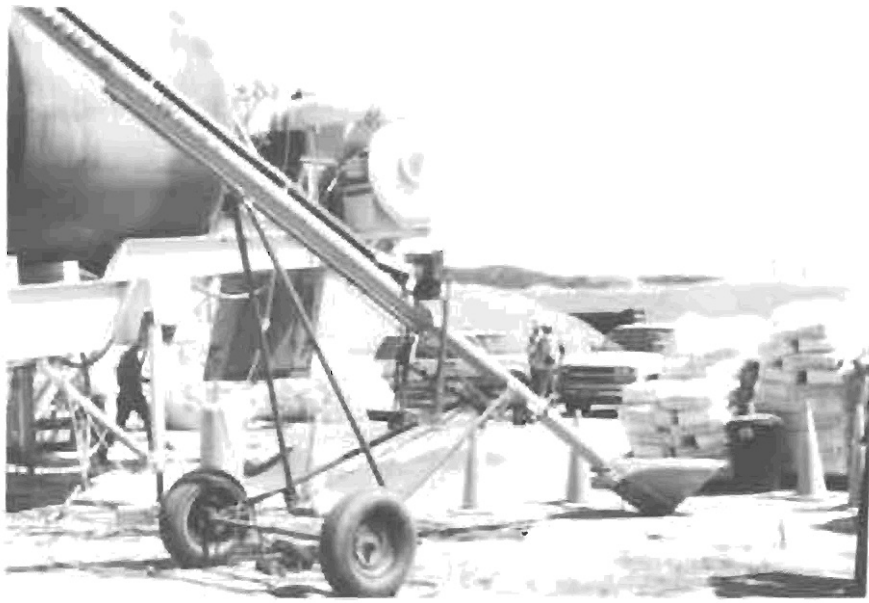
**Figure 8. Auger System Initially Used for Vestoplast S.**

caking of the Vestoplast S, the blades of the auger were sheared from the shaft. The auger that fed the Vestoplast S was then modified to be an open-troughed auger with a plate on top. This auger was also unsuccessful. Finally, a shingle conveyor was used to transport the Vestoplast S to the RAP collar. The shingle conveyor had slats on the belt to prevent the Vestoplast S from sliding down the conveyor. This method worked well (except in high wind conditions) and was used for the remainder of the project. The fiber pellets were added only with the shingle conveyor.

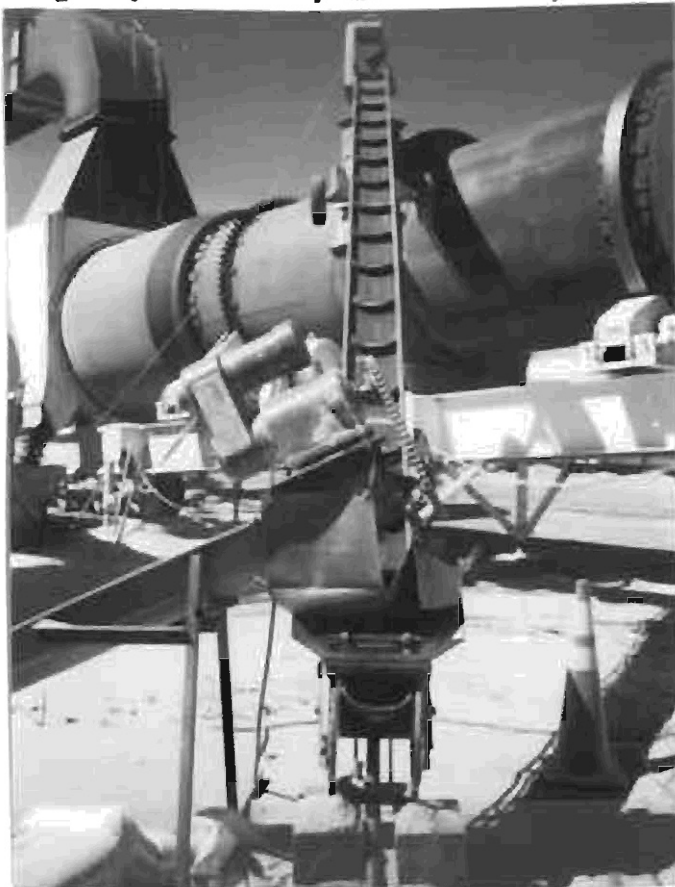
**Figure 9. Conveyor System Used to Add Vestoplast S and Fiber Pellets at the RAP Collar.**

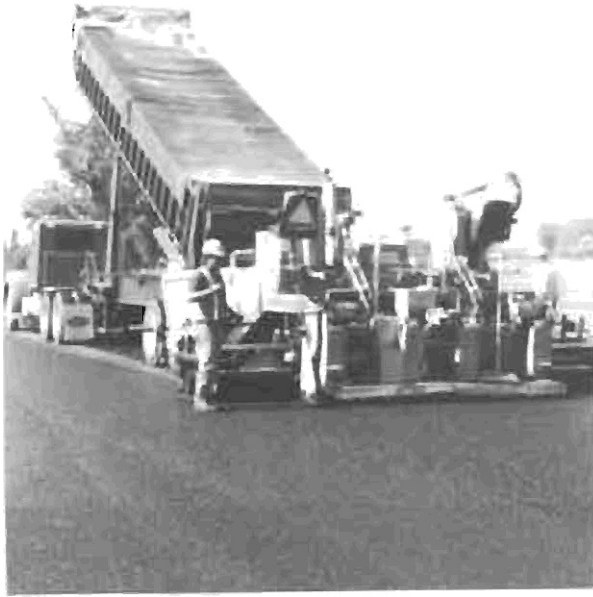
**Figure 12. Typical Laydown Operation.**

One Blaw-Knox 510 paver with a variable width screed and extended augers was used. Paving widths ranged from 3 to 5 m (10 to 16 ft). Three rollers were used to compact the SMA. Because SMAs perform differently during the compaction process, a roller pattern were difficult to establish. The final roller pattern that was established used two steel-wheeled rollers for breakdown (Caterpillar 534B) and one steel-wheeled roller for finishing (Hyster 766). The first roller used for breakdown was a 10 tonne roller which made one pass in the vibratory mode and one in the static mode. The next roller (10 tonne) made two passes in the vibratory mode and two passes in the static mode. A 7 tonne steel-wheeled roller operated in the static mode as the finish roller. A pneumatic roller was not used on the SMA pavement. It is very critical that rollers are kept close to the laydown operation. Photographs of construction are shown in Figures 12 through 15.

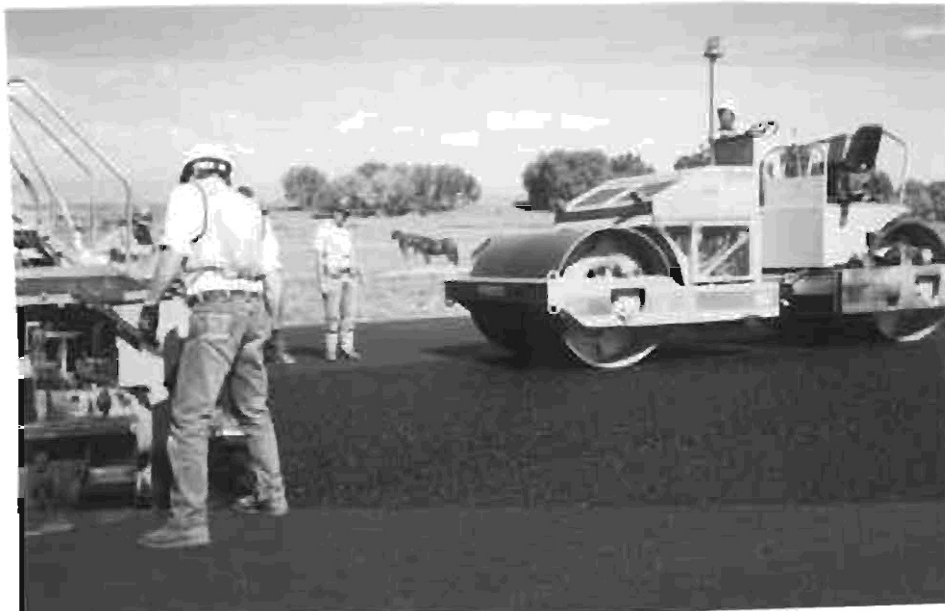
**Figure 13. The Breakdown Roller Was Kept Close to the Laydown Machine.**

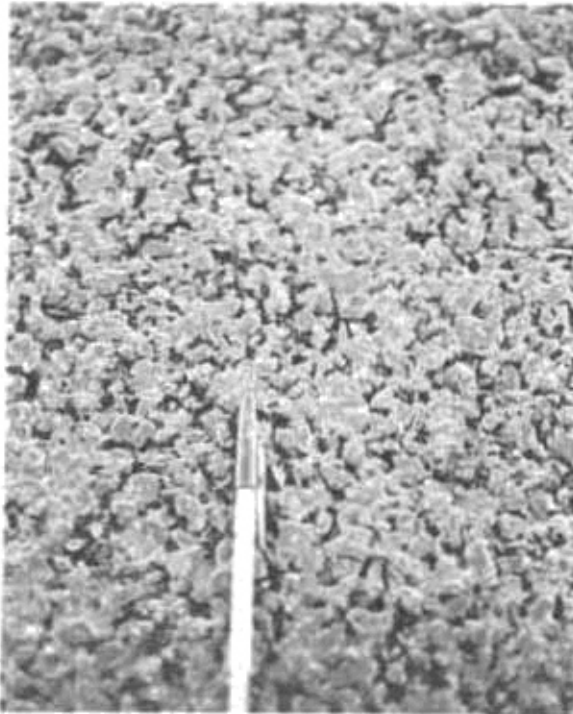
**Figure 15. Surface Texture of the Finished Mat.**

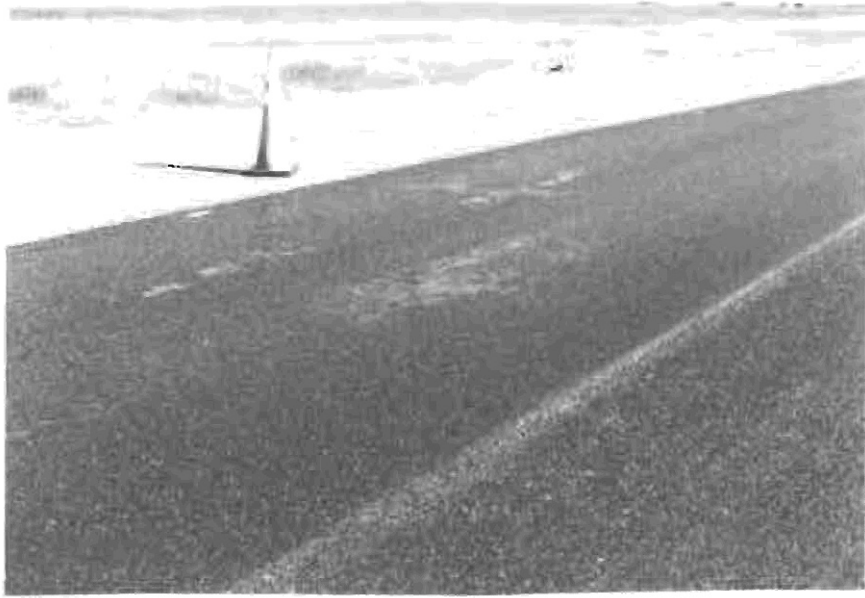
**Figure 16. Limited Problems With Dralndown Were Encountered.**

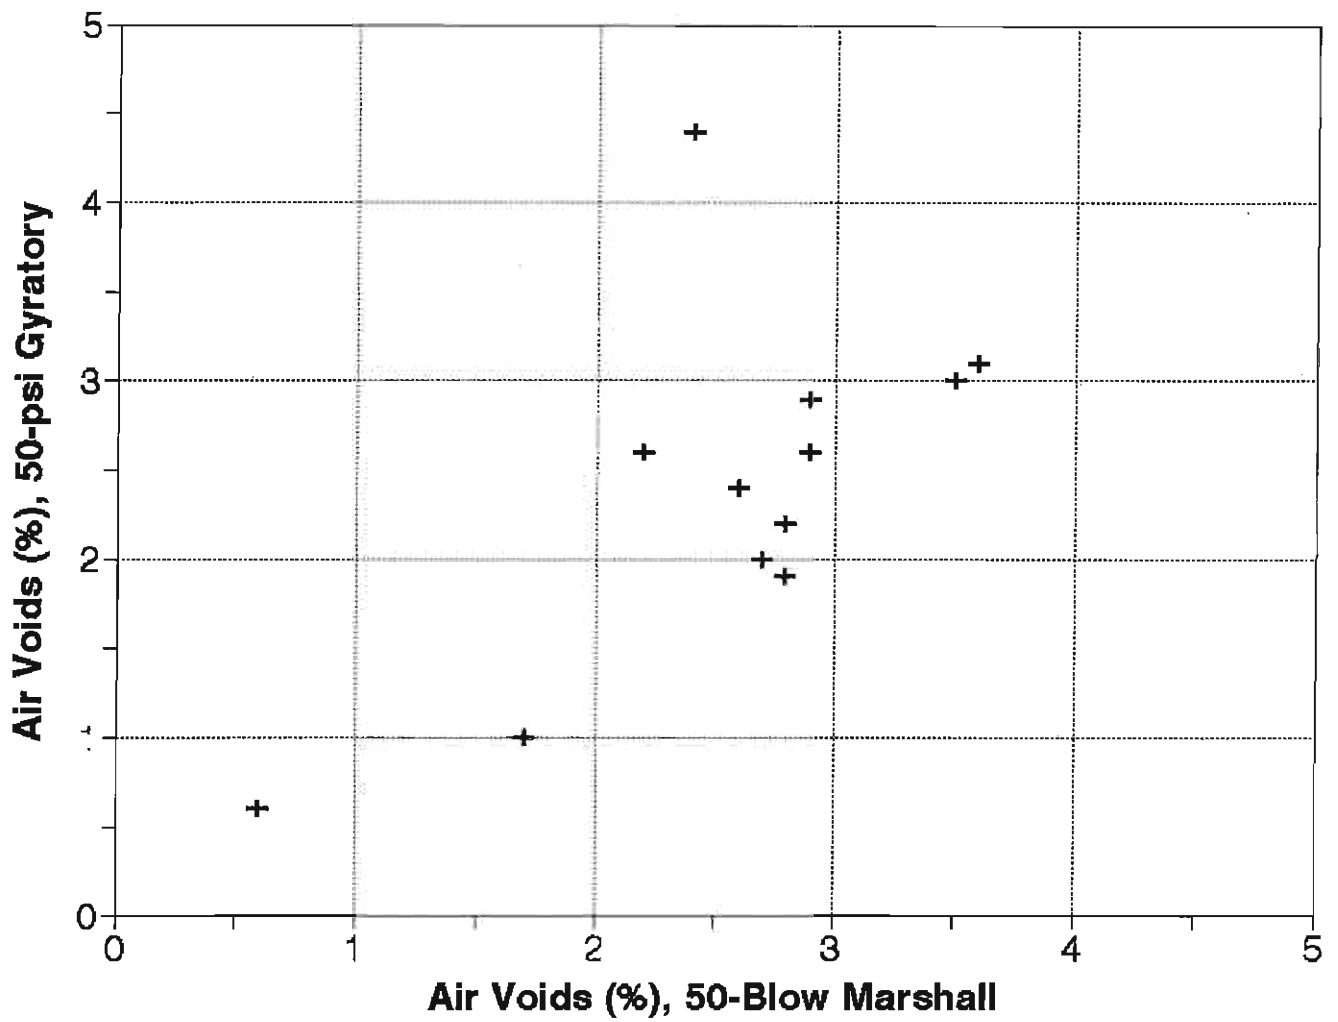
Figure 18. Comparison of Air Voids from Texas Gyrotory and Marshall Compaction.

$$y = 0.93 x + 0.51$$

It should be recognized that any attempt to replace the Marshall hammer with the gyratory compactor will not yield an ideal conversion. If the gyratory is used as a matter of convenience to replace the Marshall hammer, the 340 kPa (50 psi) end point stress appears reasonable. More data should be gathered before making this a specification change for SMA mixtures.

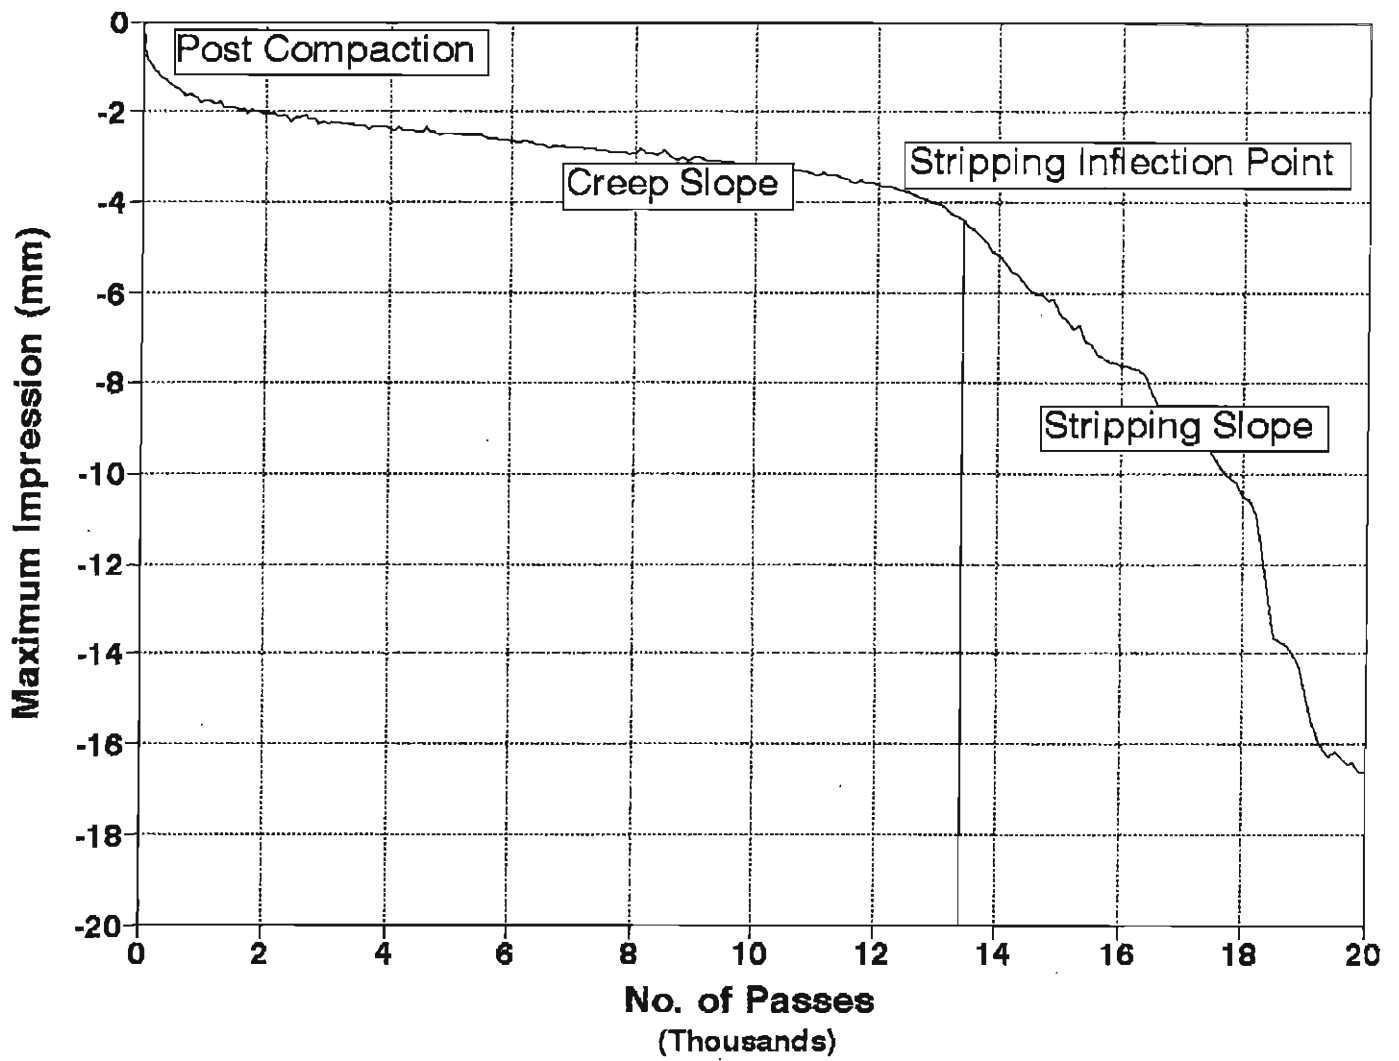
The results from the Hamburg wheel-tracking device include the creep slope, stripping slope and stripping inflection point as shown in Figure 21. These results have been defined by Hines (10). The creep slope relates to rutting from plastic flow. It is the inverse of the rate of deformation

Figure 21. Typical Results from the Hamburg Wheel-Tracking Device.

in the linear region of the deformation curve, after post compaction effects have ended and before the onset of stripping. The stripping slope is the inverse of the rate of deformation in the linear region of the deformation curve, after stripping begins and until the end of the test. It is the number of passes required to create a 1 mm impression from stripping. The stripping slope is related to the severity of moisture damage. The stripping inflection point is the number of passes at the intersection of the creep slope and the stripping slope. It is related to the resistance of the HMA to moisture damage.

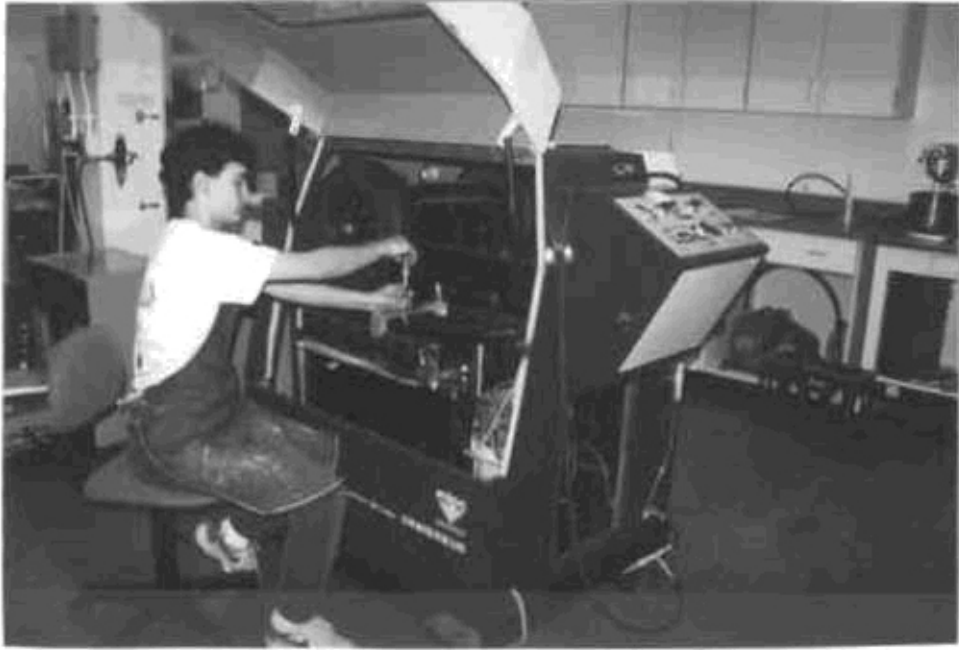
**Figure 22. French Rutting Tester.**

The samples are tested by having a tire roll back and forth over the sample at elevated temperatures. The samples are loaded with 5000 N (1124 lbs.) by a pneumatic tire inflated to 0.6 MPa (87 psi). The tires load each sample at 1 cycle per second; one cycle is two passes. The chamber is heated to 60°C (140°F) but can be set to any temperature between 35° and 60°C (95° and 140°F).

When a test is performed on a laboratory compacted sample, it is aged at room temperature for as long as 7 days. It is then placed in the French rutting tester and loaded with 1000 cycles at room temperature. The deformations recorded after the initial loading are the "zero" readings. The sample is then heated to the test temperature for 12 hours before the test begins. Rutting depths are measured after 100, 300, 1000, 3000, 10,000, 30,000 and possibly 100,000 cycles. The rutting depth is reported as a percentage of the sample thickness. After a given number of cycles, the percentage is calculated as the average of 15 measurements (five locations along the length and three along the width) divided by the original slab thickness. A pair of slabs can be tested in about 9 hours.

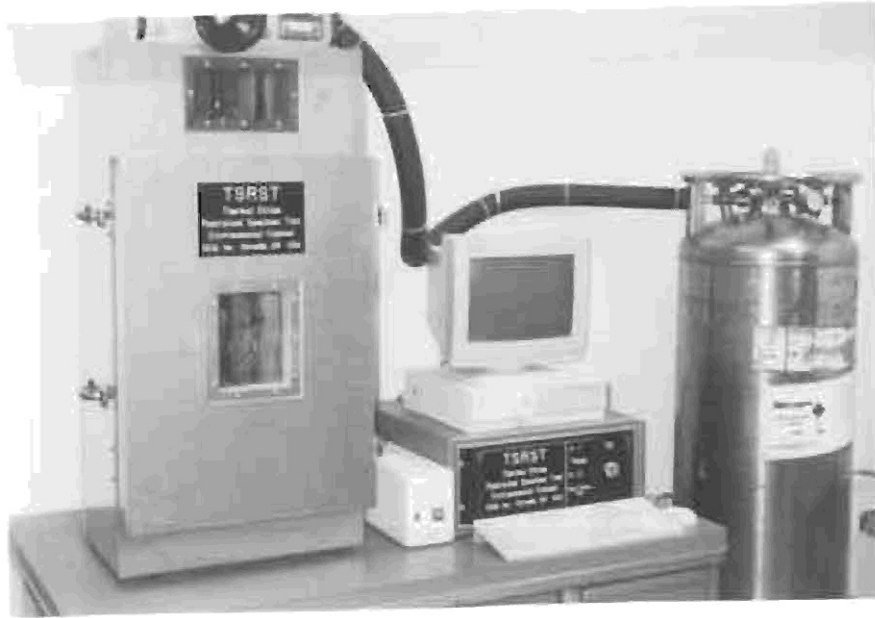
Figure 24. The TSRST Device.

The thermal stress restrained specimen test (TSRST) is used to evaluate the resistance of the HMA to low temperature thermal cracking. The TSRST was developed at Oregon State University as part of SHRP. The TSRST is manufactured by OEM, Inc. in Corvallis, Oregon.

After a sample is mounted in the TSRST, it is cooled at a rate of 10°C (18°F) per hour. Liquid Nitrogen is used to provide the cooling. The sample is not allowed to contract during the cooling period. The sample length is monitored with LVDTs and the use of Invar steel rods. Since the sample is not allowed to contract as it cools, stresses develop within it. A closed-loop system keeps the sample at a constant length. When the developed stress exceeds the strength of the sample, the sample breaks. The temperature and stress at fracture are recorded. A typical plot of the test results is shown in Figure 27.

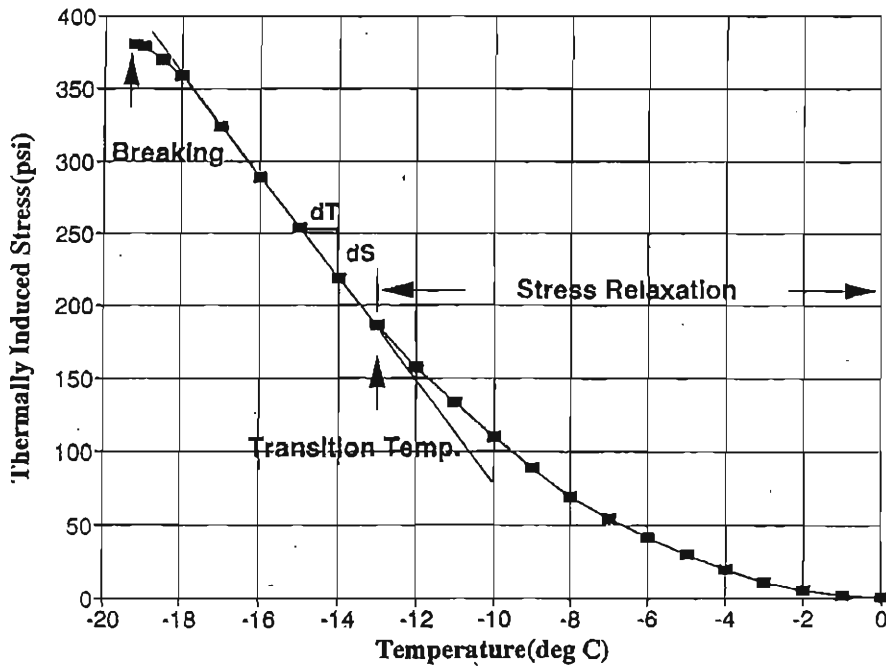
Figure 27. Typical TSRST Test Results.
