# **PCCP Texturing Methods**

**Interim Report  
March, 1995**

**95-2**

PCCP Texturing Methods  
Project IR (CX) 070 -4 (153)  
Deer trail - East

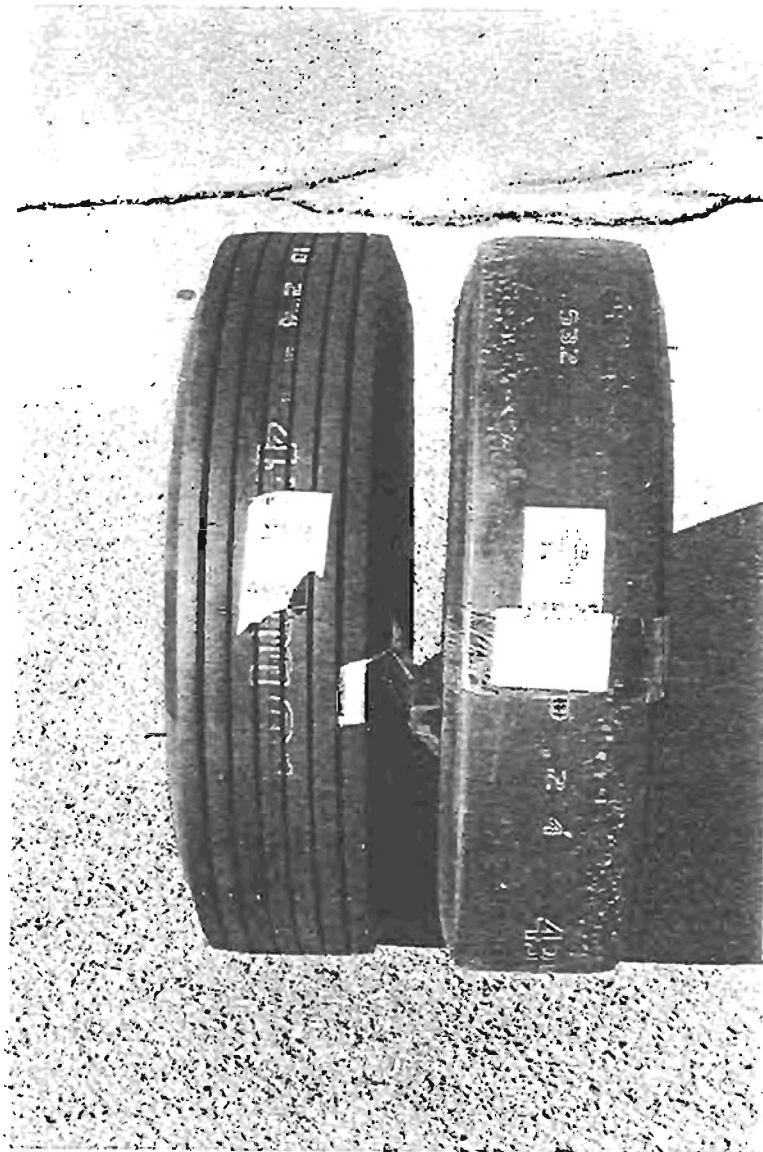
Photo A: View of the ribbed tire (ASTM E 501), and the smooth tire (ASTM E 524).

provide drainage for water regardless of pavement macrotexture. On the other hand, tests with the smooth-tire (ASTM E 524) have produced skid-resistance data which are sensitive to both macrotexture and microtexture (5). Another advantage of using a smooth tire is that the influence of tire wear on the friction data is eliminated (6). Photograph A compares the ribbed and the smooth tires.

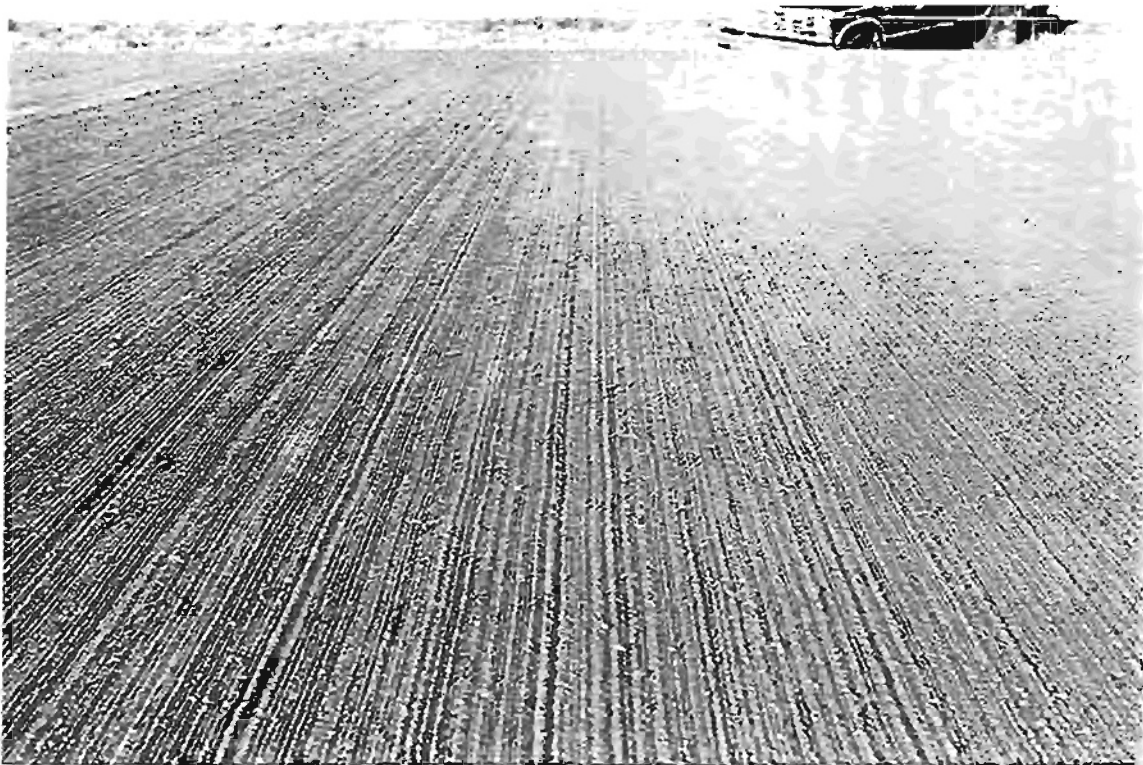
Photo 7 & 8: Installation and close-up view of transverse astro-turf texture

Photograph 7 shows the installation of transverse astro-turf texture. The set-up used was similar to that of transverse tining. A 12 foot wide, 2 foot long piece of astro-turf was folded in half and nailed to a 2" x 2" x 12 foot long piece of wood. The entire unit was then attached to the tining bridge in a manner similar to transverse tines.

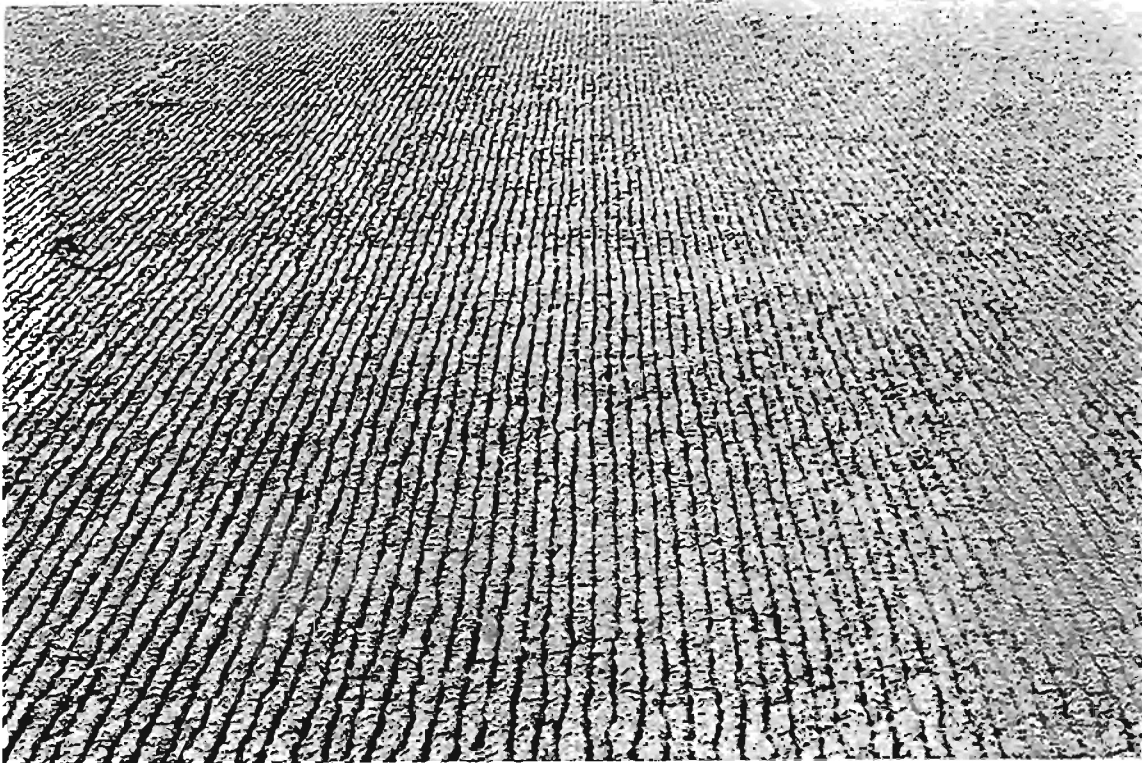
Photo 11: 1/2" uniform spaced transverse tining

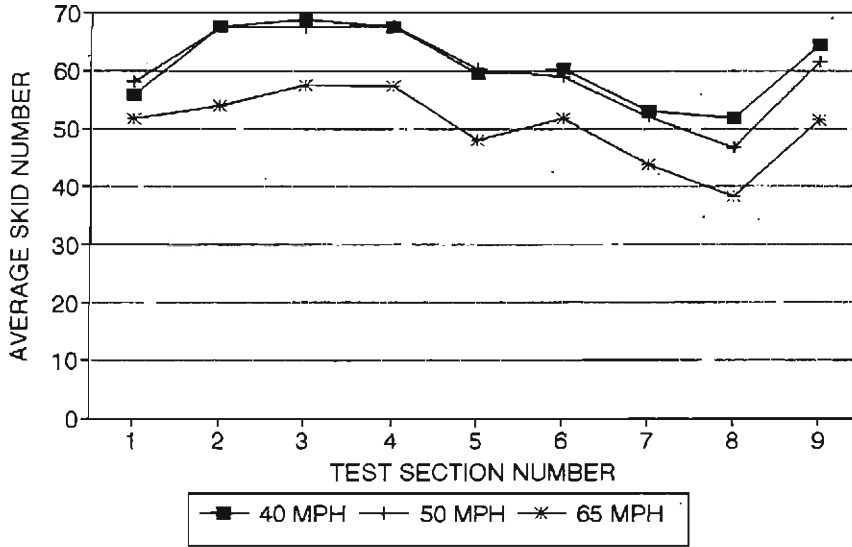
Figure 3

# RIBBED TIRE SKID NUMBERS

macrotexture. The primary reason for the ribbed-tire's insensitivity to macrotexture is its deep grooves which provide drainage for water and somewhat ignores the drainage capability of the sawed or tined surfaces.

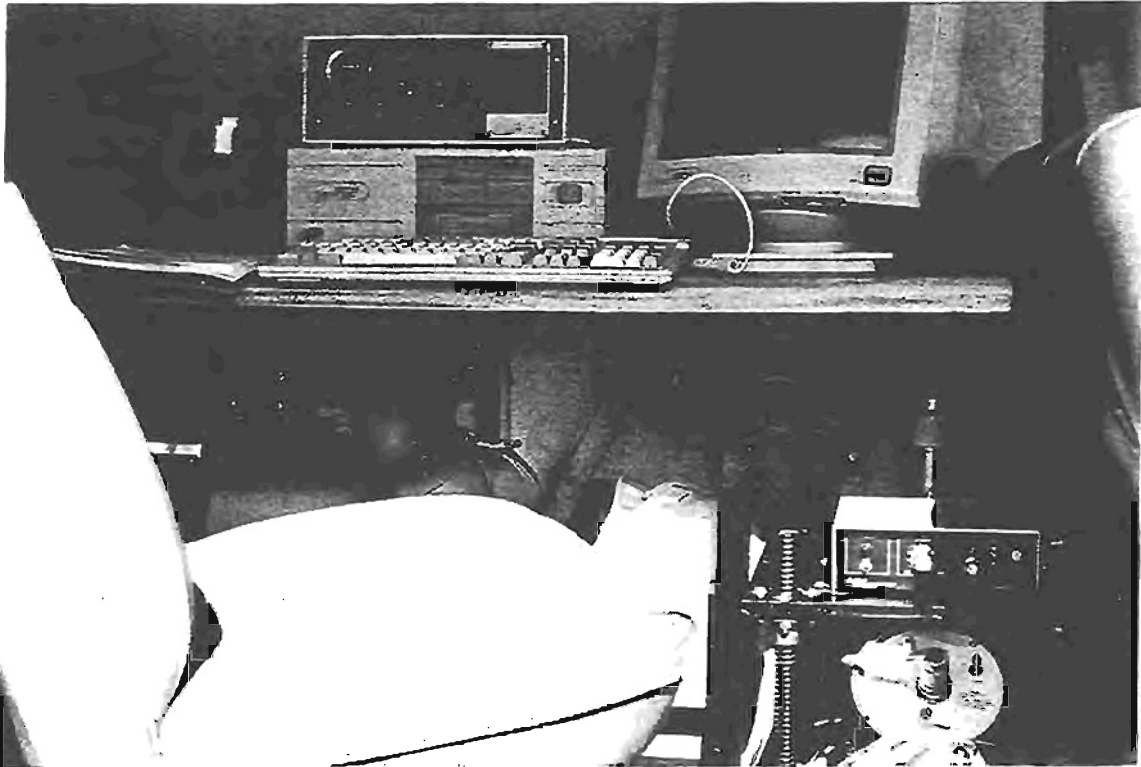
Photo 18: Inside of a texture van.

This equipment (Photograph 18), can measure texture at travel speeds and does not interfere with normal traffic. It uses a television camera to take snapshots of a small pavement section in the wheel track (about 4 inches long). It will take a pre-selected number of exposures spaced about 50 feet apart at 50 miles per hour. To assure image sharpness the exposure time is given by a strobelight, and an infrared sensor assures that the field of view is in focus. The images are formed by a slit mask over the lens, giving two profile edges at every exposure.

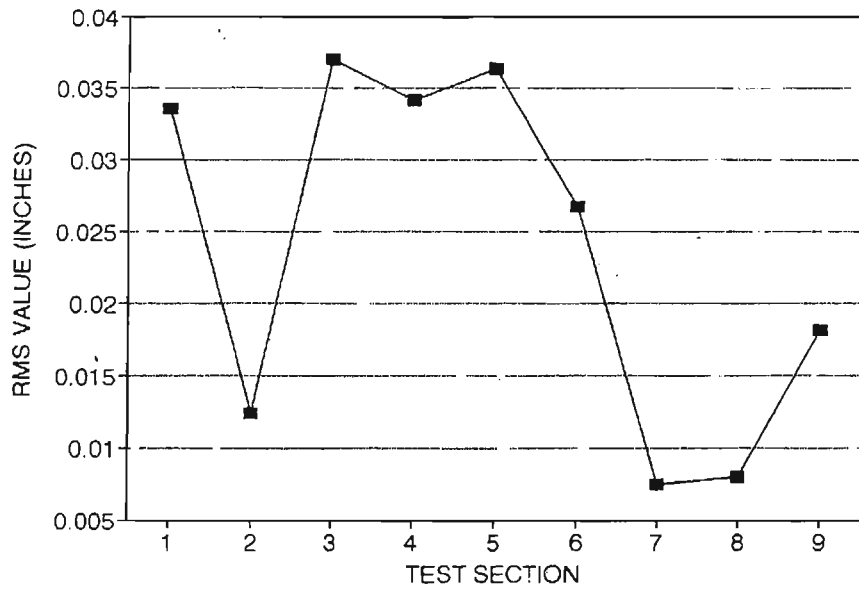
## TEXTURE MEASUREMENT LASER VAN

An rms (root mean square) value is computed for each of the two profiles. The final output is an average rms value for the test section. Figure 6 compares the average rms values for the individual test sections. As expected, the texture van showed lower values for sections 2 and 8 with microtexture; however, it also showed low values for longitudinal sawing (test section 7), and longitudinal tining (test section 9). This may indicate that the laser van is more sensitive to transverse texture than the longitudinal texture. It should also be noted that, of the two microtexture (section 2 and 8), section 2 with the transverse orientation showed higher rms values.

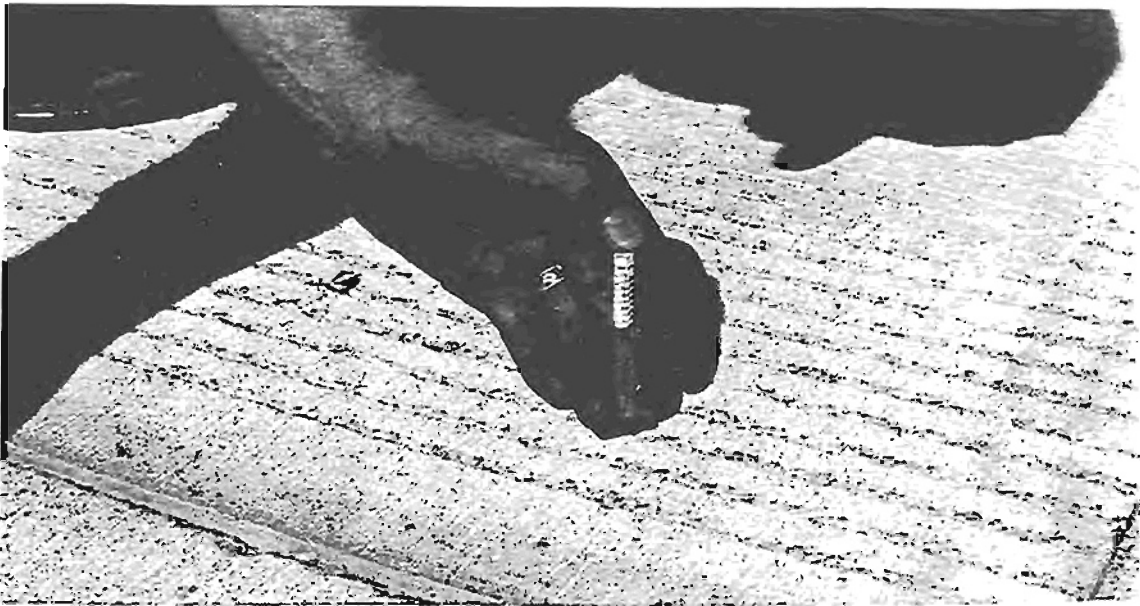
Photo 22: Texture depth measurement using a tire gauge.

A tire tread depth gauge with an accuracy of 1/32 of an inch was also used to measure texture depth (Photograph 22). Five texture depth measurements were taken and averaged at the same spot that the sand patch tests were taken. The results of the tire gauge measurements are shown in Figure 11. These measurements appeared

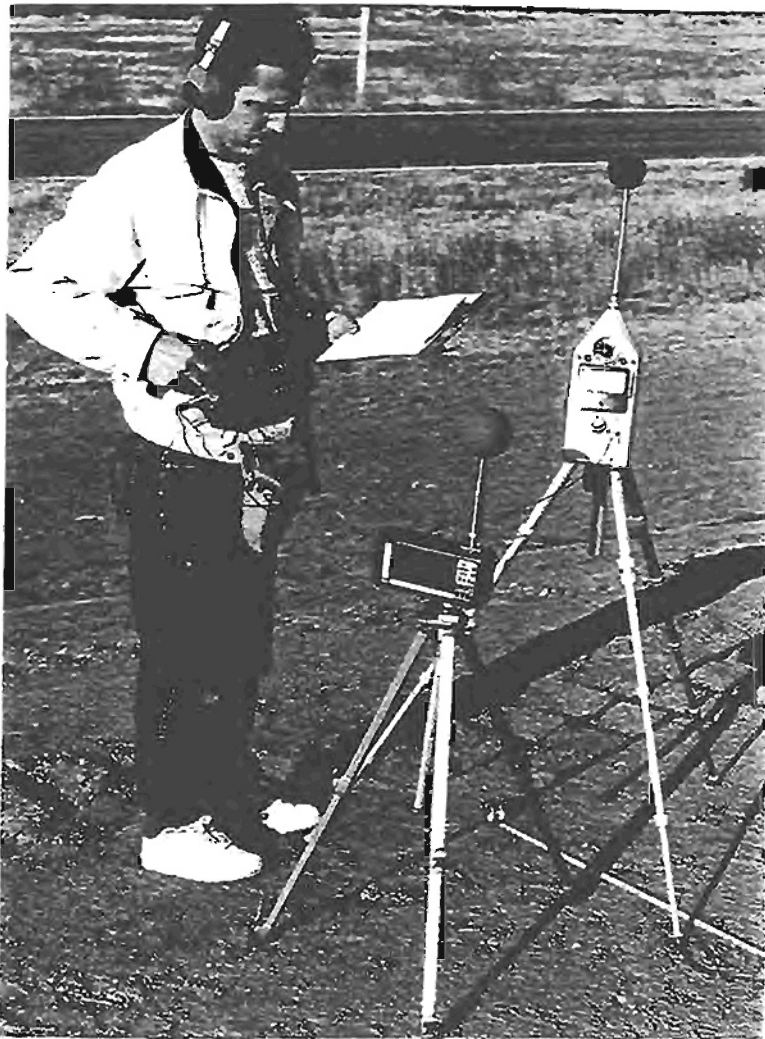
Photo 23: SPL measurement at the roadside.

1. SPL measurements were acquired at 25 feet from the center line of the test sections. The microphone was placed on a tripod just beyond the shoulder of the road at a height of 4.5 feet (Photograph 23). The Oldsmobile station wagon was traveling in the driving lane at a speed of 65 miles per hour. In an effort to minimize the impact of engine noise, the station wagon coasted out of gear while passing the measurement station. However, it should be noted that measurements taken with the engine on and the engine off produced the same SPL, indicating that the tire noise was predominately louder than the engine noise.

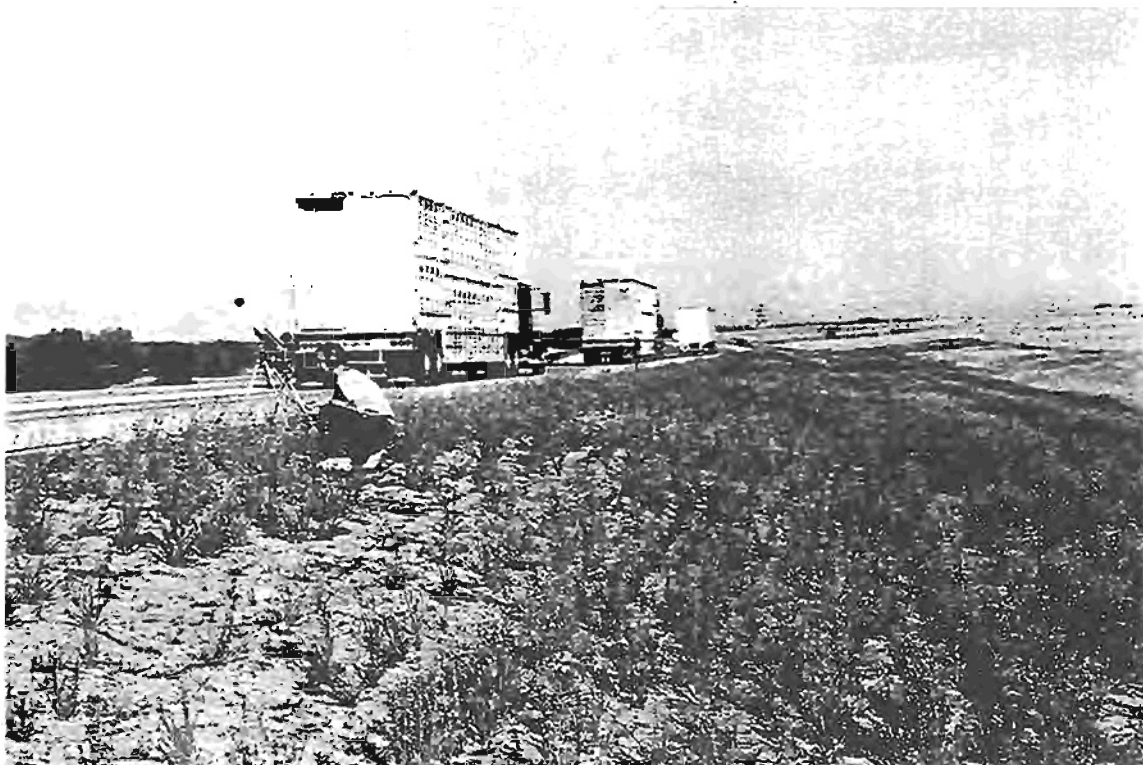
Photo 25: Acquiring truck noise levels at the roadside

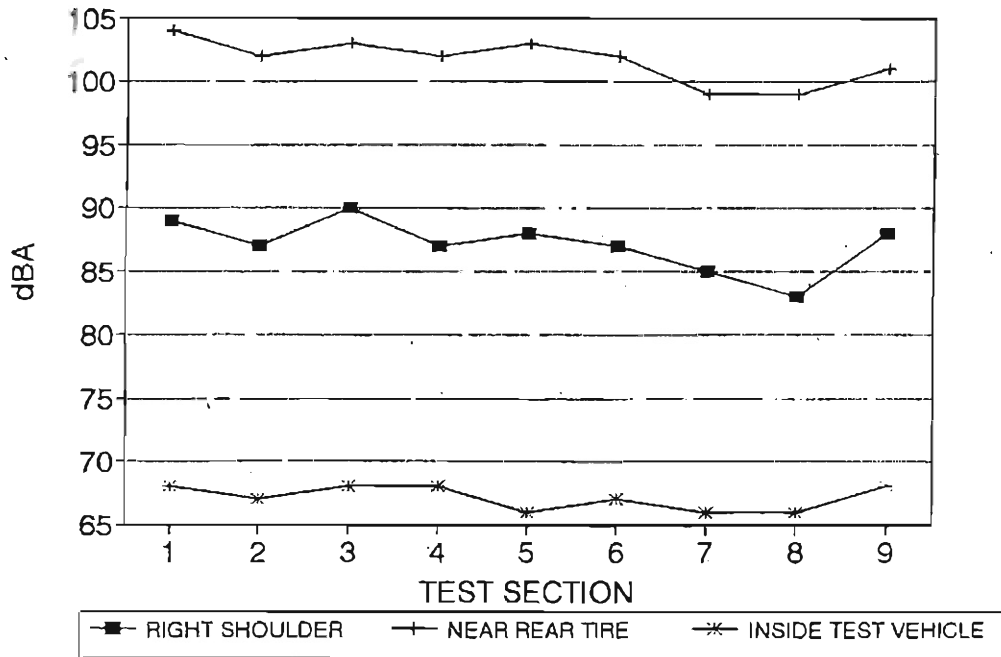
Figure 15

# A-WEIGHTED SOUND LEVELS

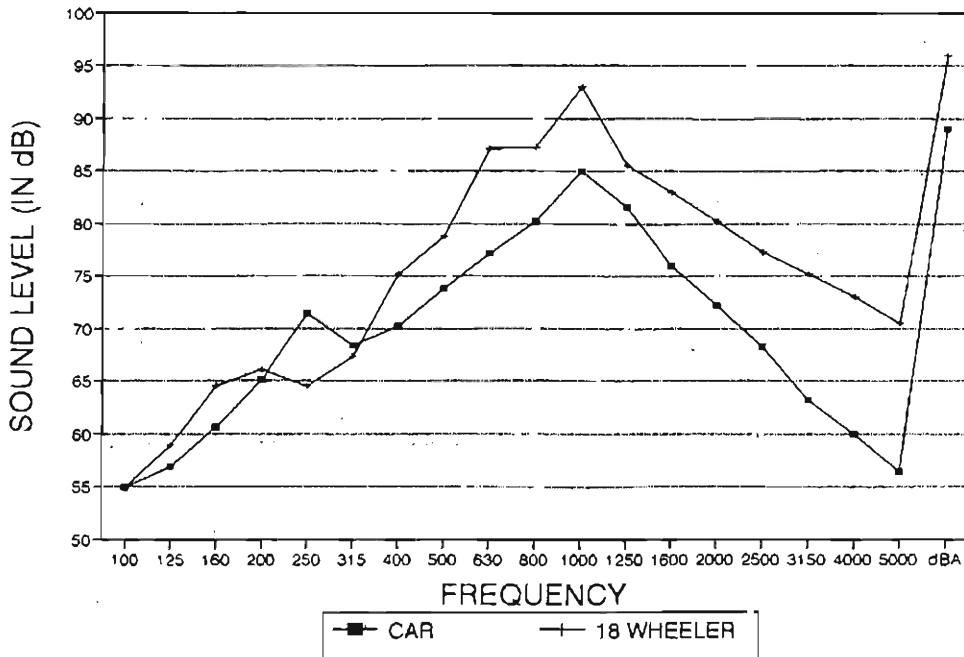
Figure 16

# SPL COMPARISONS

## CAR vs. TRUCK (SHOULDER SECT 1)

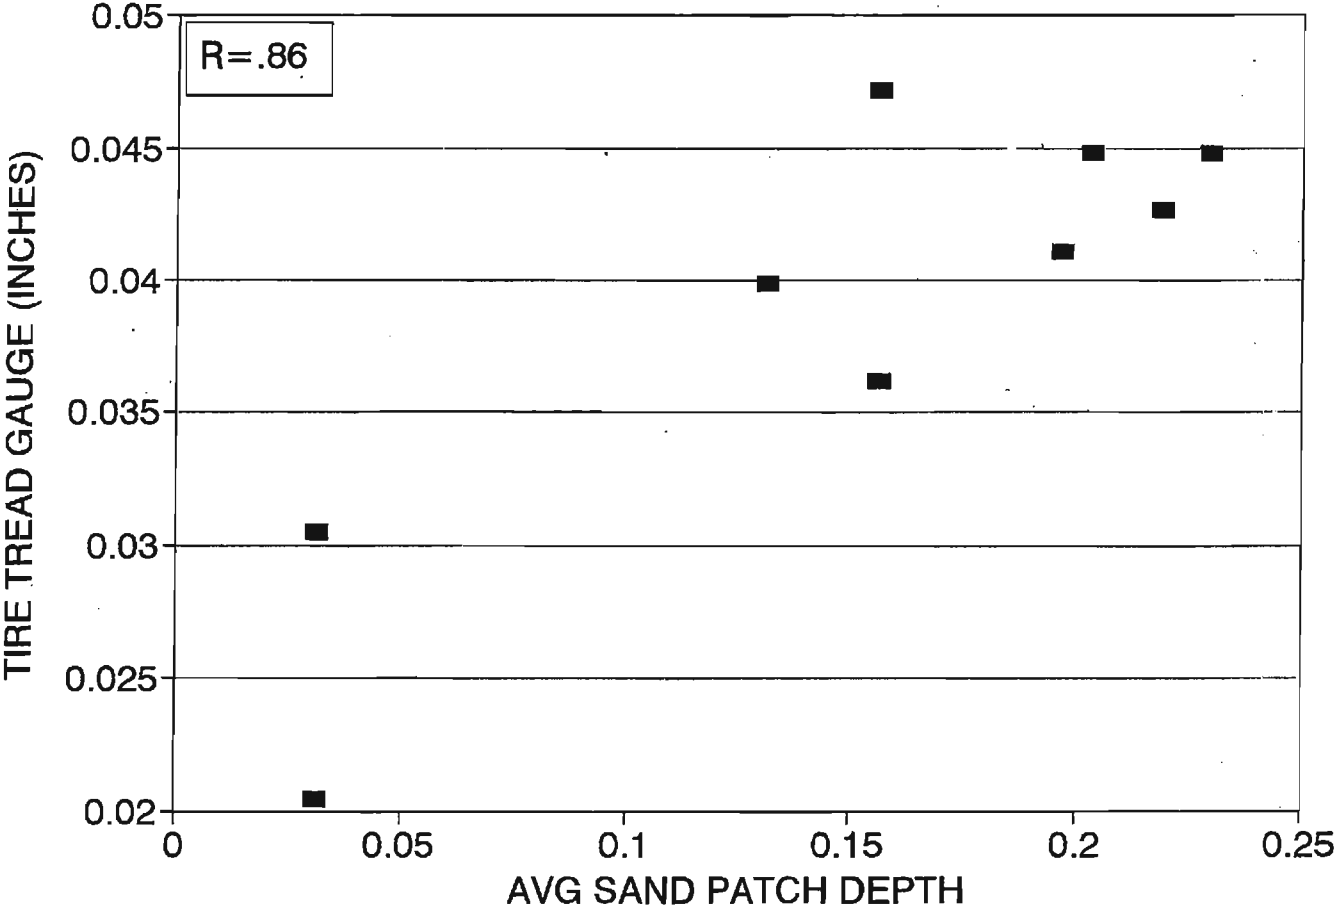
# SAND PATCH DEPTH VS TIRE TREAD GAUGE

to have a linear relationship with those of the sand patch tests with a correlation factor of  $r = 0.89$ . For an in-depth look at the test results and relationship between various variables refer to scatter charts in Appendix A.
