**Report No. CDOT-DTD-96-12**

# **Evaluation of Rumble Treatments on Asphalt Shoulders**

**David A. Price  
Colorado Department of Transportation  
4201 East Arkansas Avenue  
Denver, Colorado 80222**

**Final Report  
December 1996**

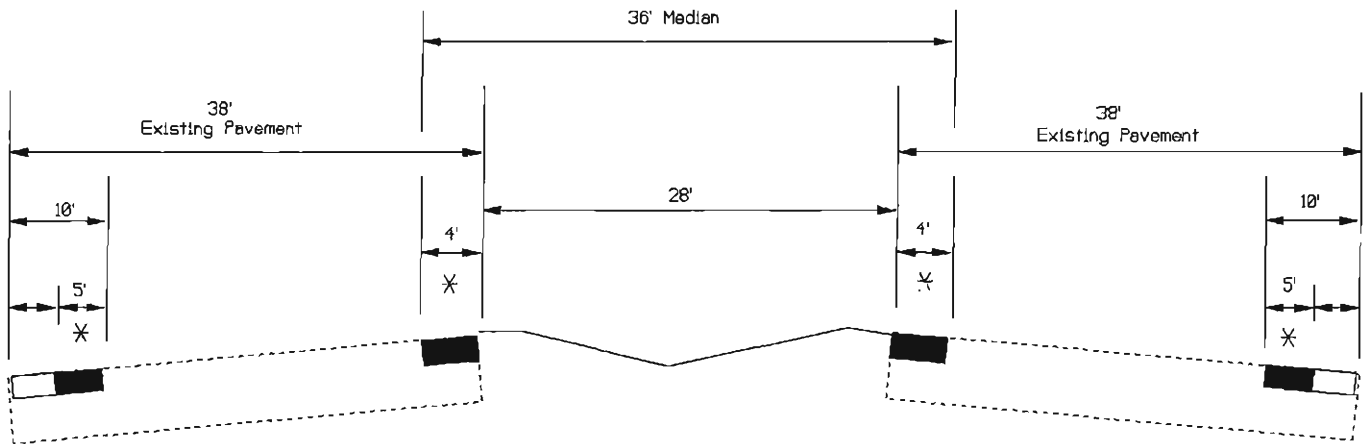
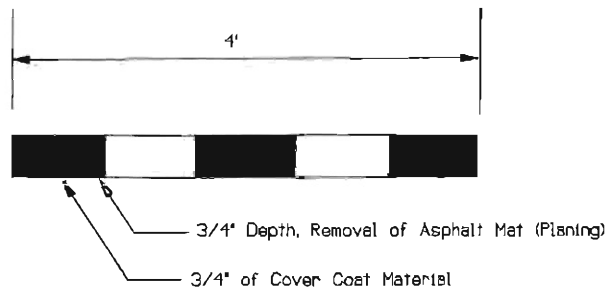
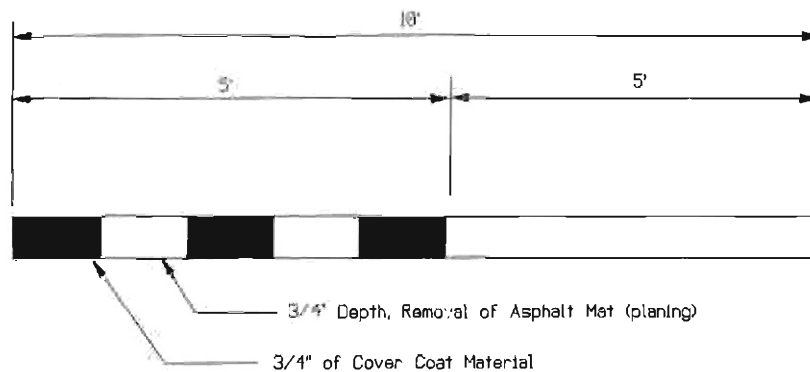
Figure 2  
 Project IR(CX) 76-1(152)  
 Typical Section  
 (Chip Sealed Shoulders)

\* Shoulder Areas to be Planed and Chip Sealed. (no scale)

### Planing and Chip Seal Detail

Detail 4' on Inside Shoulders

Detail 10' on Outside Shoulder

Construction began during the last week of May 1991 with the planing of the shoulder as shown in figure 2. The figure shows that the 10 foot outside shoulder was planed 5 foot wide from the existing concrete driving lane. The purpose behind placing the chip seal for only 5 feet rather than full width was to allow a smooth section for bicycle traffic. The inside shoulder was planed for the full width of 4 feet.

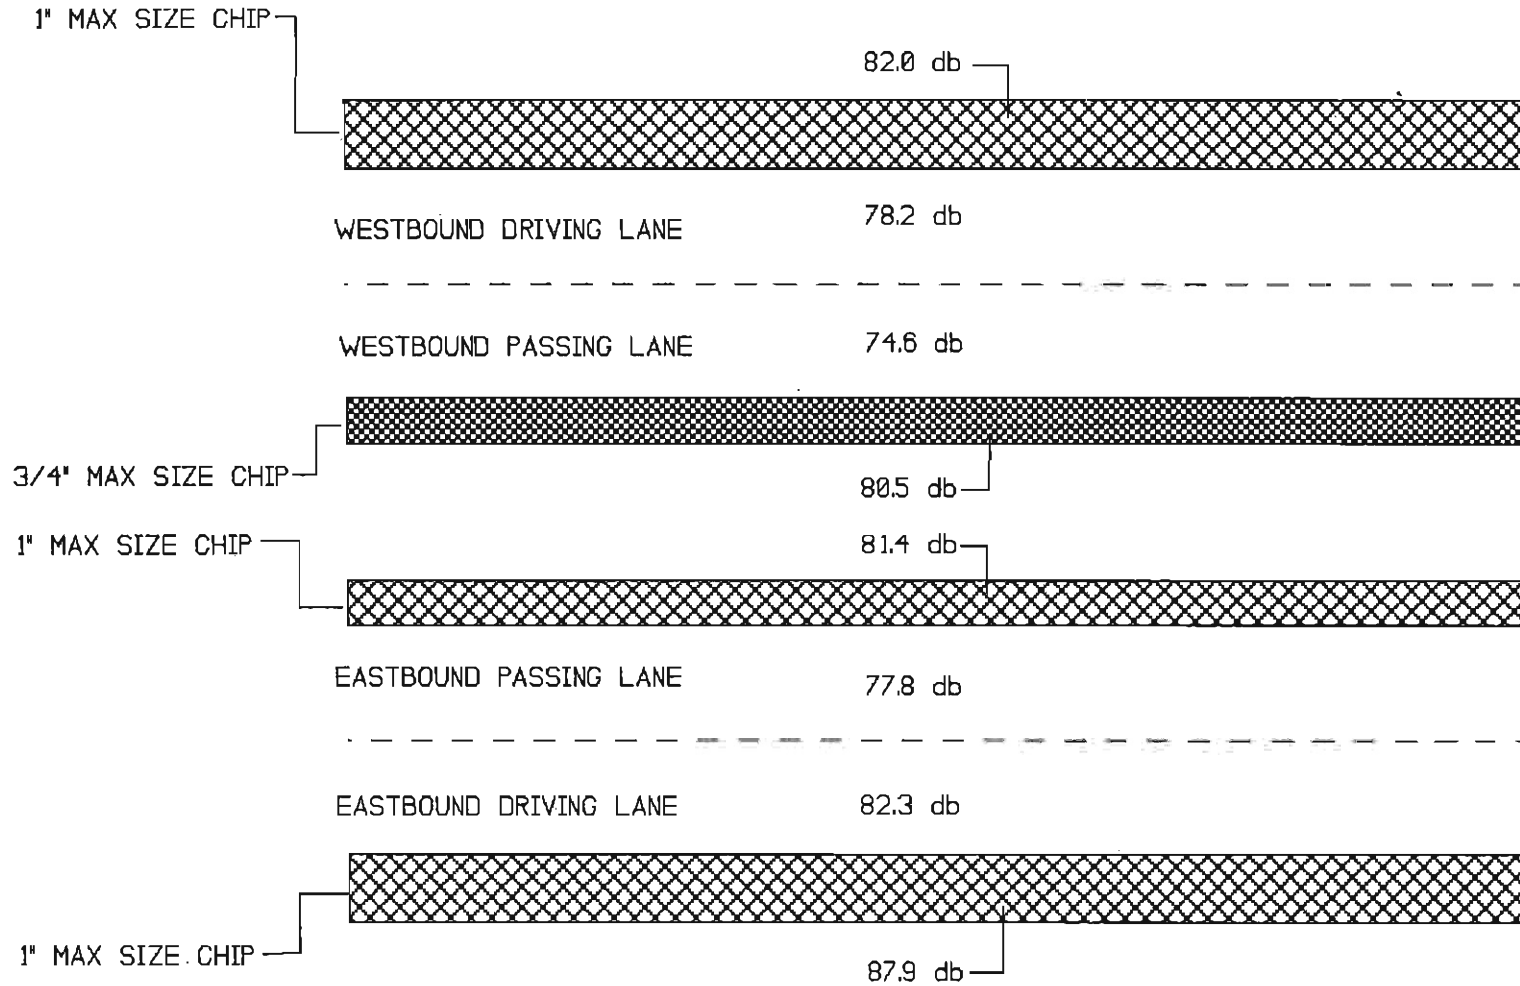
# I-76 SHOULDER CHIP SEAL

A Noise meter built by Quest Electronics model M-28 was used for obtaining noise data. The comparison was performed between the adjacent highway driving lane and the chip-sealed shoulder. Vibration is also a very important part to the effectiveness of rumble strips in waking an errant driver to the condition. However, at this point we have no instruments within the department that can measure the magnitude of vibrations, so only noise readings were taken. The noise meter was placed on a tripod above the transmission hump of a 1989 Dodge Aries K wagon. The noise meters microphone was than placed at a height that would be in the general area of the drivers ear. Tests were taken at a highway speed of 55 mph for a duration of one tenth of a mile. Results are shown in Table A. Figure 4 shows the overall results of the testing by lane and shoulder.

Looking at the westbound driving lane and outside shoulder in figure 4 it can be seen that there is an increase of 3.8 db at 55 mph between the two which is a noticeable difference. The passing lane or inside lane was consistently quieter than the driving lane. This was due to the

there is an increase of 3.8 db at 55 mph between the two which is a noticeable difference. The passing lane or inside lane was consistently quieter than the driving lane. This was due to the fact that the driving lane is much more deteriorated and rougher than the passing lane. The westbound inside shoulder was chip-sealed with a smaller gradation of maximum size 3/4 inches. The sound levels were lower in this area however, the overall change in sound levels was 5.9 db which was again a noticeable difference.

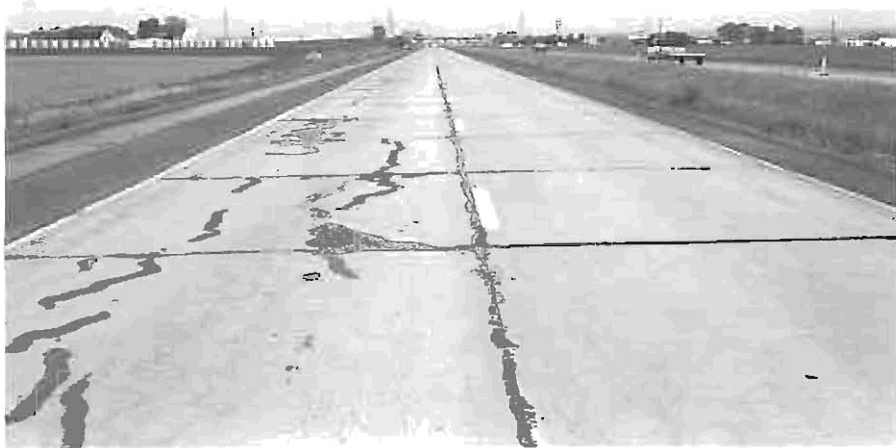
Photo 1 - Eastbound lanes I-76 between MP 13.87 and MP 16.37. Five foot of the outside shoulder was planned  $\frac{3}{4}$  of an inch and four foot of the inside shoulder was planned.

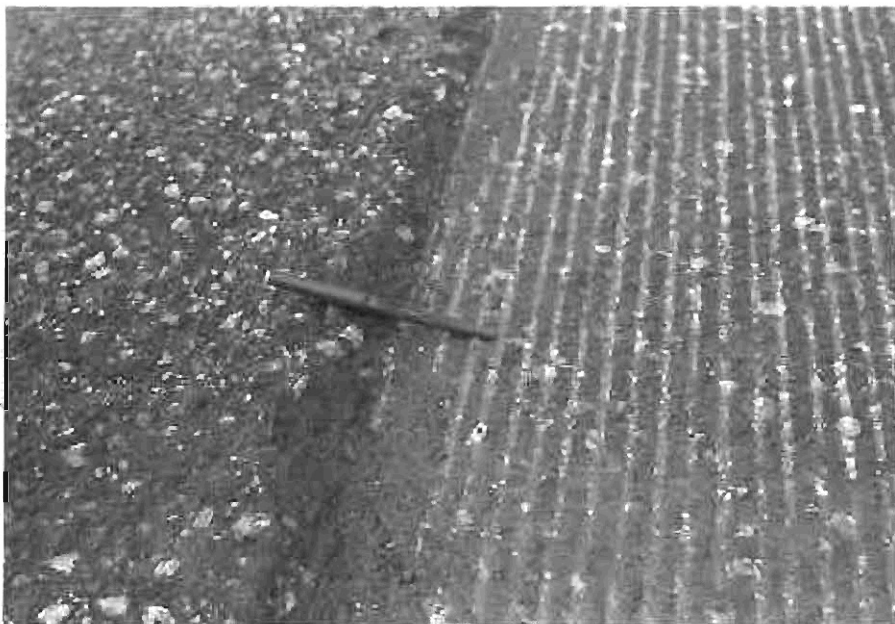
Photo 2 - Planning was performed to a depth of  $\frac{3}{4}$  of an inch.

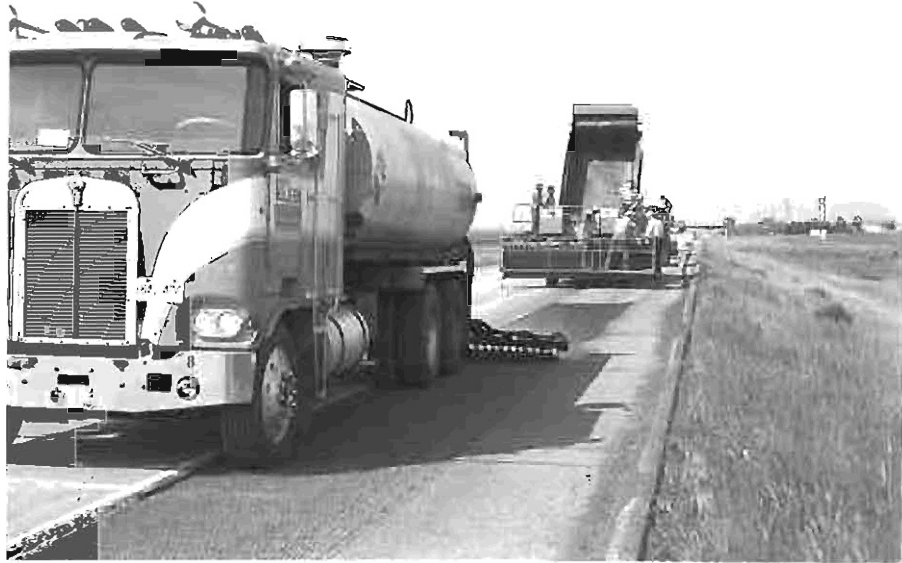
Photo 3 - Emulsified asphalt was rapid-setting, polymerized placed at 0.9 gallons per square yard. Original plans called for 0.4 gallons per square yard.

Due to the large size of the cover coat material emulsified asphalt quantities had to be increased so the chip-seal would remain in place. Emulsified asphalt was increased to 0.90 gal./sq.yd. Emulsified asphalt was also shot over the top of the chip-seal at a quantity of 0.25 gal./sq.yd. to help hold the chips in place. This gave a total of 1.15 gal./sq.yd for the project.

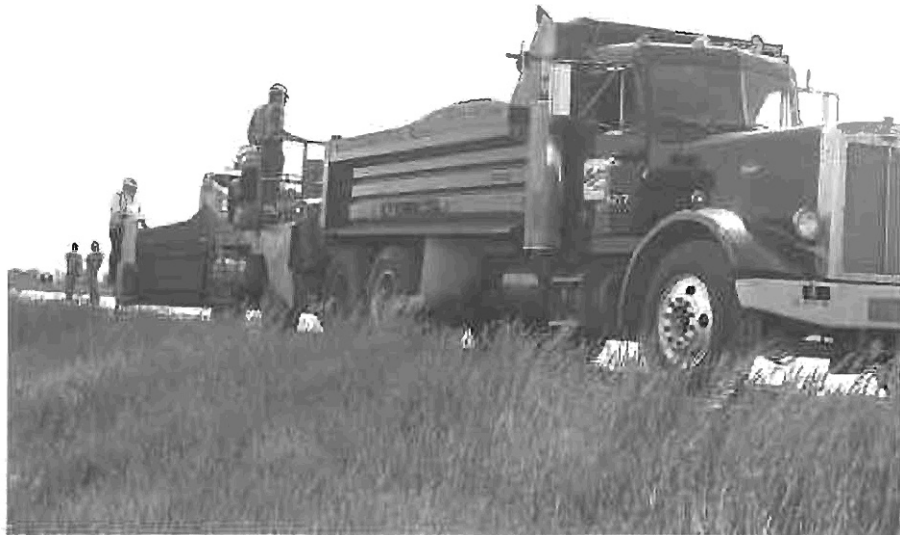
Photo 4 - Placement of the aggregate for the chip seal.

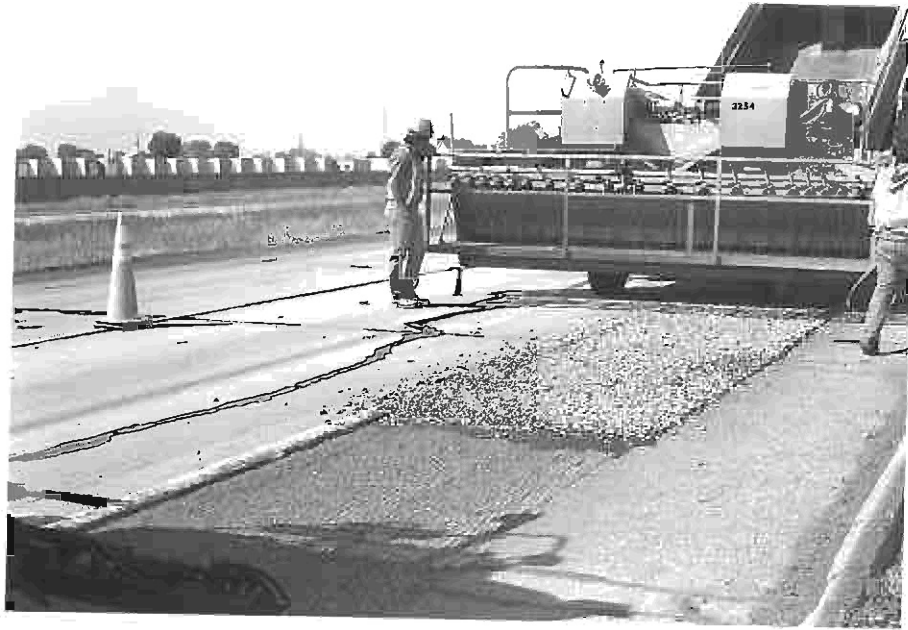
Photo 5 - The cover coat material was placed at 45 lbs./sq.yd.

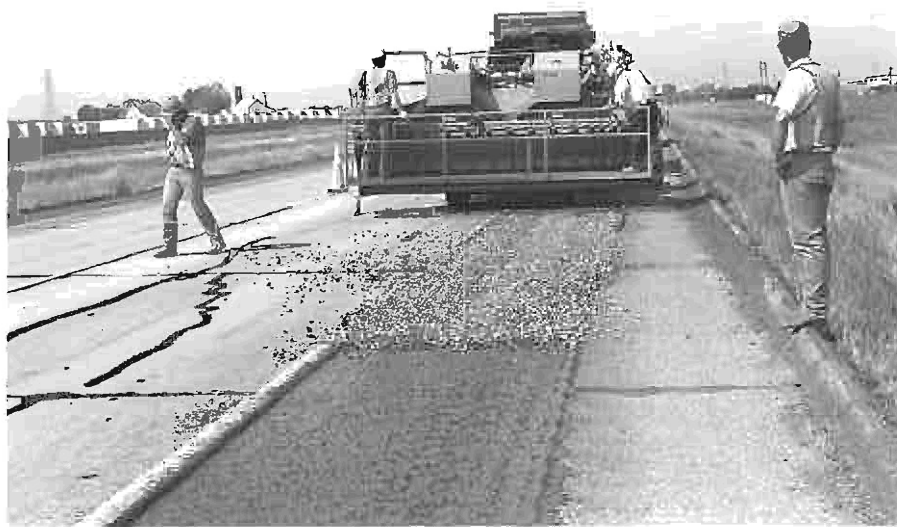
Photo 6 - Five feet of the outside shoulder was left uncovered by the chip seal for bike traffic.

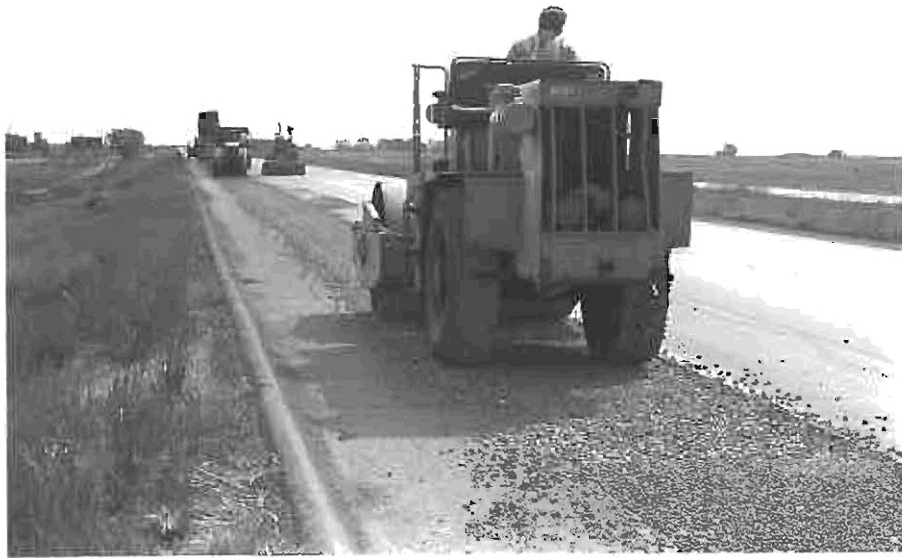
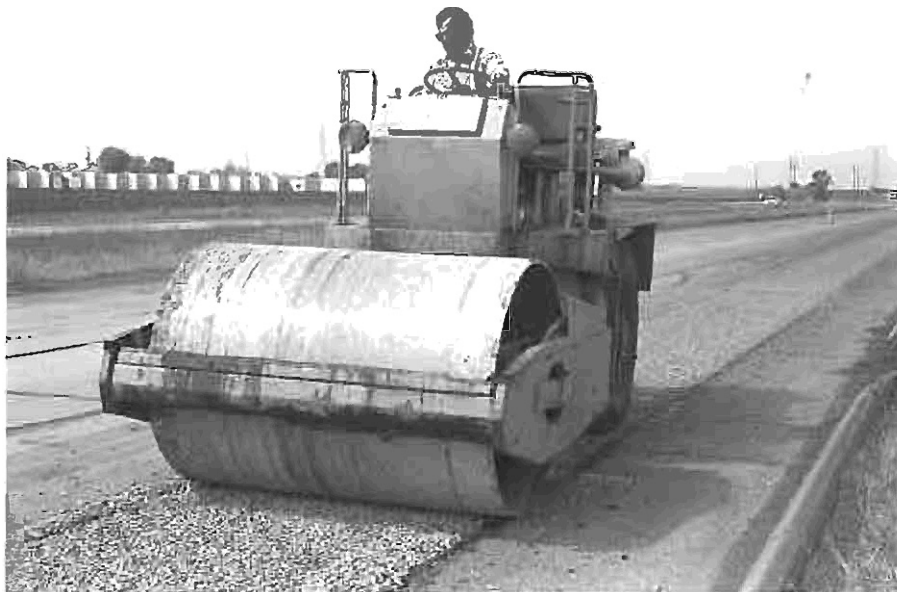
Photo 7 - The chips were rolled into the emulsified asphalt first by a rubber tired roller and then followed by a lite weight steel roller.

Photo 8 - Same as above.

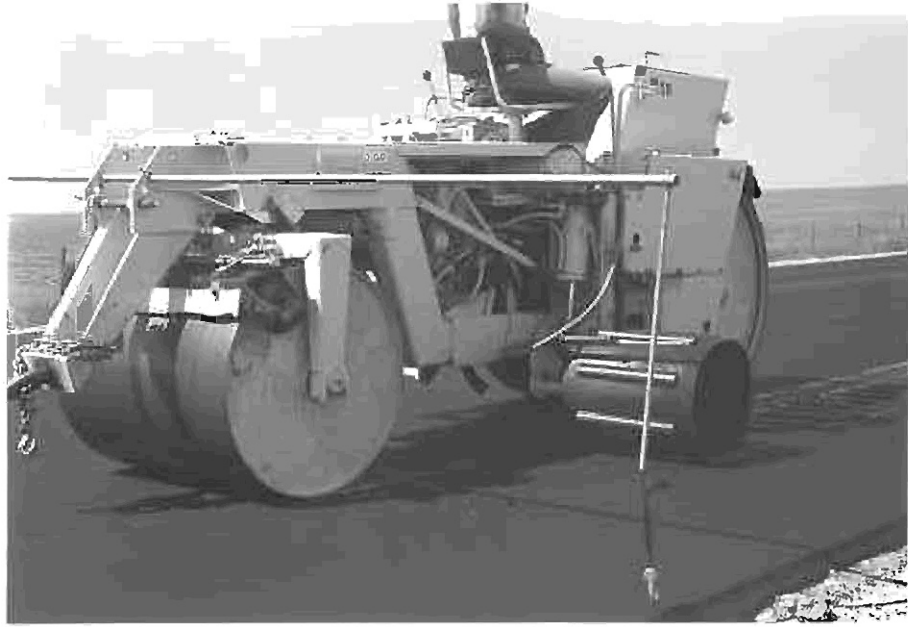
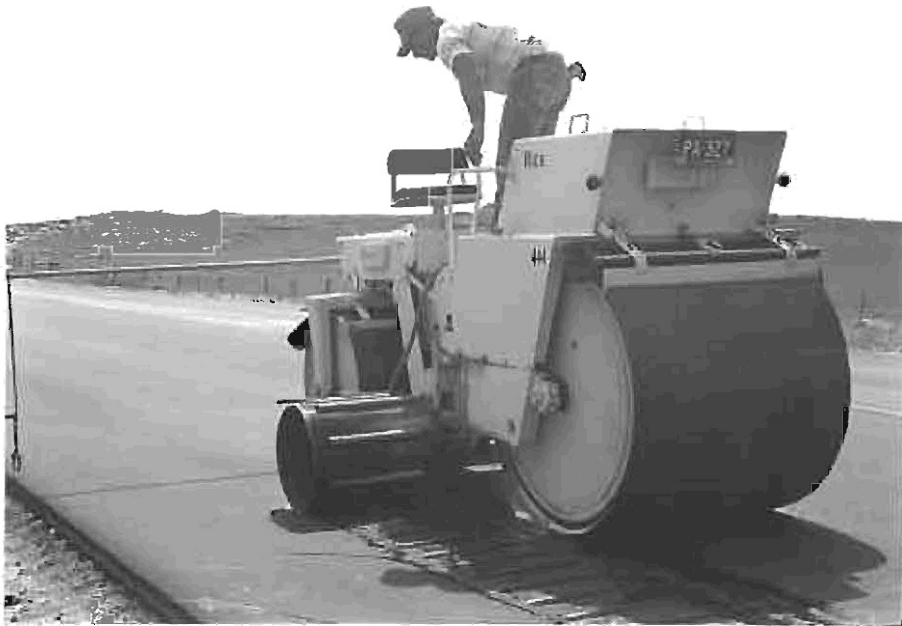
Photo 9 Rumble strips rolled into shoulder with modified hydraulic roller attachment during repaving.

Photo 10 - Same as photo 9.

Construction began on SH-14 just east of SH-71 in July of 1991. Photos 8 and 9 show the roller that the contractor manufactured to place the rumble strips into the new mat. The contractor cut 2-1/2 inch steel pipe in half and welded them to a steel drum. This drum was then mounted onto the roller using a hydraulic arm to lift it up and place it into position. Water was sprayed onto the fabricated drum to reduce the amount of asphalt sticking to it. The cost to place this strip amounted to the cost of one extra roller operator.

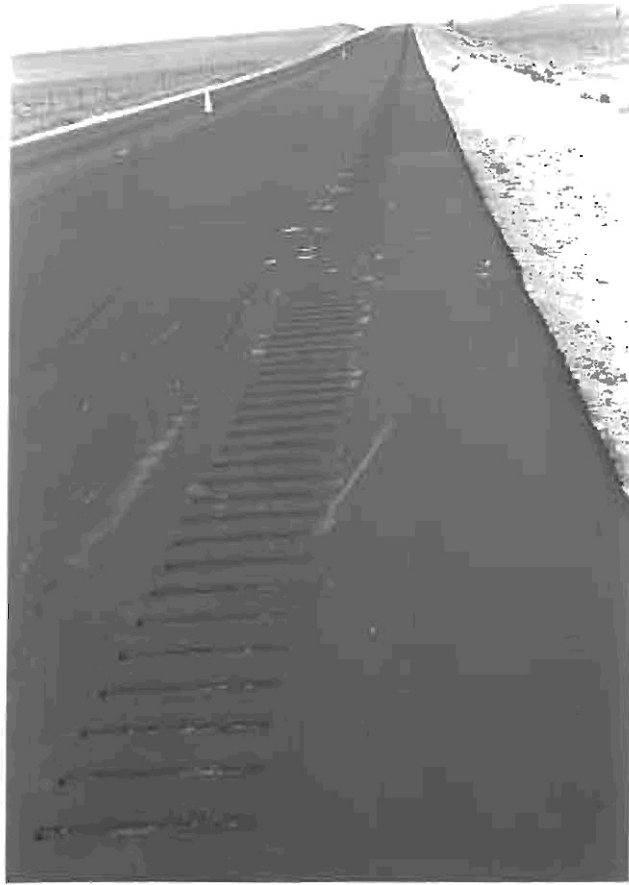
Photo 11- Finished rumble strip on SH-14.

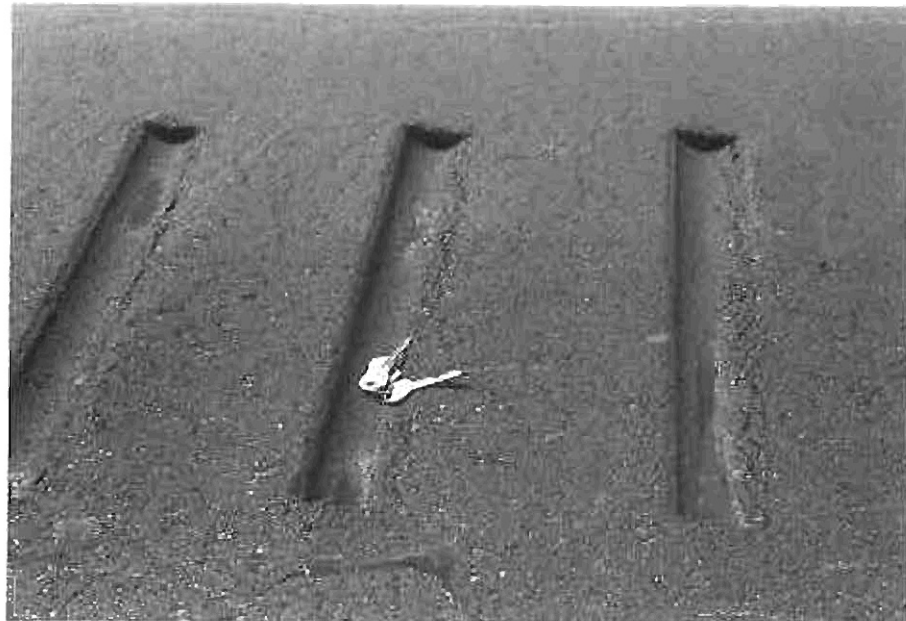
Photo 12 - Photo shows good penetration by modified roller into shoulder overlay producing a well defined rumble strip.

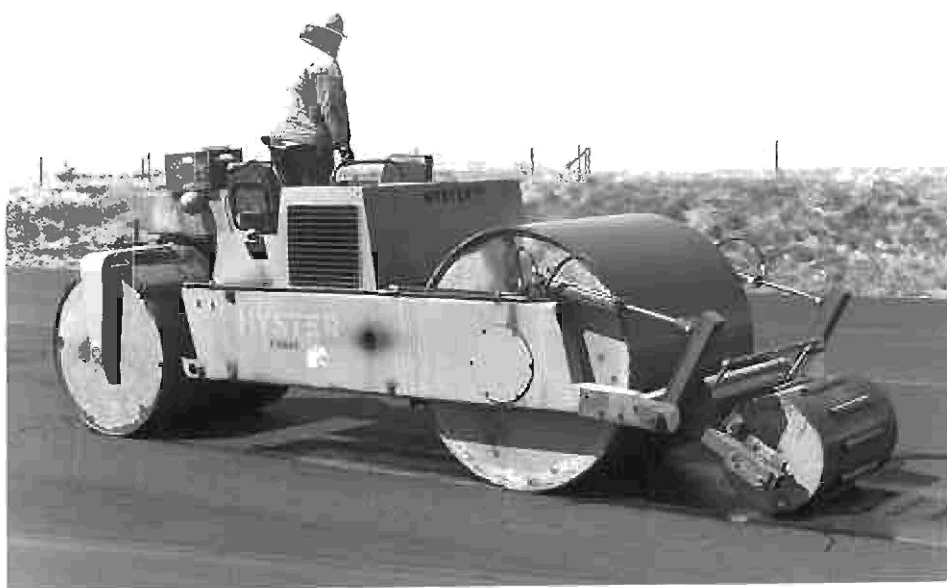
Photo 13 - Rumble strips being placed on SH-63 south of Akron.

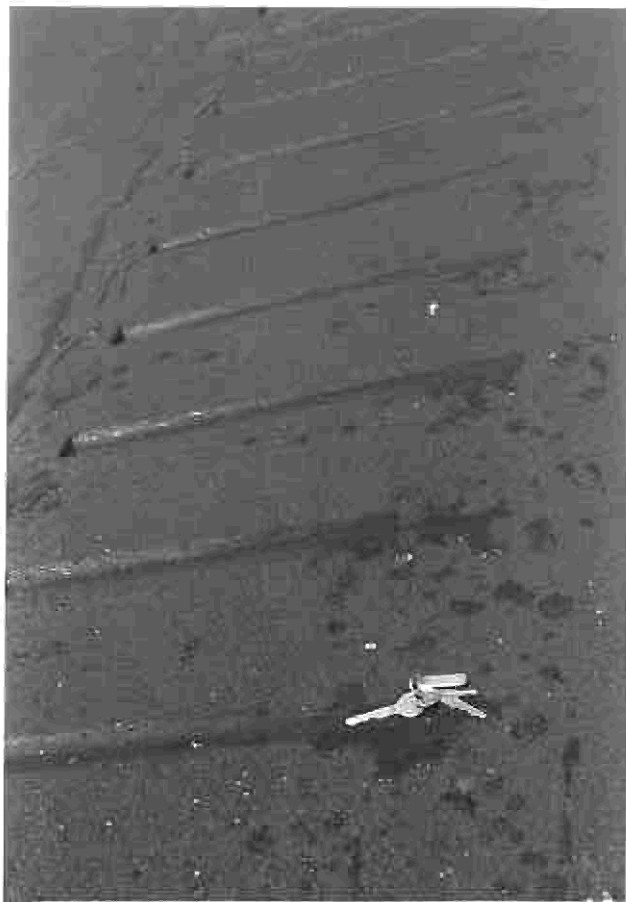
Photo 14 - Rumble strip without proper depth due to low asphalt temperature during placement.

These strips were placed behind the breakdown roller with the pavement at a temperature of 225 degrees F. The mat was a 1-1/2 inch Colorado spec grading F, (a gradation that 85% passes a #8 screen). The ideal temperature for rolling in rumble strips will vary depending on the thickness of the mat and the gradation of the asphalt being placed. The rumble strips placed on SH-14 were placed with little problem and are very noticeable when driven over. The ease in which the strips were placed may be partly due to the small aggregate size of the mat. All costs for rumble strips on this project were included in the bid price for the H.B.P (Gr. F). The finished product is shown in photos 10 and 11. Figure 5 shows the rumble strip detail and the site location can be seen in appendix A.

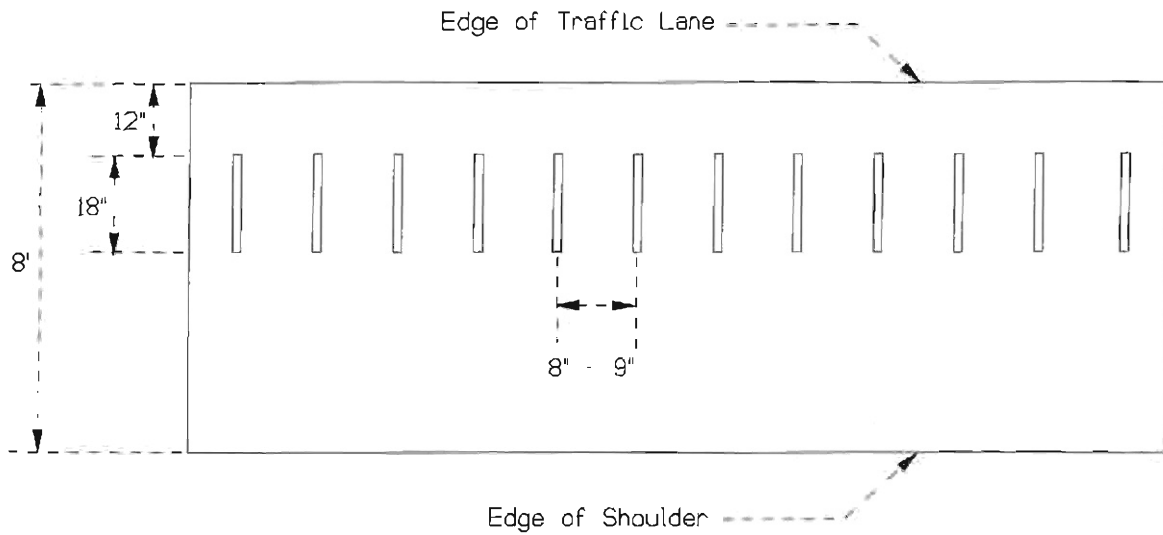
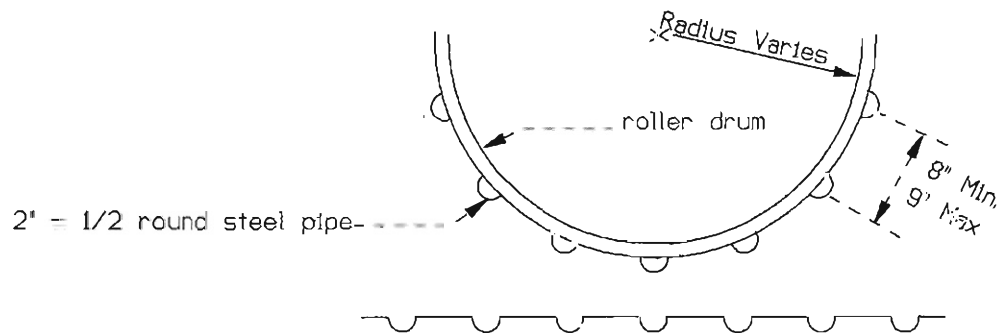
Figure 5

# DETAIL OF RUMBLE STRIP

# STEEL DRUM DETAIL

During the 1991 construction season several projects in Colorado incorporated rumble strips that were rolled into the shoulder during overlay construction. The detail for construction on SH-14 (figure 5) shows the rumble strip to be placed 12 inches from the lane edge strip, 18 inches long, 8 to 9 inches apart and 1-1/4 inches deep.
