Report No. CDOT-DTD-R-96-7

SMA
(Stone Matrix Asphalt)
Colfax Avenue Viaduct

**Construction Report
April, 1996**

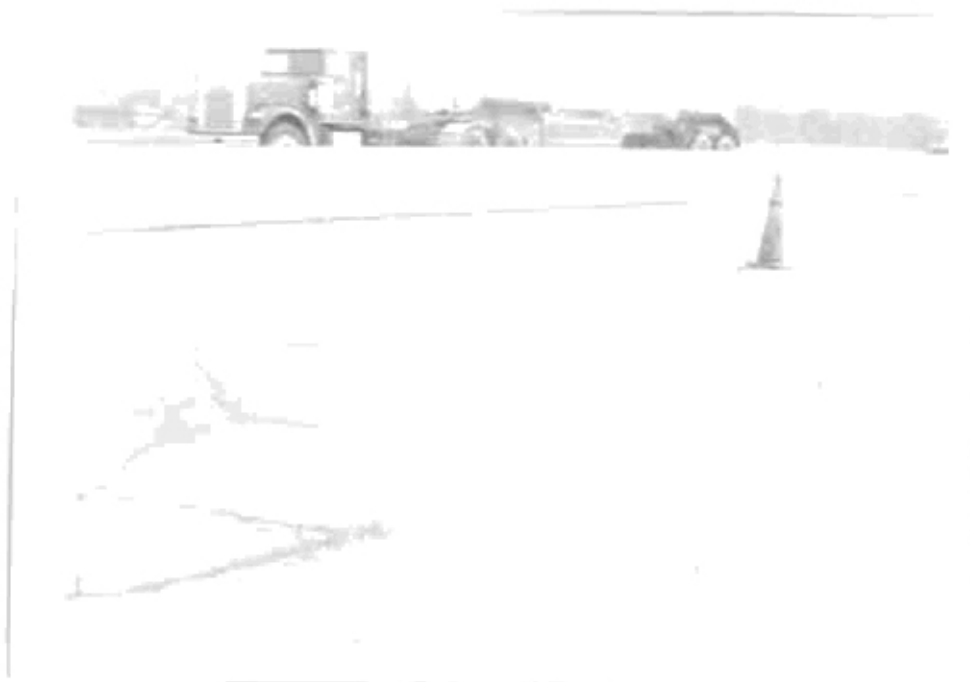
Figure 3. Typical cracking pattern prior to paving.

Crack maps were prepared for the evaluation section. Cracking was very extensive so only the transverse cracks were recorded. On the average there were about 14 transverse cracks per 100 foot of pavement. It was observed that on the average there was only 1 transverse crack per 100 foot that ran the entire width of the pavement. This type of cracking does not follow the typical thermal cracking pattern that is found in roadways. Thermal cracking in roadways tend to extend the full width of the pavement.

The cracks had began to deteriorate on the edges and there were a number of areas on the mat where the membrane was exposed. These areas ranged in size from 25cm²(4in²)to 0.1m²(1ft²) square. Prior to paving the larger areas were repaired. The membrane was removed and a cold pour material was applied. Typical distress found in the existing overlay on the deck surface is shown in Figures 3 and 4. The removal and repair of the exposed membrane is shown in Figures 5 and 6.

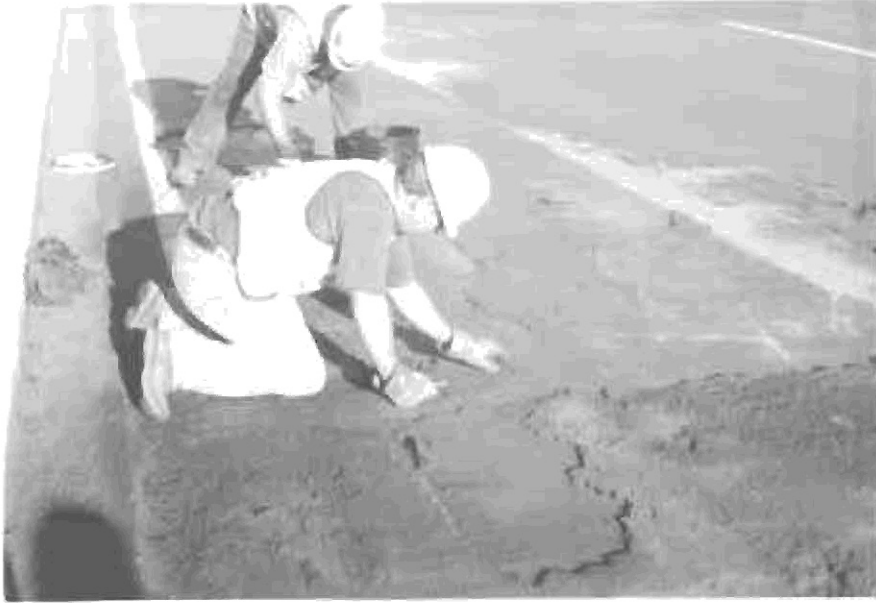
Figure 5. The exposed membrane was removed.

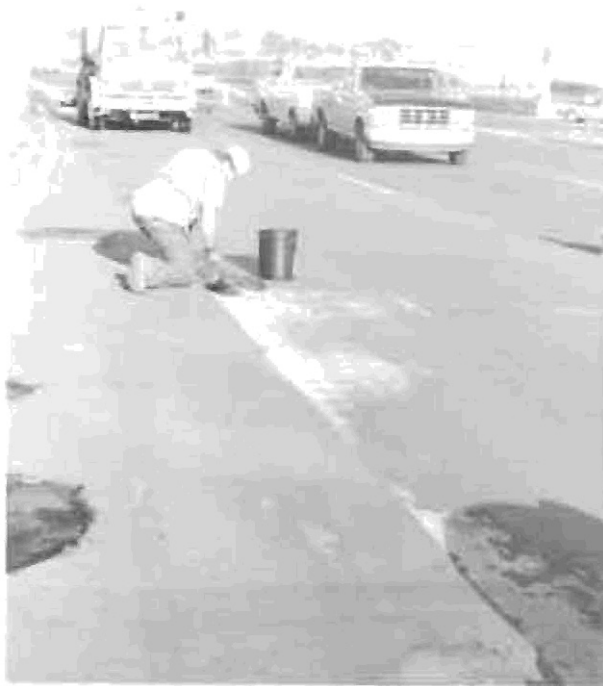
Figure 6. A cold-pour material was used to cover the area where the membrane was removed.

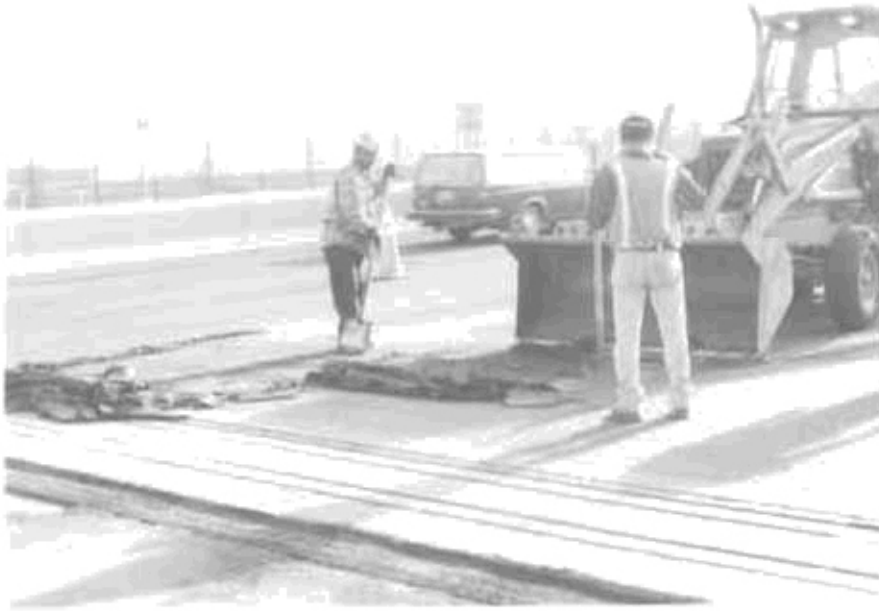
Figure 7. Removing the taper at the expansion joint.

Tapers were placed at all expansion joints once the pavement was milled. These tapers were removed prior to placing the SMA pavement. Although hand work is difficult with SMAs the contractor did not have much difficulty working with the SMA material at the expansion joints.

Figures 7 and 8 show the preparation at the expansion joints. Figure 9 shows the required hand work at the expansion joint.

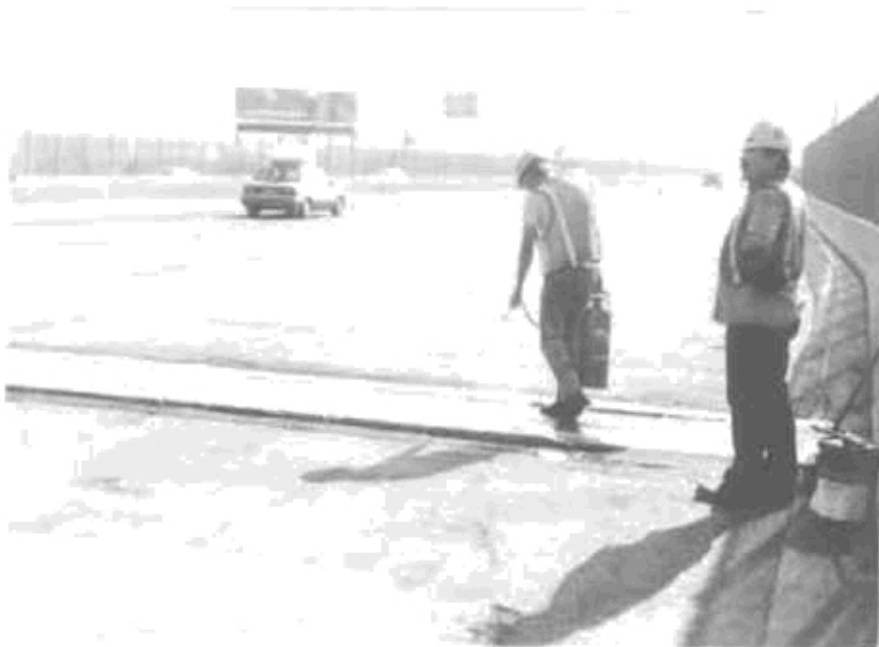
Figure 8. Preparing the joint prior to SMA placement.

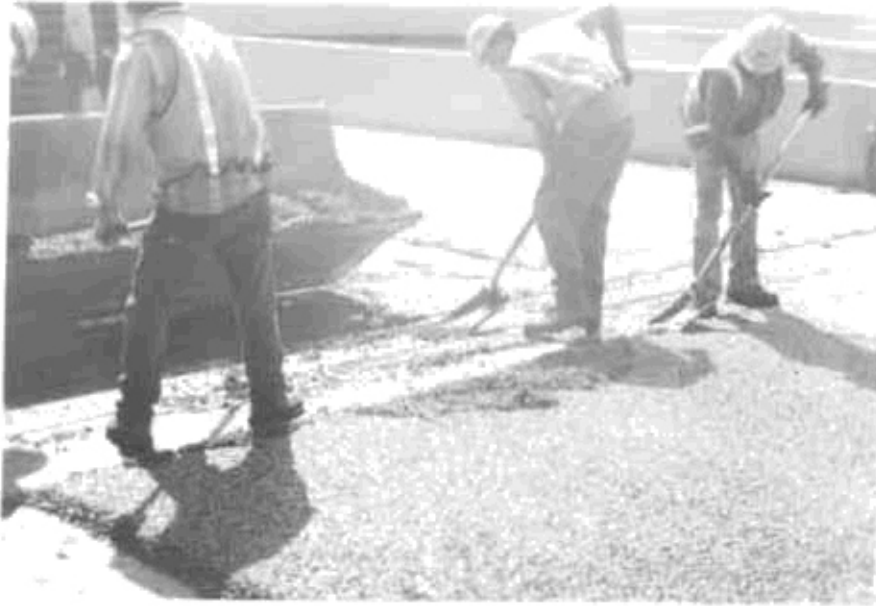
Figure 9. Hand work is required at the expansion joint.

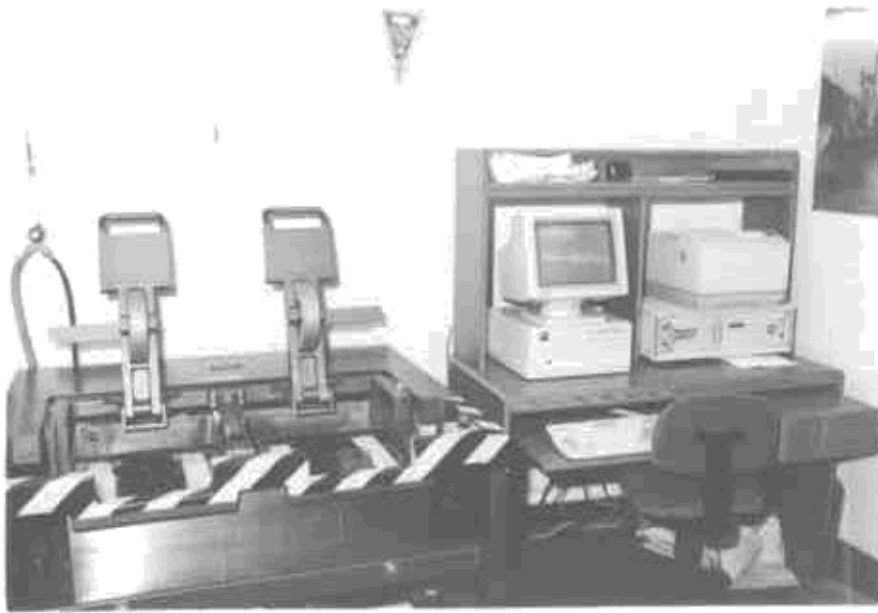
Figure 10. The Hamburg Wheel-Tracking Device.

The Hamburg wheel-tracking device is used to evaluate the resistance of the HBP to moisture damage. It is manufactured by Helmut-Wind Inc. in Hamburg, Germany as shown in Figures 10 and 11.

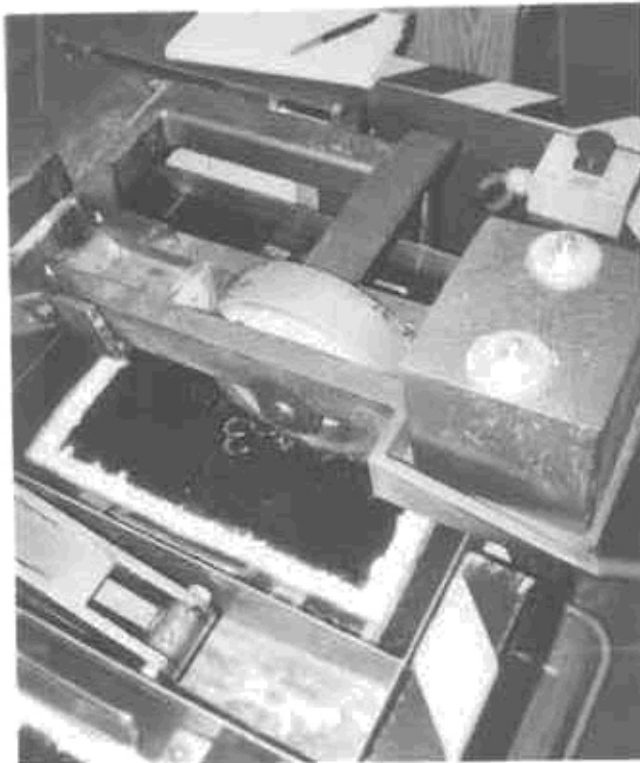
Figure 11. Close-Up of the Hamburg Wheel-Tracking Device.

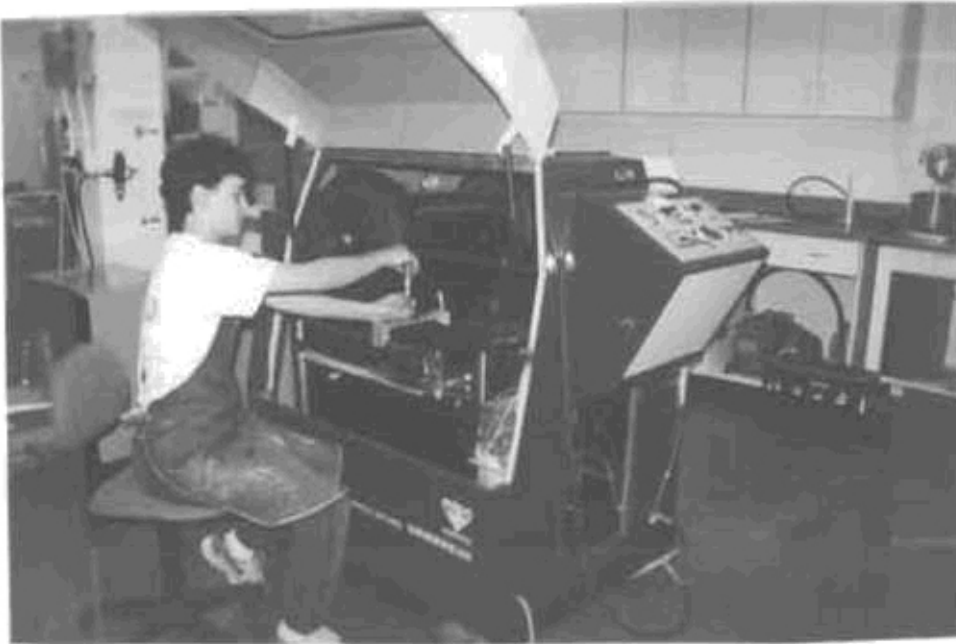
Figure 13. French Rutting Tester.

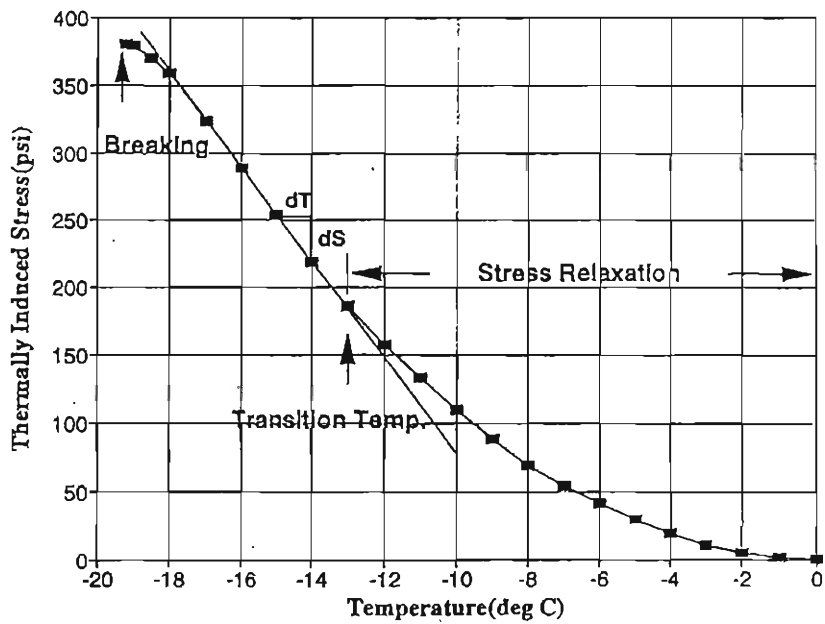
Figure 18. Typical TSRST Test Results.

After a sample is mounted in the TSRST, it is cooled at a rate of 10°C (18°F) per hour. Liquid Nitrogen is used to provide the cooling. The sample is not allowed to contract during the cooling period. The sample length is monitored with LVDTs and the use of invar steel rods. Since the sample is not allowed to contract as it cools, stresses develop within it. A closed-loop system keeps the sample at a constant length. When the developed stress exceeds the strength of the sample, the sample breaks. The temperature and stress at fracture are recorded. A typical plot of the test results is shown in Figure 18.

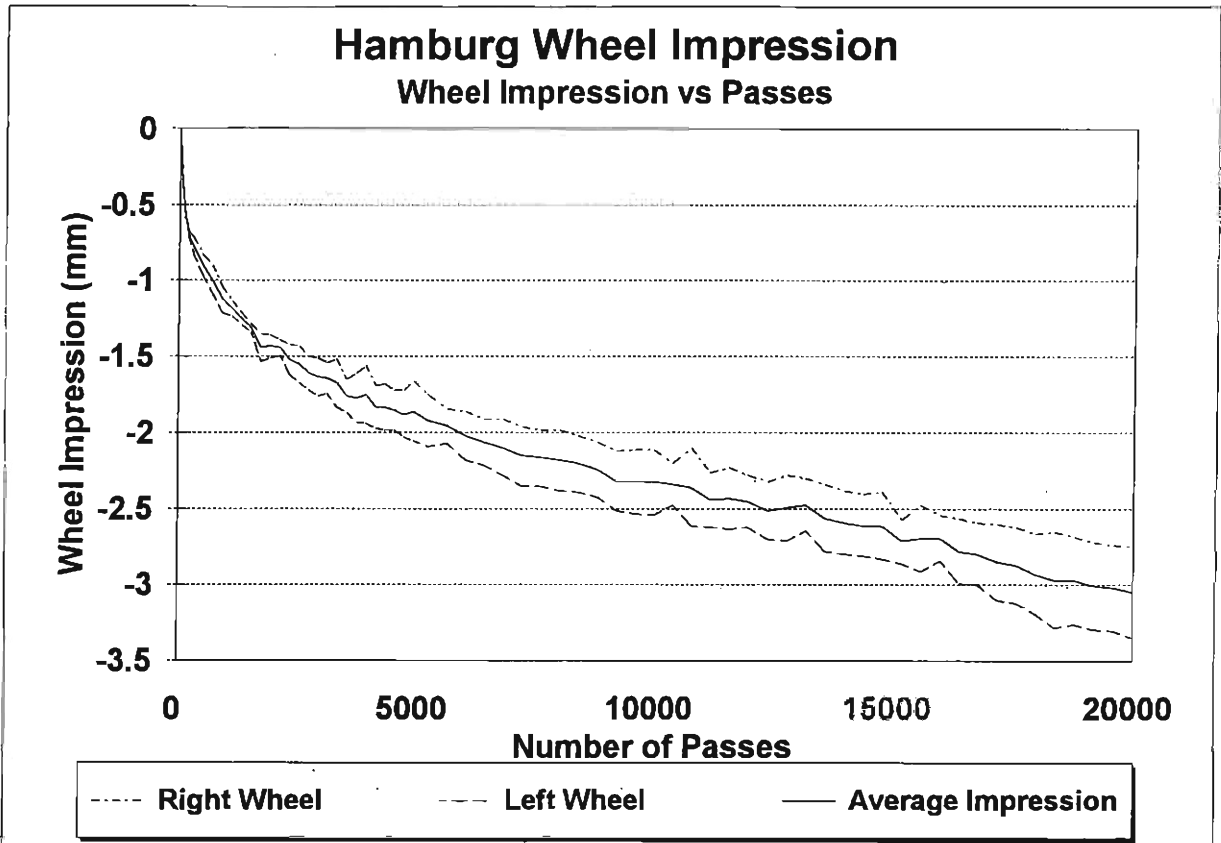
SMA Colfax

Temp: 50° C
