Report No. CDOT-DTD-R-2000-5

PERFORMANCE OF GEOSYNTHETIC- REINFORCED WALLS SUPPORTING THE FOUNDERS/MEADOWS BRIDGE AND APPROACHING ROADWAY STRUCTURES

**REPORT 1: DESIGN, MATERIALS, CONSTRUCTION,
INSTRUMENTATION, AND PRELIMINARY RESULTS**

**COLORADO DEPARTMENT OF TRANSPORTATION
RESEARCH BRANCH**

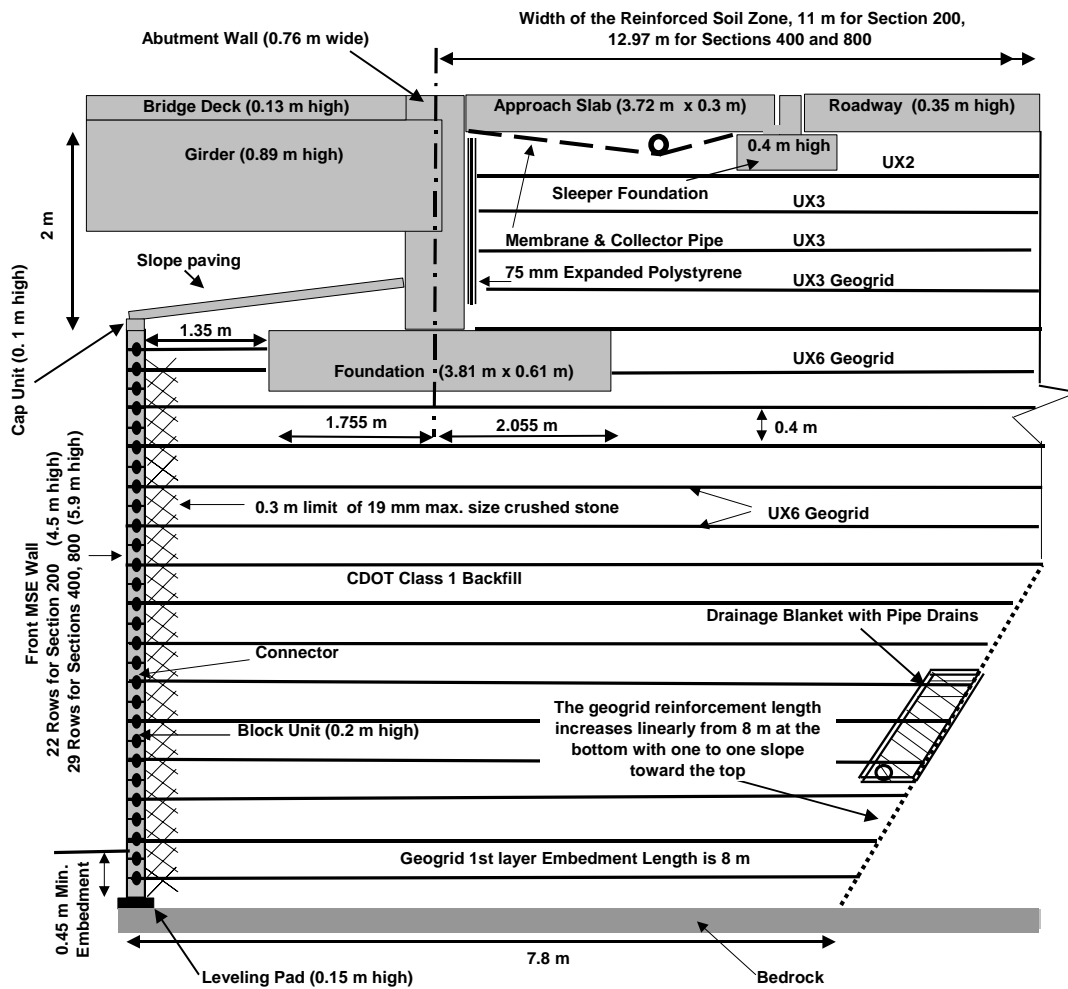
Figure 3. Typical monitored cross-section (sections 200, 400, and 800 in Figure 2) through the front and abutment MSE walls.

Figure 3 shows a typical monitored cross-section through the front MSE wall and abutment wall (sections 200, 400, and 800 in Figure 2). The figure illustrates that the bridge superstructure load (from girders, bridge deck) is transmitted through abutment walls to a shallow strip footing placed

directly on the top of a geogrid-reinforced segmental retaining wall. The centerline of the bridge abutment wall and edge of the foundation are located 3.1 m and 1.35 m from the facing of the front MSE wall. A short reinforced concrete abutment wall and two wing walls, resting on the spread foundation, confine the reinforced backfill soil behind the bridge abutment (see Figures 1, 2, and 3) and support the bridge approach slab. Figure 4 shows a typical cross-section, along the tiered MSE walls, lower and upper MSE wall (sections 300 and 900 in Figure 2). These walls support the approaching roadway structure. Sections 200, 400, and 800 are instrumented and monitored in this study. The bridge is supported by central pier columns along the middle of the structure (Figure 2), which in turn are supported by a spread footing founded on bedrock in the median of Interstate 25.

A compressible 75 mm low-density expanded polystyrene sheet was placed between the reinforced backfill and the abutment walls (Figure 3). It is expected that this system will eliminate the passive earth pressure induced on the fill behind the abutment from the horizontal thermal movement of the structure. In addition, CDOT engineers expect that this system will also reduce the backfill active horizontal pressures on the facing of the abutment wall to half or less of those predicted from Equation 2. This efficient and economical technique has been tried by CDOT for the first time in the Founders/Meadows Bridge and, if its performance is acceptable, it will replace the more expensive flow-fill technique.

Infiltration of water into the reinforced soil mass may lead to loss of shear strength and reduced stability against sliding along the relatively impermeable claystone bedrock. It can also lead to migration of the fines out of the soil mass which would soften the soil mass. This will cause problems ranging from soil settlement (leading to bridge bump) to cracks at the top of MSE walls. Several measures were implemented to prevent surface run-off water and ground water from getting into the reinforced soil mass and the bedrock at the base of the fill. This included the placement of impervious membranes with collector pipes at the top of the reinforced soil (Figures 3 and 4) to intercept surface runoff water. Also, a drainage blanket (1 m high minimum) with pipe drains was placed directly behind the reinforced soil zone (see Figure 3) to divert any infiltration and ground water from the reinforced soil mass.

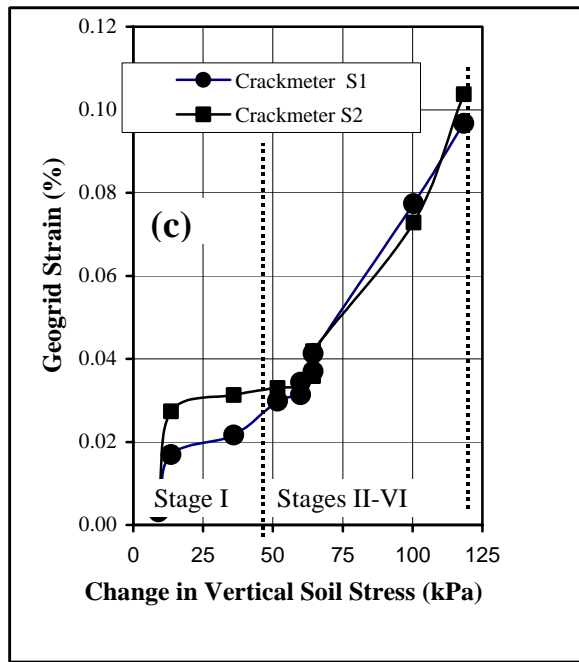
Figure 10. Measured and estimated data on section 400 of the phase I structure: (a) Vertical Stresses, (b) Horizontal Stresses, and (c) Geogrid Strains.

The measured geogrid strains versus the estimated soil vertical stresses at various construction stages are shown in Figure 10c. The Figure indicates that the measured geogrid strains from two crackmeters correlate well with each other. The geogrids experienced very low strains, on the order of 0.1 %. As shown in Figure 10c, sharp increases in geogrid strain developed immediately after the backfill was placed on top of the gauges, possibly influenced by compaction. The rate of strain decreases significantly during the rest of stage I construction and during stage II construction. Finally, the rate of geogrid straining increased steadily during construction stages III through VI.

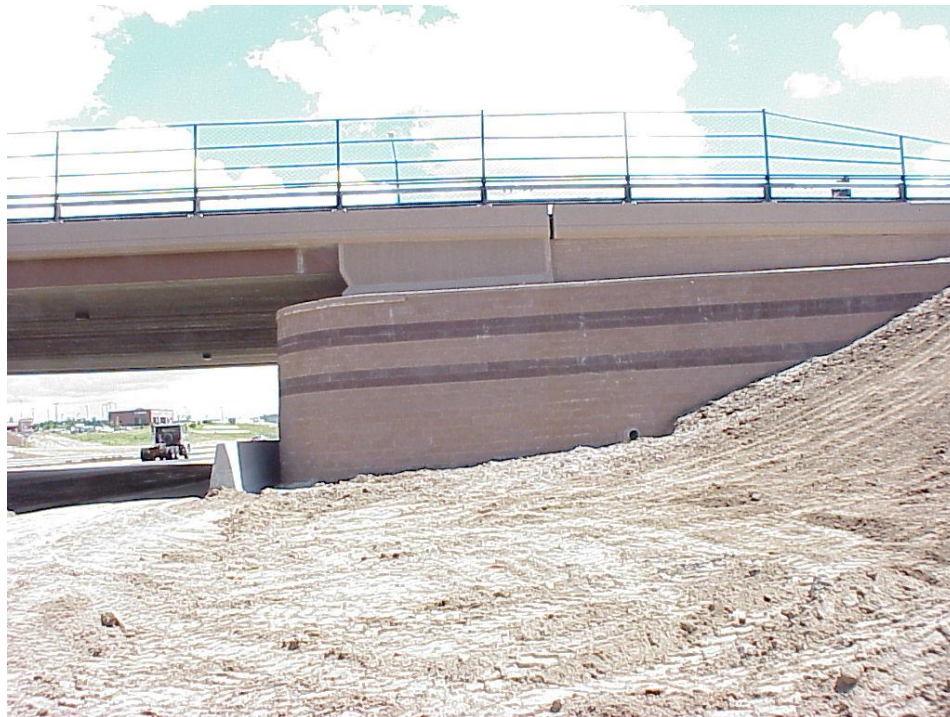
Figure B-1. A view of the northwest side of the completed Founders/Meadows bridge-approaching roadway structure showing lower and upper MSE walls, wing walls, and girders.

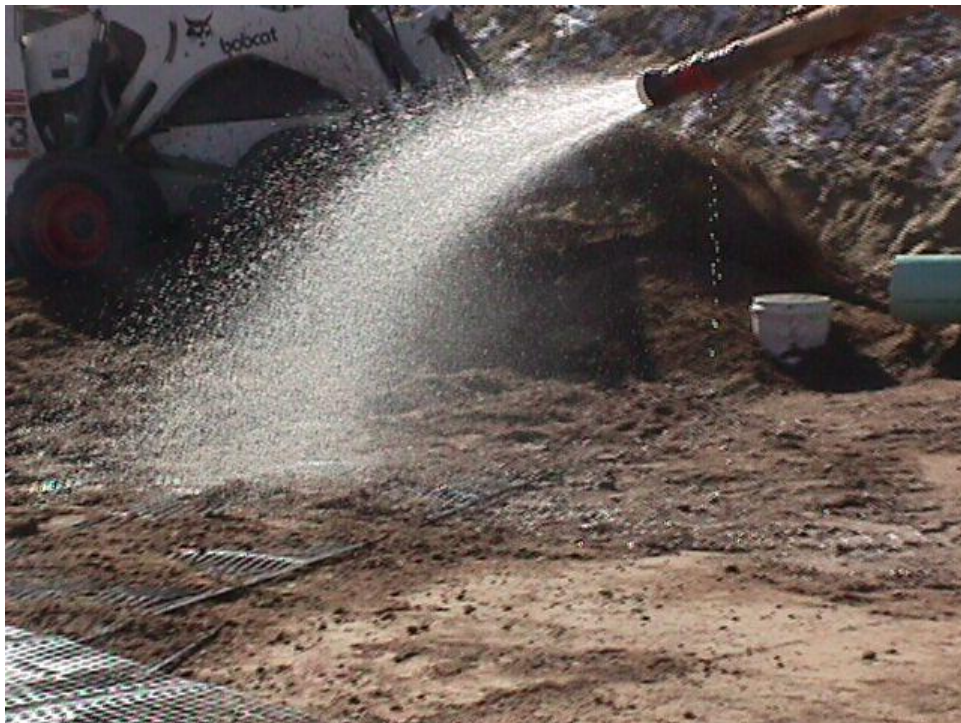
Figure B-14. Water was added before the fill was compacted.

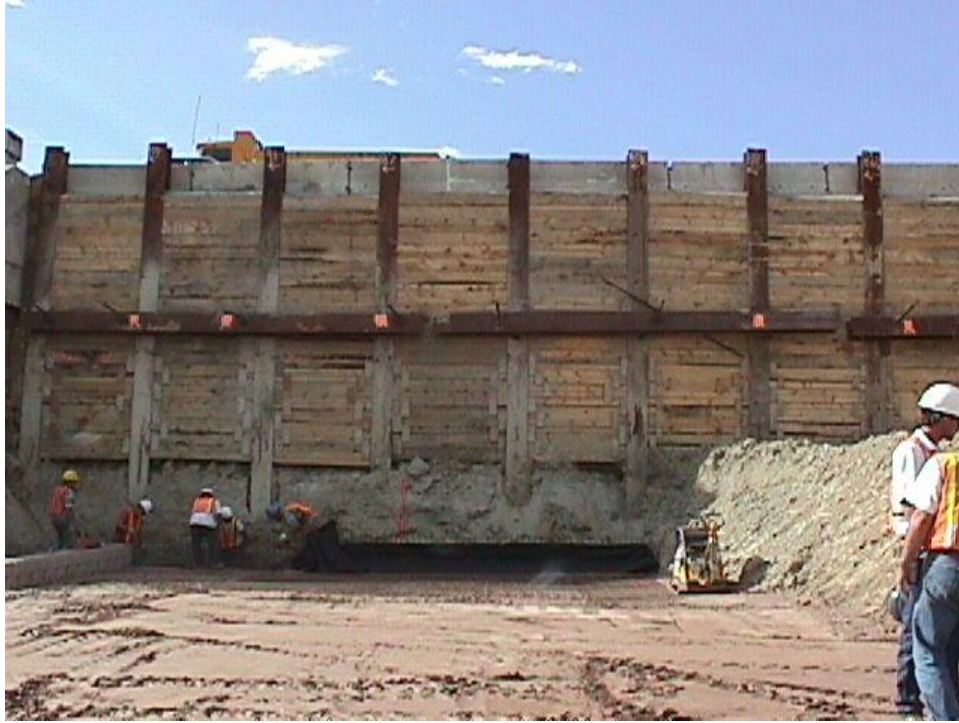
Figure B-17. The first layer of fill material at the east side of the Phase I Structure has been placed. In the background, H-beams and shoring support the approach to the old bridge during the construction of the Phase I Structure.

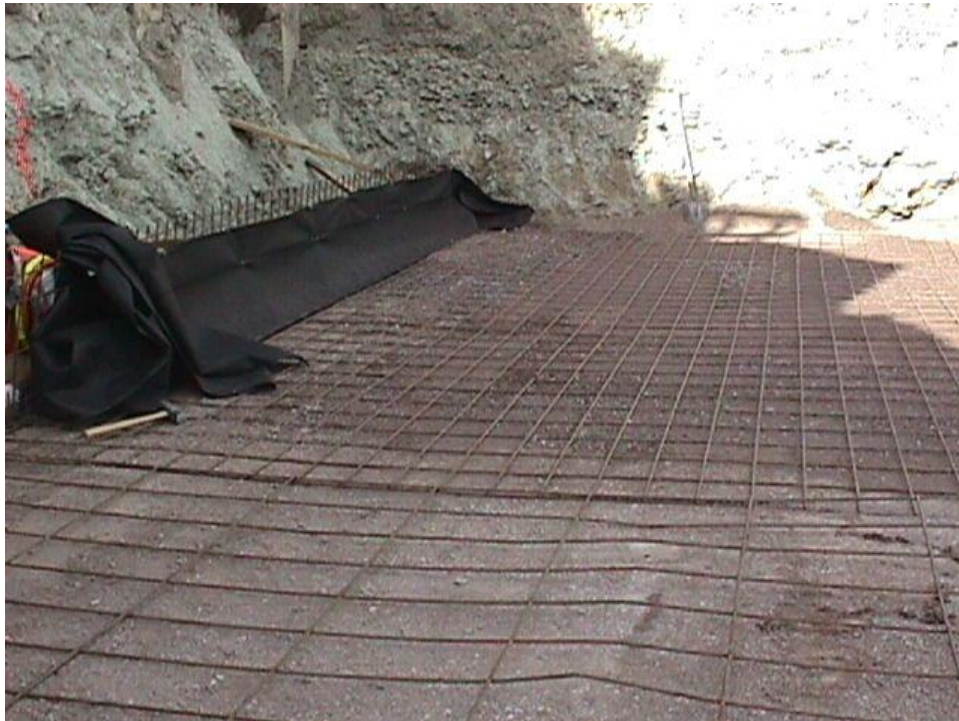
Figure B-18. The northern side of Phase I structure was internally stabilized with steel wire mesh. The steel extended past the edge of the wall and was tied to the geogrid placed to stabilize the front MSE wall.

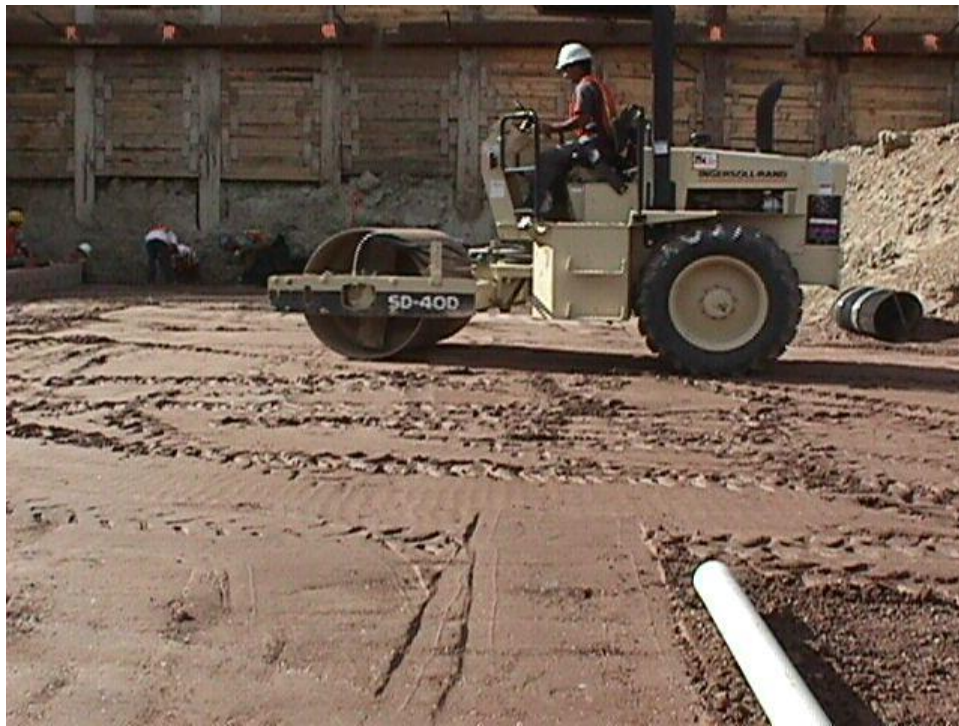
Figure B-21. A vibratory roller was used to compact the fill material.

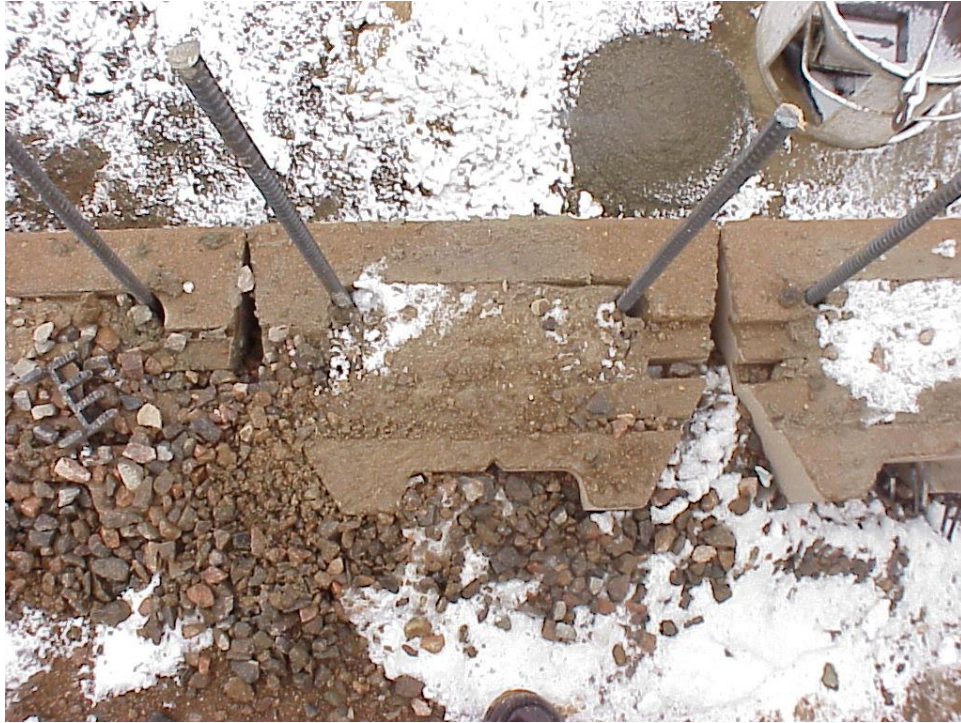
Figure B-27. The top two rows of blocks were filled with concrete. Steel rebars inserted in the plastic concrete were later bent over to tie the concrete cap at the top of the front MSE wall.

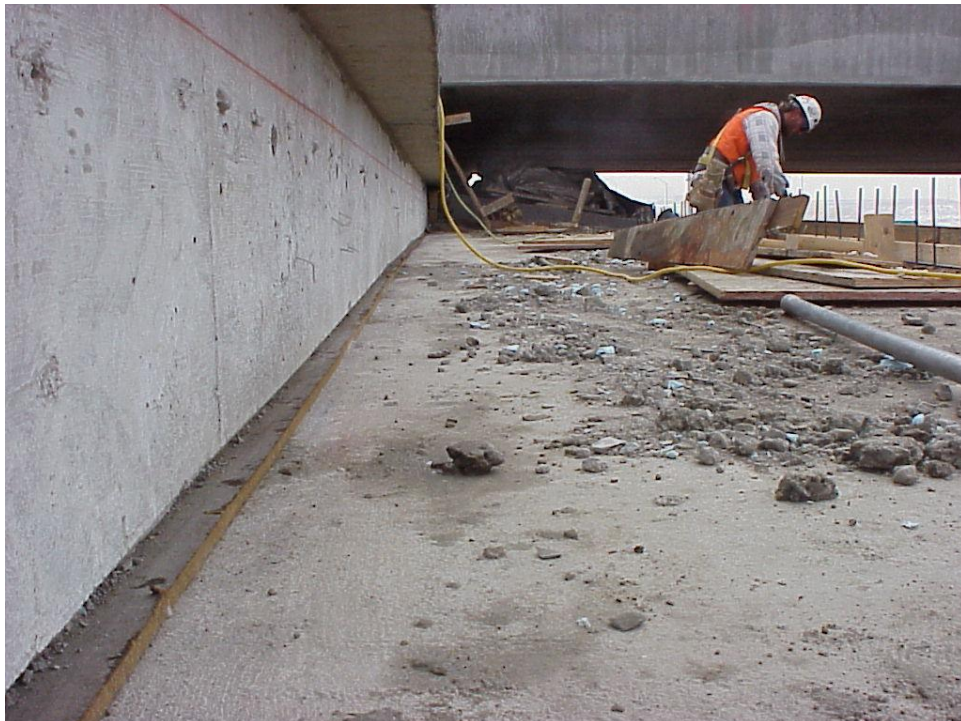
Figure B-28. Expansion joint material was installed below the sides of the abutment wall on top of the footing. In the center zone below the abutment wall on top of the footing, galvanized sheet metal centered on a bearing pad was placed (see figure 29).

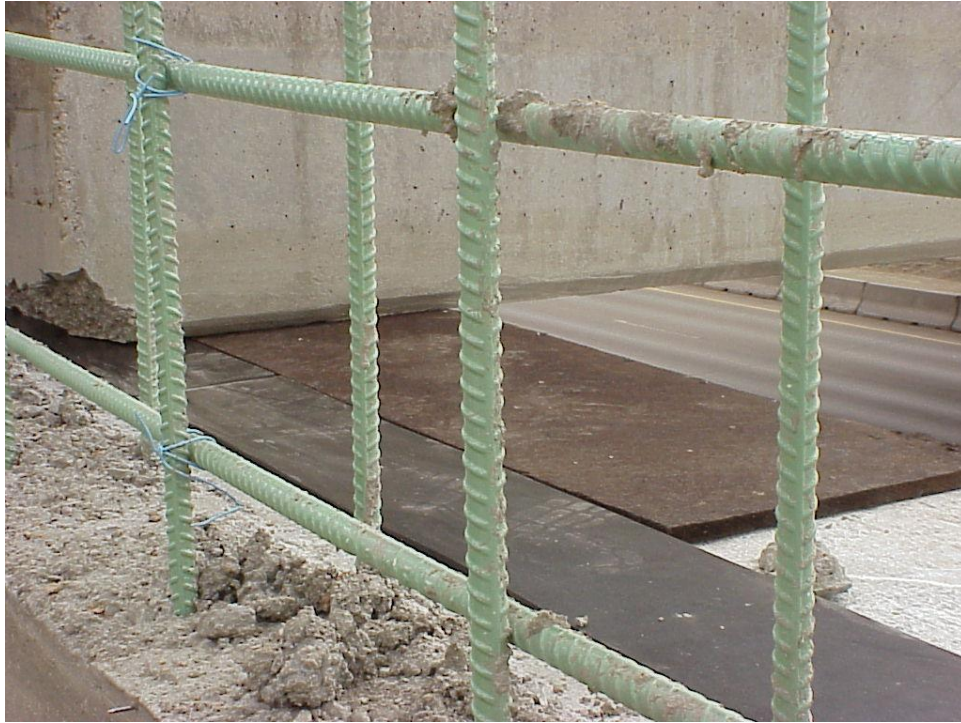
Figure B-31. The elastomeric bearing pad and expansion joints material placed on the abutment wall where girders will be seated.

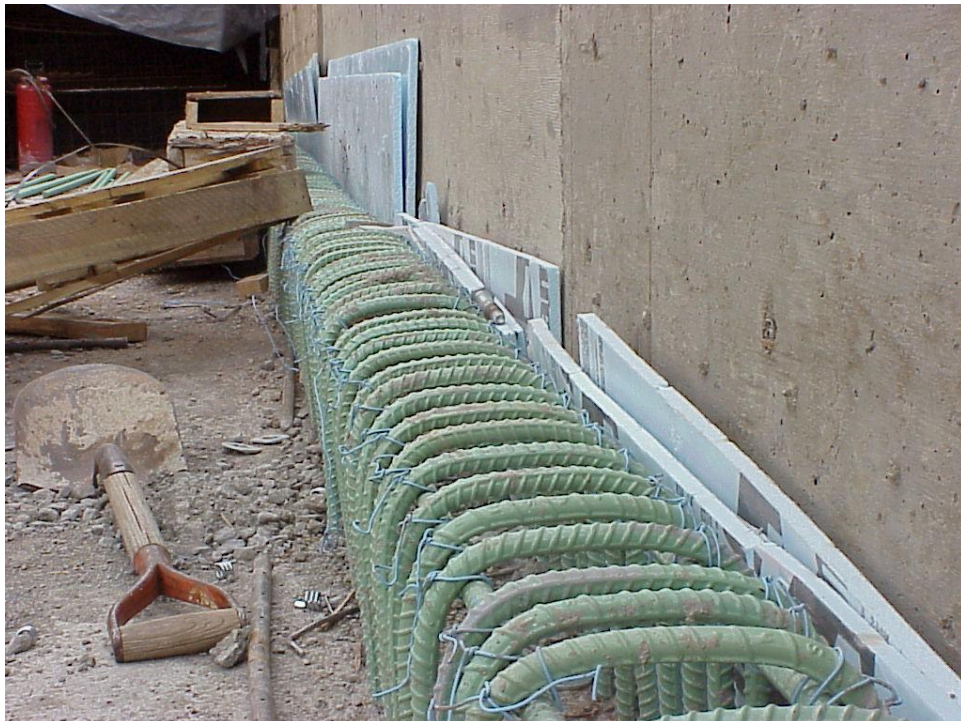
Figure B-32. A reinforced concrete “kicker” strongly attached to the bridge foundation was placed behind the bottom of the abutment wall. This kicker was placed to provide an extra bracing at the top of MSE wall for global stability.

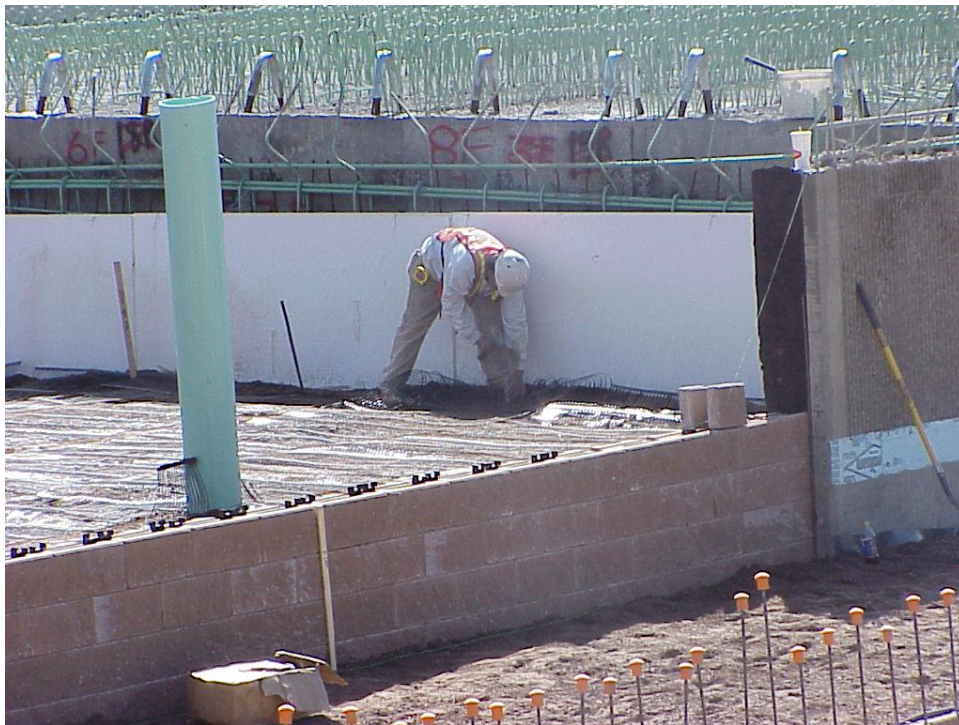
Figure B-36. The wrapped geogrid behind the abutment wall.

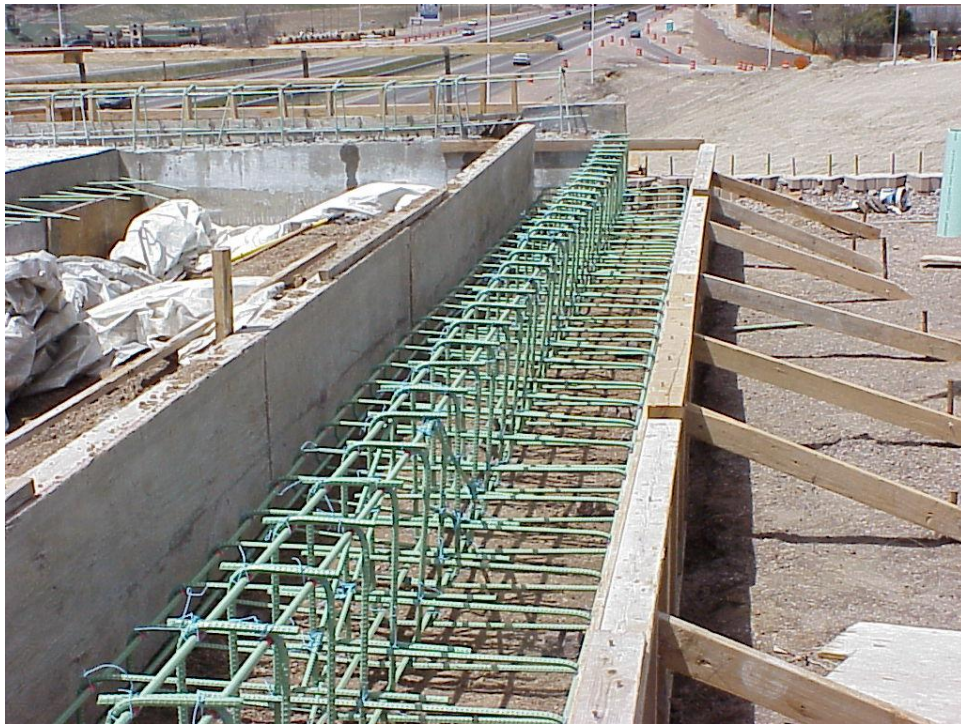
Figure B-42. The forms and reinforcing steel for the sleeper foundation supporting the approach slab.
