**Report No. CDOT-DTD-R-2003-13  
Final Report**

**STUDIES ON THE USE OF HIGH-  
PERFORMANCE CONCRETE AND FRP  
REINFORCEMENT FOR THE I-225/PARKER  
ROAD BRIDGE**

**P. Benson Shing  
Yunping Xi**

**December 2003**

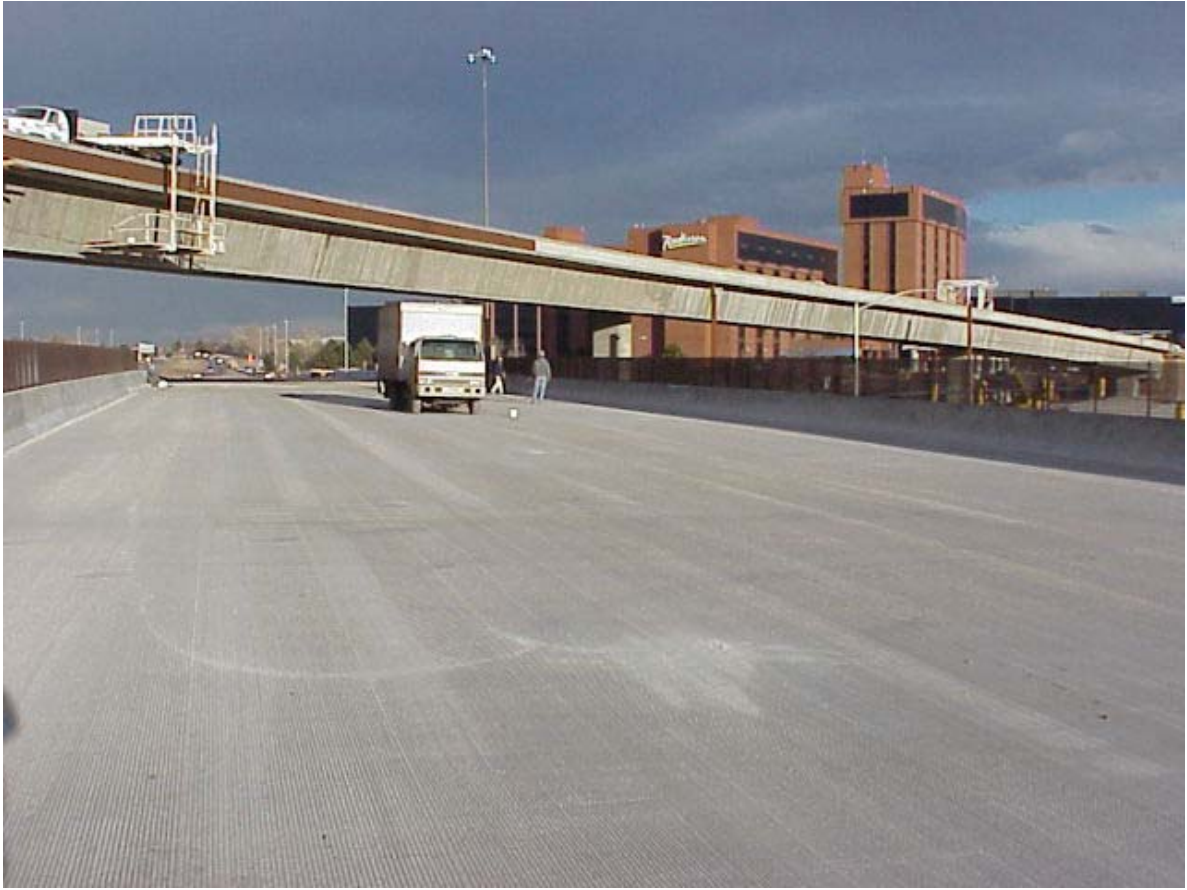
Figure 1.1 – I-225/Parker Road Bridge under Construction

The Colorado Department of Transportation (CDOT) recently completed a bridge structure at the I-225/Parker Road Interchange southeast of Denver using innovative construction materials. As shown in Figures 1.1 and 1.2, the bridge consists of post-tensioned cast-in-place reinforced concrete box girders with precast prestressed panels as stay-in-place forms and a cast-in-place topping slab for the deck. Part of the bridge deck was constructed of a crack resistant high-performance concrete (HPC) mix and fiber reinforced polymeric reinforcement (FRP) under the sponsorship of the Innovative Bridge Research and Construction (IBRC) program of the Federal Highway Administration (FHWA). The goal of this was to explore the use of innovative materials to prolong the life span of a bridge by reducing corrosion problems.

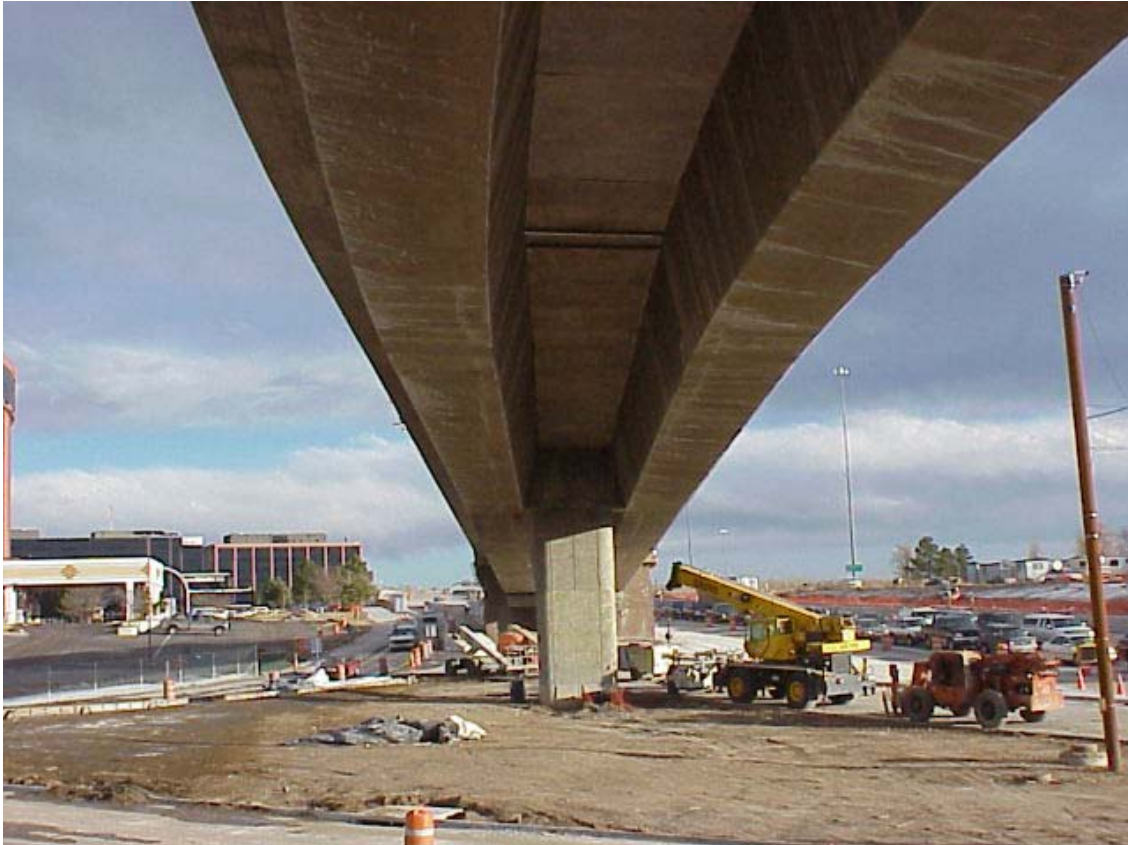
Figure 1.2 – Precast Panels Supported on Two Box Girders

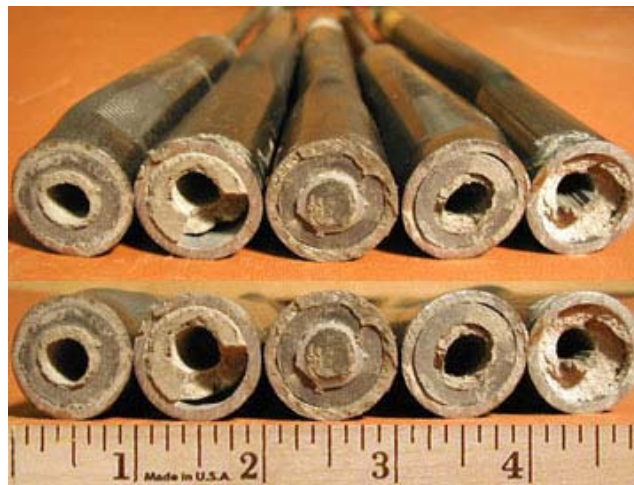
Figure 3.4 - Unconditioned CFRP Grip Failure

Figure 3.4 shows the failure of the carbon fiber bars near the grips. The cement binder did not provide adequate bond strength to prevent pullout from the anchorage before failure in the free-length of the specimen could occur. A supplementary anchorage system was designed using epoxy.

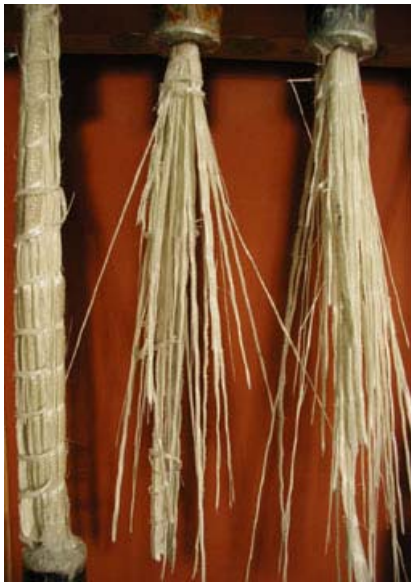
Figure 3.5 - Failure Mode of 1/2" GFRP<sub>R</sub>

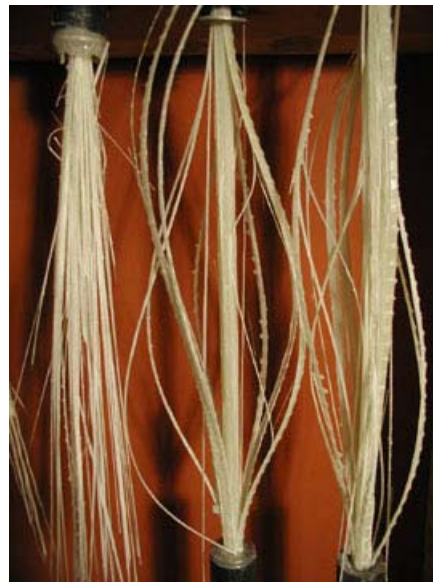
Figure 3.6 - Failure Mode of 3/8" GFRP<sub>S</sub>

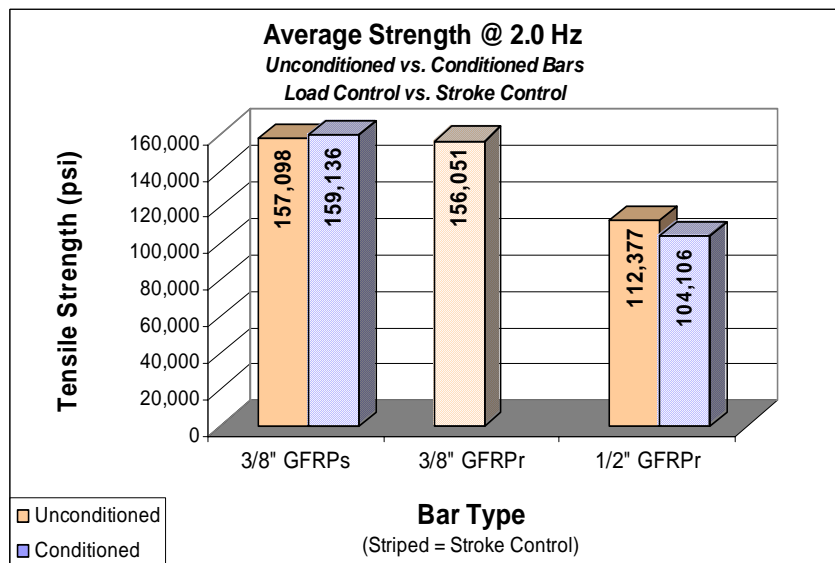
Figure 3.14 - Average Strength at 2.0 Hz

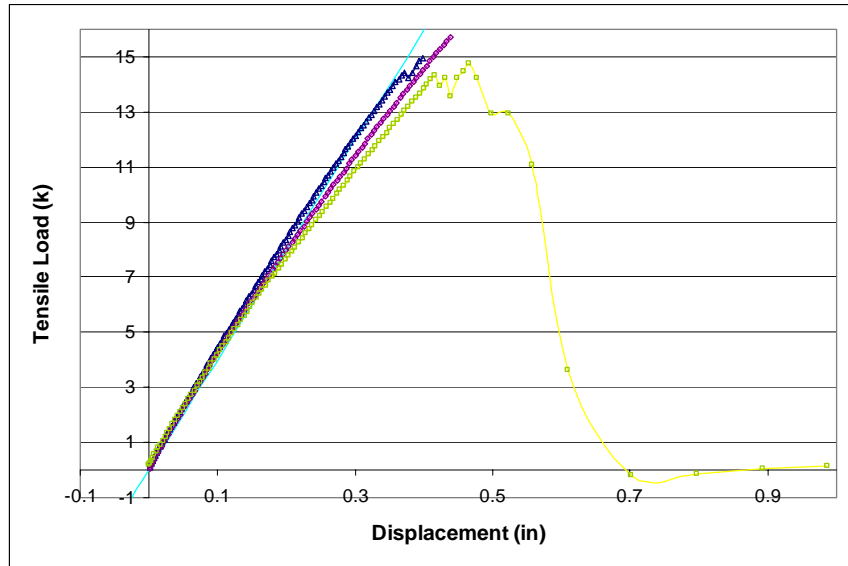
Figure 3.15 - Linear Elastic Behavior to Failure

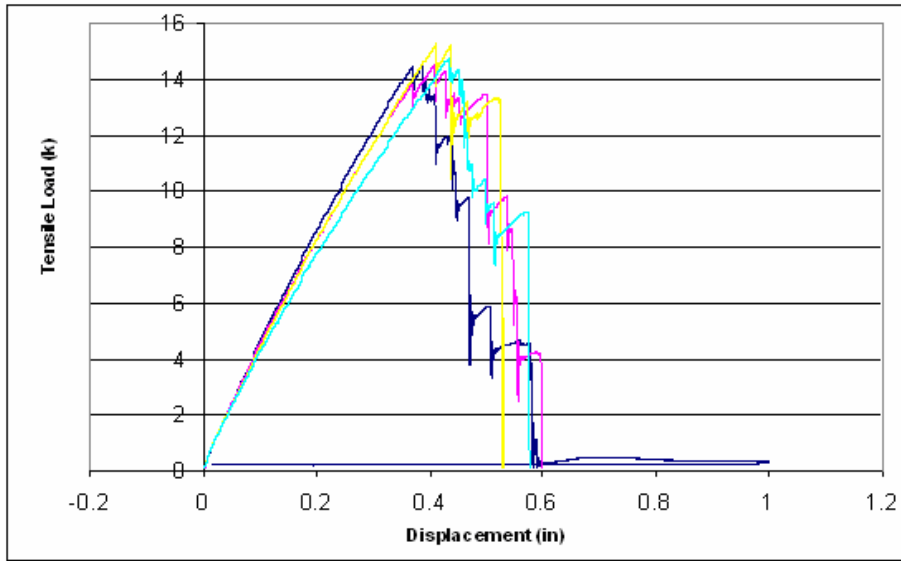
Figure 3.16 - Linear Behavior with a Non-Linear Region of Cyclic Load Reductions after Failure

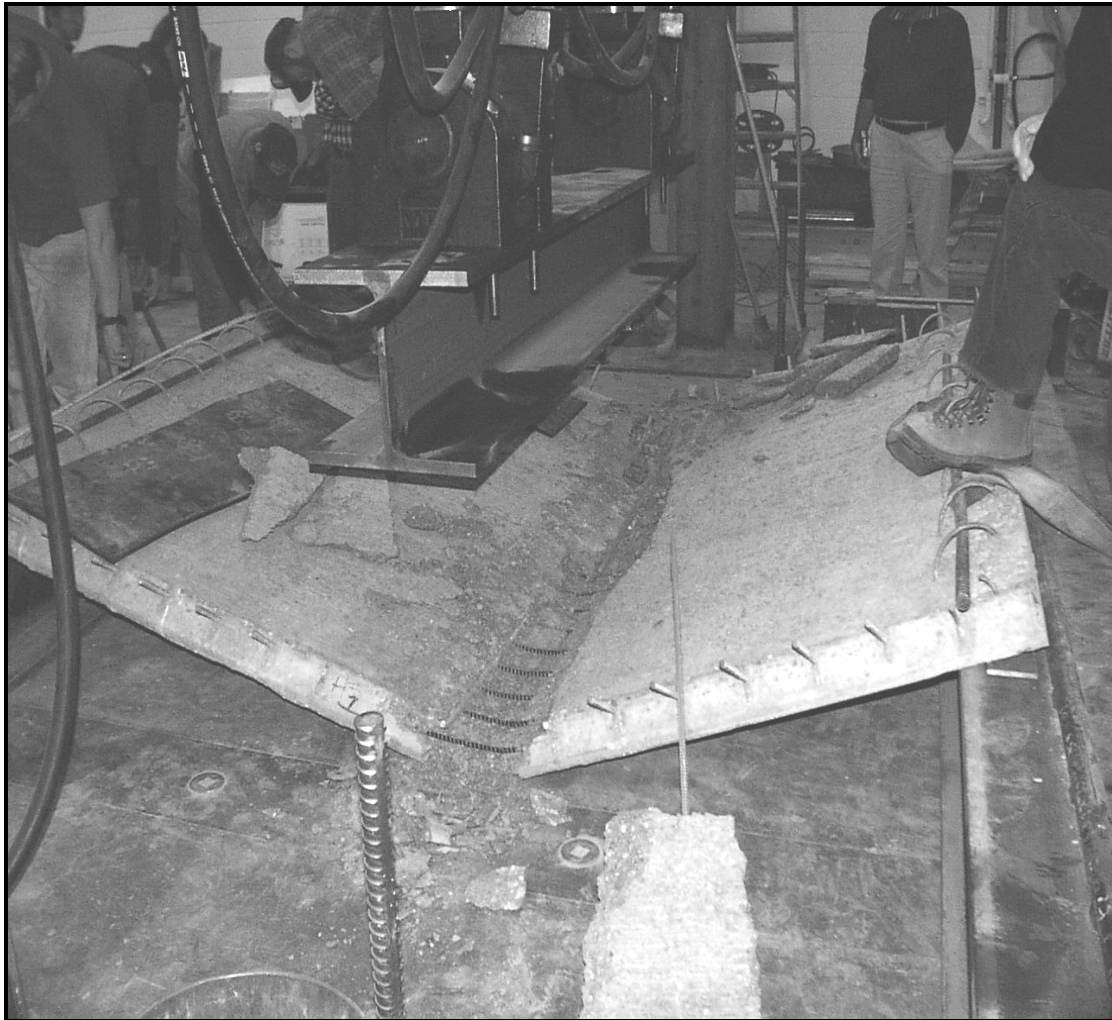
Figure 4.11 - CDOT Panel Failure

considerable duration. Then, without warning, the strands ruptured and the slab cracked into two halves and fell to the floor. Although development length was the governing criterion for the design giving nominal load capacities of 75.3 kips considering the entire width of the slab and 68.1 kips considering the equivalent width of AASHTO, no bond slip occurred.

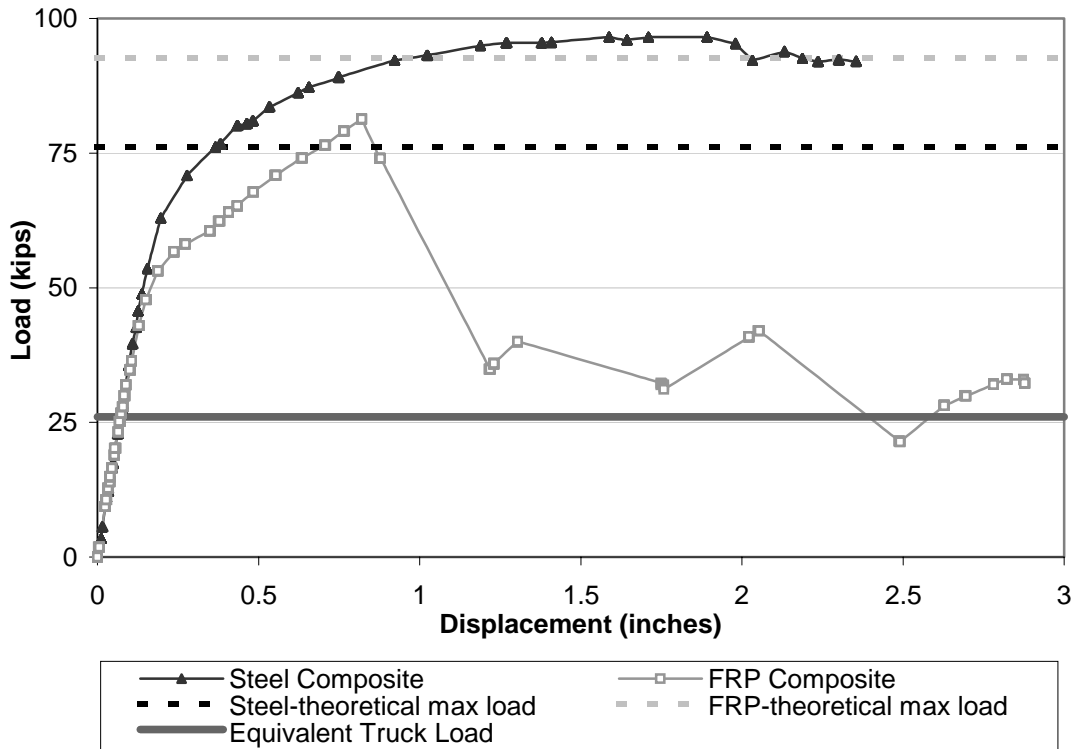
Figure 4.12 - Load vs. Displacement Curves for the Composite Slabs (the theoretical maximum loads were calculated with a full panel width)

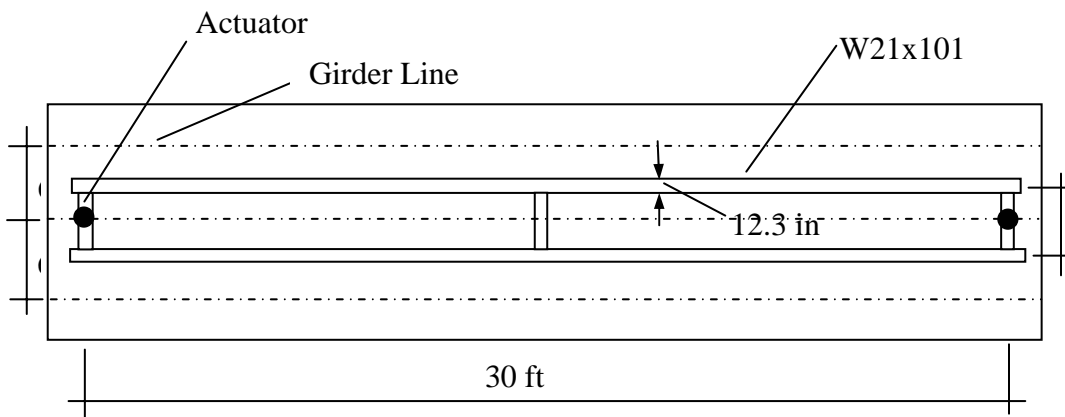
Figure 5.8 – Setup for Fatigue Test

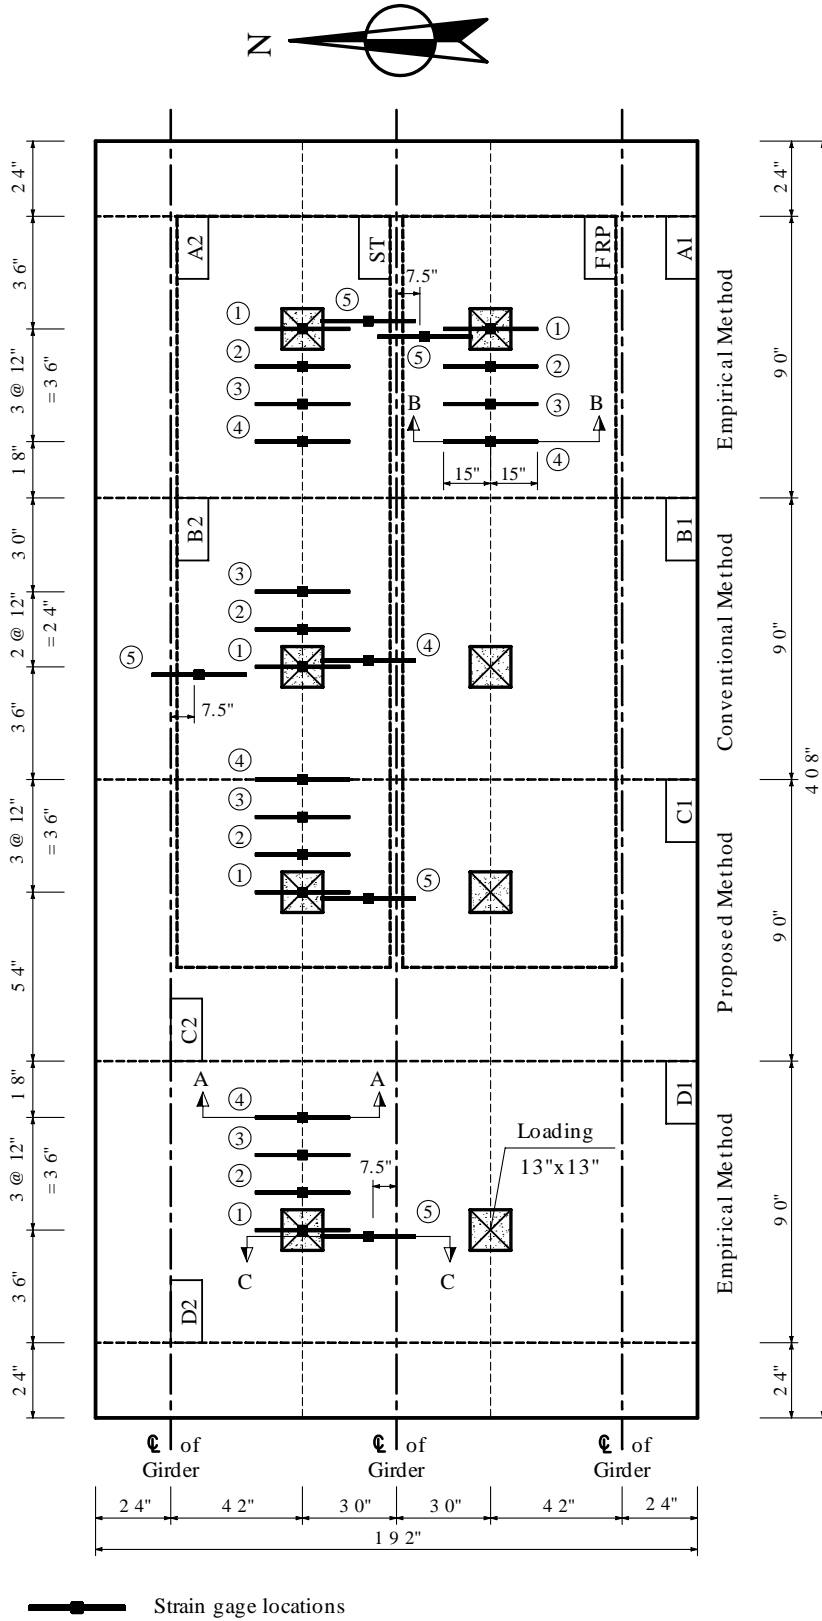
Figure 5.11 – Strain Gage Scheme

Figures 5.11 and 5.12 show the exact locations and numbering of the strain gages. The strain gages in the cast-in-place portion of the deck were glued onto rebars as shown by Sections A-A and C-C in Figure 5.12. Two bars were installed at each location to obtain two strain readings along the depth of the slab. In regions where there were precast panels, only one bar could be used at each location as shown by Section B-B in Figure 5.12. To have two strain readings at each location in this region, a surface gage was attached to the bottom of the slab. Figure 5.13 shows the attachment of strain gages to rebars, which were later embedded in concrete at the designated locations. Each bar had two strain gages along its circumference, and was oriented in such a way that one gage was at the top and the other at the bottom to average out the localized bending effect of the bar.

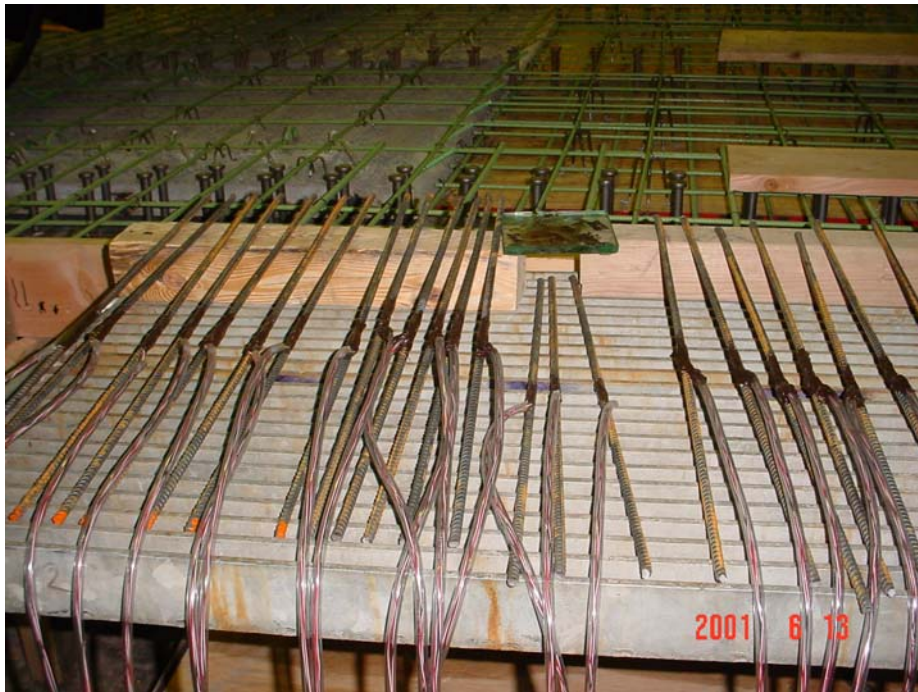
Figure 5.13 – Bars with Strain Gages
