**Report No. CDOT-DTD-R-2003-10**

# **MAILBOXES AND MOUNTING SYSTEMS**

**COLORADO DEPARTMENT OF TRANSPORTATION  
RESEARCH BRANCH**

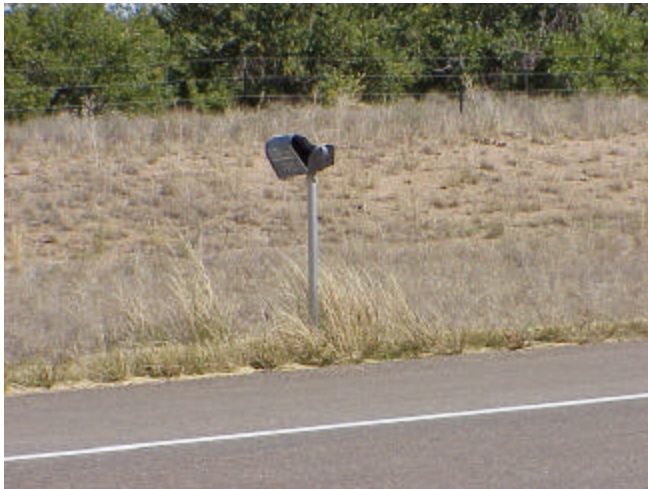
**Figure 1. Mailboxes mounted near high-speed highways are susceptible to damage from the blast of snowplow during the winter.**

A mailbox located next to a rural high-speed highway is in a harsh environment. During the winter, when snowplow clear the highway, the heavy, wet snow and ice in the blast from their blades can do considerable damage to the mailboxes, often bending them to the point that they become unusable (**Figure 1**).

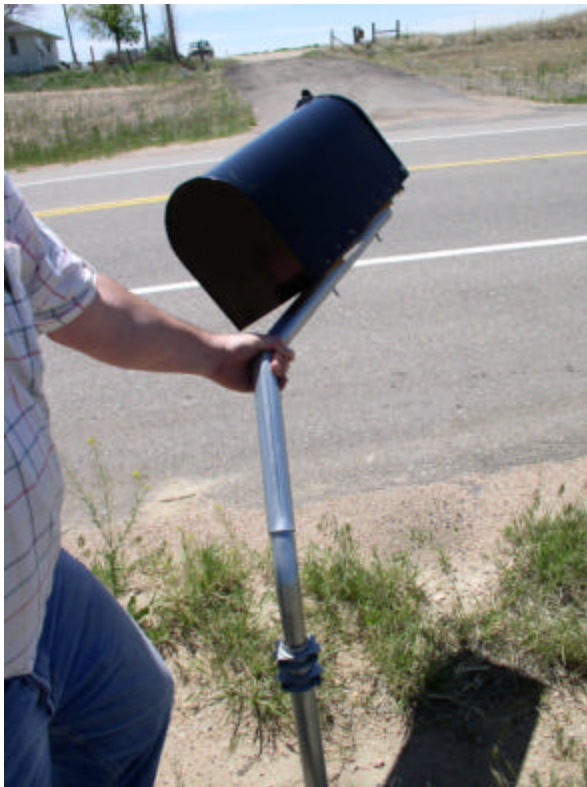
**Figure 2. The box and top section of the mount swing to the side and up.**

**The Friend Innovations system**– A three-piece all-metal post system allows the mailbox to swing to the side when hit by the snow thrown by a passing plow. The swinging action of the mount absorbs most of the impact from thrown snow, slush and ice. The geometry of the design uses gravity to swing the box back to its original position. The metal box in the picture (**Figure 2**) has survived through the winter with no damage.

A box is bolted to the top piece of the system which is bent about one-third of the way along its length at a 45° angle. The short arm of the top piece then slips over the top of the middle pipe but is not fixed to it. This allows the top section to pivot when the box is hit. The middle section, which is bent at a 45° angle near its center, is tightly clamped at the bottom to a straight 24” long vertical base pipe. The base pipe is in turn

bolted to a section of U-post that is driven so its top is 4” above ground level. The U-post is set back 46” from the edge of the pavement.

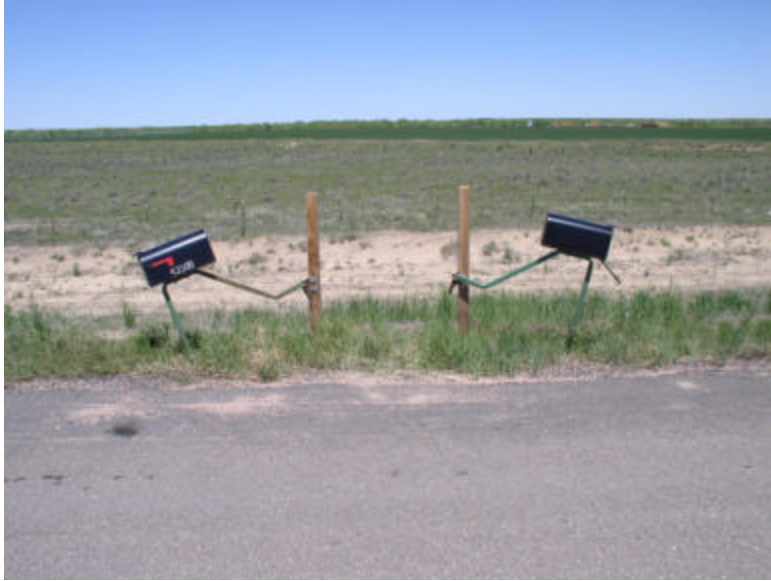
**Figure 3. The Roadside Safety Devices mounting system does not reliably return to the centered position.**

**The Roadside Safety Devices system** – Mailboxes mount to a long metal arm that attaches to a pivot bolted to a 4” x 4” wood post. This system is designed to allow the box and arm to swing away from the plow blast. The assembly should then re-center itself after the plow has passed. As the picture shows, the mailboxes were not damaged during the winter. However the system does not return the box to

the centered position reliably. Both of these boxes would be difficult for the mail carrier to reach.

Close examination of the two-piece pivot mounts on the two boxes in **Figure 3** showed two

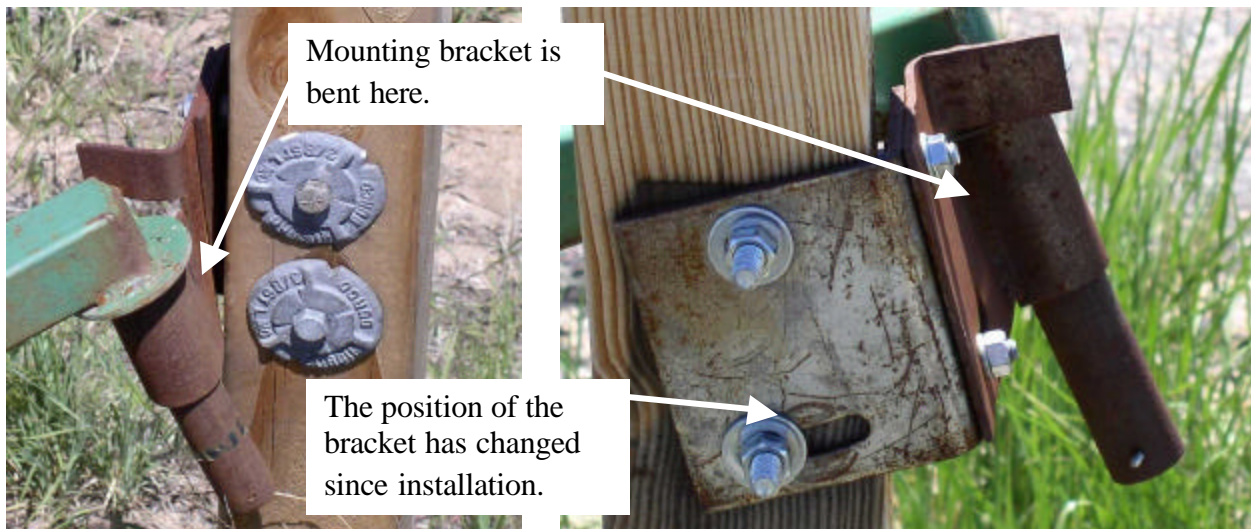
**Figure 4. Close-up pictures of the two mounts in Figure 3. Both brackets are bent. The bracket in the right picture has gone out of adjustment at the bolts facing the camera.**

problems with the system. The first is due to the fact that on both mounts in **Figures 3 and 4** there is some bending in the mounting bracket piece that holds the pivot sleeve. The bracket on the left post is bent so the pivot sleeve tilts to the left as viewed from the highway; the bracket on

the right is bent at the same point but so the pivot tilts to the right viewed from the highway. The bent bracket changes the angle of the pivot sleeve which changes the normal position of the pivot arm and the mailbox.

The second problem is with the adjustments to locate the normal position of the arm and box. Initial position adjustment of the system is done by setting the relative angles of the two-piece mounting brackets that bolt to the wood post. The adjustments, made by two pairs of bolts, set the initial positioning of the pivot sleeve so the arm returns to the centered position after it is pushed to the side. In the picture on the right of **Figure 4**, marks made on the bracket by the pair of bolts facing the camera show the initial position of the bracket and that the position has changed. Natural expansion and contraction of the wood post, due to changes in its moisture level as the weather changes, will make it nearly impossible to keep these two bolts tight enough to hold this adjustment. This system has the longest arm of the mountings evaluated. That long arm provides considerable leverage against the two adjustments held only by friction between the mount pieces and the wood post.

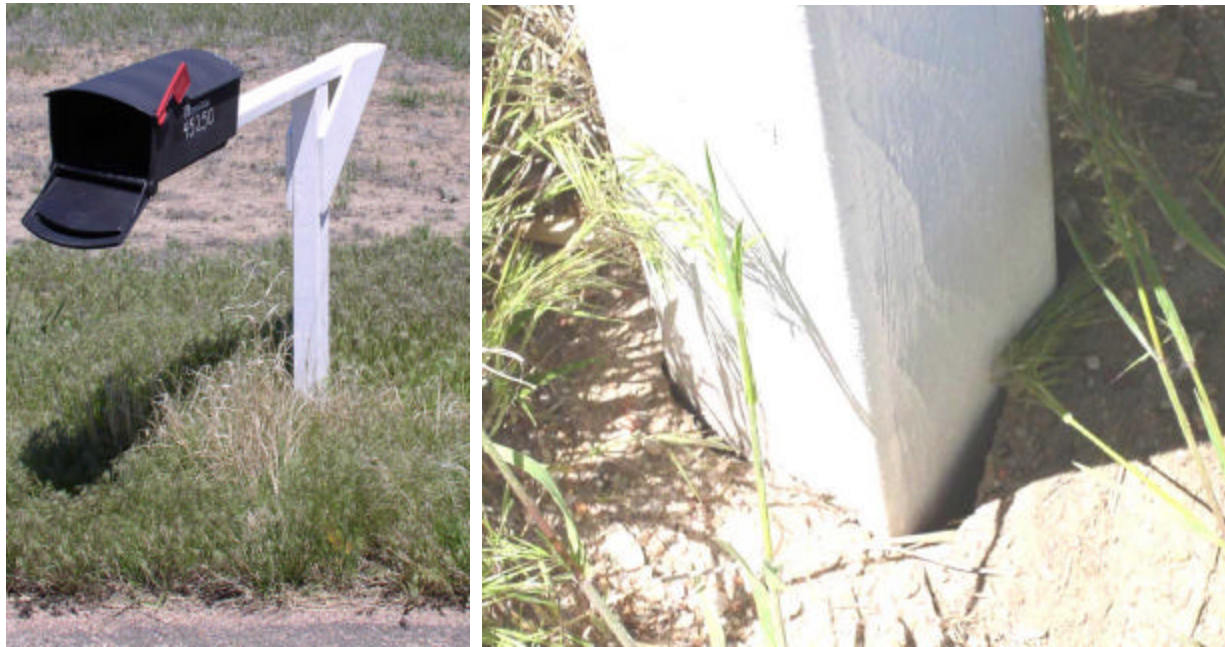
**Figure 5. The plastic box is good condition, but the twisted post shows the effects of being hit by the snow thrown by passing plows.**

**Wooden Mailbox Support system** – An all-wood mount design with a 4” x 4” post and a cantilevered wood arm sets the post 4’ back from the front of the box. This is an inexpensive, easily constructed mailbox mount. However, it is a rigid system; it doesn’t absorb any of the energy from the plow blast. While there is no evidence of damage to the plastic box in **Figure 5**, the photo at the right shows that the force of the plow blasts over the winter has twisted the post in its hole, causing the mailbox to be turned slightly away from the highway.

Plastic boxes, like the one in **Figure 5**, seem to be a better choice for rigid mounting systems. The box appears to be better able to withstand the pounding from the snowplow blasts. The fact that the plastic boxes are wider than the metal ones and have a slightly lower profile may help them resist the force of the blast better.

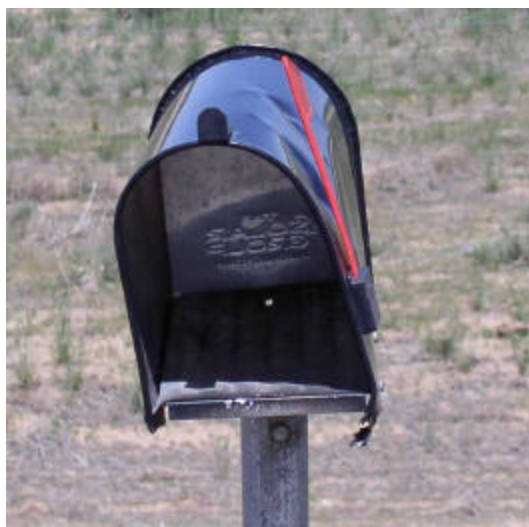
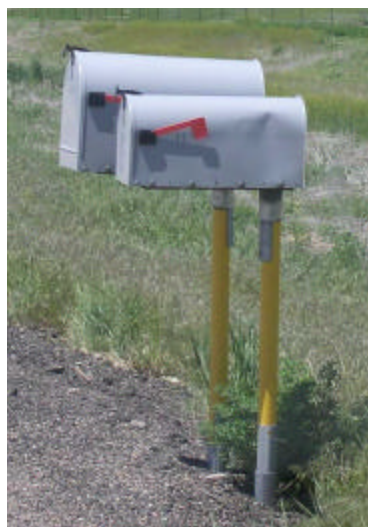
**Figure 6. Damaged metal boxes on rigid post mounts. The post on the left is set at the edge of the pavement, while the two on the right are set about 8' from the edge of the shoulder with a small gravel turn-out to allow close access to the boxes.**

**Figure 6** shows new metal boxes mounted on straight rigid posts. The post in the picture on the left is at the edge of the pavement. The box was replaced

last fall but, as the picture shows, did not stand up well to the winter. The two boxes in the right picture are set about eight feet from the edge of the pavement with a small gravel turn-out to allow mail carrier and homeowner access to them. The near box, while not as severely damaged as the one in the left picture, is slightly bent. Possibly the extra distance from the highway provided a measure of additional protection for these two boxes – the small one almost certainly provided some protection for the large one behind it.
